CITY OF
PITTSBURGH
FACILITY ANALYSIS REPORT

Bloomfield Pool and Recreation Center (B086)
408 Ella Street
Pittsburgh, Pennsylvania 15224

June 16, 2010

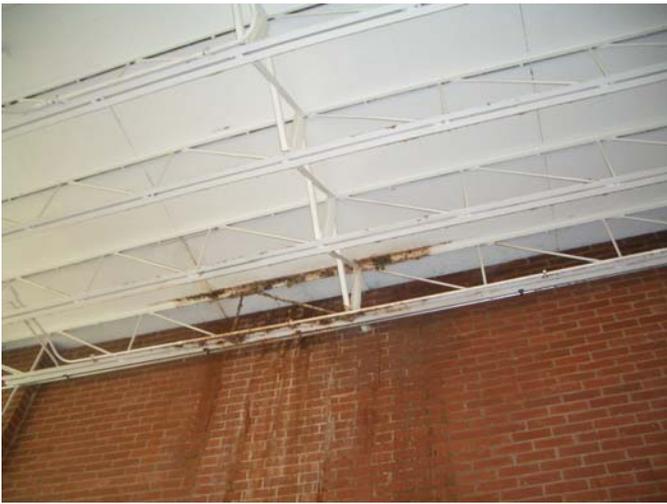
R-1 Underside of Roof in the gym of the main roof area. Leak area.

It is our opinion the roofing systems on the main and porch roof areas should be replaced as soon as possible.

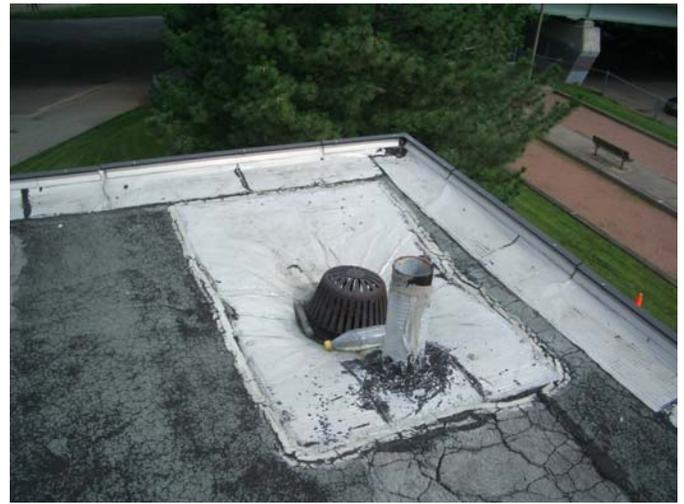
R-4 Roof drain in NE corner of main roof. Debris and crazed roof surface.

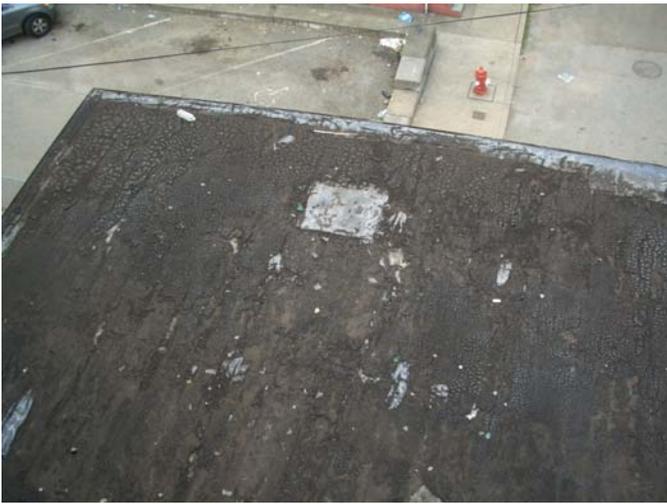
4.2 Condition: The built up roof system on the porch roof is in very poor condition and deteriorated. The modified roof system on the main roof is in poor condition. Some repairs were observed. Numerous leaks are reported and soft spots were felt on the roof surface. Debris was observed at some roof drains. Evidence of ponding water was observed in the center of the roof area. The new modified bitumen roof system being installed on the restrooms appears to be properly installed.

R-7 Porch Roof showing deteriorated roofing system

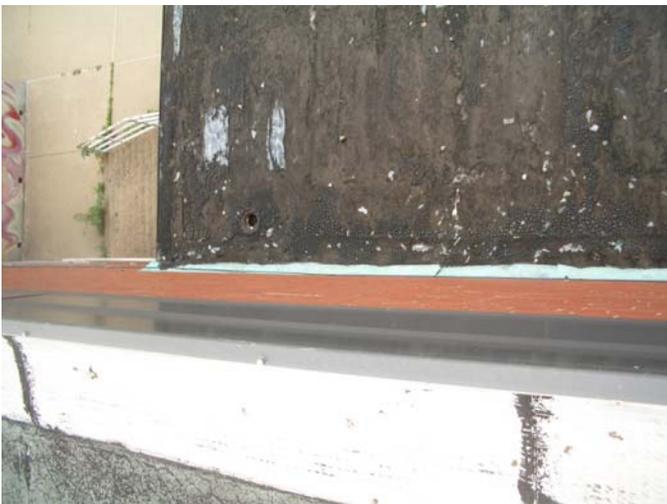
R-8 Porch roof showing porch roof, roof drain, wall flashing and deterioration

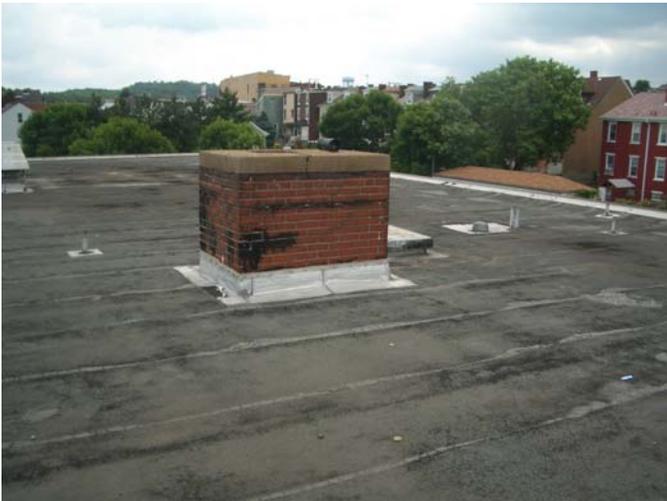
7.2 Condition: The penetrations are in fair condition. The brick chimney needs pointed.

R-9 Brick chimney on main roof

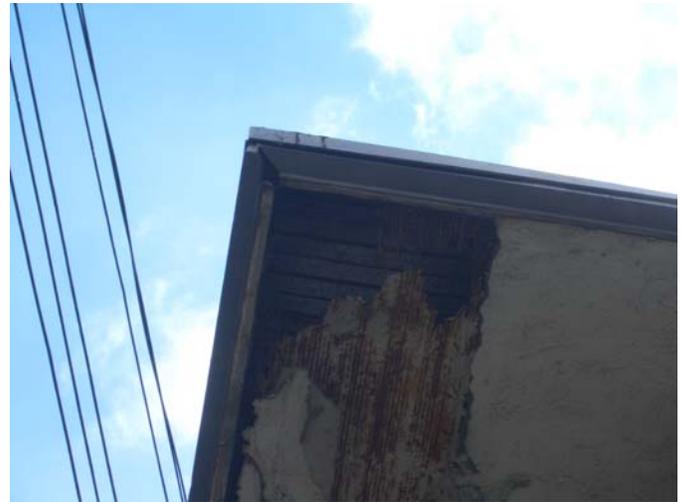
2.2 Condition: No conditions were observed that would indicate deck problems on the main and restroom areas. The deck on the porch roof is in poor condition - pieces are missing from the underside and the reinforcement is visible.

R-17 Underside of porch roof showing deteriorated decking

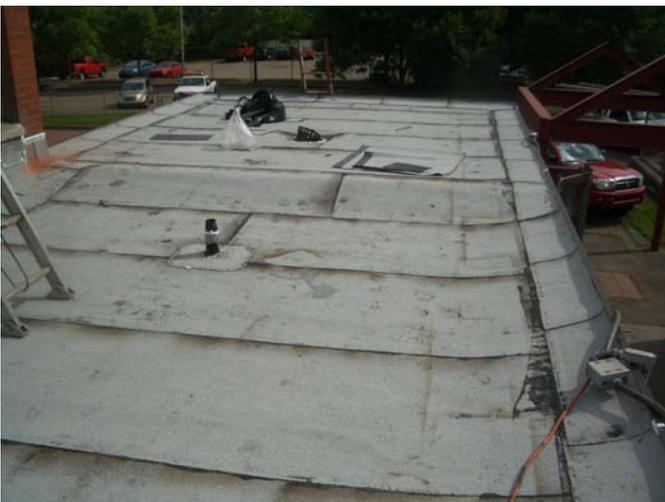
R-15 North end of restroom roof area, new roof system

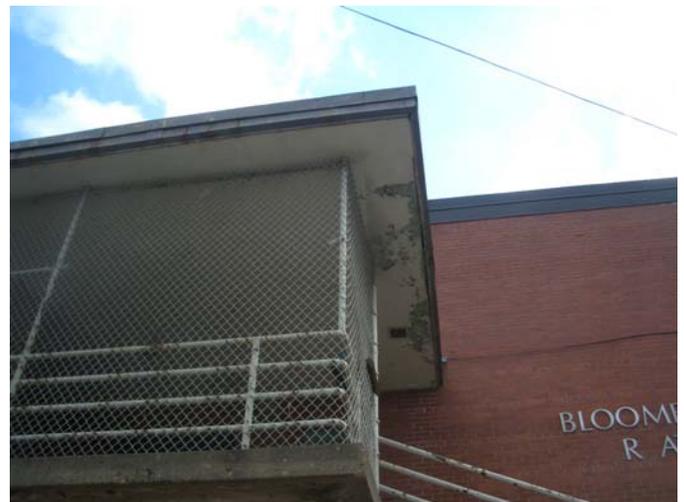
R-18 Underside of porch roof showing deteriorated decking
