CITY OF
PITTSBURGH
FACILITY ANALYSIS REPORT

Cowley – Goettman Recreation Center (B034)
1200 Goettman Street
Pittsburgh, Pennsylvania 15212

June 11, 2010

Executive Summary

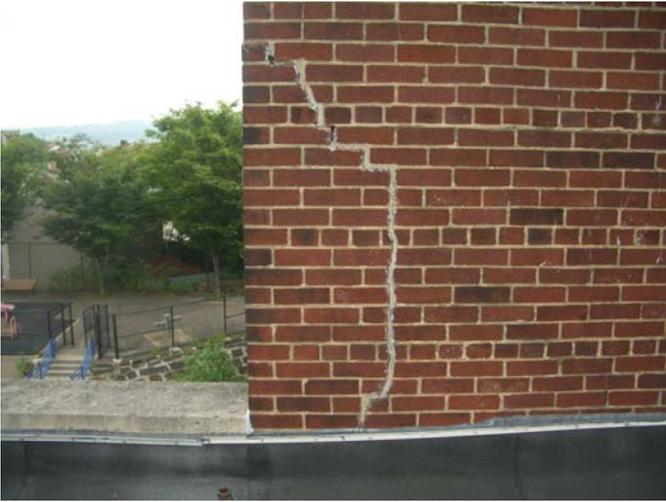
W-3 Crack in brick wall, middle of west wall
