CITY OF
PITTSBURGH
PROPERTY CONDITION REPORT

B017 – DPW 5th Division
1330 Hassler Street
Pittsburgh, Pennsylvania 15212

June 2014

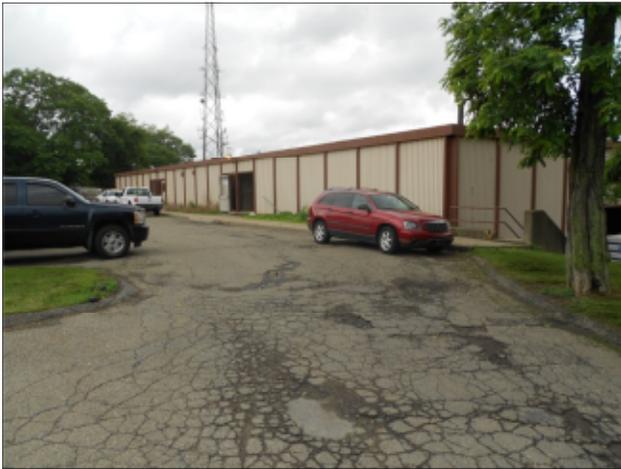
ST1 - Upper site – looking west, asphalt decay

Recommendation: Mill and replace asphalt at all areas. Add vehicle protection (e.g. bollards) at east and west vehicle garage doors.

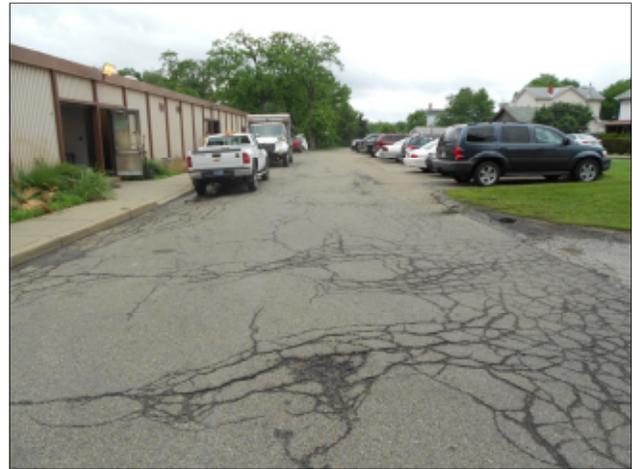
ST2 - Upper site – topography pitches towards north wall

Recommendation: Relocate (2) inlets and modify drive to drain away from building.

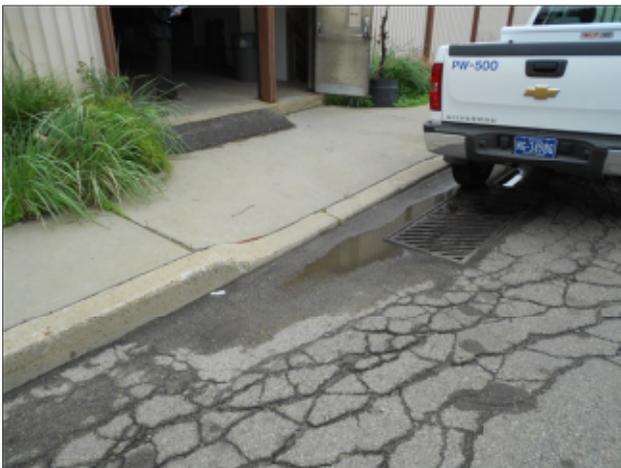
ST3 - Inadequate storm drainage along north wall

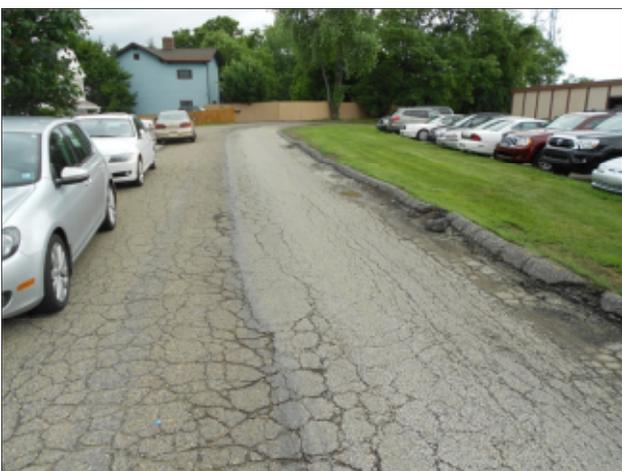
ST11 - Upper site – asphalt and curb decay on Magnus Way

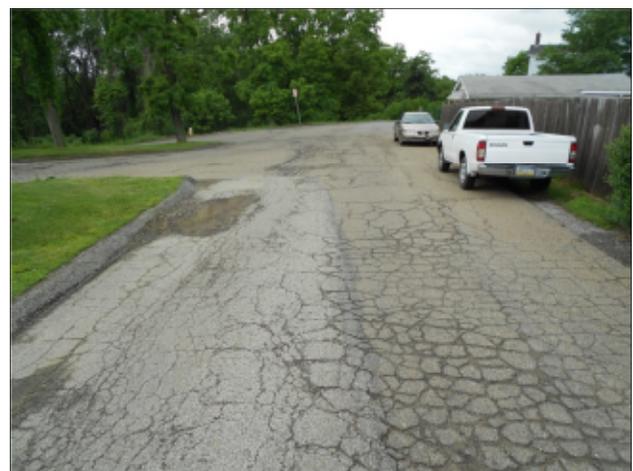
ST12 - Upper site – asphalt and curb decay on Magnus Way

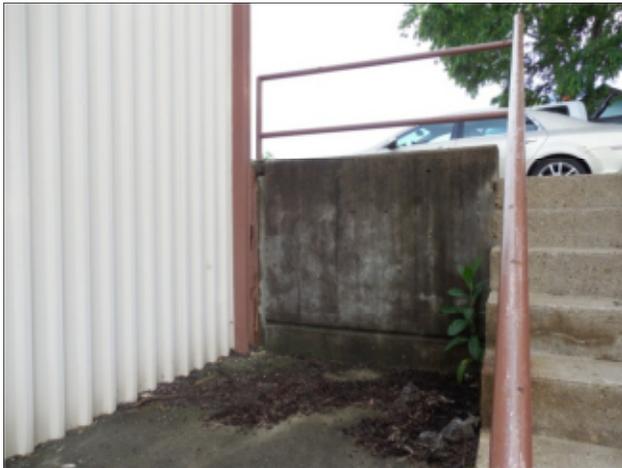
SS1 – East Stair – Open joint between building and retaining wall

Recommendation: Repair east exterior stair, remove and replace railings.

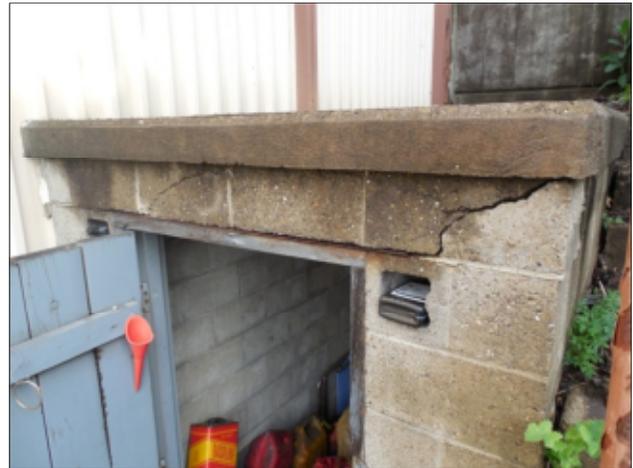
SS2 – East Stair Storage Room – Masonry shifted

Recommendation: Demolish east Storage Room, repair adjacent surfaces.

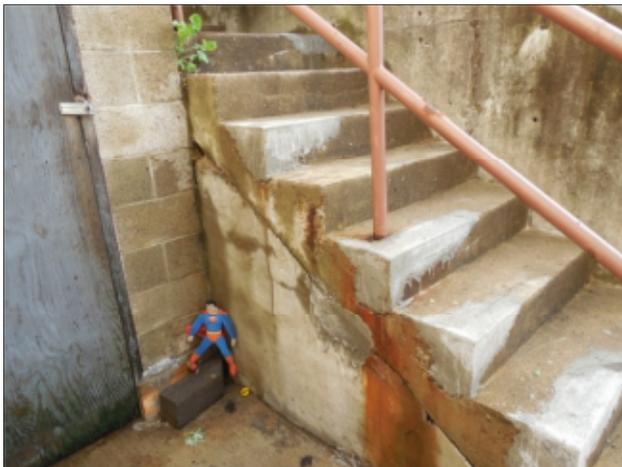
- 1.7.1. Top tread is undermined due to spalling approximately 6 sq. inches.
- 1.7.2. From the top down treads 3, 7, 10,11 and 18 have longitudinal cracks with efflorescence
- 1.7.3. From the top down treads 8, 10, 12, 13 and 14 have patches
- 1.7.4. Railing has heavy rust at bases and post at tread 5 has 100% section loss and is no longer connected. Entire railing has light rust and loss of paint coating system.
- 1.7.5. Concrete Wall on west side of stairs has heavy spalling and holes

SS3 – East Stair – Heavy spalling and hole

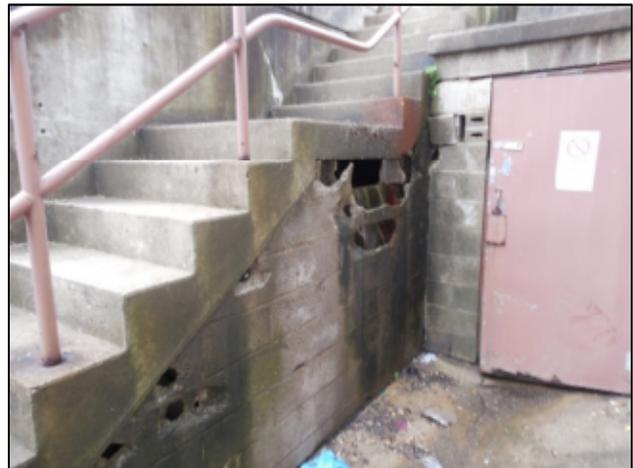
1.8.2. Masonry Wall on East Side of West heavy masonry unit damage and voids

SS4 – West Stair and Storage Room – Masonry wall damage

Recommendation: Repair west exterior stair, remove and replace railings.

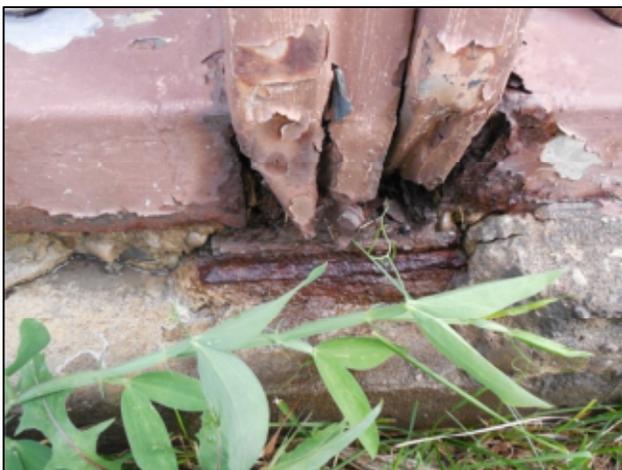
SS5 – South wall - typical condition at column base plates

2.1. The Exterior main columns and the grade beam columns are heavily rusted due to poor drainage.

Recommendation: A qualified Architect and Structural Engineer should perform detailed field survey of these conditions and make specific recommendations.

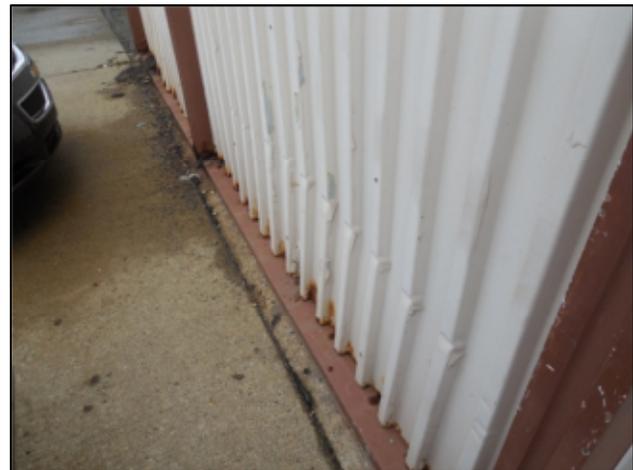
SS6 – West wall – Metal panel damage, no vehicle impact protection

parking area adjacent to the wall with no bollards or curbs stops to protect it from vehicle damage; there is deformation in the wall panels. The painted surface is faded throughout the building.

Recommendation: Repair, patch and paint metal panels where rust damaged.

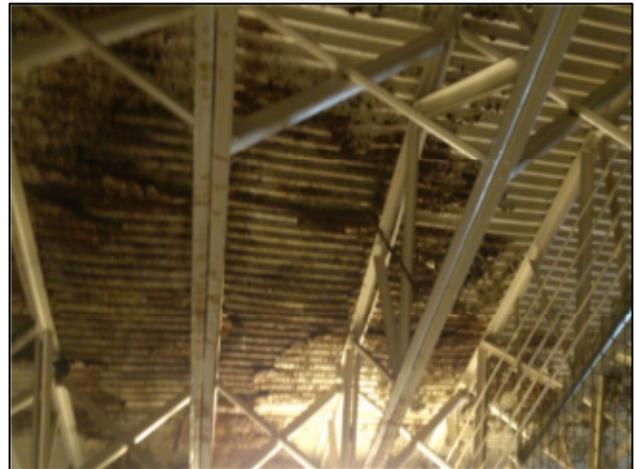
SS8 – Below Mezzanine A-3 area – Heavy SIP rust and spalling with exposed rusted rebar

2.4. Mezzanine Concrete Floor consists of 3 ½” of concrete with stay in place pans. The concrete in in Column Line A -2 to A-4 area appears to have heavy chloride content and the SIP are heavily rusted. There is localized area of 100% section loss to SIP exposing a large spall with exposed rusted rebar with +/- 25% section loss. The mezzanine has several longitudinal cracks varying from 0.08” to 0.03” See Attached Drawing Sheet 1 and 2.

Recommendation: Replace slab and deck at compromised area.

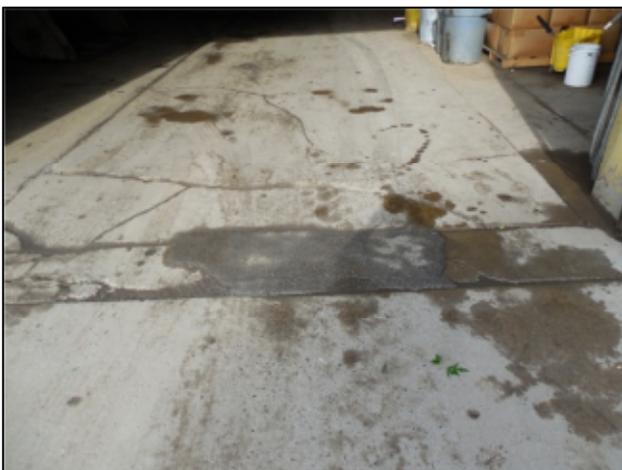
- 1.3. Column Lines B & C rest upon grade beams and have concrete column guards. The column guards have minor spalls.
- 1.4. Main Concrete Floor on grade has several cracks and has settled in the traffic lane between the two overhead doors. The concrete aprons at the overhead doors are heavily cracked. The floor drains do not appear to have settled but the concrete surrounding the drains is cracked and settled. See Attached Drawing Sheet 1

SS11 – East OH door – apron and floor cracked

Recommendation: Garage Slab - Remove slab at areas indicated to nearest control joints and replace.

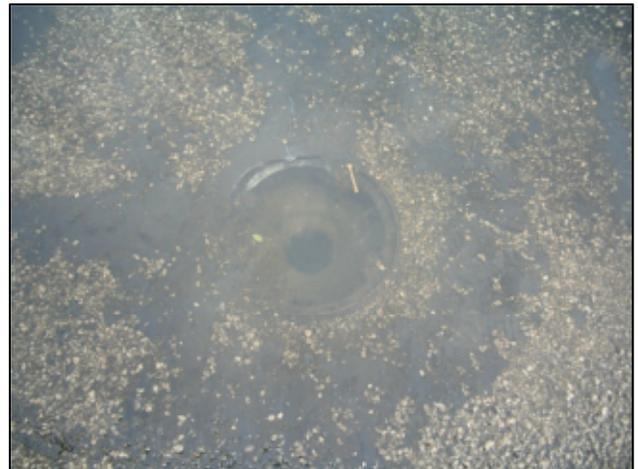
10.2. Condition: Two drains appear to be in good condition and operating properly. The west drain is clogged and ponds water.

SH4 – Clogged roof drain

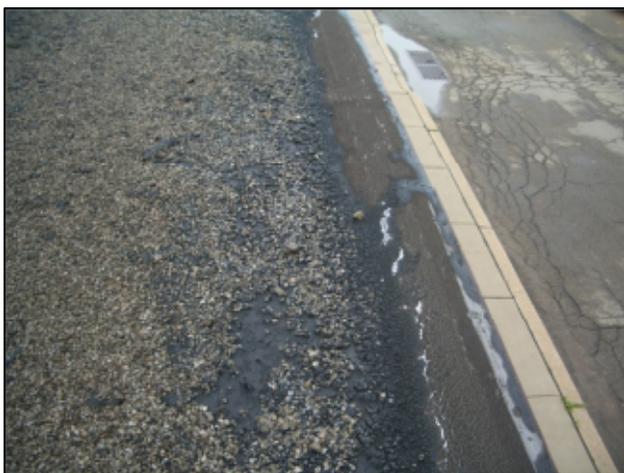
6.2. Condition: The roof membrane appeared in poor condition. Bare felts were observed throughout the roof surface. Patches and repairs were observed in some areas. Ponding water was observed around the west end roof drain.

SH5 – Bare felts and flashing repairs

Recommendation- 1 year: Replace roofing and flashing system – Estimated cost: \$201,600 (13,440 SF x \$15/SF) NOTE: The building walls and roofing systems should be addressed in order to maintain the structural integrity.

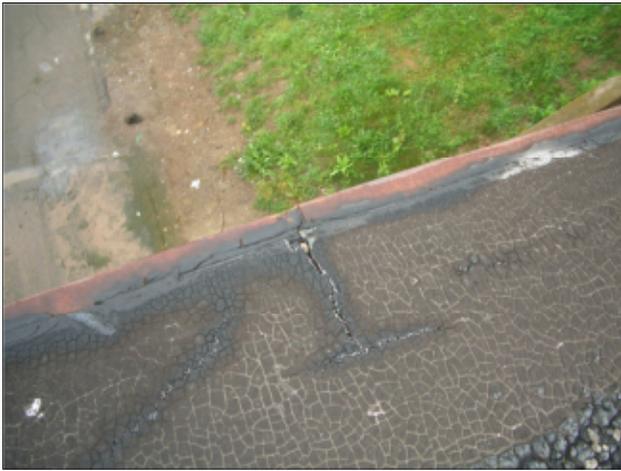
7.2. Condition: The membrane flashing system is in poor condition. The flashing is aged and cracked. The flashing appears to contain asbestos.

SH7 – Cracked flashing

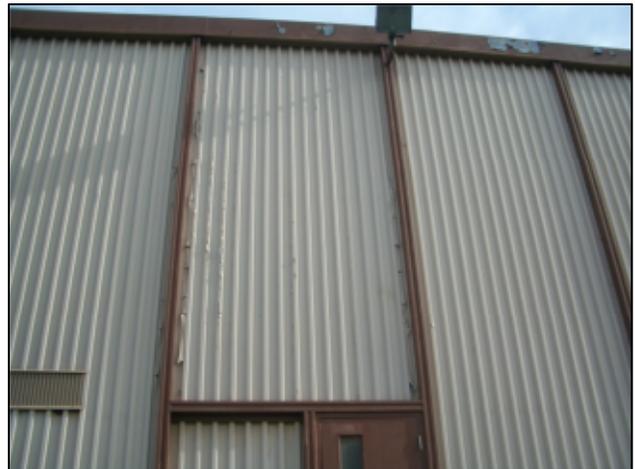
SH10 – Peeling paint

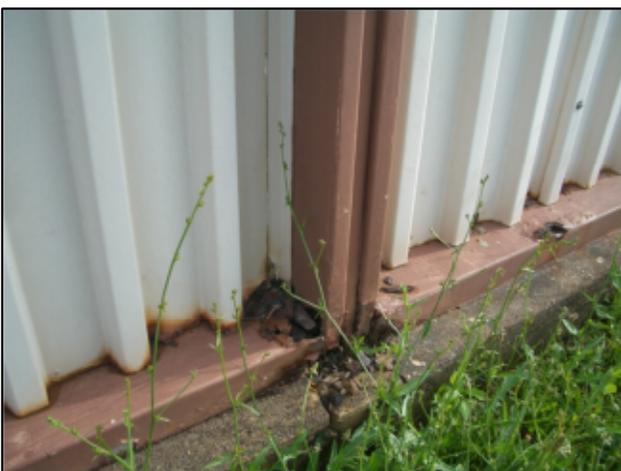
3.2. Condition: The building walls appear to be in poor to fair condition. The bottom of the wall panels, columns, doors and jambs are rusted in several areas and completely deteriorated in some areas. The steel grade beam is rusted throughout the perimeter. The paint is peeling on the wall panels in various areas and at both ends and the south wall. A few areas of physical damage to the wall panels were observed. The west wall has a

SH11 – Rusty wall panels and column base

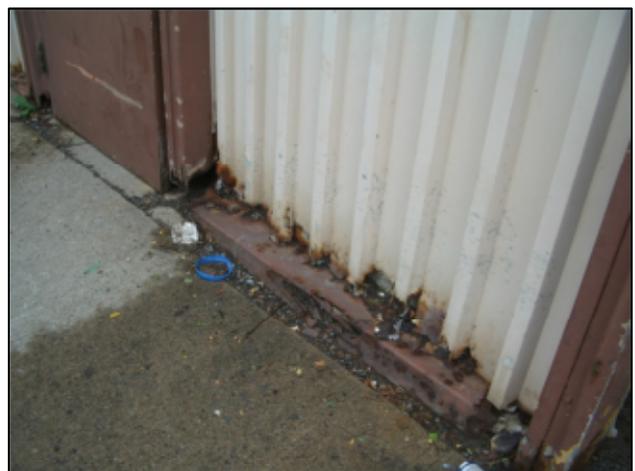
3.1.2. A metal man door is located on the south side. Two metal man doors with overhead doors beside them are installed on the north side (main entry). Man doors exist on both the East & West Sides adjacent to the Overhead Doors. All doors have metal frames. The metal frames are all in poor condition and on the south side of the building does not close properly. The frames are severely rusted at the bottoms and there are rust holes in the fascia panels of several doors.

SH12 – Rust wall panels and door

Recommendation: Replace exterior man doors & frames, (5) typical.

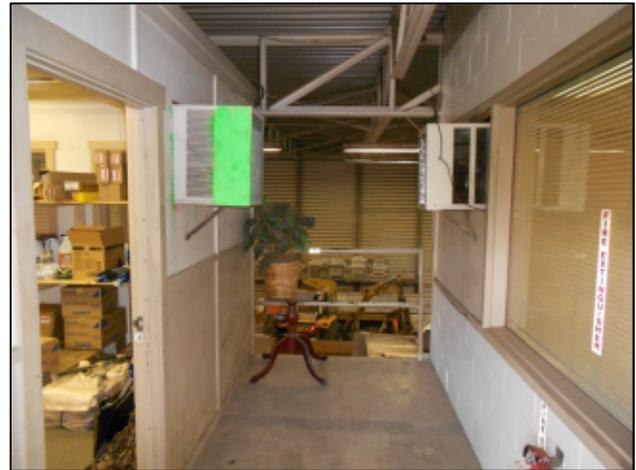
14 – View from entrance area to high-bay garage, protruding air conditioners, inadequate guardrail.

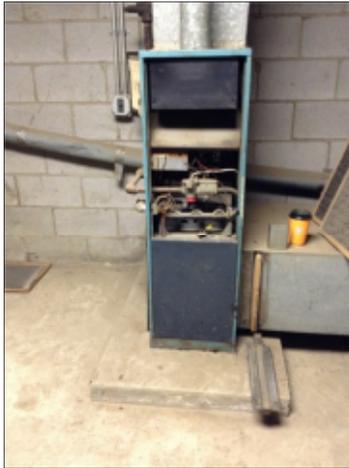
- c. Condition Assessment
 - i. The central natural gas furnace (GFAH) is original to the building – 1974. It is beyond its expected useful life. Condition: Poor.

H 1 – Main office furnace GFAH

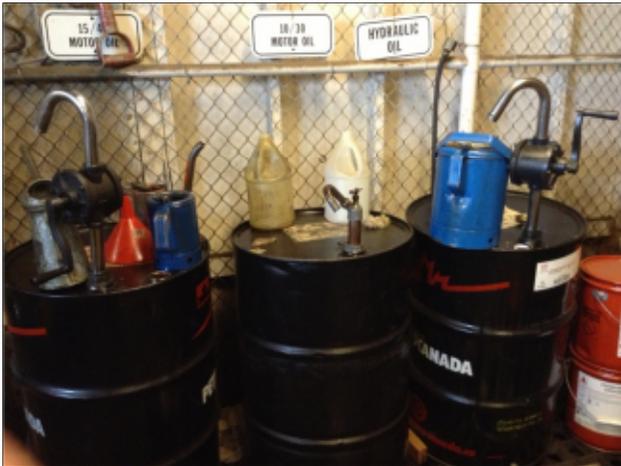
SR – 5 NFPA Classification Drum storage and dispensing

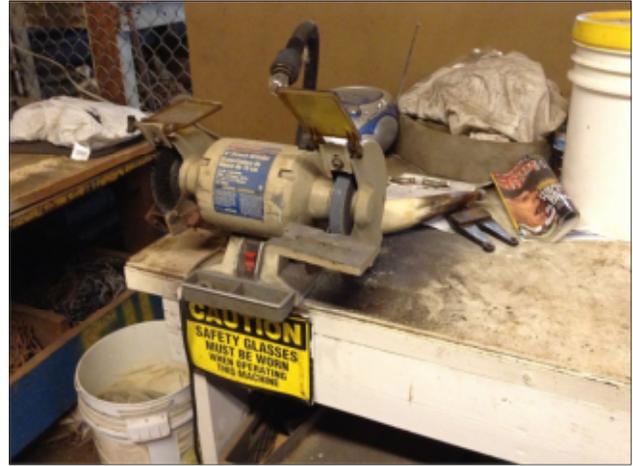
SR – 6 NFPA Classification: Bench Grinder

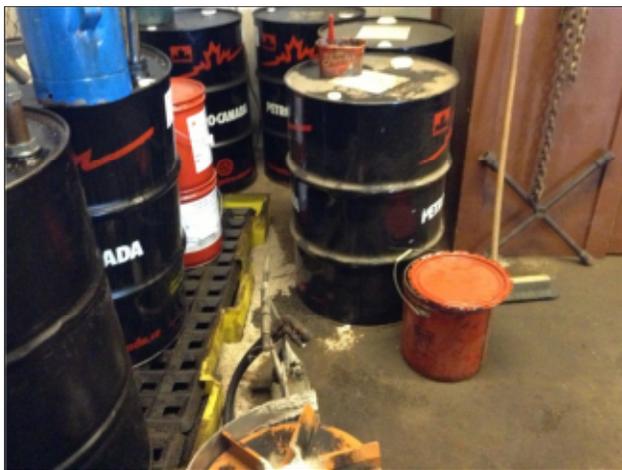
SR – 7 NFPA Classification: Leak containment

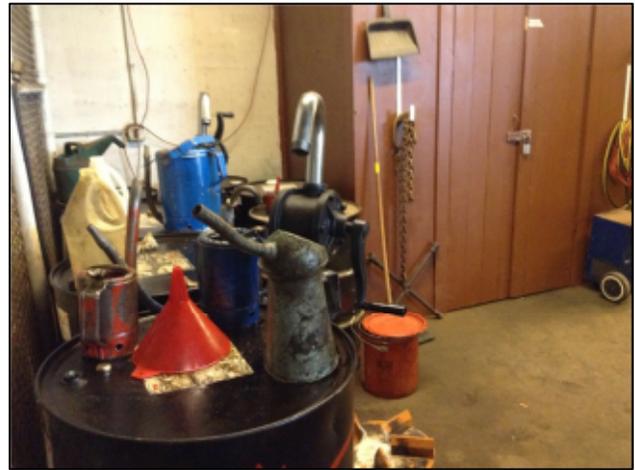
SR – 8 NFPA Classification: Wooden cabinet

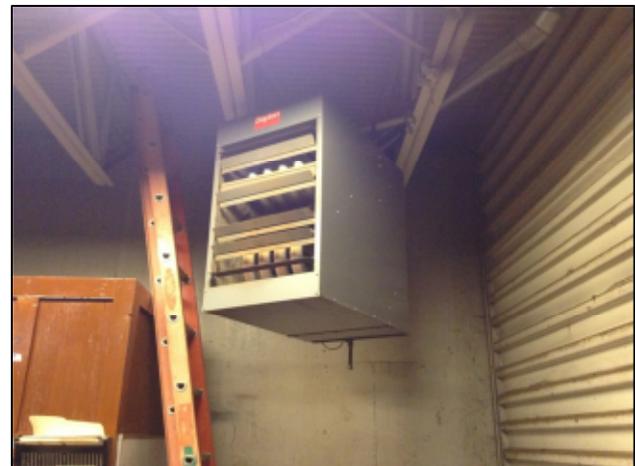
SR – 10 NFPA: Open flame heater w/ open contact T-stat

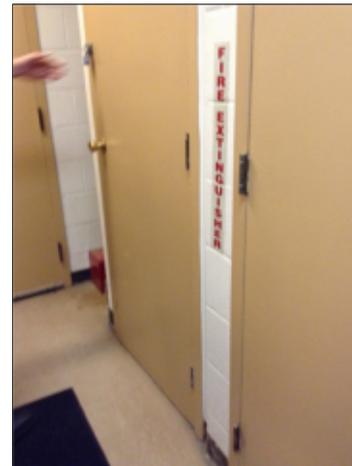
FP2 – Main office, mezzanine (missing)

- (1) Inspect/test all fire extinguishers
 - (2) Replace missing extinguishers
 - (a) Main mezzanine office: \$250
 - (b) 1st floor MER: \$250
- ii) Short-Term Costs
- (1) Add fire extinguishers:
 - (a) Mezzanine shop: \$250 (*Issue: gasoline can storage and mower filling*)
 - (b) Lunch room: \$250 (*Issue: gas heater code violation and gas stove unsecure gas line and flex connector*)
 - (c) Center shop office: \$250 (*Issue: portable, old floor mount electric spot heater*)
 - (2) Add fire and smoke alarms:
 - (a) Mezzanine level main office: \$200
 - (b) Mezzanine shop: \$300
 - (c) Main shop: \$600
 - (d) Lunch room: \$200
 - (e) Drum Storage: \$300
 - (3) Add fire alarm pull stations:
 - (a) Mezzanine level: \$3,000
 - (b) Shop level: \$3,000

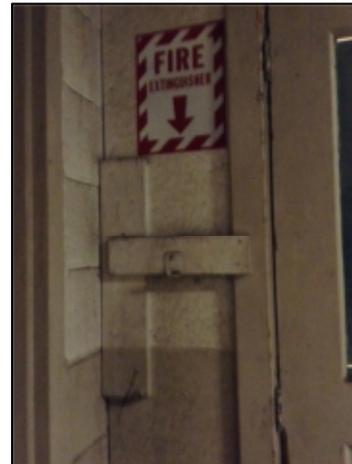
FP4 – Furnace Room (missing)
