CITY OF
PITTSBURGH
PROPERTY CONDITION REPORT

B110 – Firehouse 14
259 McKee Place
Pittsburgh, Pennsylvania 15213

June 2014

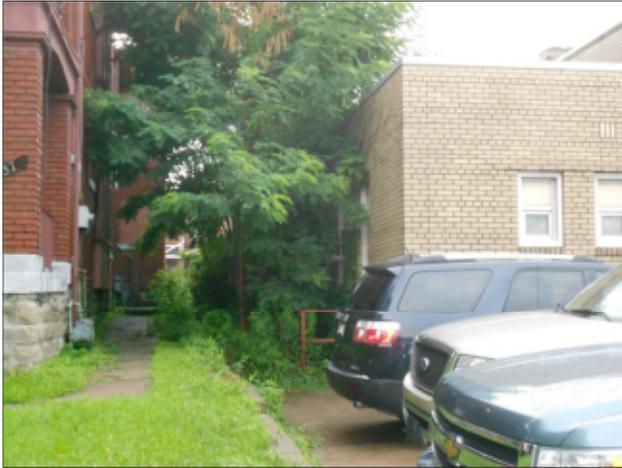
ST1 – Overgrown vegetation along NW side

Recommendation: Cut back overgrown vegetation.

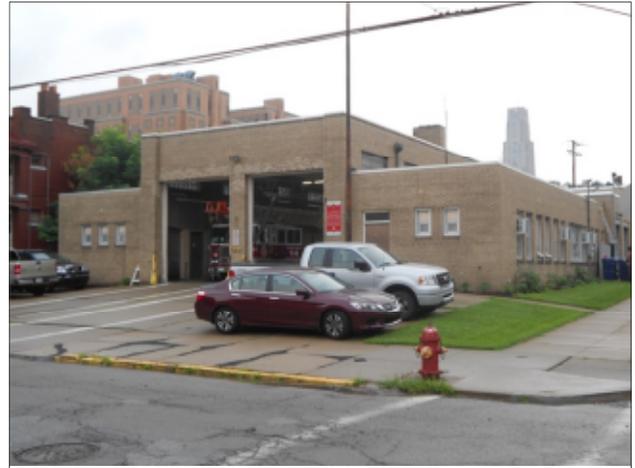
5. Site Amenities / Accessory Structures- A low-rise segmental retaining wall in Good condition runs along the west side of the drive. The flagpole on site is heavily rusted and in need of replacement.

ST2 – View from McKee Place, flagpole in foreground

Recommendation: Replace the flagpole.

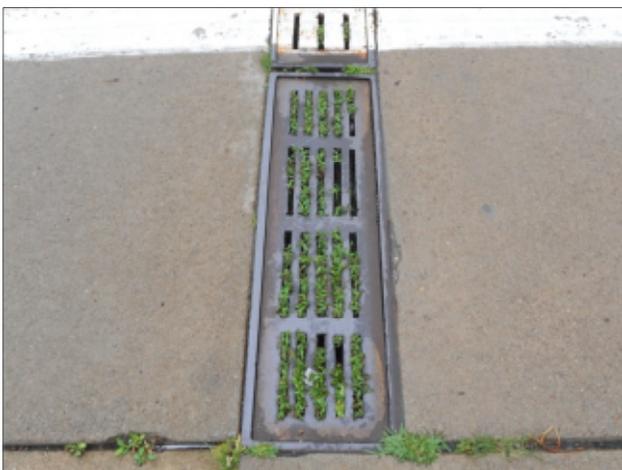
ST5 – Trench drain filled with sediment

Recommendation – Clean and repair trench drains. Prep and paint railings and well gratings.

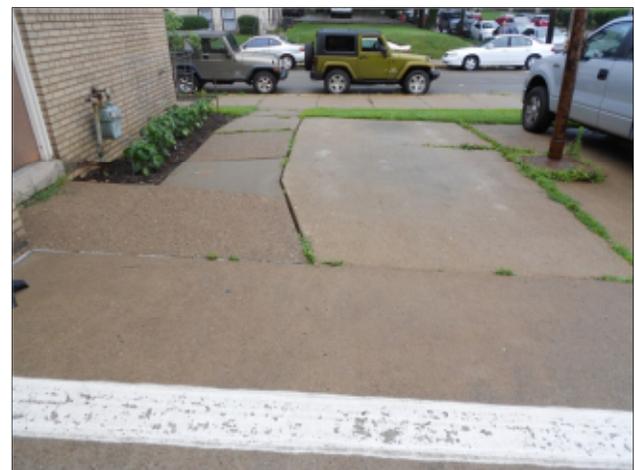
ST6 – Concrete pavement – differential settlement, open joints

Recommendation: Repair / Replace broken and settled concrete paving and walks. Seal all joints.

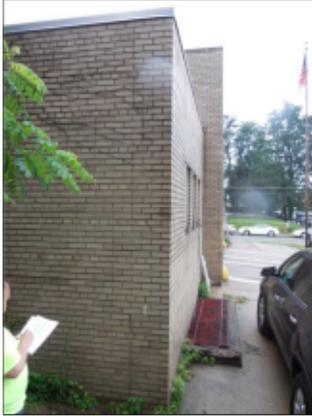
SH1 – NW wall +/- 2' from corner – light vertical crack full height

- Parapets need to be programmed for replacement, align with roof replacement.
- Masonry restoration including replacing lintels and sealing open joints

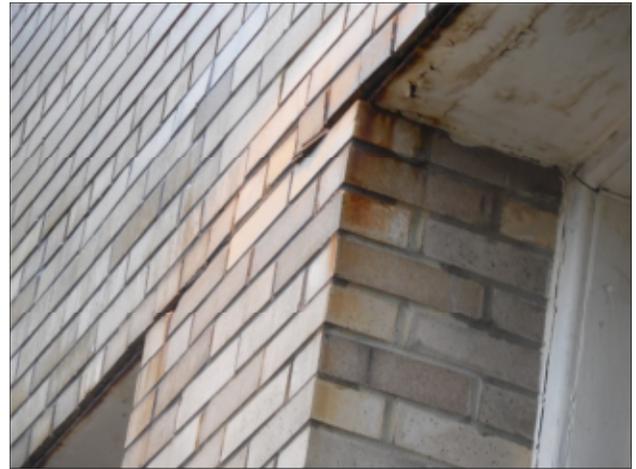
- 3.4.1 Exterior metal man doors are in good condition. There is light spall in the door trim at the rental area on the south east wall
 - 3.4.2 Window lintels have light/ heavy rust with areas of bulging brick, loss of mortar and minimal brick displacement.

SH2 – Center pier at apparatus doors; bulging brick above lintels

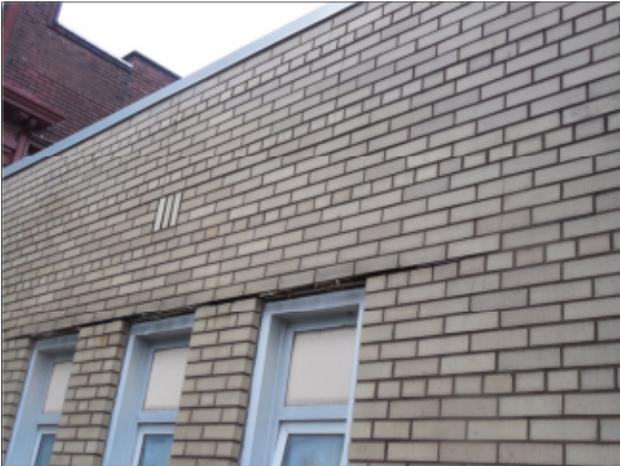
- 3.2 There are areas on west wall and the western half of the north and south walls with light brick cracking, step cracking, brick bulging at lintels and areas of minimal brick displacement

SH3 – SW wall - Step cracking from window lintel, Light Vertical crack from lintel to coping, rusted lintel

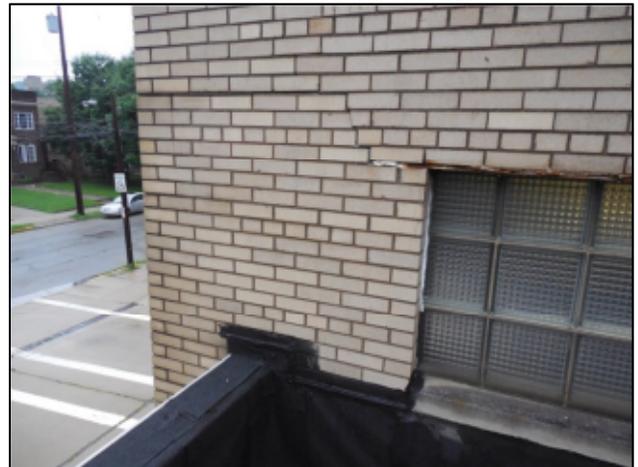
SH4 – SE corner @ upper level – step cracking from lintel

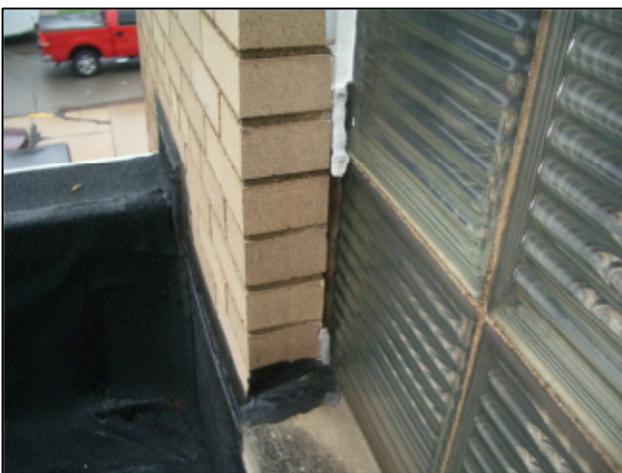
The building walls are in fair condition. A few defects were observed. Some cracked bricks and missing mortar were observed. The caulking/sealant at the doors and windows is in poor condition.

SH5 – SE corner @ upper level – missing sealant

1 year: Repair existing roof defects - Estimated cost: \$3,000. Replace caulking and sealant at doors and windows – this work does not have to be done at one time but as the maintenance budget permits. Inspect roofs and walls yearly and remove debris – Estimated cost: None (perform with in-house personnel)

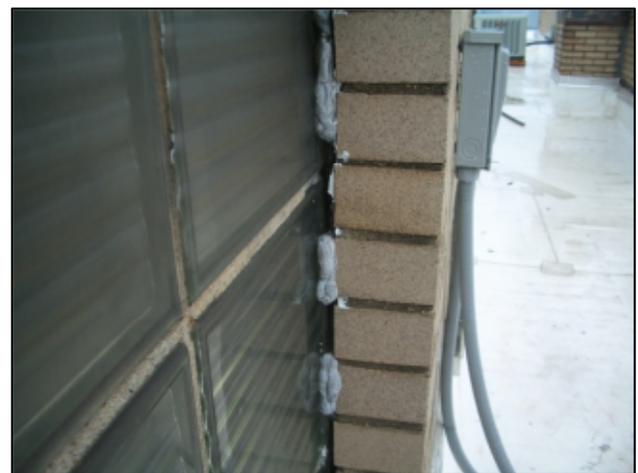
SH6 – NE wall above Career Center – missing sealant

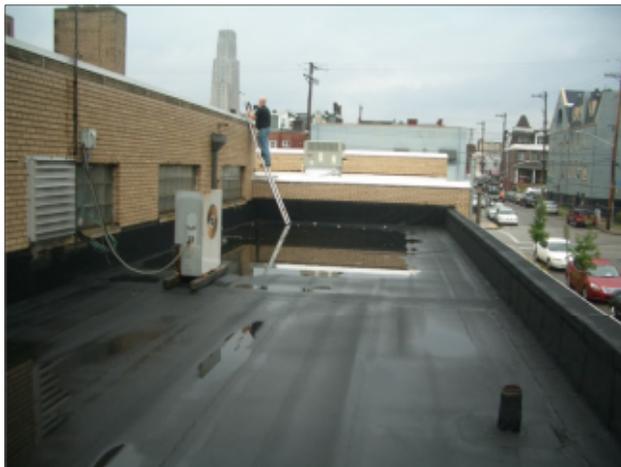
SH9 – SE lower roof looking NE – ponding water

The drainage system is in fair condition. The clogged drains on the Firehouse should be cleaned. The debris should be cleaned from the roof surface and continue to be cleaned twice yearly.

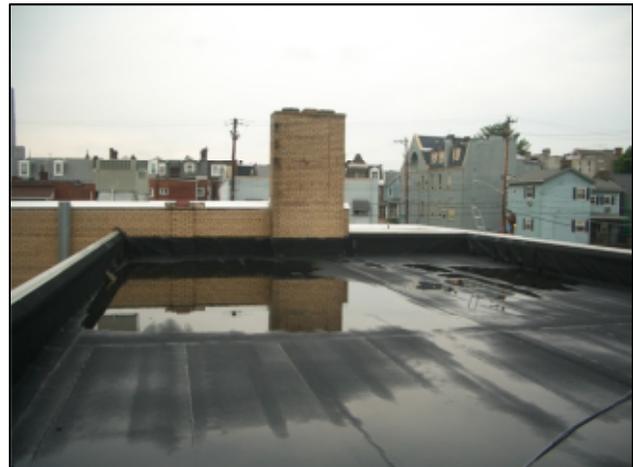
SH10 – Upper roof looking NE – ponding water

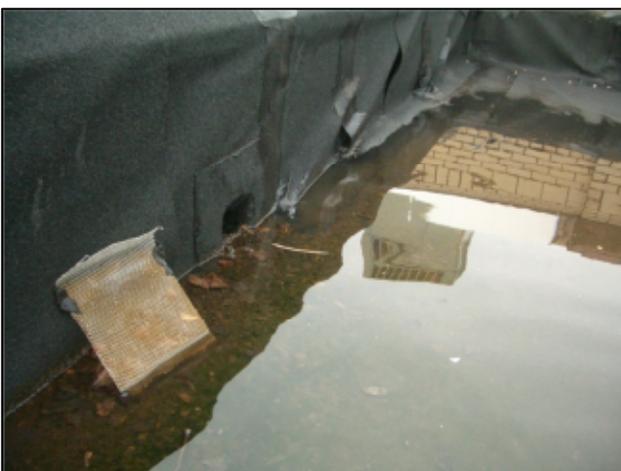
7.2. Condition: The membrane flashing systems on the Oakland Career Center are in fair condition. The membrane flashing systems on the Firehouse are in poor condition. The flashing is loose from the wall and buckled (wrinkles) in some areas with numerous open vertical joints. The flashing extends up and over top the metal coping. Numerous repairs were observed. Repairs were made using roof cement only and have failed and are open.

SH11 – Upper roof; ponding water, open and loose flashing

The roof membrane and flashing systems are in poor condition on the Firehouse and in fair condition on the Career Center. The open, loose and buckled flashing on the Firehouse areas should be monitored and repaired until the roof is replaced.

5 year: Replace Firehouse 14 roofing and flashing system – Estimated cost: \$79,560 (4,420 SF x \$18/SF)

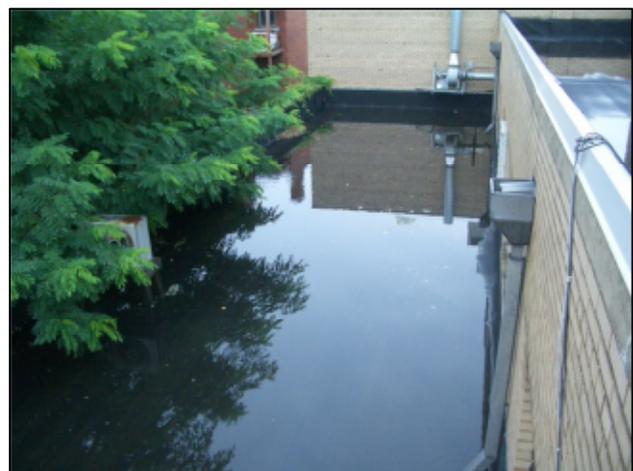
10.2. Condition: Firehouse 14: The north side low roof area is covered with ponded water, water ponds at all drains, 1 drain on the south side and both drains on the north side appear clogged. Career Center: There is some minor ponding but the drains appear to be operating properly.

SH12 – NW lower roof looking NW – ponding water all drains clogged

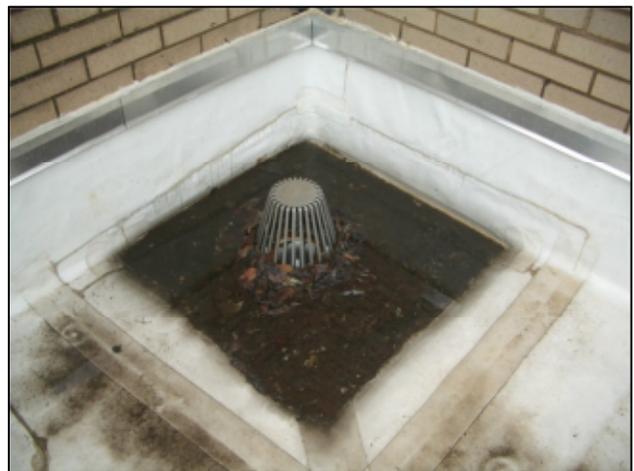
SH18 – Lower roof – debris at roof drain

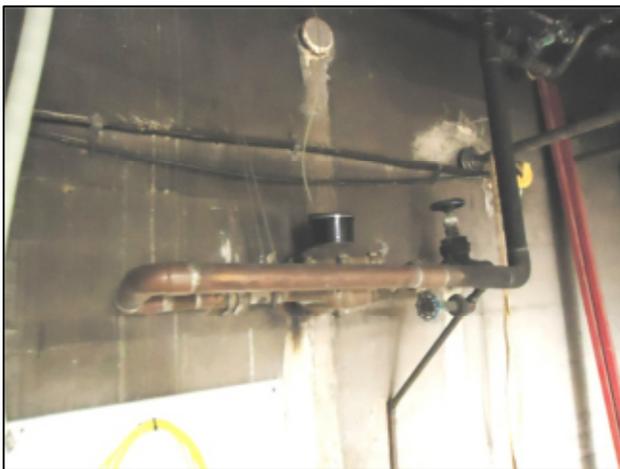
- 3.1 General Description: Potable water supply
- 3.2 Construction
 - 3.2.1 Original meter, shut-off valve, and piping.
 - 3.2.2 No back-flow prevention.
- 3.3 Condition Assessment: **Fair**

P5 – Water meter, pressure reducer and shut-off valve

- 5.1 De minimus conditions
 - 5.1.1 Insulate supply pipes from water heaters.
- 5.2 Immediate Costs
 - 5.2.1 Install back-flow preventer: \$2,000.

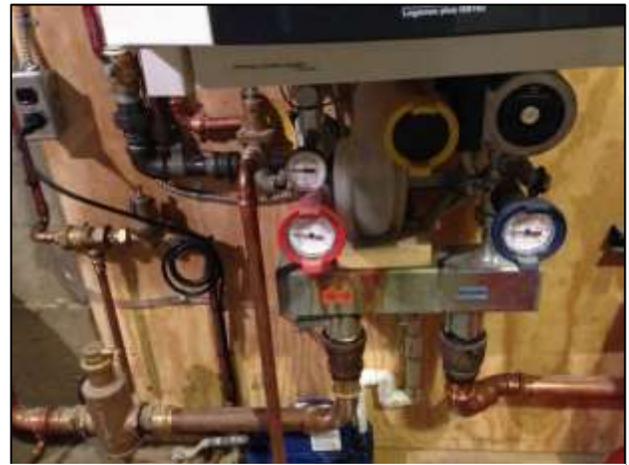
HVAC 21 – Hot water heating boiler (leaking zone manifold)
