CITY OF
PITTSBURGH
FACILITY ANALYSIS REPORT

Firehouse 17 (B128)
7601 Hamilton Avenue
Pittsburgh, Pennsylvania 15208

May 21, 2010

RE: Visual Survey - Firehouse #17

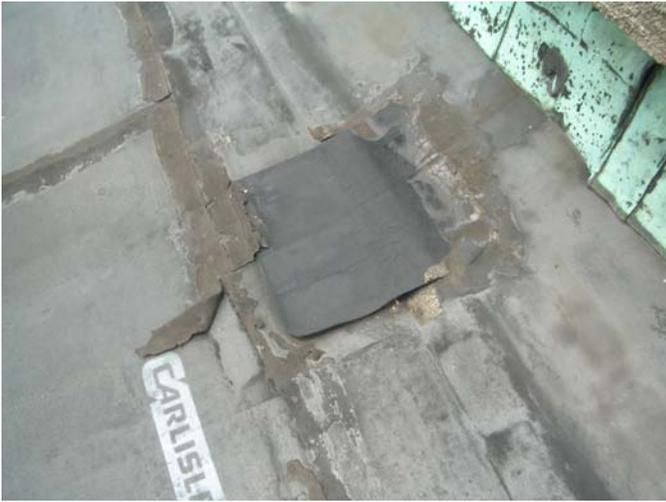
R-13 Loose patch typical

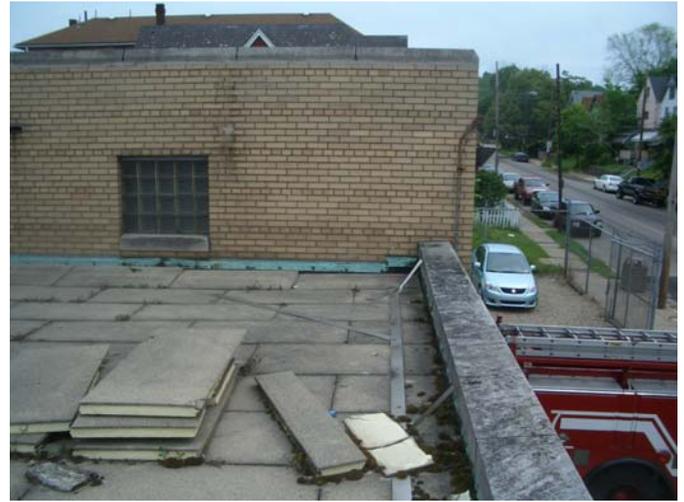
R-16 Low roof, vegetation, displaced insulation

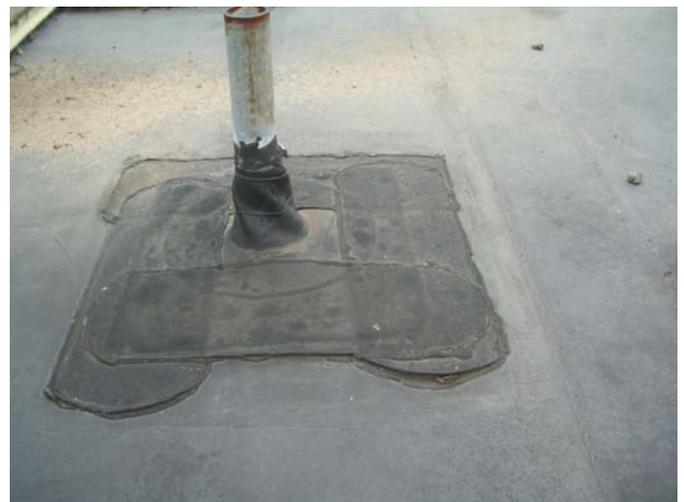
R-18 Low Roof loose patch and repair typical

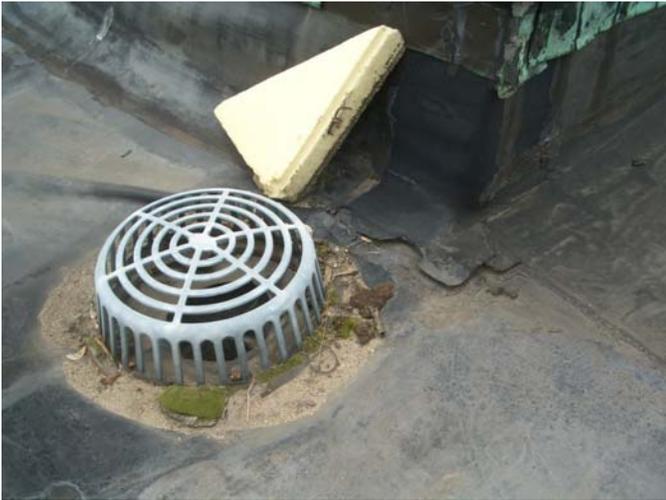
R-19 Low roof, debris at drain,
loose wall flashing

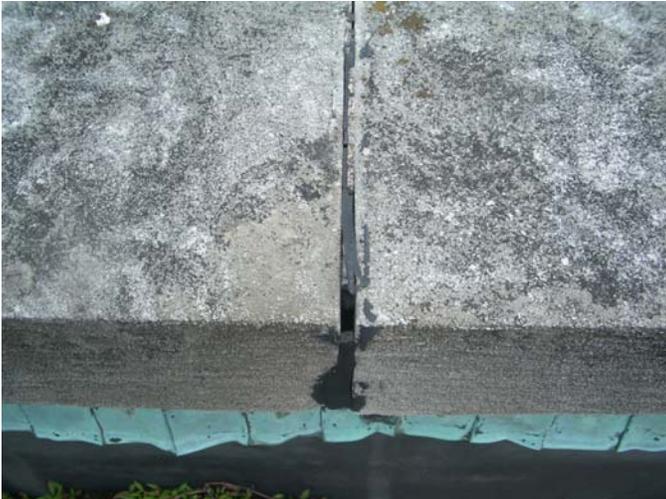
R-20 Pre-cast coping, open mortar
joint, missing mortar

1 year: Replace roofing and flashing system, re- point and seal the coping joints - Estimated cost: \$70,000 (5,050 SF x \$12/SF)

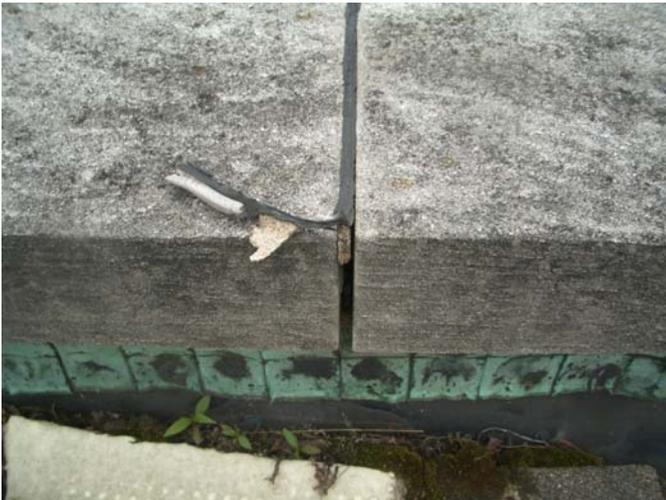
R-21 Precast coping, open mortar
joint, missing mortar, loose
caulking
