CITY OF
PITTSBURGH
PROPERTY CONDITION REPORT

B135 – Firehouse 26
630 Brookline Blvd.
Pittsburgh, Pennsylvania 15226

June 2014

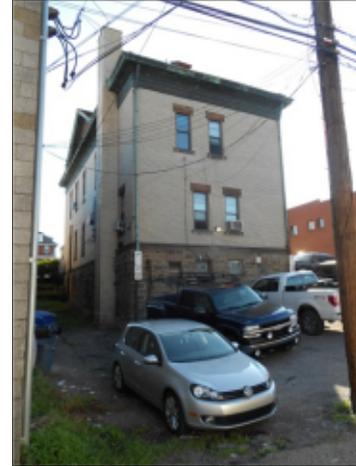
ST4 – Looking SW across parking area - storm inlet in foreground

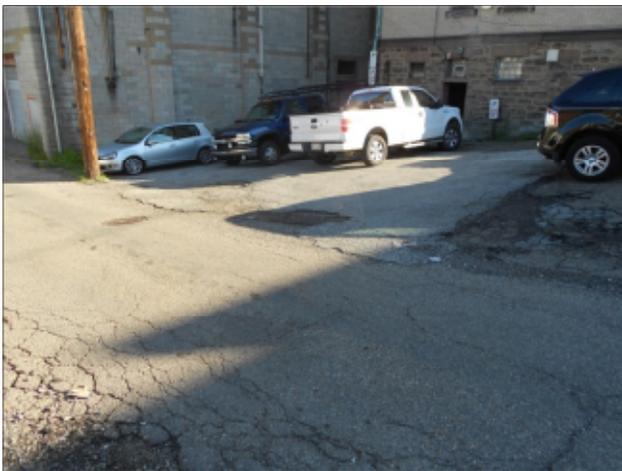
1. Topography and Drainage – The site slopes considerably down from Brookline Blvd. along both Wedgemere and Fitch Way. The site appears to be positively drained away from the building. The steep grade at the parking area may create a safety hazard in winter conditions.
2. Access and Egress – Vehicle access to the subject property is available from Brookline Blvd. Egress from the building to grade is available from the first and lower levels.
3. Paving, Curbing and Parking – The site paving is asphalt and concrete. Concrete apron has areas of joint spalling but is in Fair condition. Accessible parking is NOT available. The asphalt at the parking area is in Poor condition.

ST5 – Asphalt paving off Fitch Way

- Replace asphalt paving and walks at parking area.
 - Repair concrete apron and seal all joints.
4. Landscaping and Appurtenances – Landscaping and plantings consist primarily of ornamental planting beds and a food garden. The NE side of the property consists of terraced vegetated areas that appear to be infrequently maintained.
 5. Site Amenities / Accessory Structures- Timber retaining walls in Fair condition support the terraces. The flagpole is in Good condition.

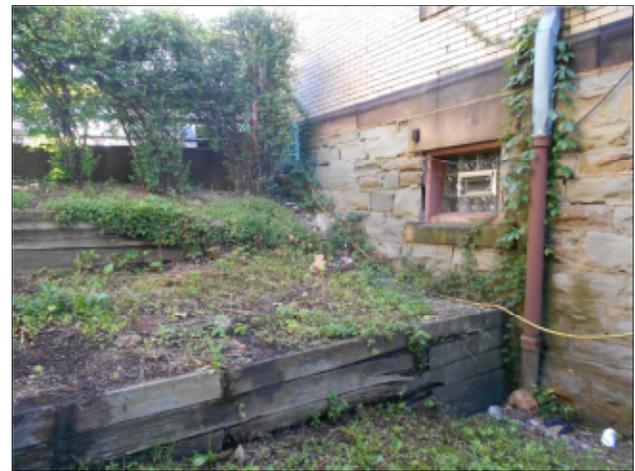
ST6 – Timber retaining walls form terraces at NE side of lot

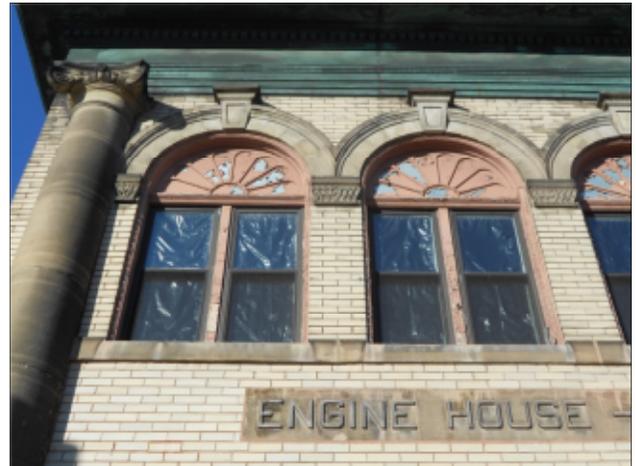
The painted wood trim is in poor condition. Numerous areas of peeling paint was observed.

SH2 – Peeling paint at windows

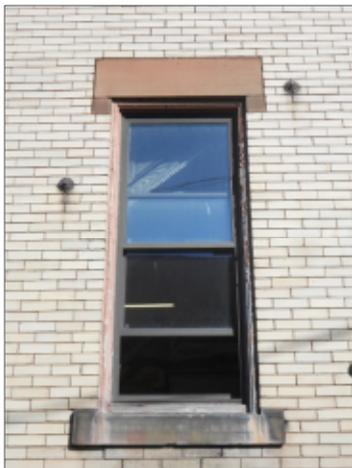
SH3 – Typical window on east wall – peeling paint at trim

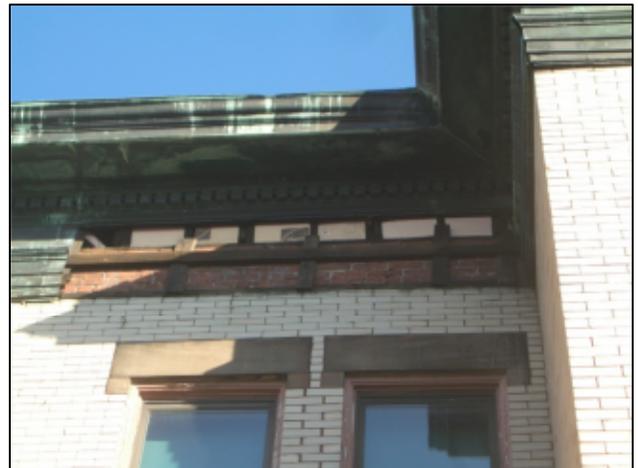
8.2 Condition: The cornices are in fair condition. One section of cornice is missing on the south side and one cornice joint is open on the north side.

SH4 – Missing cornice on east wall

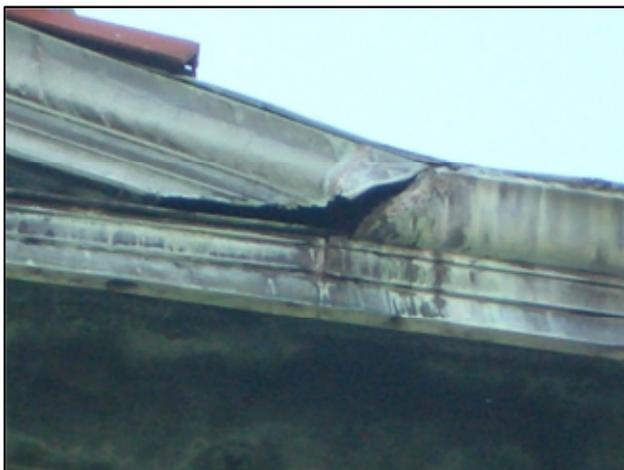
SH5 – Opening at cornice

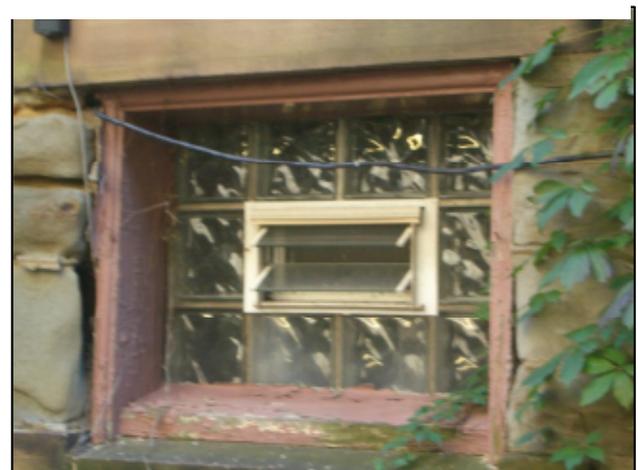
SH6 – Peeling paint and open joints at window on NE wall

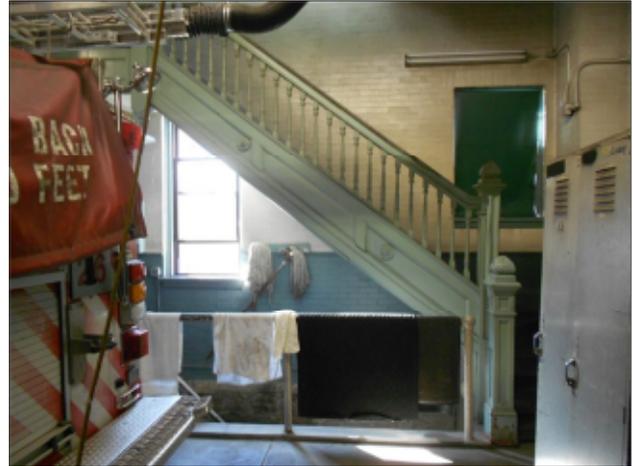
12 – Wood stair

1. Interior Construction - Interior partitions are primarily wood framed with cement plaster and are in fair condition. Doors and frames are typically wood construction with commercial grade hardware. Overall the Interiors are in Fair condition.
2. Stairs – All interior stairs are in Poor condition. The first to second floor stringer is cracked. The top stairs at the hose tower are unsafe and pulling away from the wall.

Recommendation – Repair stairs at all levels.
