CITY OF
PITTSBURGH
FACILITY ANALYSIS REPORT

Firehouse #27 (B136)
90 Virginia Avenue
Pittsburgh, Pennsylvania 15205

July 7, 2010

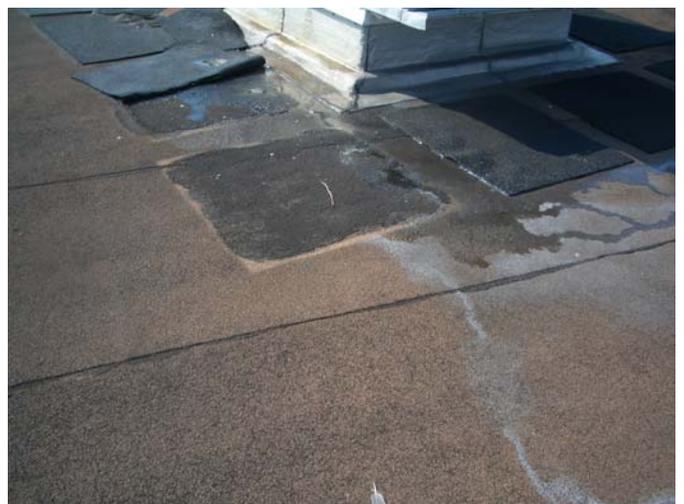
R-6 loose and missing walk pads, crazed surface of membrane

The existing walkway system is in poor condition and should be replaced.

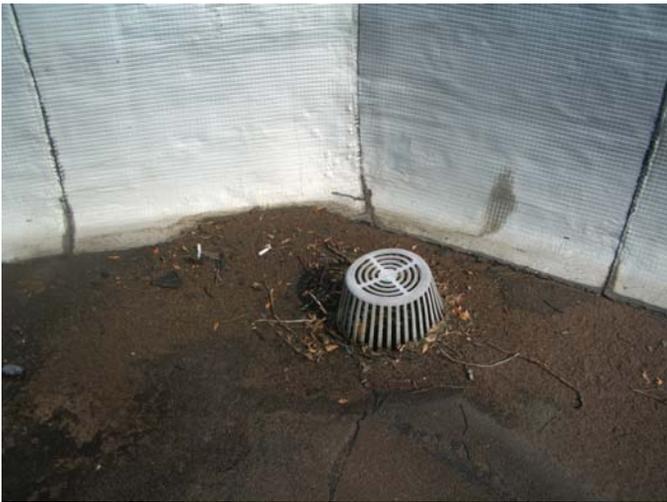
R-7 East roof drain, debris

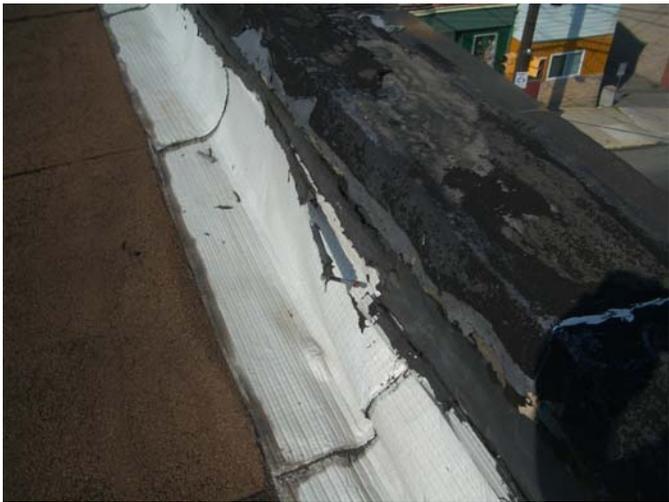
R-10 Open and loose flashing, SW wall area

The roof membrane and flashing systems are in fair condition. Repairs to the flat roof should be limited to leak chasing. Repairs to the wall flashings should be done as soon as possible.

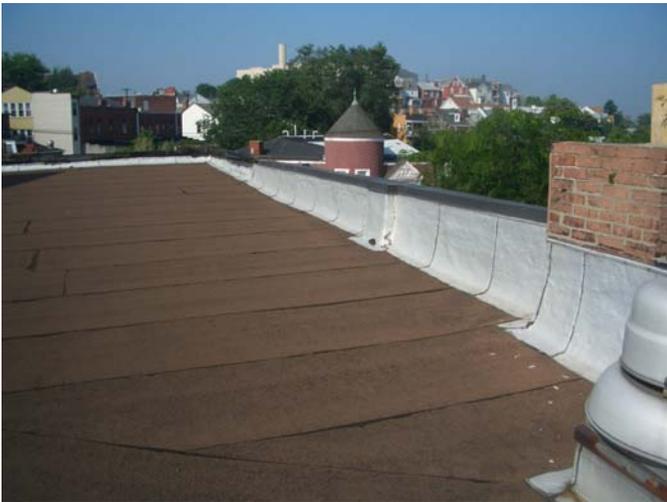
R-8 West wall with metal coping

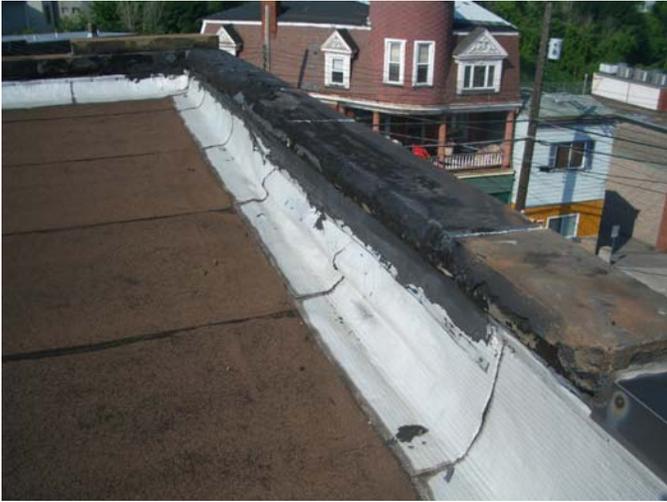
R-9 SW wall, repairs at top of flashing

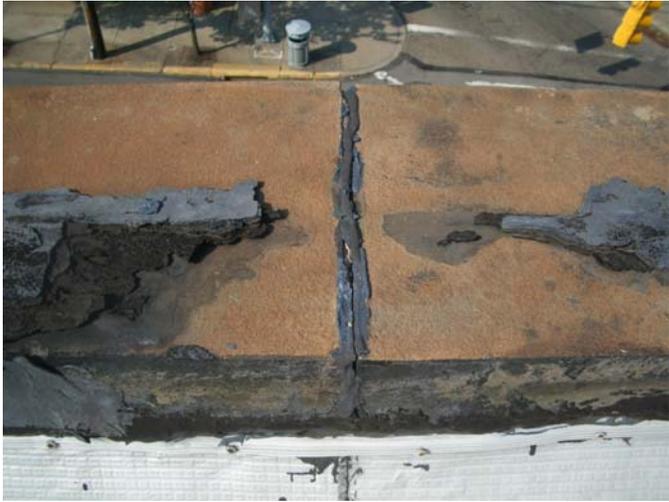
R-12 Open mortar joint on stone coping, south (front) wall

The stone and tile coping systems are in fair condition. The mortar joints should be repaired. The roof top penetrations are in fair condition.

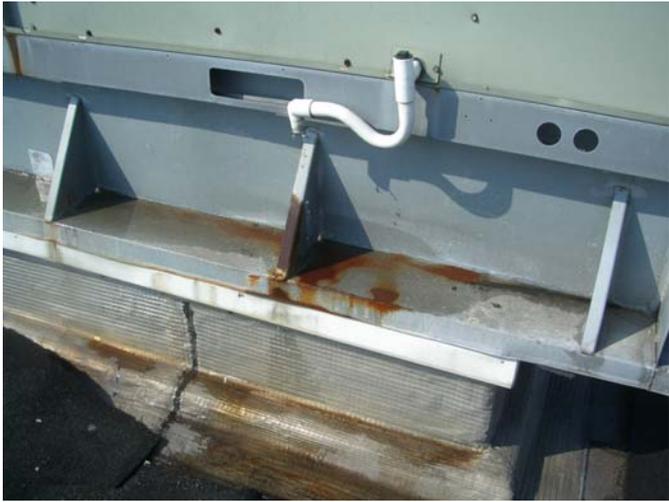
R-16 Rust on HVAC unit

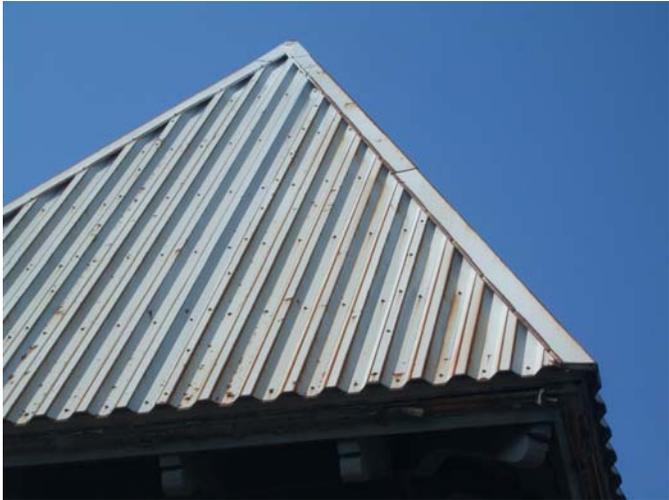
R-17 Rusted metal panels on Hose Tower Roof

The metal roof system on the Hose Tower is in fair condition but rusting and should be painted.

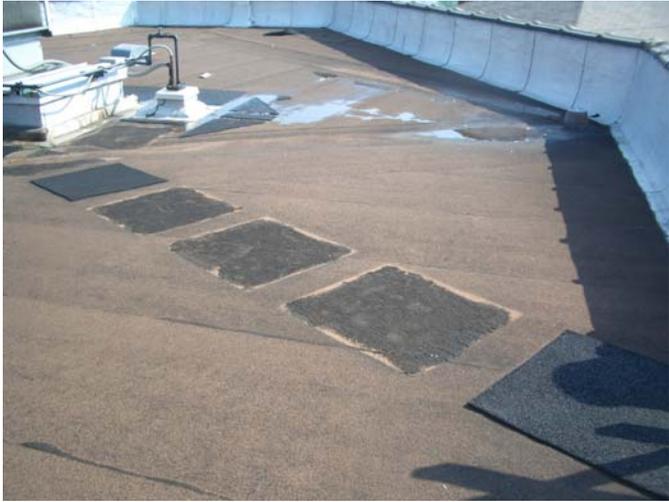
R-18 Missing walk pads

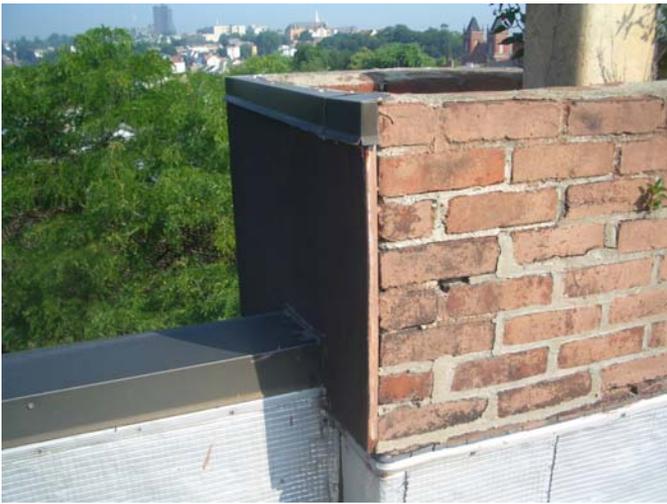
7.2 Condition: The penetrations are in fair condition. The chimney is in poor condition - some brick joints are cracked, the cement capping is cracked and loose, and plants are growing out of the chimney.

R-19 Cracked joints in Brick on chimney

Chimney Poor. Hazard. Repair immediately. 2 vents fair.

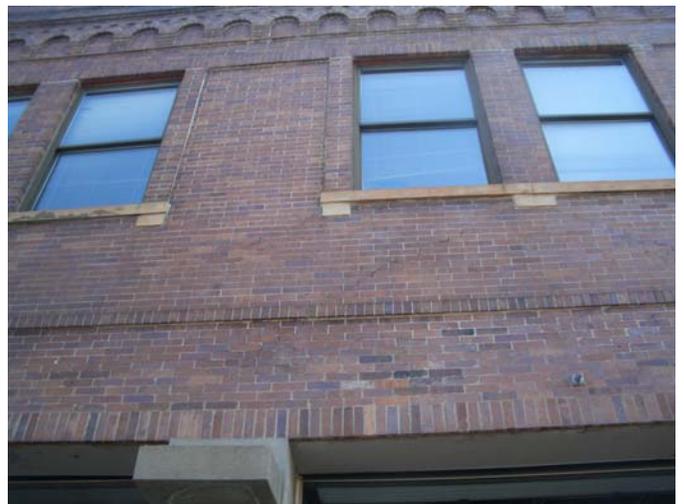
W-8 crack in brick joint above truck door

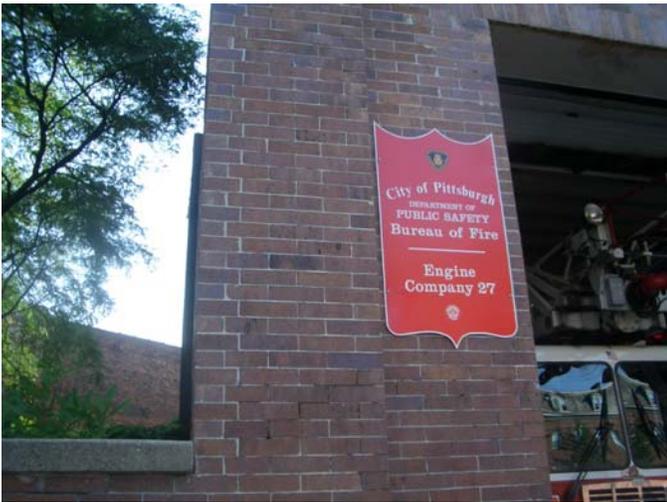
W-9 crack in brick joint below sign

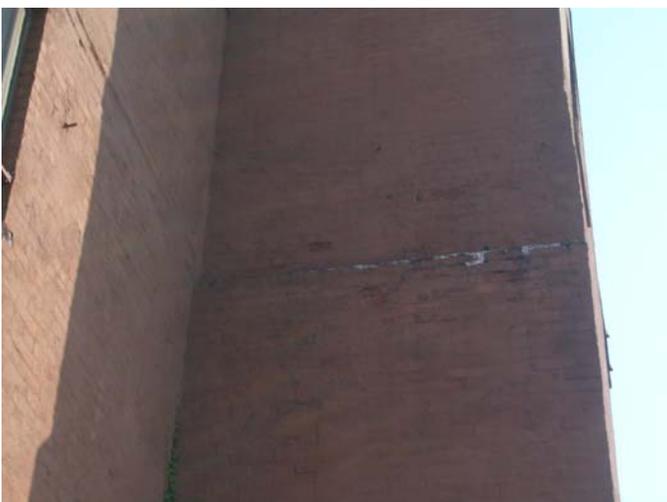
W-11 Crack in brick joint on Hose Tower with efflorescence
