CITY OF
PITTSBURGH
FACILITY ANALYSIS REPORT

Firehouse # 29 (B225)
2100 Noblestown Avenue
Pittsburgh, Pennsylvania 15205

July 2, 2010

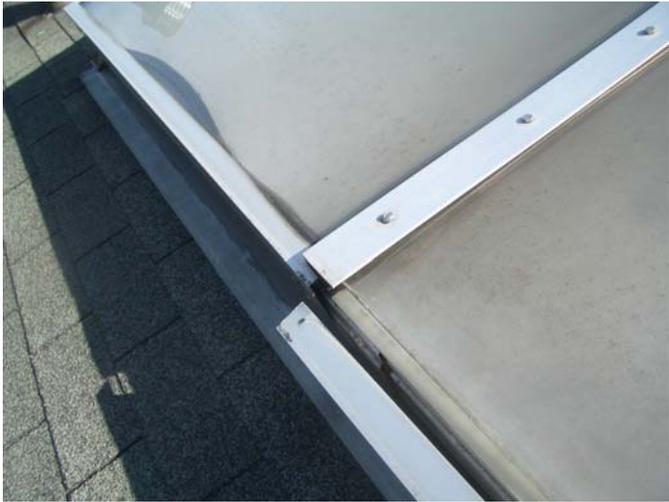
R-12 Loose metal trim on skylight (west side) over the truck bay

10.1 The caulking and sealants appear to be original construction and are aged, cracked and open. The brick walls are in good condition. The caulking and sealants should be replaced and the skylight should be repaired to maintain water tight integrity.

1 year: Maintain a pro-active maintenance program. Inspect the roof and gutter systems on a regular schedule - minimum twice a year (late spring and late fall). **NOTE: The caulking and sealants on the building walls should be addressed in order to maintain water tight integrity. The skylight should be repaired to prevent leakage.**

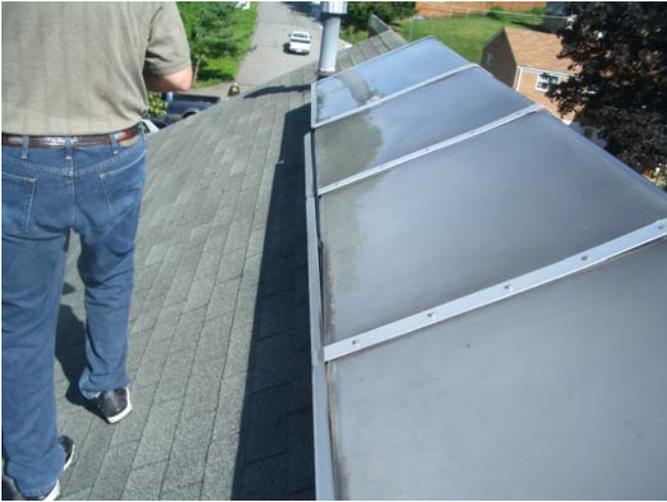
R-13 Loose metal trim on skylight (west side) truck bay with dirt between skylight panels

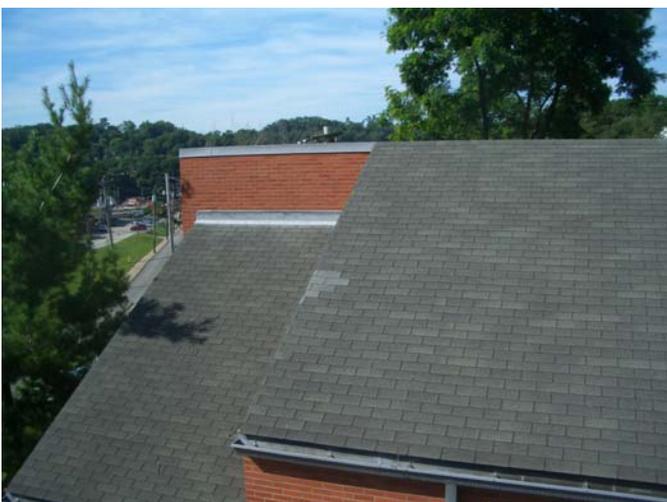
R-17 Shingle installation at eave showing inverted shingle used as starter

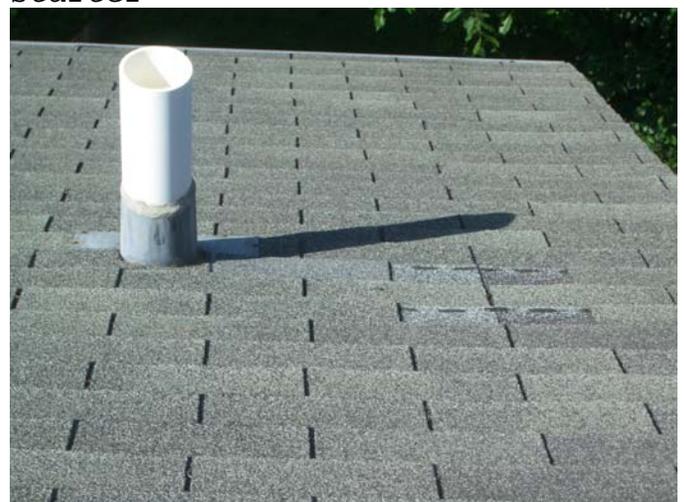
R-15 Small repair to shingles

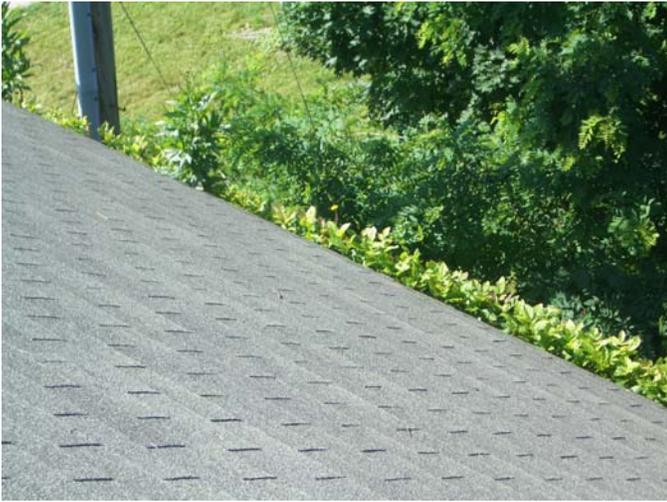
R-18 Missing shingle tabs to right of vent pipe, west side of roof

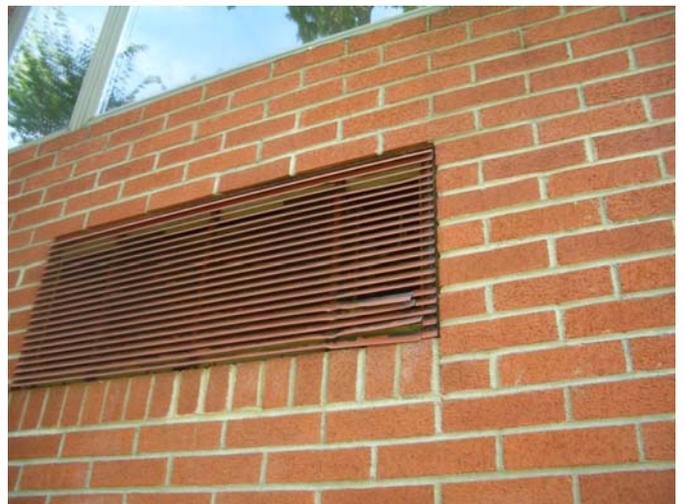
W-1 SW corner of building
