CITY OF
PITTSBURGH
FACILITY ANALYSIS REPORT

Firehouse #32 (B140)
900 Spring Garden Avenue
Pittsburgh, Pennsylvania 15212

July 9, 2010

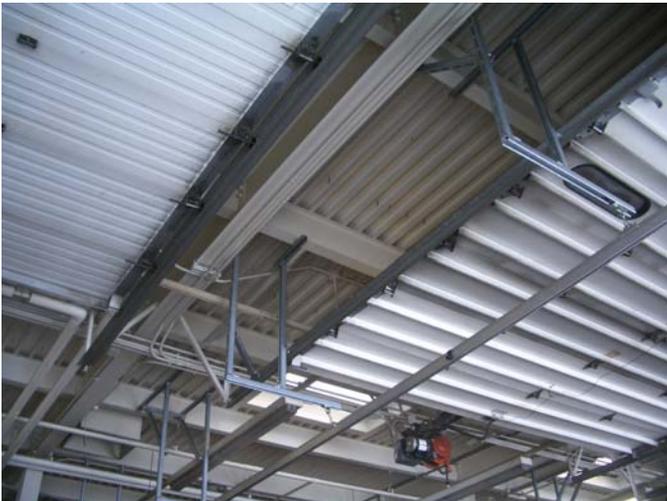
Current leaks are reported near the skylights. Stains and peeling paint was observed near the skylight during the underside inspection.

R-5 Underside of skylight, peeling paint from leaks

The skylights have been improperly sealed and should be replaced.

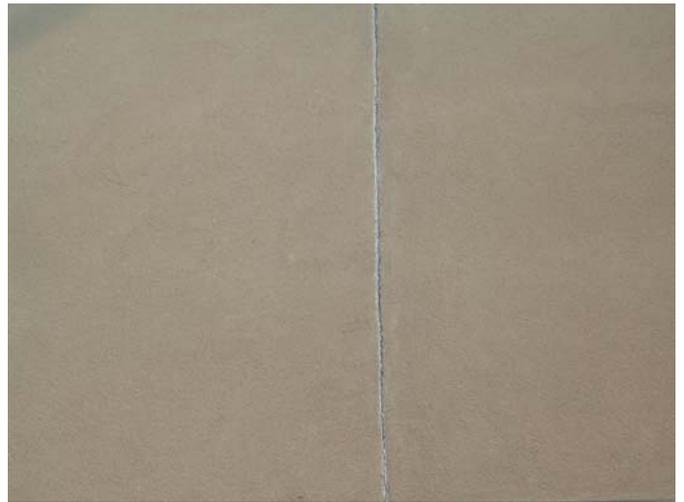
1.2 Condition: The building walls appear to be in fair condition. The caulking at the control joints of the EIFS is cracked and aged. The EIFS at the rear has been damaged by vandals throwing stones against the building.

W-3 Cracked caulking on EIFS joint on west wall

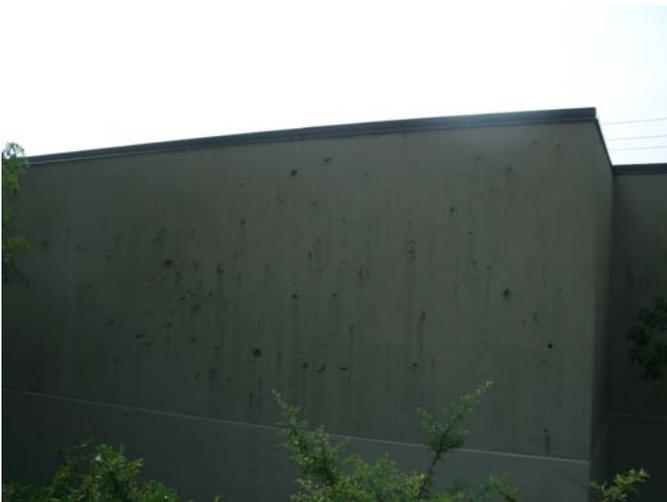
W-6 Cracked caulking on EIFS joint on south wall

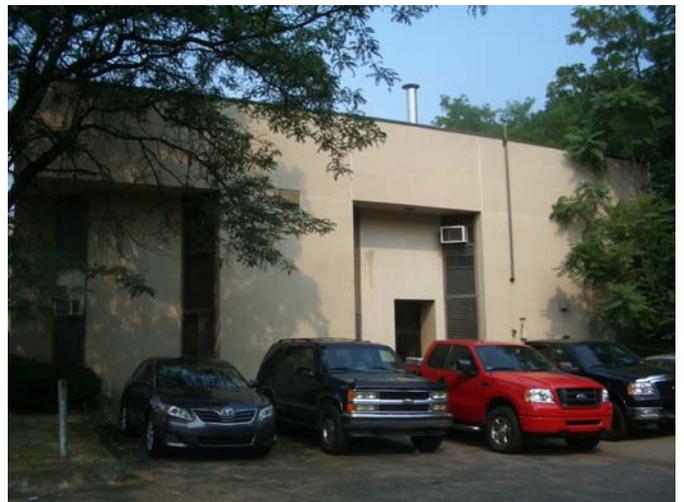
W-4 Damage to EIFS on north wall
