CITY OF
PITTSBURGH
PROPERTY CONDITION REPORT

B142 – Firehouse 35
1519 Orchlee St.
Pittsburgh, Pennsylvania 15212

June 2014

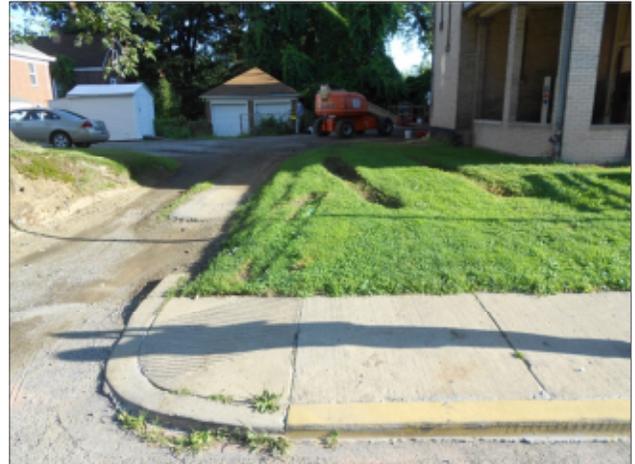
ST2 – Looking north from Orchlee St. – the driveway at left is on adjacent property; damage to lawn from manlift is apparent

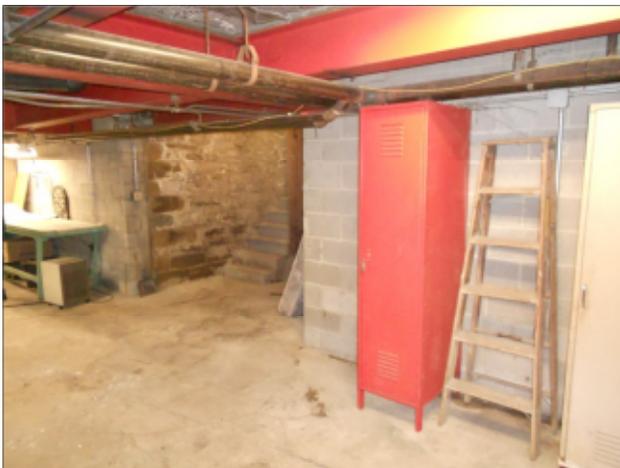
1. Foundation
 - a. Constructed of stone masonry - Good condition
 - b. Areas of foundation wall were supplemented with newer CMU wall construction at interior during structural repairs.
 - c. The exterior basement stair well has a few light cracks.
2. Slab on grade: The basement floor is concrete and has some light cracks and areas of spalling. Prior repairs are evident.

SS1 – Lower level - original masonry foundation and newer CMU infill

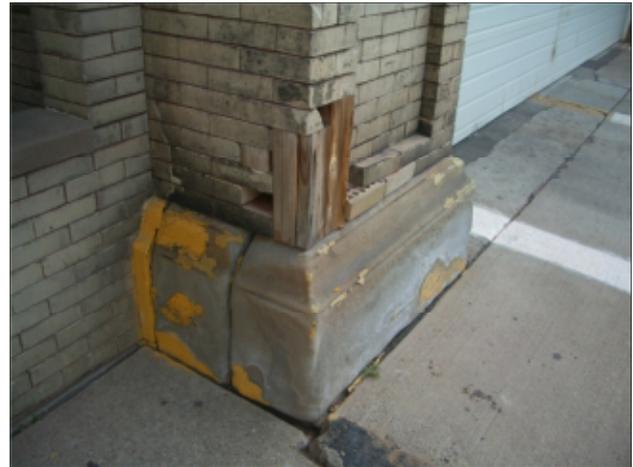
SH2 – 'Repair' of masonry damage at apparatus door

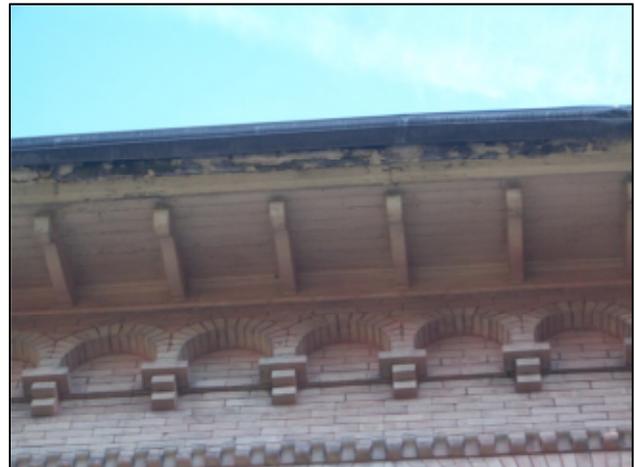
- 8.2. Condition: The cornices are in fair condition. The paint is peeling. Some repairs were observed.

The painted wood trim is in poor condition. Numerous areas of peeling paint were observed.

SH4 – Peeling paint at cornice

1 year: Replace the shingle roof systems – Estimated cost: \$50,000 (5,000 SF x \$10/SF). Paint all wood trim – Estimated cost: none (can be performed in house). Inspect roofs and walls yearly and remove debris from the gutter system.

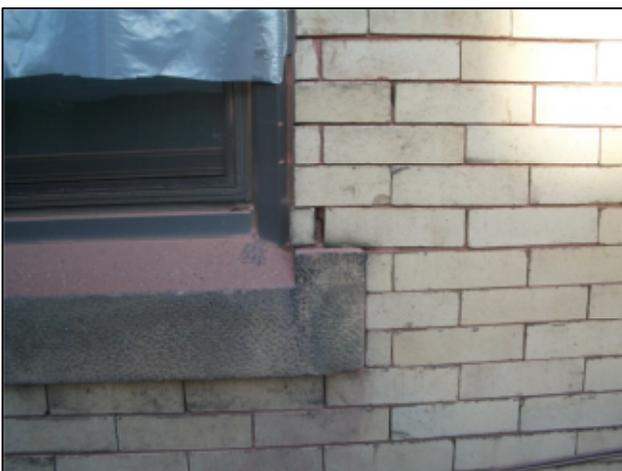
The building walls are in fair condition. A few defects were observed. A few cracks were observed in the stone foundation walls. A few brick joint cracks were observed. The masonry is being cleaned and repaired now.

SH5 – Masonry repair in progress at lintel

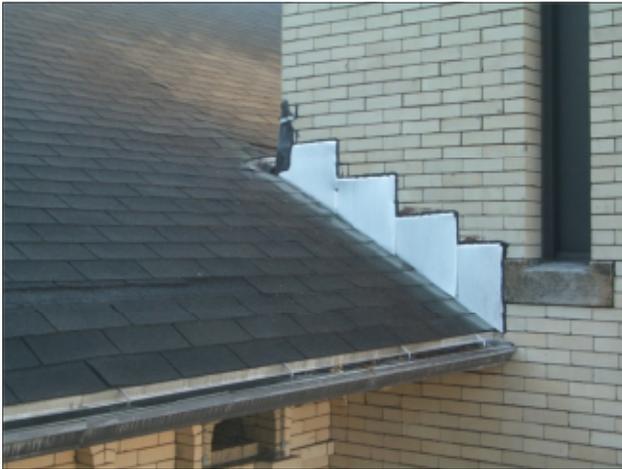
- 6.2. Condition: The shingle roof systems appeared in poor condition. Some shingles are missing, broken and loose. Some shingles have been replaced. The EPDM roof system appeared in fair condition. The membrane is loose from the wall and bridged.

The shingle roof systems are in poor condition. Some shingles are loose, broken and missing. The EPDM roof system on the Tower is in fair condition. Some membrane shrinkage was observed.

With proper Maintenance and corrective repairs, it is our opinion that the EPDM roofing system on the Tower is in a maintainable condition for the next five years. The shingle roof systems are 24 years old and should be replaced.

SH7 – Missing and damaged shingles at west face

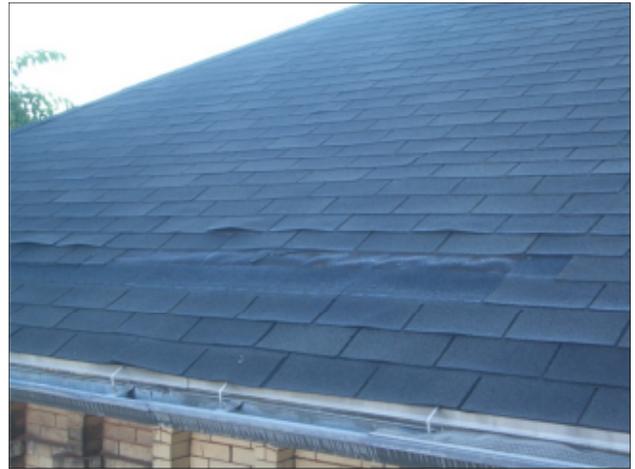
SH8 – Missing, damaged and lifting shingles

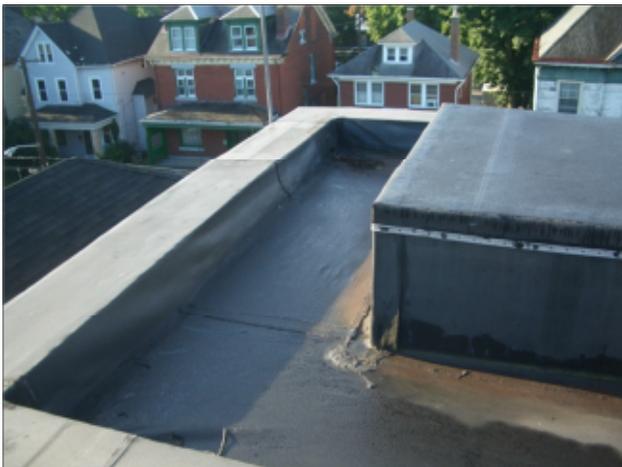
SH9 – EPDM membrane on tower, roofed over skylight, loose and bridged flashing

5 year: Replace the EPDM roofing system – Estimated cost: \$4,000 (200 SF x \$20/SF)

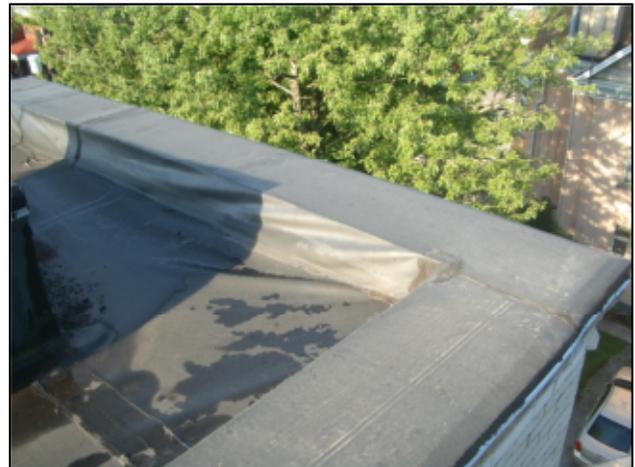
SH10 – Tower roof – loose and bridged flashing

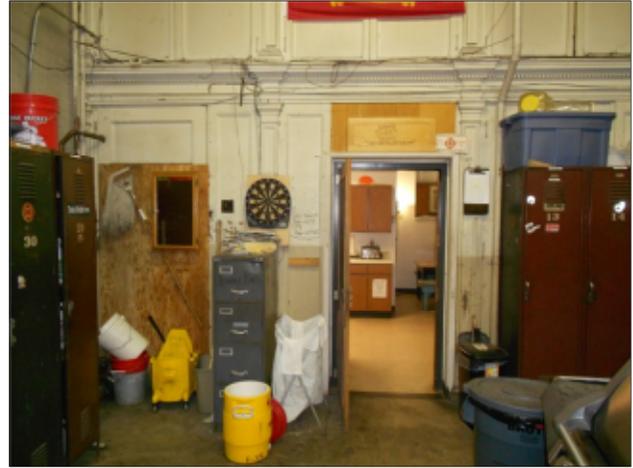
- 1.1. Interior partitions are primarily wood framed with cement plaster or drywall and are in fair condition.
- 1.2. The partition separating the Apparatus Bay from the Kitchen / Dining Area is constructed of wood and offers little or no fire separation rating. This appears to be a safety hazard.
- 1.3. Doors and frames are typically wood construction with commercial grade hardware.

12 – Wood partition separating apparatus bay from Kitchen / Dining area

Recommendation – Evaluate partition at Apparatus Bay / Kitchen for fire rating and determine required level of compliance.

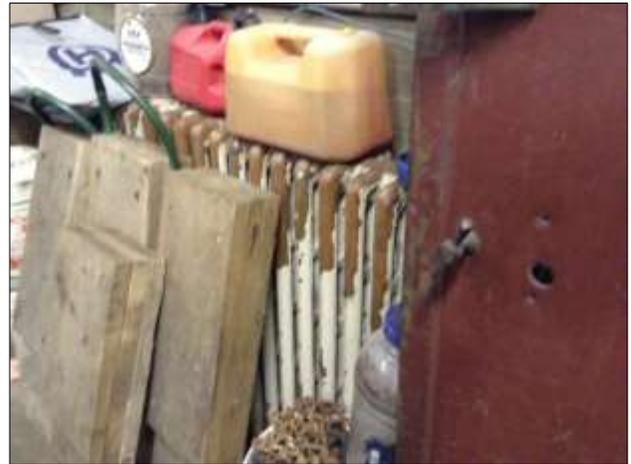
| 1.1.1.1. Safety Deficiencies: | Gasoline storage containers paled on hot water radiators |

HVAC 6 – Hot water radiator (Gasoline Storage)

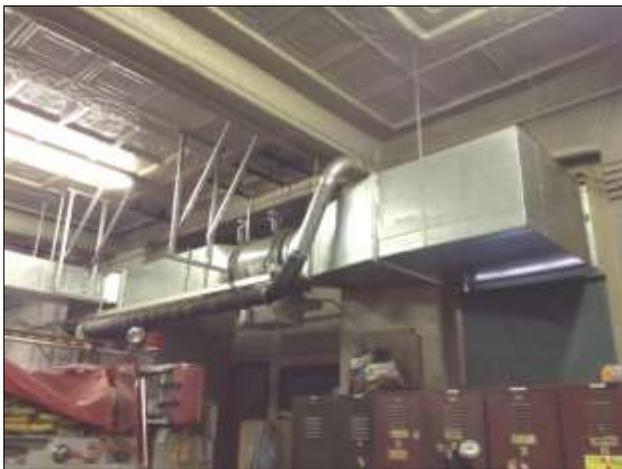
HVAC 7 – Exhaust Duct (abandoned in place)

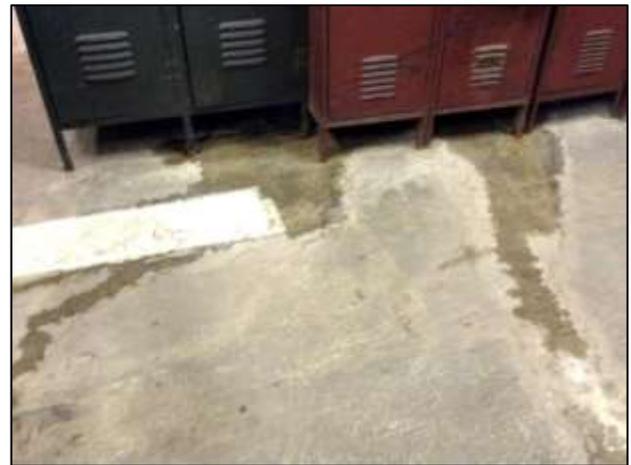
HVAC 8 – Hot water radiator Leak

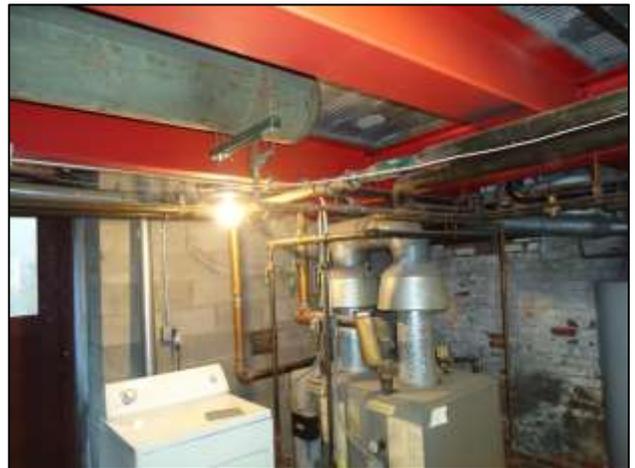
E16 – Boiler / Laundry (clearance issue)
