CITY OF
PITTSBURGH
FACILITY ANALYSIS REPORT

Firehouse #37 (B144)
1124 West North Avenue
Pittsburgh, Pennsylvania 15233

June 30, 2010

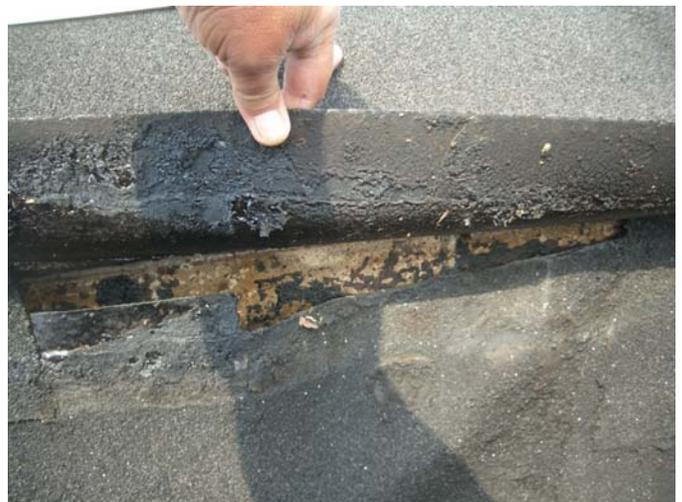
R-3 Truck bay SW corner, buckled and open flashing

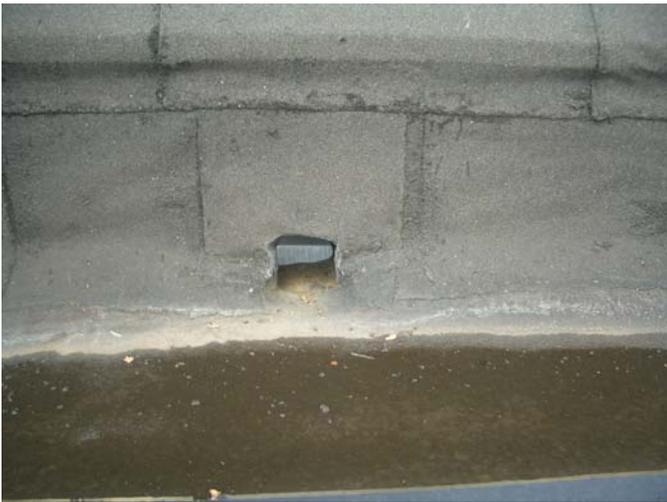
R-6 Truck bay, buckled, open and loose flashing on NW corner

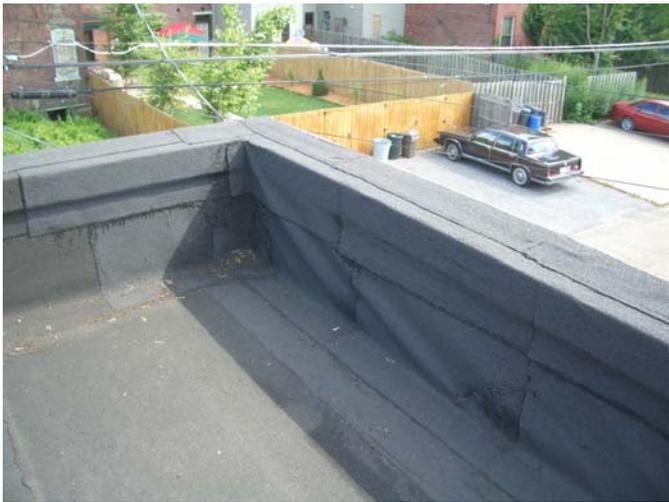
R-13 Main roof, debris at SW end

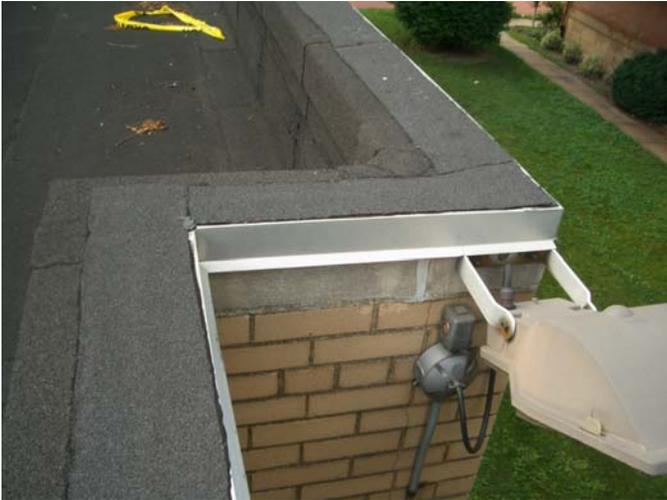
6.2 Condition: The stone coping is in fair condition. The caulking at the butt joints is aged. The cement in the coping bed joint is aged, deteriorated and falling out.

R-22 Deteriorated mortar in bed joint of coping

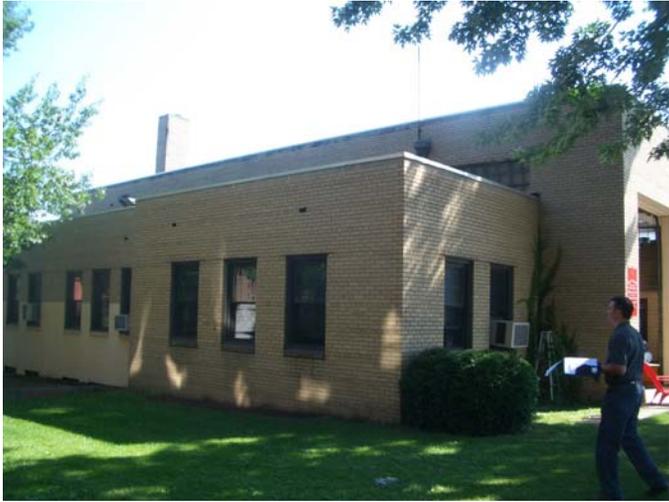
7.2 Condition: The penetrations are in fair condition. Some bricks are cracked on the south side of the chimney. The exposed pipe above the flashing needs painted.

R-21 Cracked brick in chimney

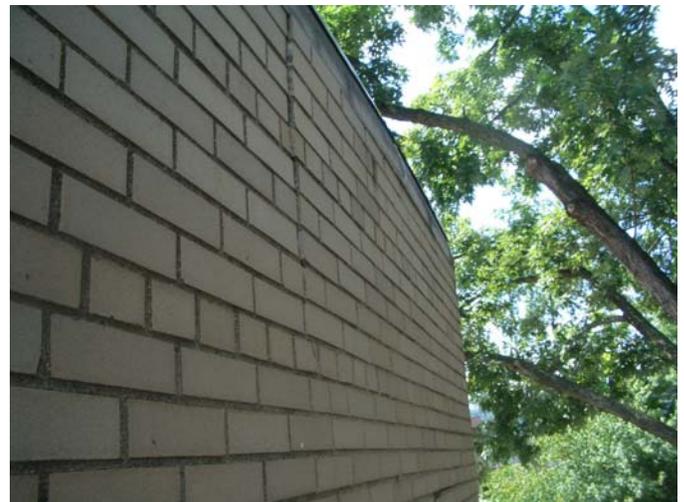
W-4 East wall

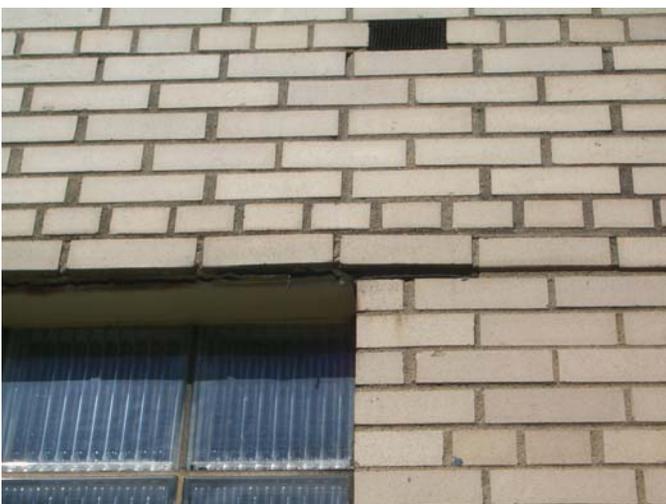
10.1 There are numerous cracked brick, cracked mortar joints, missing mortar and deteriorated mortar in the south end of the Truck Bay (front). Water stains were observed on the truck bay wall and support beam. Caulking has been applied to the window lintels and this has caused leaks in the wall and mortar to fall out of the brick joints at the lintels, mostly in the Truck Bay walls. The potential for damage to the structural integrity is high.

W-7 Cracks in brick and wall blister at SW corner of Truck bay

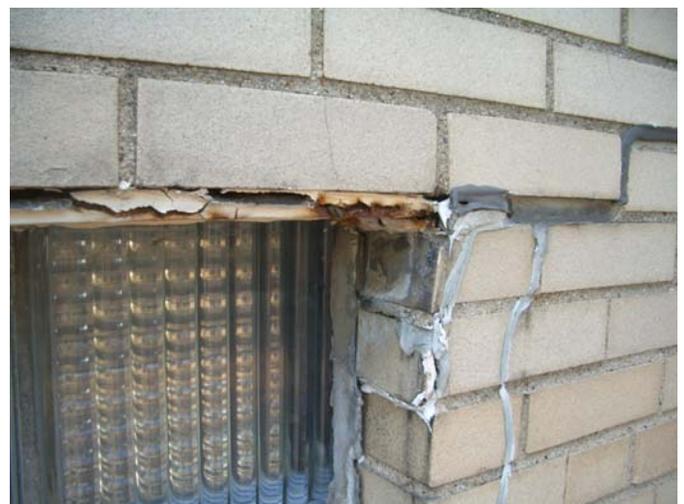
W-5 Truck bay, caulking on lintel, Missing mortar

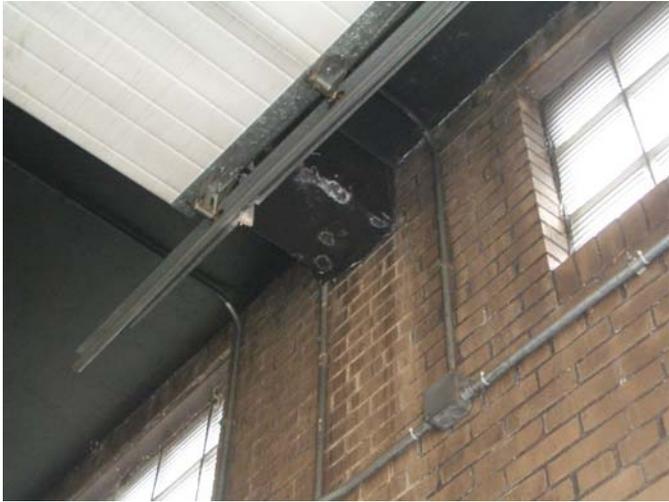
W-10 Truck bay SE corner, open mortar joints
