CITY OF
PITTSBURGH
PROPERTY CONDITION REPORT

B124 – Firehouse 12 / Medic 7
4156 Winterburn Avenue
Pittsburgh, Pennsylvania 15207

June 2014

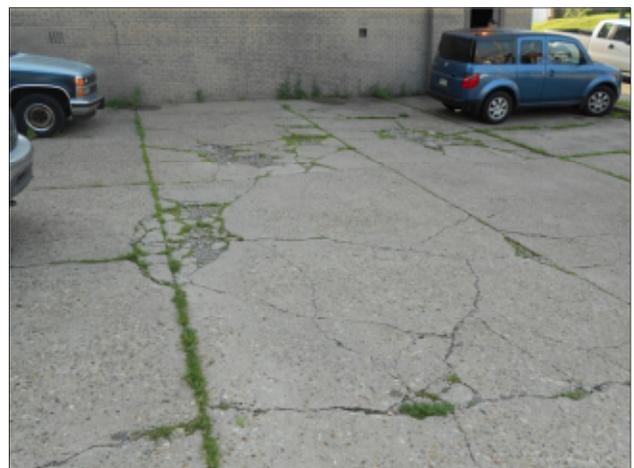
ST6 – Broken pavement at parking area

Recommendation: Replace concrete pavement/ curbs at parking area and improve storm water infrastructure to prevent onsite storm water from leaving the property.

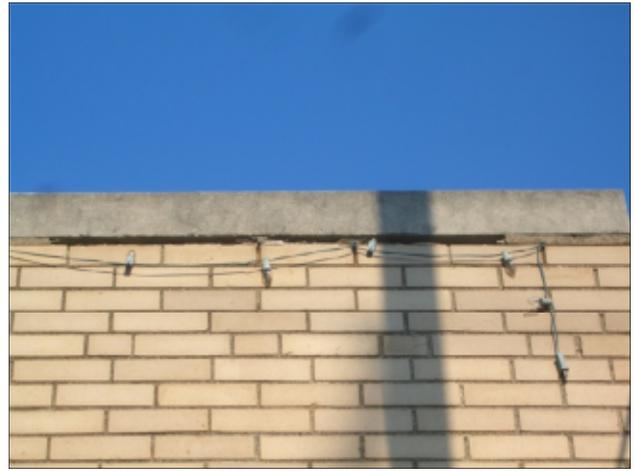
- 8.2. Condition: The limestone coping is in poor condition. The mortar in the bed and butt joints is cracked and missing in some areas. The metal counter flashing appears in fair condition.

SH2 – NE corner - Missing mortar at precast coping

1 year: Replace caulking and sealant at doors and windows, re-point brick walls and limestone coping – this work does not have to be done at one time but as the maintenance budget permits. Inspect roofs and walls yearly and remove debris – Estimated cost: None (perform with in-house personnel)

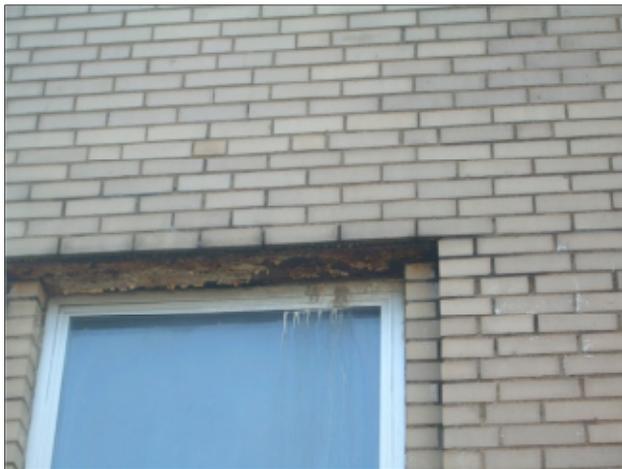
- 3.4. Window lintels have light/ heavy rust with areas of bulging brick, loss of mortar and minimal brick displacement
 - 3.5. Sidewalks have areas of heavy cracking, scaling, spalling and minimal settlement.

SH3 – Rusted lintel - typical

- Masonry restoration including sealant and lintel repair/replacement
- (5yr.) Replace the front trench drain and repair apparatus drive - \$10,000

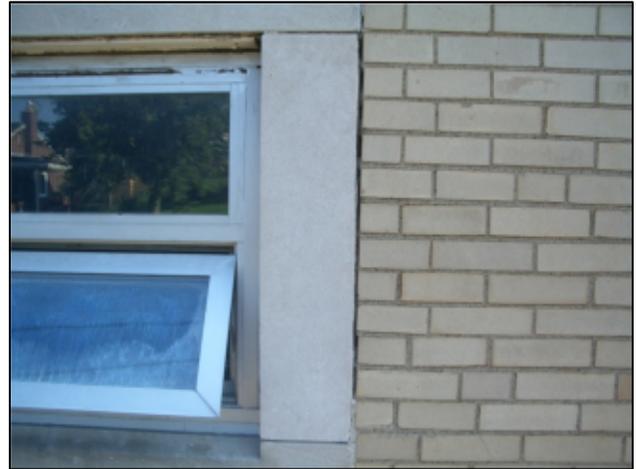
- 12.1. A few leaks are reported and some have been repaired. There is one active leak in the watchroom (open flashing above).
- 12.2. The building walls are in fair condition. A few defects were observed. A few cracked bricks were observed. The caulking/sealant at the doors and windows is in poor condition.

SH4 – Missing sealant at window surrounds - typical

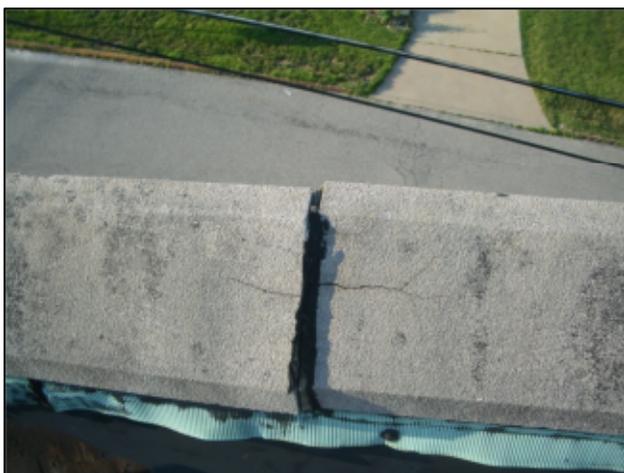
- 12.4. The roof membrane and flashing systems are in fair condition. One area of open flashing was observed above the watchroom
- 12.5. The limestone coping is in poor condition. A few units are cracked. The mortar joints are cracked and open in most areas. The bed joint mortar is cracked and missing in some areas.

SH5 – Cracked and displaced coping above truck doors

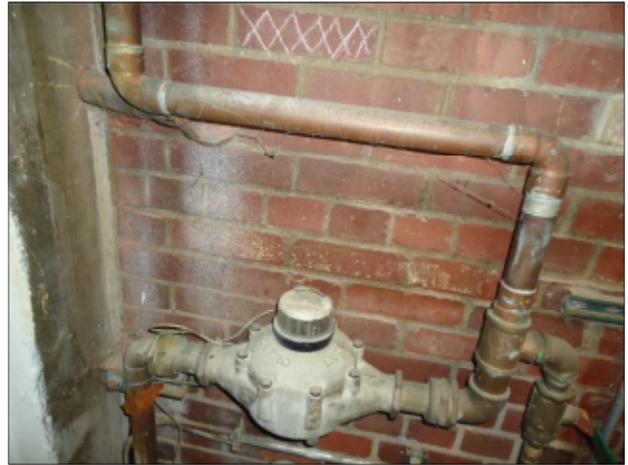
- 3.1 General Description: Potable water supply
- 3.2 Construction
 - 3.2.1 Original meter, shut-off valve, and piping.
 - 3.2.2 No back-flow prevention.**
- 3.3 Condition Assessment: **Fair**

P14 – Domestic water meter and piping - 1

- 5.1 De minimus conditions
 - 5.1.1 Insulate supply pipes from water heaters.
- 5.2 Immediate Costs
 - 5.2.1 Install back-flow preventer: \$2,000.

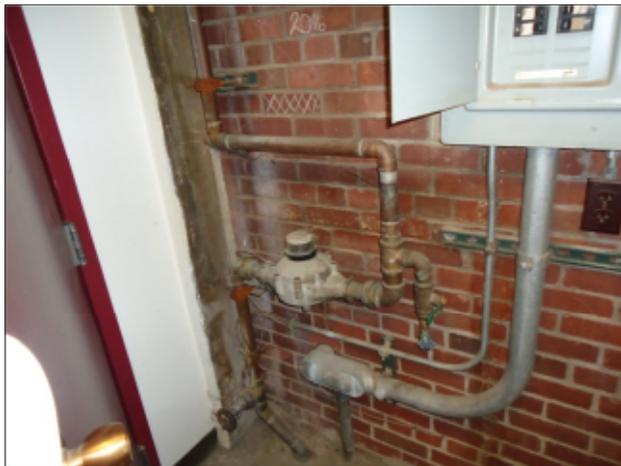
P15 – Domestic water meter and piping - 2

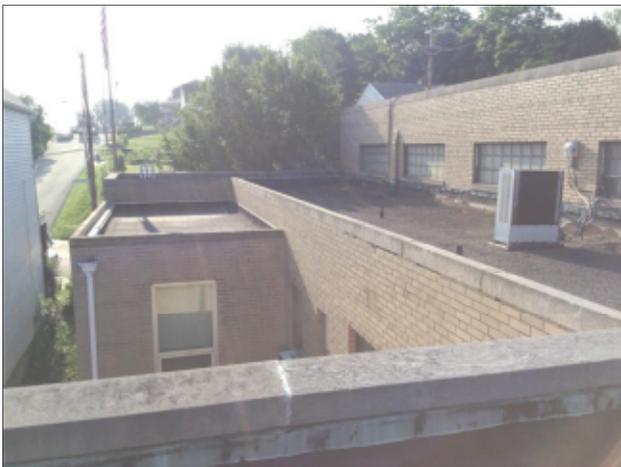
HVAC 3 – Abandoned in-place ACCU
