CITY OF
PITTSBURGH
PROPERTY CONDITION REPORT

B032 – Jefferson Recreation Center
605 Redknap Street
Pittsburgh, Pennsylvania 15212

June 2014

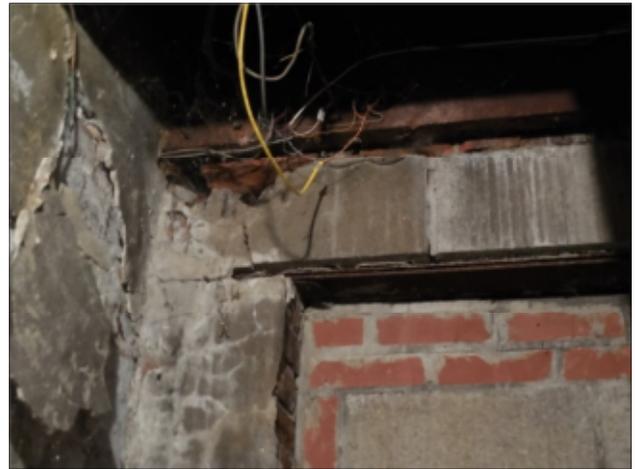
- 2.2. The wood floor joist and steel beams are in good condition.
 - 2.3. The 2x8 rafters on 16" centers roof joists are in good condition.
 - 2.4. The SE corner of the bottom floor wall has lost its coating and reveals a steel beam supporting the top floor with moderate rust

SH2 – SE corner, loss of wall coating reveals steel beam with moderate rust

- 3.4.1.1. Monitor the NW Parapet and top section for movement: \$0
 - 3.4.1.2. Correct the moisture problem at SW corner to prevent steel beam deterioration. \$250

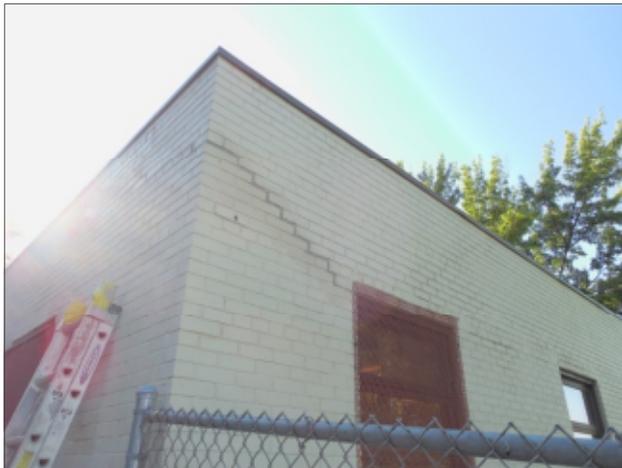
1. Overall the Shell appears to be in Fair condition.
2. Building Frame
 - 2.1. NW corner has bulging bricks and patched step cracking from NW past the mid-point in the SE direction. The parapet is leaning inwards and has caused a diagonal warp in the roofing material.

SH3 – Patched step cracking in the joints

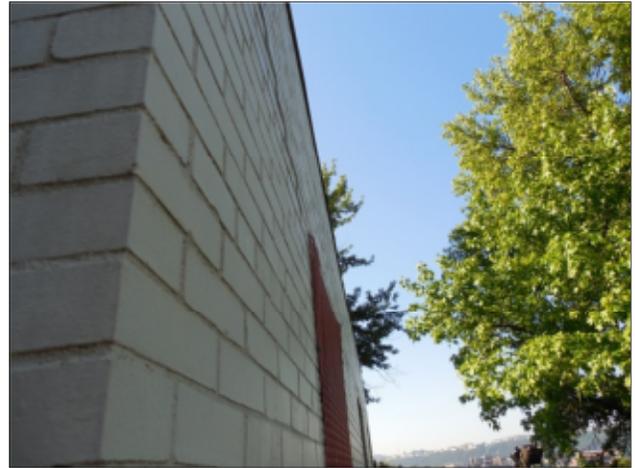
SH4 – NW corner bulge with parapet leaning towards east

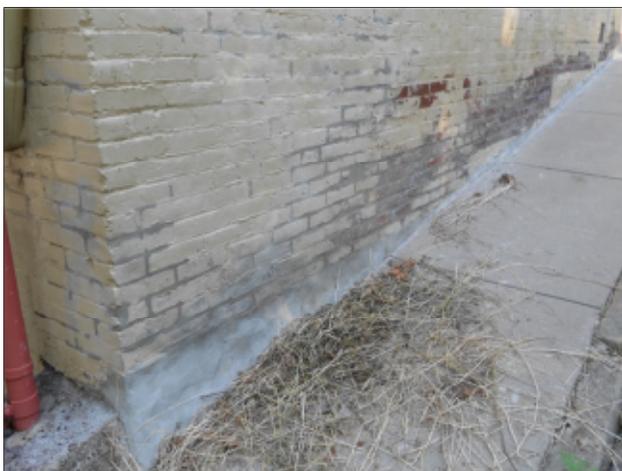
SH5 – Recent mortar repairs at SE corner

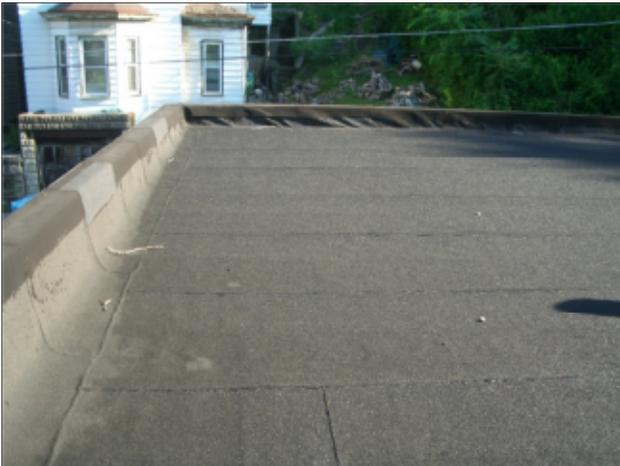
4.4.2. Condition: The membrane flashing system is in fair to poor condition. The flashing is loose from the wall and buckled (wrinkles) in some areas. The flashing extends up and over top the metal coping. The flashing was not installed to industry standards.

SH9 – West wall looking north – note loose flashing

The roof membrane and flashing systems are in fair to poor condition. The loose and buckled flashing should be monitored and repaired until the roof is replaced.

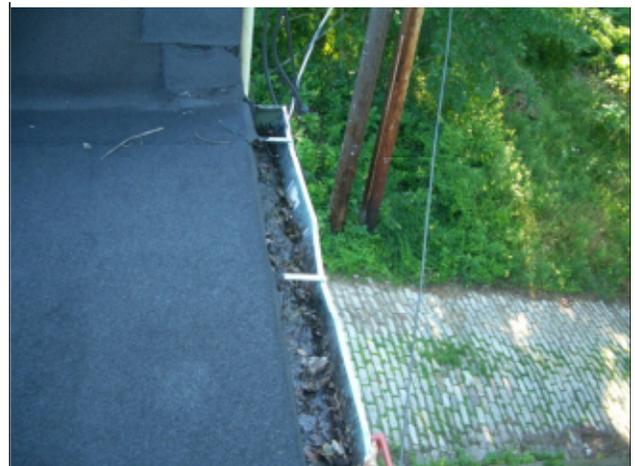
4.7.2. Condition: The gutter contains debris and overflows during a rain causing water to enter the building at the door below. Two of the downspouts drain into standpipes. One downspout empties onto the ground level paved area.

SH10 – Debris in the gutter system

The drainage system is in fair condition. The gutter should be cleaned and continue to be cleaned twice yearly.

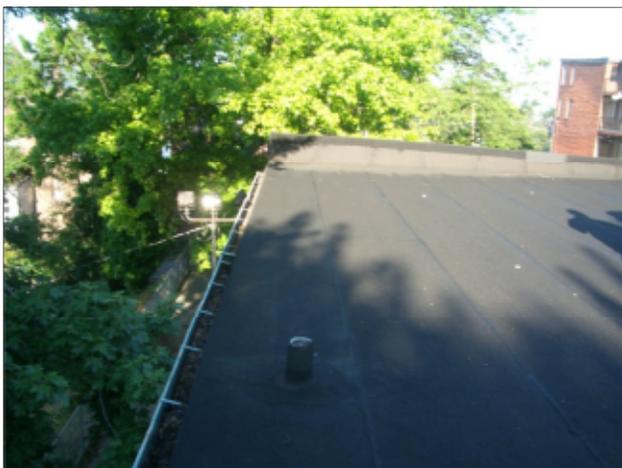
SH11 – South (rear) wall looking west, debris in gutter system

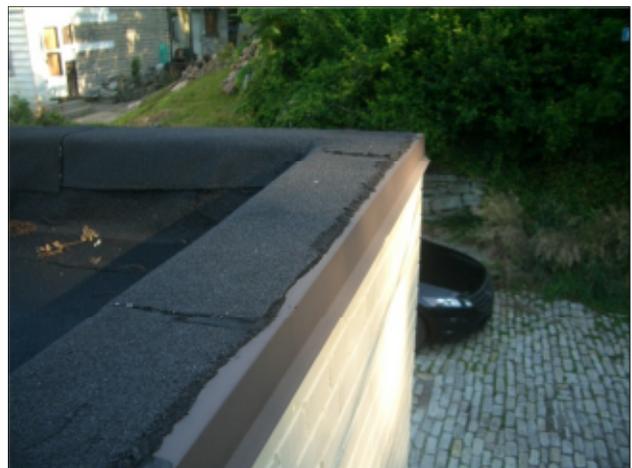
4.5.2. Condition: I could not observe the metal coping or drip edge except for the exterior face. It appears the metal terminations were part of the previous roof system and left in place when the current system was installed.

SH12 – Metal coping covered with membrane flashing

The metal coping and drip edge are covered with roof membrane and should be monitored and repaired until the roof is replaced.

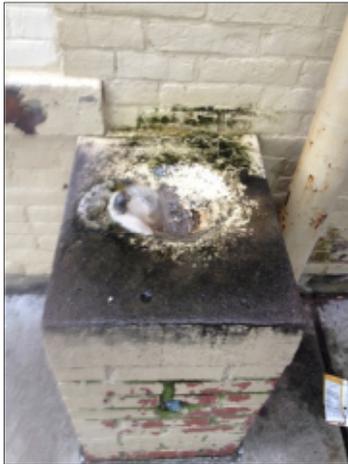
- 1.1. General Description: The plumbing system is served by a combination of sanitary fixtures, supply and drain piping, water fountain, and supply water meter service.
- 1.2. Construction: Interior
 - 1.2.1. The ladies room has two (2) toilets, and one (1) lavatory sink.
 - 1.2.2. The men's room has: one (1) urinal, one (1) toilet, and one (1) lavatory sinks.
 - 1.2.3. The kitchen has one (1) stainless steel, double-bowl sink.
- 1.3. Condition Assessment
 - 1.3.1. Condition: Poor.
- 1.4. Performance Observations
 - 1.4.1. Energy and Sustainability: The outside water fountain runs continuously, wasting potable water and causing high sewage bills.

P1 – Outside water fountain

- 5.1 Immediate Costs
 - 5.1.1 Install back-flow preventer: \$1,200.
 - 5.1.2 Replace leaking PRV: \$1,000
- 5.2 Short-term Costs
 - 5.2.1 Add solenoid valve and timer for outside water fountain: \$1,300

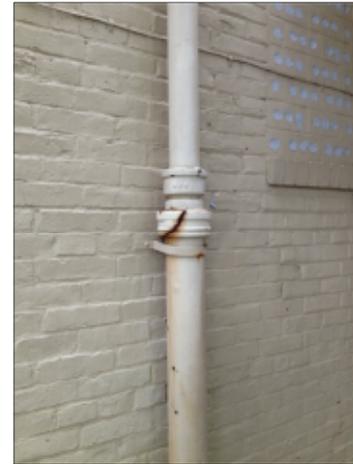
P2 – Old damaged downspout pipe

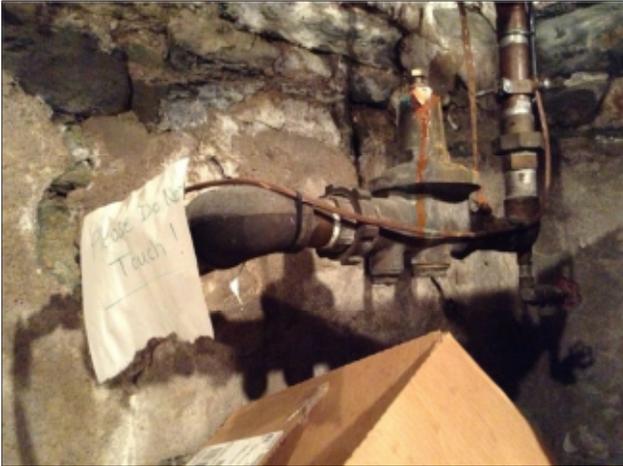
- 3.1 General Description: Potable water supply
- 3.2 Construction
 - 3.2.1 Original meter, shut-off valve, and piping.
 - 3.2.2 No back-flow prevention.
- 3.3 Condition Assessment: Derelict.
 - 3.3.1 Pressure regulating valve (PRV) leaking.

P7 – Water meter and piping

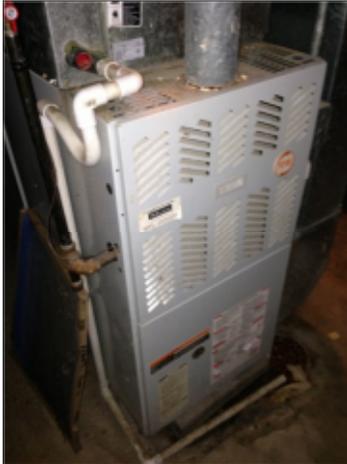
- 1.2.3.1. There is no provision for ducted combustion air, this is a code violation.
- 1.2.3.2. Service clearance dimensions for GFAHUs are insufficient. This may be a code violation.
- 1.2.3.3. Supply and return air ductwork in the MER is not insulated.

H/C 1 – Central furnace GFAH: typical of 2

- 5.1. De minimus conditions
 - 5.1.1. Reconnect return air grille in bottom floor game room.
- 5.2. Immediate Costs
 - 5.2.1. Install combustion air duct per code: \$3,500
- 5.3. Short-Term Costs
 - 5.3.1. Replace ACCU hot gas piping insulation: \$1,000
 - 5.3.2. Replace existing thermostats: \$1,000
 - 5.3.3. Add damper and timer to OA inlet: \$1,700

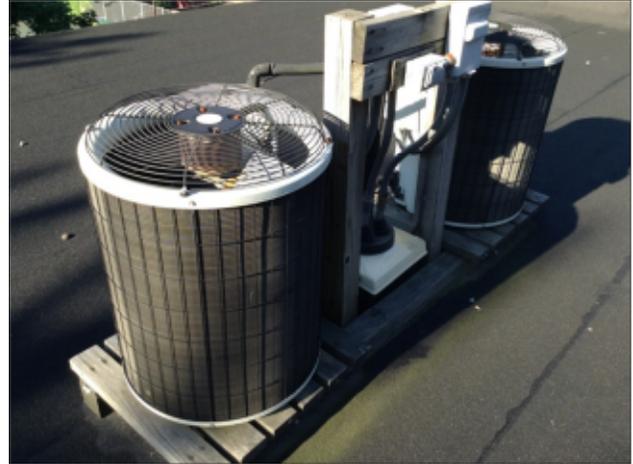
H/C 2 – Roof-top ACCUs

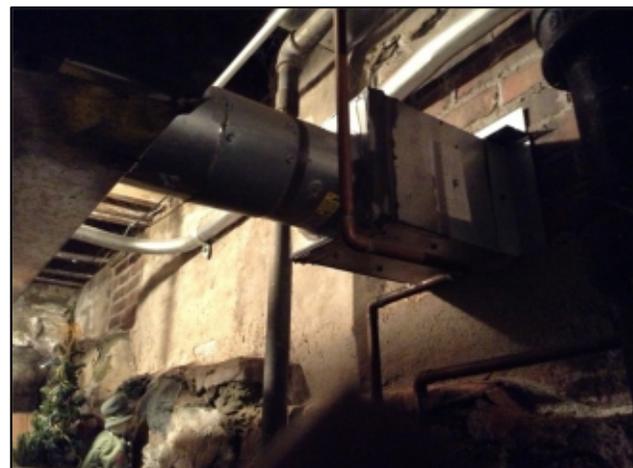
- 2.1. General Description: Ventilation is provided by a duct connection between an outside air (OA) louver the main return air (RA) duct.
- 2.2. Construction
 - 2.2.1. Galvanized ductwork without control damper, filtration, insulation, vapor barrier, or inlet hood.
- 2.3. Condition Assessment: Poor.

H/C 6 – Outside air (OA) inlet

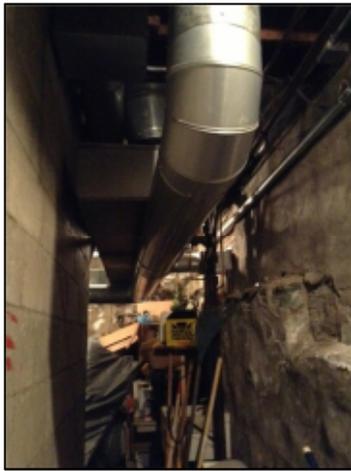
H/C 7 – Uninsulated ductwork

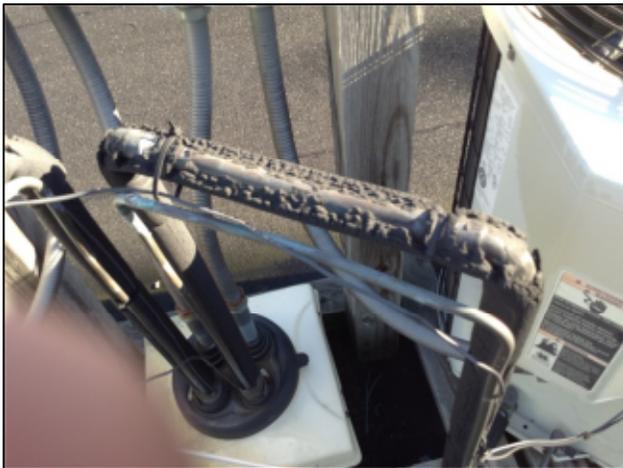
- 1.3.4.1. Insulation on roof-top ACCU lines is severely deteriorated. Condition: Derelict.
- 1.3.4.2. Return air grill in bottom-floor game room is dis-connected.

H/C 9 – Deteriorated insulation: ACCU refrigerant piping

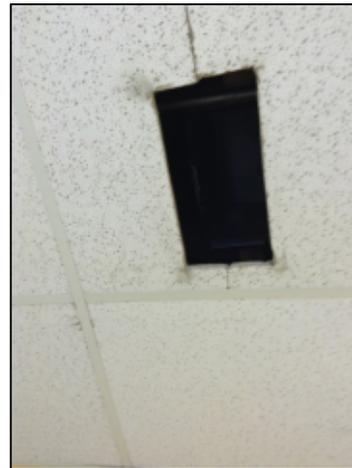
H/C 10 – Missing RA grille: bottom level game room

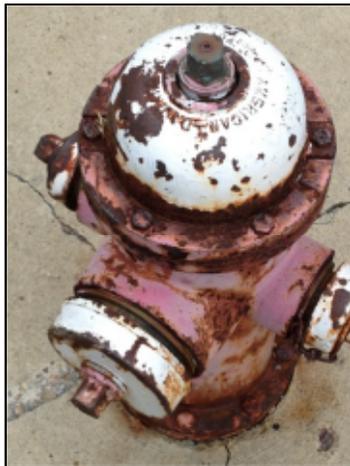
4. Sprinklers and Standpipes
 - 4.1. No sprinkler system.
5. Fire Hydrant
 - 5.1. Construction: Located at roadway corner.
 - 5.2. Condition Assessment: Poor

FP3 – Fire Hydrant
