CITY OF  
**PITTSBURGH**  
FACILITY ANALYSIS REPORT

**Medic 3 / Arson / Police Zone #6**  
312 South Main St.  
Pittsburgh, Pennsylvania 15220

**Medic 3 / Arson / Police Zone 6 (B112)**

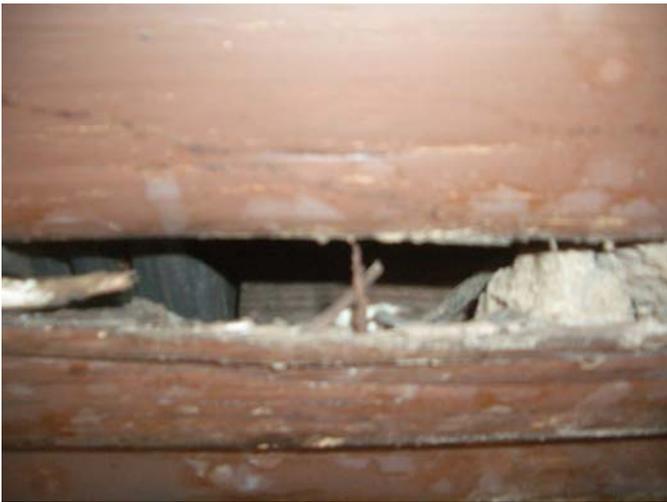
R-1 Underside of deck at stairwell, wood deck observed

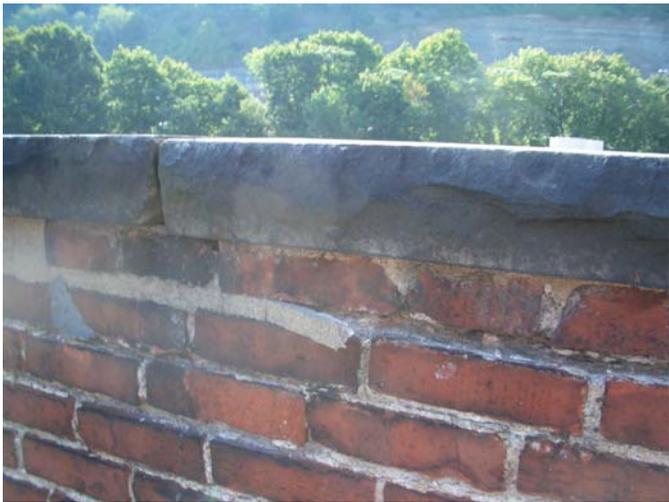
The stone coping is in poor condition. The mortar bed and butt joints are cracked and open. The metal coping is in fair condition. The roof top penetrations are in fair condition.

R-4 Front wall with stone coping, missing and deteriorated mortar

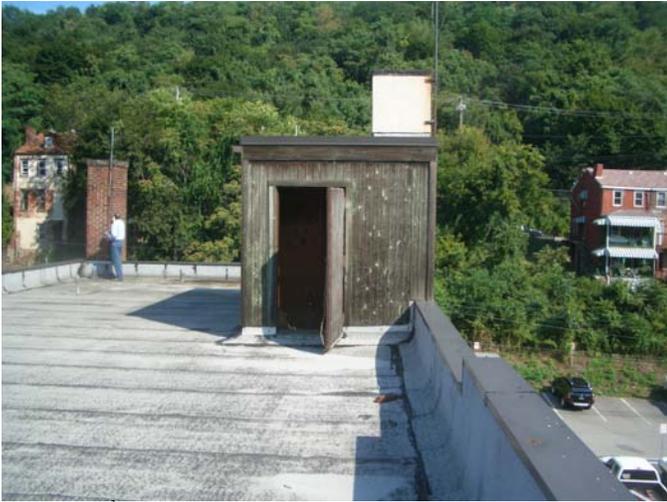
R-2 2<sup>nd</sup> floor roof look west along north wall

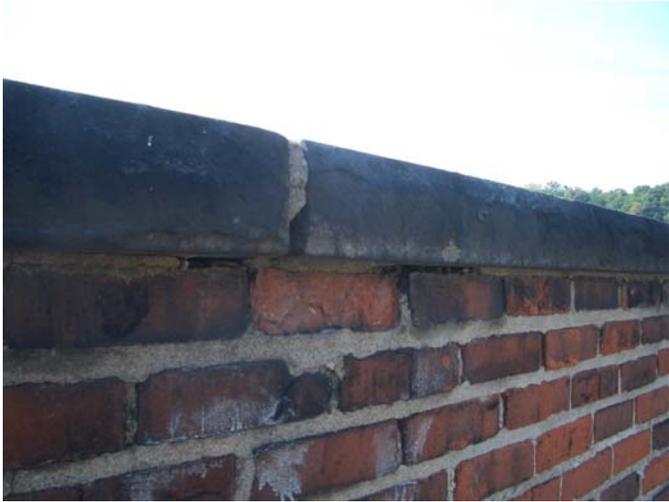
R-5 Front wall, missing and deteriorated mortar

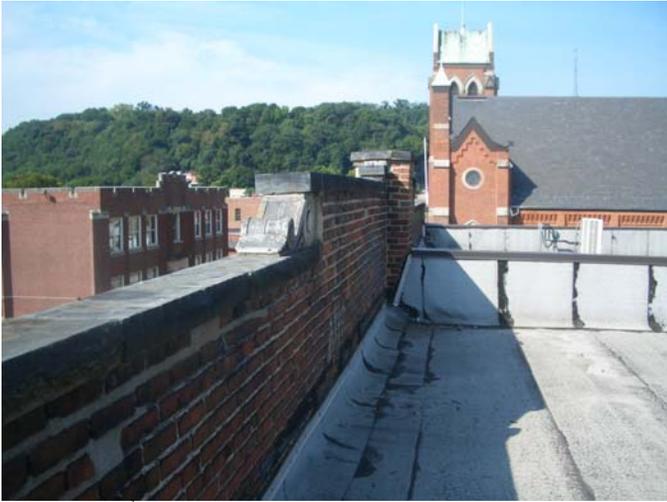
R-3 2<sup>nd</sup> floor roof looking south along front wall

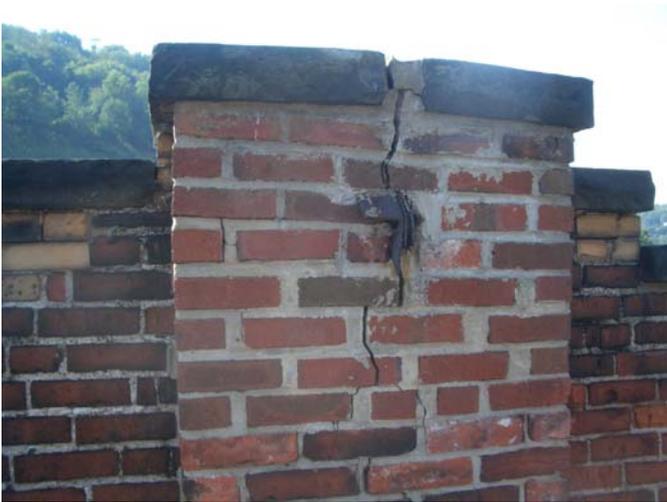
R-7 Front wall, support for flag pole, cracked brick

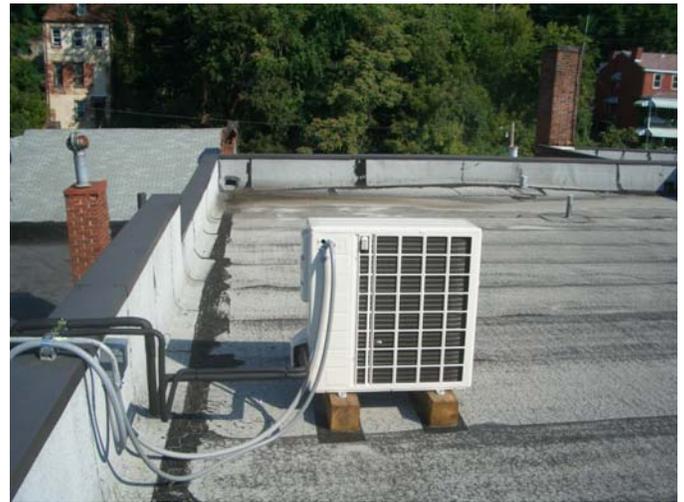
R-10 2<sup>nd</sup> floor roof looking west along the south wall

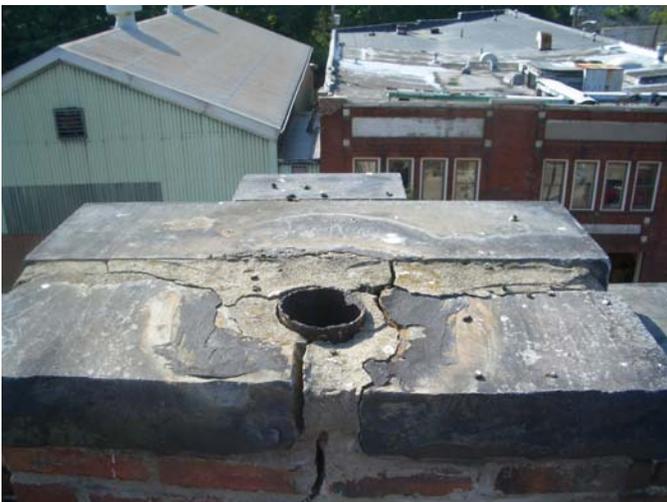
R-8 Front wall, support for flag pole, cracked cap

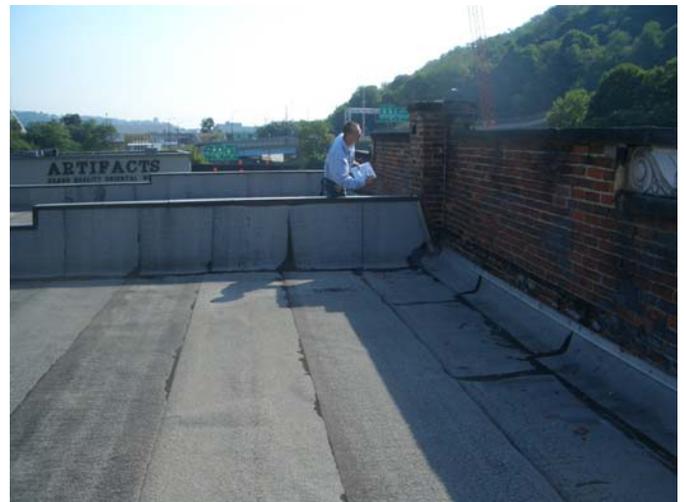
R-11 2<sup>nd</sup> floor roof looking north along the front (east) wall

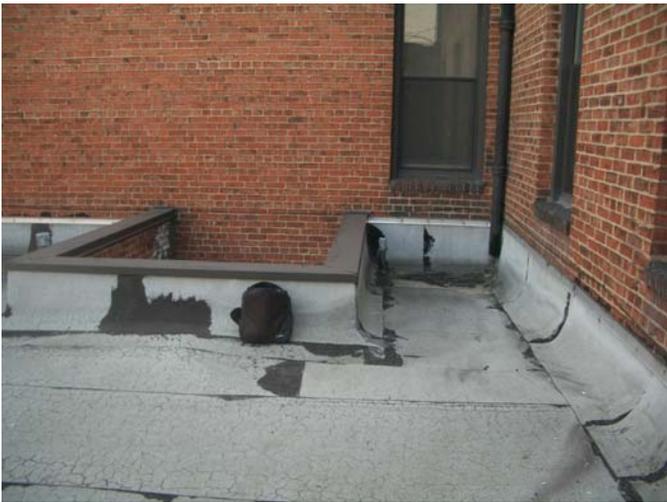
R-31 1<sup>st</sup> floor roof, repairs and blisters

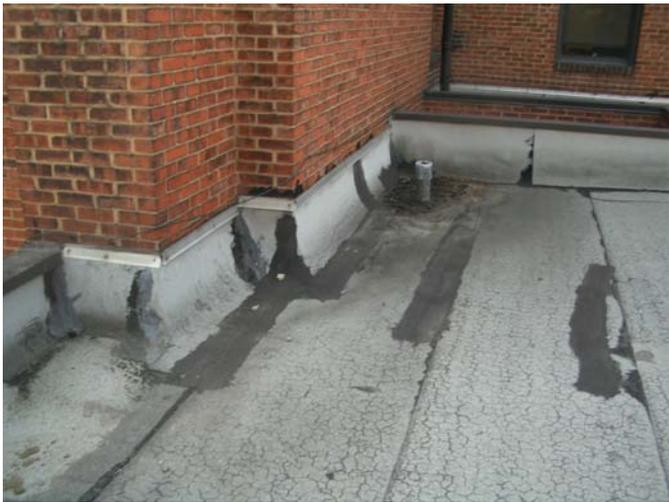
R-34 1<sup>st</sup> floor roof, repairs along north wall

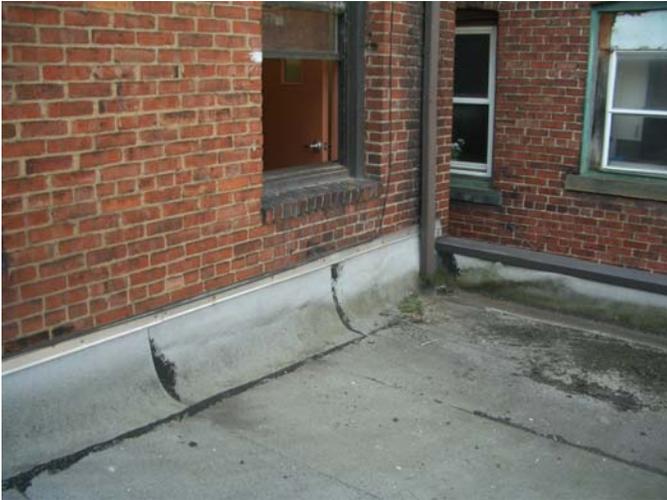
5.2 Condition: The flashing systems are in poor condition. In some areas the flashing is loose from the walls. The flashing is buckled at a few corners. Some vertical flashing joints are open. The surface is cracked and crazed.

R-32 1<sup>st</sup> floor roof, buckled flashing in NE corner

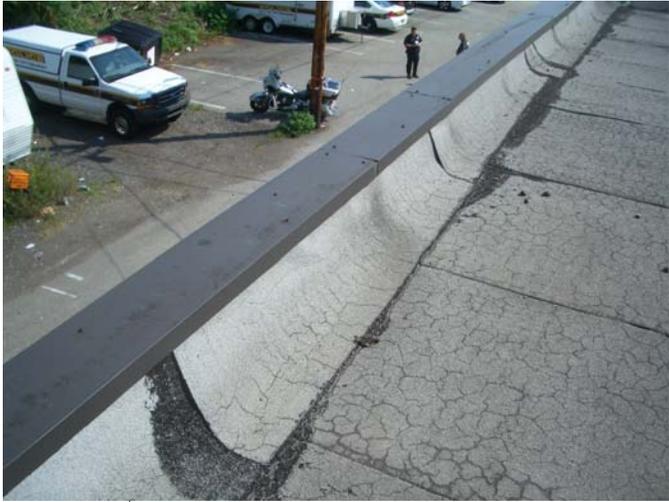
R-36 1<sup>st</sup> floor roof, open flashing joints and loose flashing

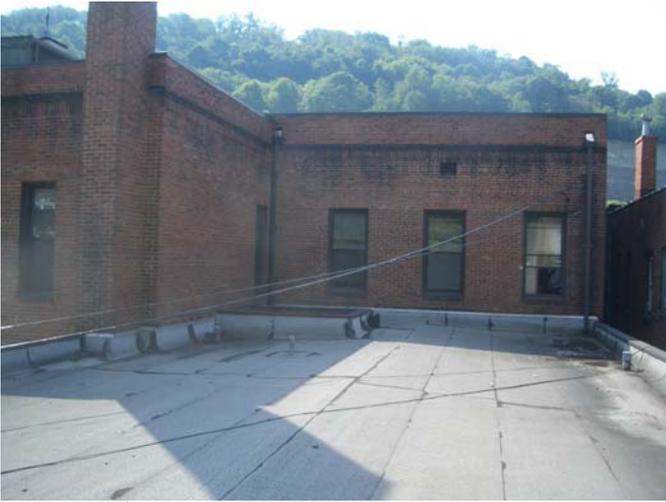
R-37 1<sup>st</sup> floor roof looking east
