CITY OF
PITTSBURGH
PROPERTY CONDITION REPORT

B150 – Medic 4
Federal & Lafayette Streets
Pittsburgh, Pennsylvania 15214

June 2014

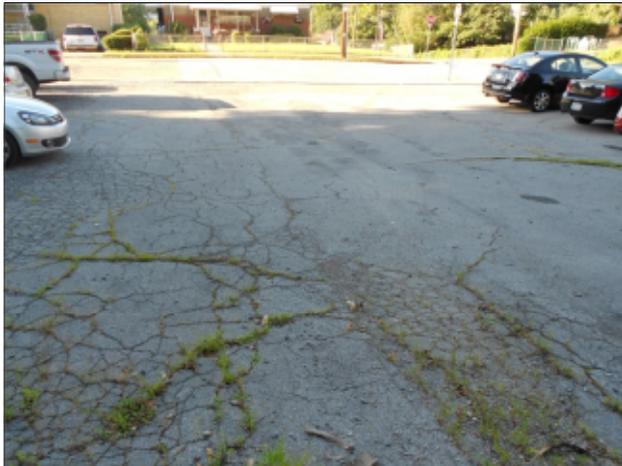
3. Paving, Curbing and Parking – The site paving at the parking area is asphalt and in Poor condition. The curbs and walks are also in Poor to condition. The concrete slab at the terrace on the NW side of the building is severely cracked and settled. Concrete apron has areas of cracking and joint spalling and is in Poor condition. Accessible parking is NOT available. Approx. five (5) spaces are available for on-site parking. Note that the parking area extends on to the adjacent corner lot which is NOT owned by the City. Overall the site paving is in Poor condition.

ST3 – Broken paving at parking area

- Replace asphalt at drive/parking
 - Replace damaged curbs and walks
 - Replace concrete slab and repair site drainage at NW terrace
 - Repair concrete apron and seal all joints
4. Landscaping and Appurtenances – Unimproved plantings surround the building on three sides. Overhanging trees and overgrown vegetation significantly impacts drainage and limits maintenance.

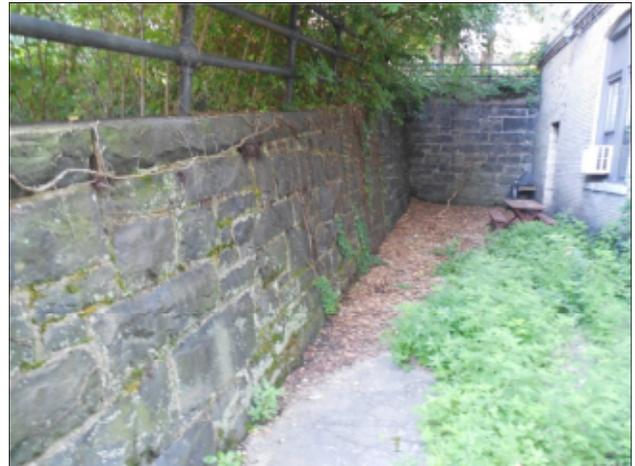
- Remove overgrown vegetation and cut back overhanging trees
 - Remove debris from site area adjacent to building.
5. Site Amenities / Accessory Structures- A large stone masonry retaining wall at the NW side of the building appears to be in Fair condition except the south corner was apparently damaged during the sump pump line installation. The cap stones are shifted and the steel railing is broken, apparently by equipment impact.

ST4 – Retaining wall at NW terrace, broken concrete paving, inadequate site drainage

Recommendation – Repair cap stones and guardrail at retaining wall

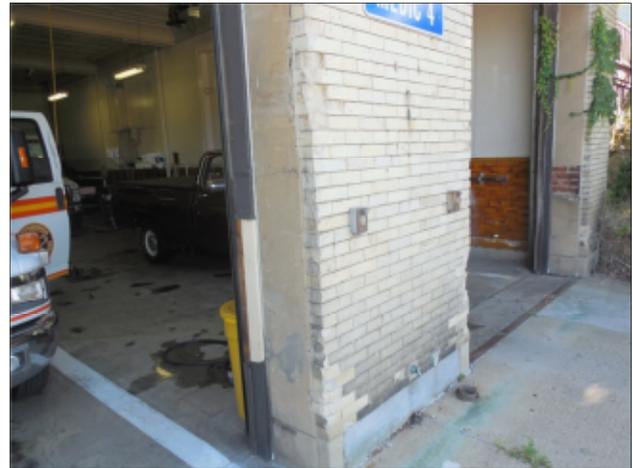
1. Overall the Shell is in Fair condition.
2. Building Frame
 - 2.1. The walls are brick. West wall has open mortar joints. North Wall has step cracking
 - 2.2. Porch lintel bricks are step cracked
 - 2.3. Minor collision damage to brick at overhead doors and spalling of concrete cover
 - 2.4. The steel beams are concrete encased, there is patches and light cracking
 - 2.5. The basement floor level was filled in for the first 14-6" from overhead doors and a CMU wall was constructed to contain the fill material in 2010
 - 2.6. The first floor concrete slab has 3 spalls with exposed rusted rebar G2-B7 (7'x7') area and G2-B8 (2'x2') area , G3 –B15 (3'x3'), There are random patches
 - 2.7. G2 has two additional steel support columns added in 2010
 - 2.8. The concrete encased steel beams are not visible.

SH2 – Impact damage at apparatus bay doors

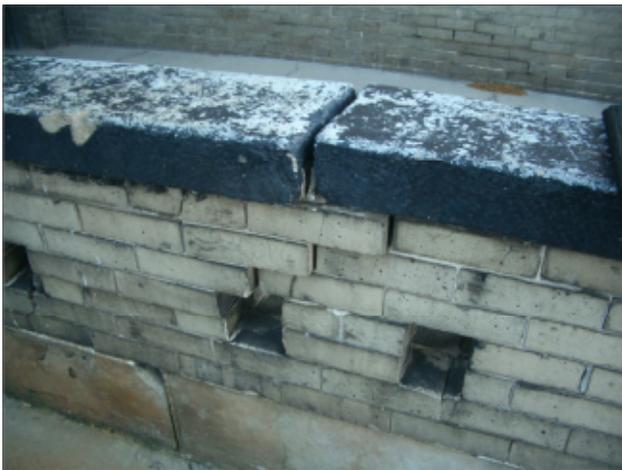
SH3 – Knee wall at porch – damage from impact

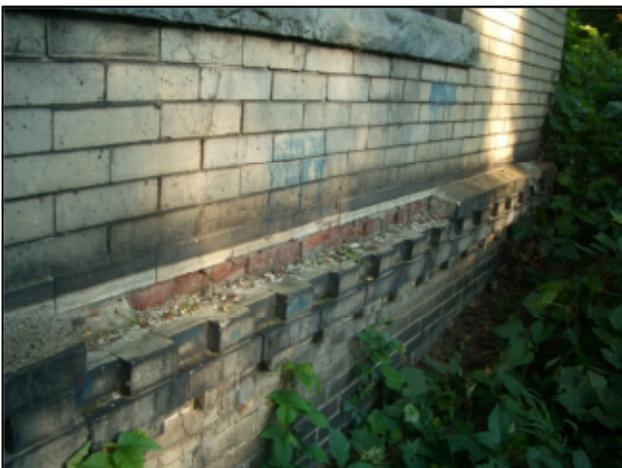
The building walls are in fair condition. A few defects were observed. A few brick joint cracks and missing bricks were observed.

SH5 – Missing brick at east wall, NE corner

- Masonry restoration work to replace missing or damaged masonry, seal open joints and lintels
- Replace frame and door to main roof from hose tower

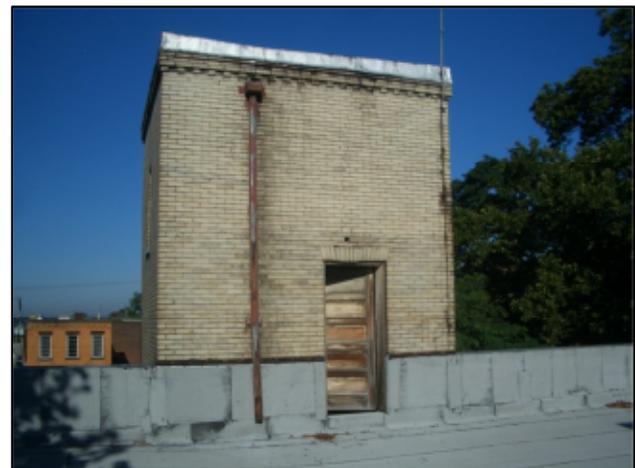
- 11.1. Access to the main roof is through a wood man door in the hose tower. No direct access to the Hose Tower or porch roof without providing an extension ladder.
- 11.2. The paint has weathered away on the wood man door and frame leaving mostly bare wood exposed. The jack arch header is cracked and settling.

The painted wood door and trim on the Hose Tower is in poor condition (access door to the main roof).

SH6 – Hose tower from main roof – rusted downspout, failing lintel and door, condition of tower roof is unknown

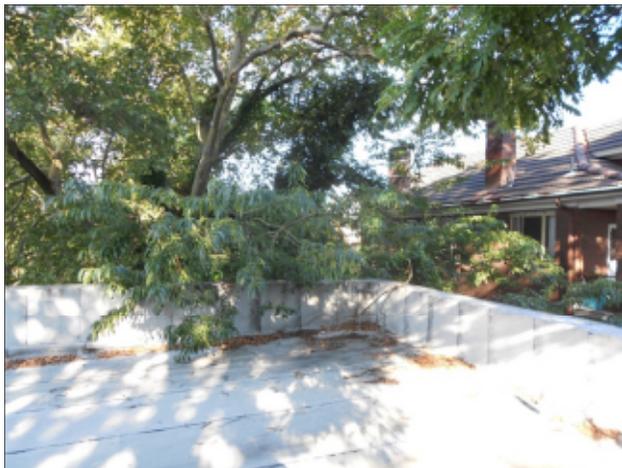
SH9 – Looking NW – overhanging trees, debris on roof

The drainage system is in fair condition. Any debris should be cleaned from the main roof and continued to be cleaned twice yearly. A new roof drain system and emergency overflow drain should be installed on the main roof. The rusted downspouts should be replaced and a splash block provided on the main roof for the Hose Tower downspout.

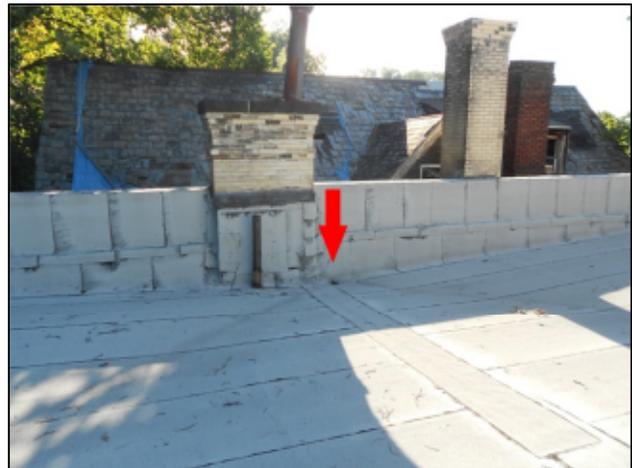
SH10 – Looking east – arrow indicates location of main roof drain – this is the ONLY drain, there is no secondary drainage

1 year: Replace the porch roof and drainage system – Estimated cost: \$6,000 (192 SF x \$30/SF). Install new roof drain and emergency overflow drain on the main roof – Estimated cost: \$5,000. Repair openings in metal cornice cover – Estimated Cost: \$3,000. Paint all wood doors and trim – Estimated cost: none (can be performed in house). Inspect roofs and walls yearly and remove debris from the main roof system.

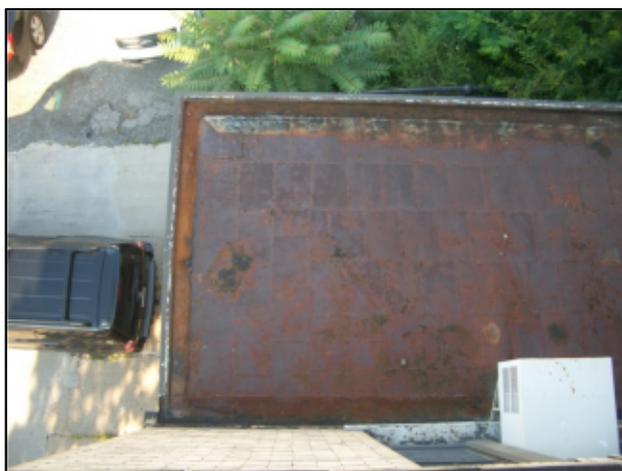
The main roof system is in fair condition. The porch roof metal roof system is in poor condition and should be replaced. The hose Tower roof was unobservable.

SH11 – View looking down on porch roof, rusted

With proper Maintenance and corrective repairs, it is our opinion that the modified bitumen roofing system on the main roof is in a maintainable condition for the next ten years. The metal roof system on the porch roof should be replaced as soon as the budget permits.

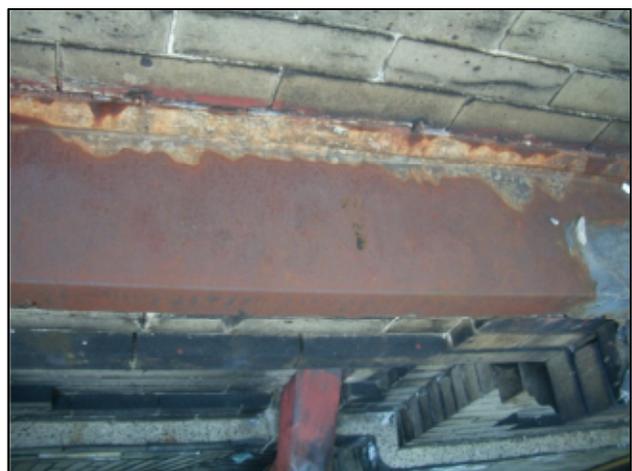
3. Building Façade
 - 3.1. Construction: The building walls are constructed with brick masonry. A brick cornice is constructed on the top of the building at the roof line and covered with a metal cap. Wall penetrations include: 2 garage doors with metal clad wood frames, 2 wood man doors with metal frames, 16 windows with metal sashes and metal frames, 2 closed in windows, 8 closed in wood louvers in the tower.
 - 3.2. Porch parapet railing has collision damage to cap stones and wall with brick displaced
 - 3.3. Condition: The building walls appear to be in fair condition. Some cracked brick joints were observed. The brick walls at the porch contain some displaced bricks. Missing bricks were observed at the base of the north end of the east wall. The mortar joints at the cornice brick work are open in some areas. The metal cap on the cornice is rusted and has open joints and holes.

SH12 – Rusted metal cornice cover, downspout from main roof drain
