CITY OF
PITTSBURGH
PROPERTY CONDITION REPORT

B153 – Medic Headquarters
700 Filbert Street
Pittsburgh, Pennsylvania 15232

June 2014

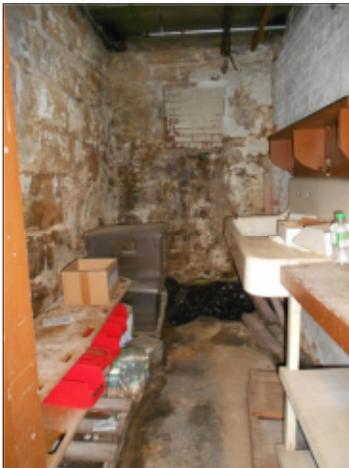
1. Foundation - Stone Masonry in Good condition with a few open mortar joints, areas of plaster spalling from walls. South West corner where water is infiltrating the wall and causing spalling of the plaster. There are open mortar joints and a window well that should be sealed off to prevent this damage.
2. Slab on grade: The basement floor slab has areas of cracking and minor failures but is in Fair condition overall. The concrete floor in the SW Storage Room has concrete failure approximately 18 sq ft near an old well, floor drainage system needs improved. The South West window well is allowing water infiltration and should be sealed

SS1 – SW Storage Room

- SW foundation walls – seal to prevent water infiltration – \$7,500
- SW window well- repair masonry and seal - \$1,000
- SW Storage Room - repair concrete floor slab– \$5,000

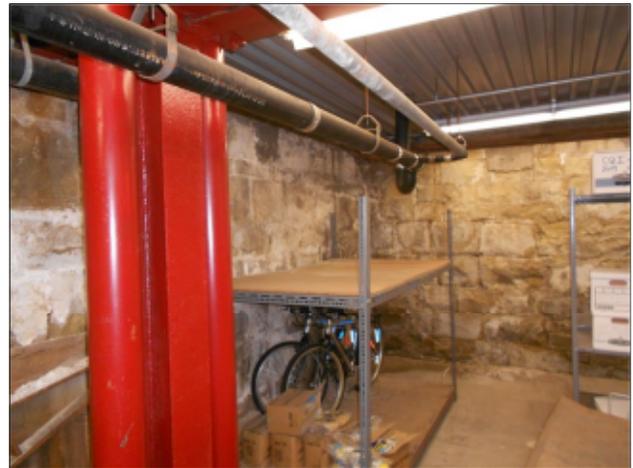
SS2 – Typical foundation wall and slab

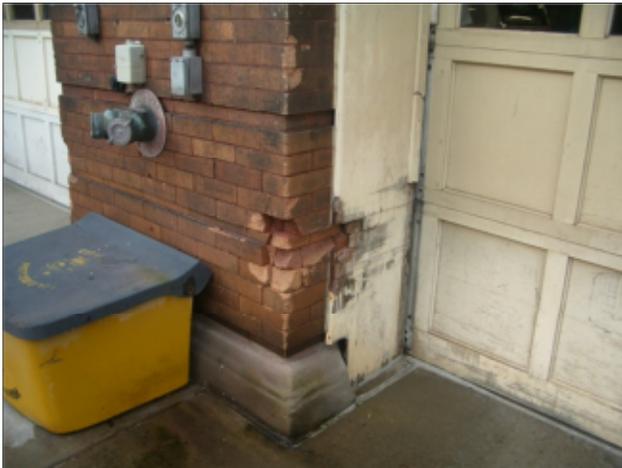
- 3.2. Condition:
 - 3.2.1. Main Building: The building walls appear to be in fair condition. Some cracked and open brick joints were observed. There are a few damaged bricks. There are some open mortar joints in the stone and terra cotta features above the doors and windows. There are open mortar joints in the stone foundation walls. The paint is peeling from the wood doors and windows and the metal clad cornice. The caulking at the doors and windows is cracked and aged.

SH1 – Damaged brick at apparatus doors

- Secure the second floor storage area window masonry lintel
- Hose Tower Penthouse – Re-clad and reglaze exterior walls. Replace exterior stair to roof. See below for re-roofing.
- Masonry restoration to repair loose/damaged brick, seal cracks, joints and lintels.

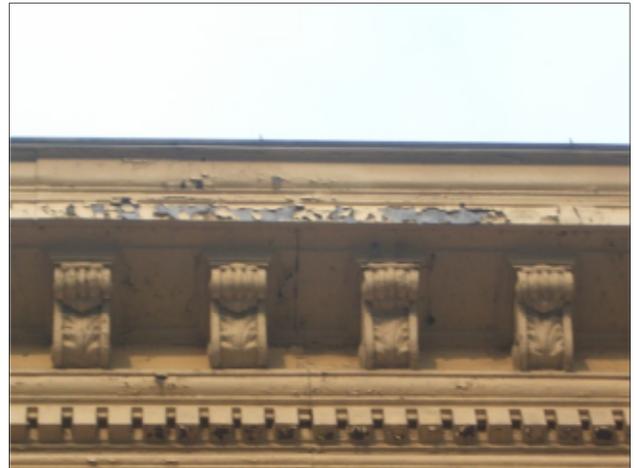
The Main building walls are in fair condition. A few defects were observed. A few brick joint cracks, open mortar joints and damaged bricks were observed. The paint is peeling from all painted surfaces (windows, doors and trim). Bare wood and metal is exposed in some areas.

SH2 – Peeling paint at main cornice

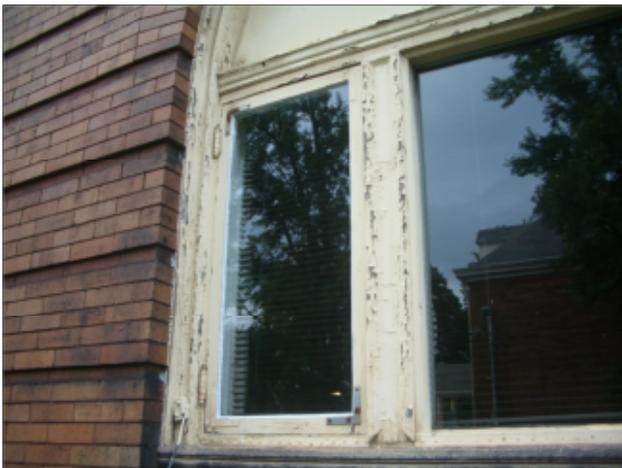
SH3 – Typical window – peeling paint and cracked or missing caulking

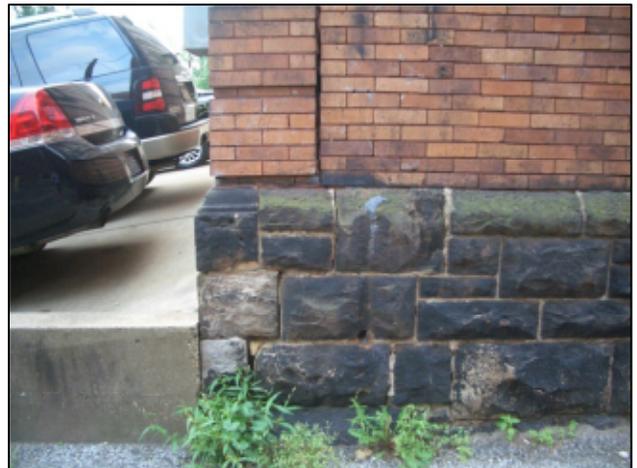
SH4 – Cracking and open joints at NW corner

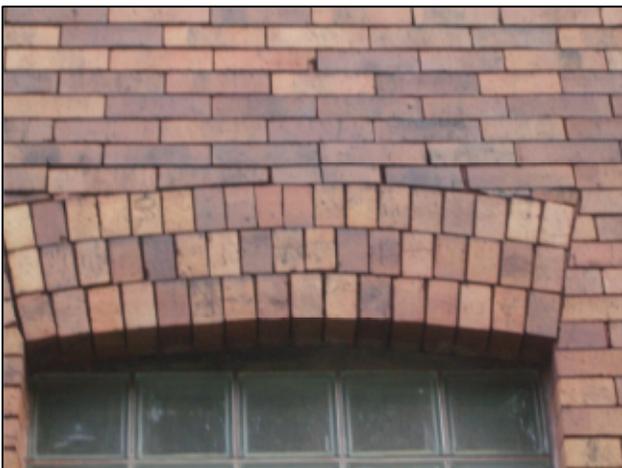
SH5 – Numerous open joints

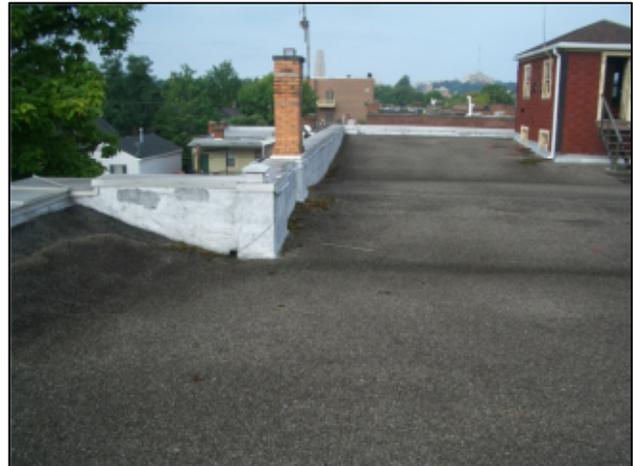
9.2. Condition: The penetrations are in fair condition. The brick chimney on the south wall is in poor condition and needs repointed.

SH10 – Main roof looking west, chimney at center needs repair

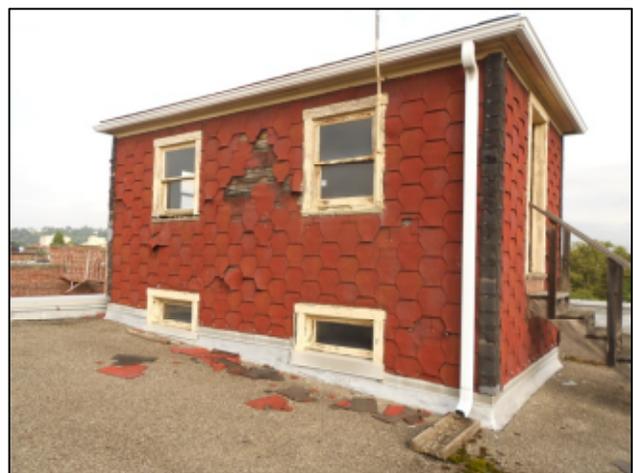
- 3.2.2. Low Addition: The building walls appear to be in good condition.
 - 3.2.3. Hose Tower (Penthouse): The walls are in extremely poor condition. The shingles are aged, cracked, loose and missing. The underlying wood lath is exposed in some areas. The windows and door are in poor condition. The paint is peeling and some wood trim is loose and broken. The wooden steps are in poor condition. Some stair treads are broken, others are cracked.

The shingles are falling off the side of the tower leaving exposed wood. The windows are broken, the paint is peeling and the outside steps are in poor condition.

SH12 – Hose tower penthouse - Poor condition

The wall covering, windows, door and steps on the Tower area will have to be replaced. This work will have to be bid and estimated to be in the \$20,000 range.

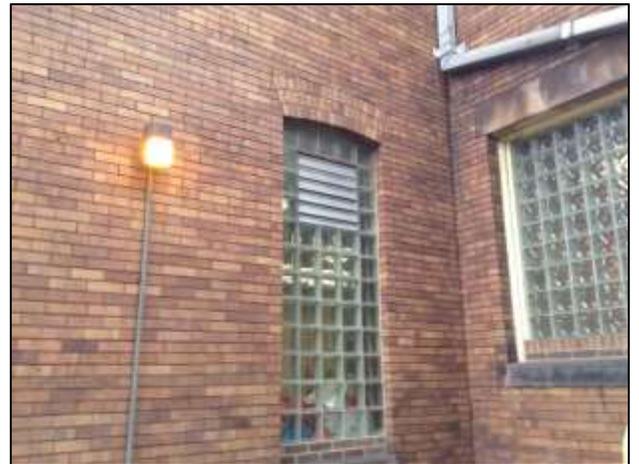
E41 – Perimeter lighting: Photo cell malfunction

5. Estimates: Suggested remedies and Opinion of probable cost
 - 5.1. De-Minimus Costs
 - 5.1.1. Replace defective photo cells for perimeter light.
 - 5.2. Short-Term Costs
 - 5.2.1. Replace heat trace elements: \$2,500
 - 5.2.2. Specialty Consulting – Light meter testing: \$1,700
 - 5.2.3. De-lamping to ASHRAE/IES standard: \$800

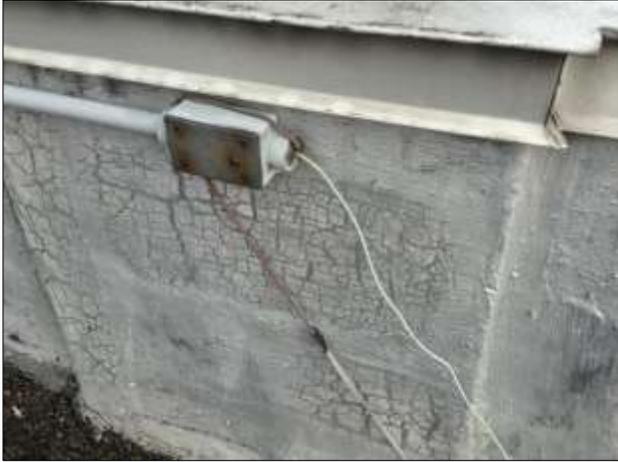
E48 – Heat trace cable: Insulation deterioration – Safety hazard (Typical of 4)

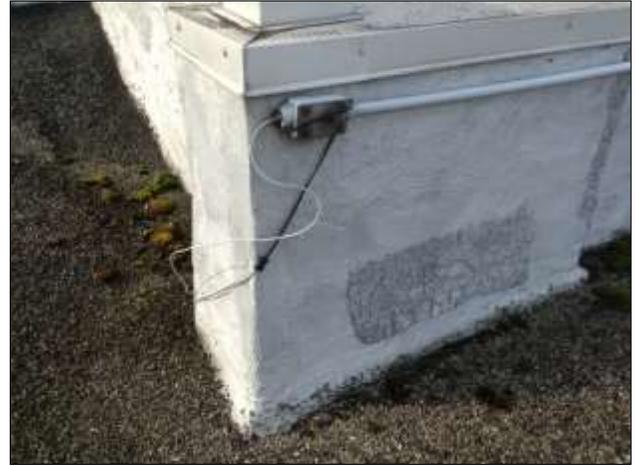
E49 – Heat trace cable: Insulation deterioration – Safety hazard

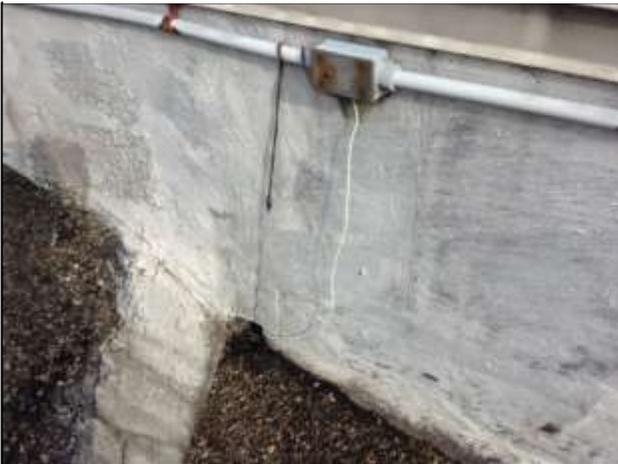
E50 – Heat trace cable: Insulation deterioration – Safety hazard

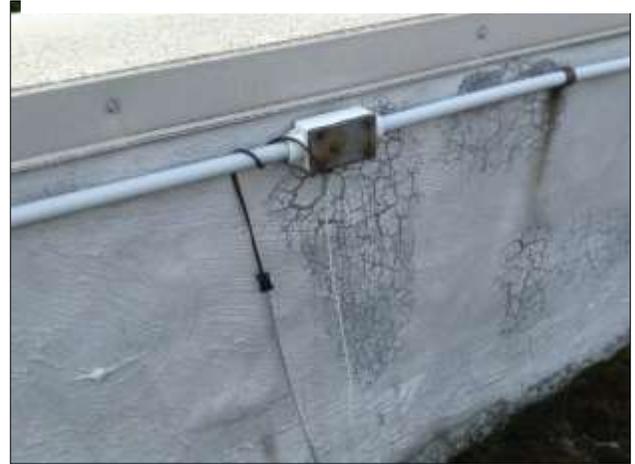
E51 – Heat trace cable: Insulation deterioration – Safety hazard

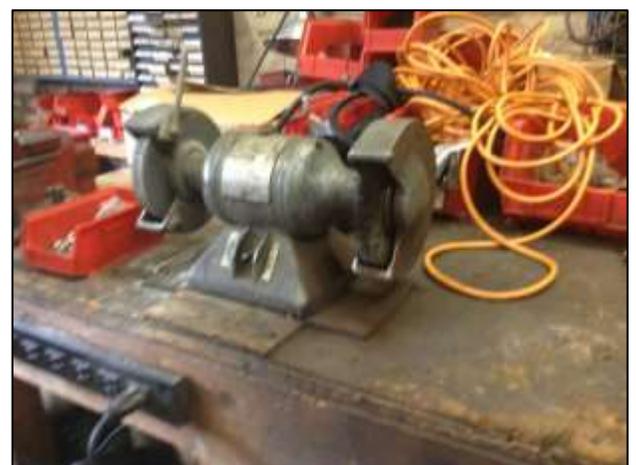
LS 44 – Work room bench grinder: Sparking concern
