CITY OF
PITTSBURGH
FACILITY ANALYSIS REPORT

Medic Training
2100 Liberty Ave.
Pittsburgh, Pennsylvania 15222

Medic Training (B151)

2100 Liberty Avenue
Pittsburgh, PA 15222

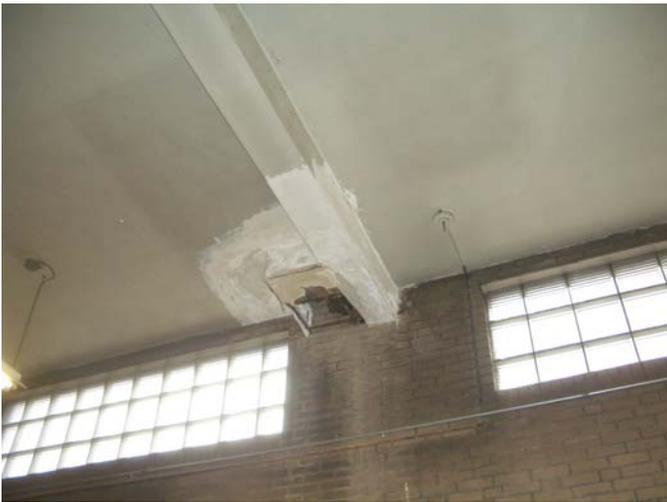
R-1 Underside of Truck Bay, leak at roof drain and damaged ceiling

1 year: Repair roof system in drain areas on the Truck Bay. The roof system should be under warranty. Contact the Membrane manufacturer for a roof inspection. Maintain a pro-active maintenance program. Inspect the roof systems and walls on a regular schedule - minimum twice a year (late spring and late fall). Estimated cost: \$4,000 for repair to the Truck Bay roof drains if not under warranty.

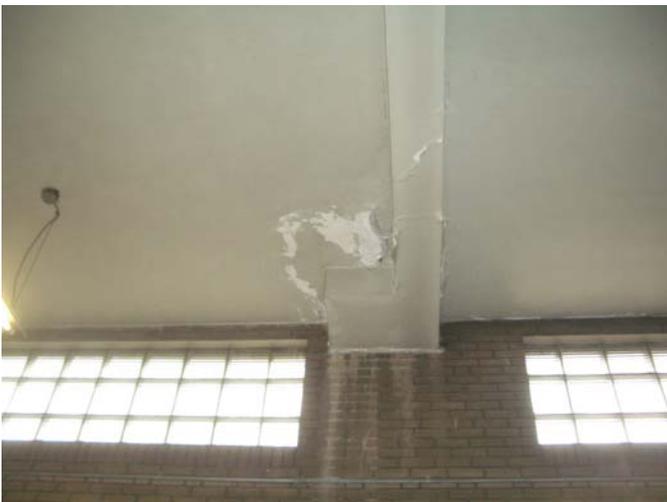
R-2 Underside of Truck Bay, leak at roof drain and damaged ceiling

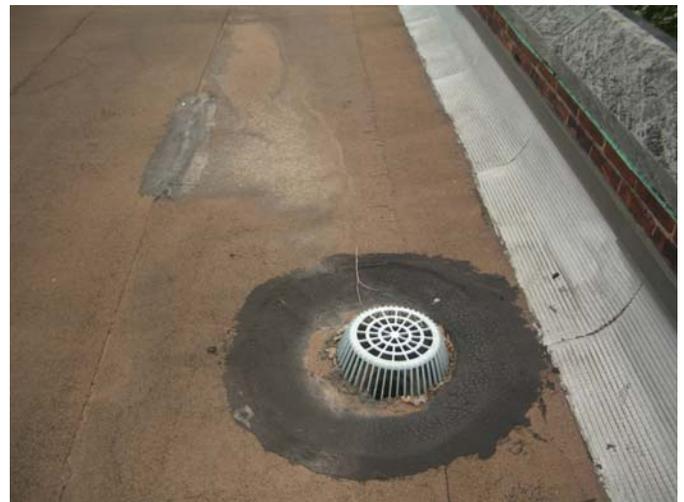
R-5 Truck Bay, repair at roof drain

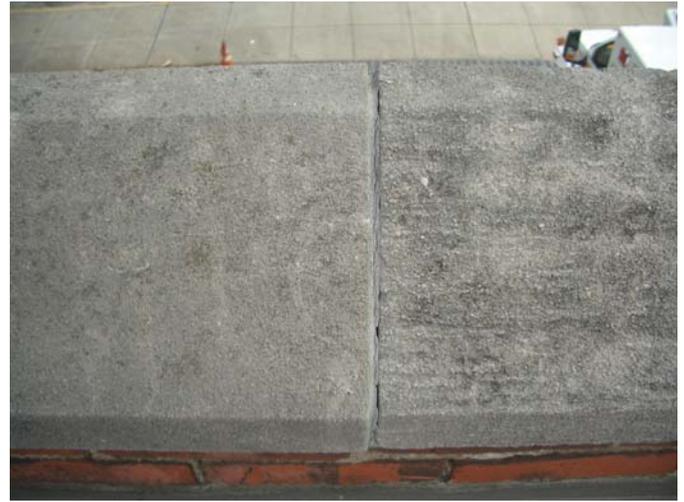
R-10 Truck Bay, cracked and open caulking in coping stone

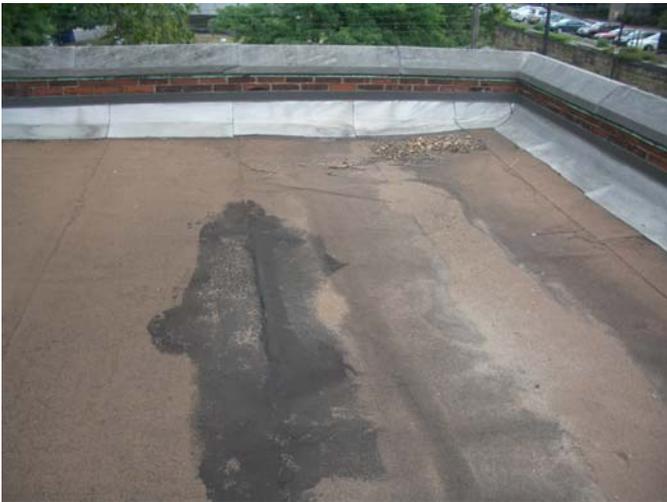
R-8 Truck Bay, repair work and ridge

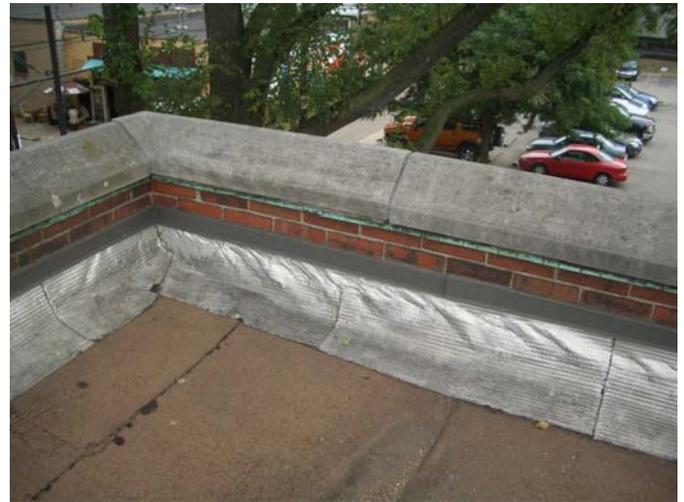
R-11 Truck Bay, buckled wall flashing

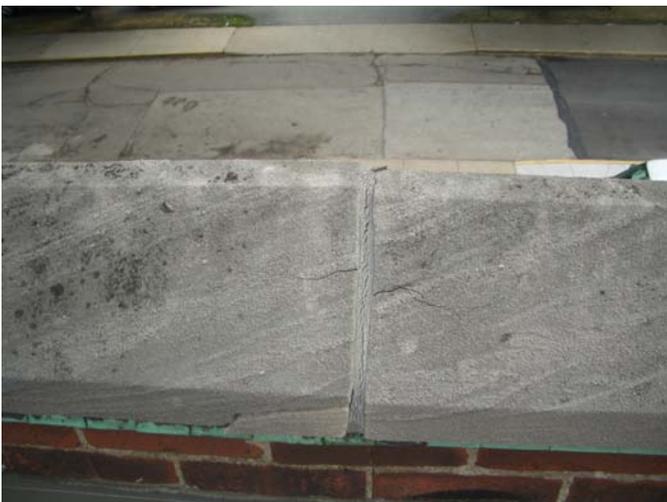
R-9 Truck Bay, cracks in caulking at coping stone

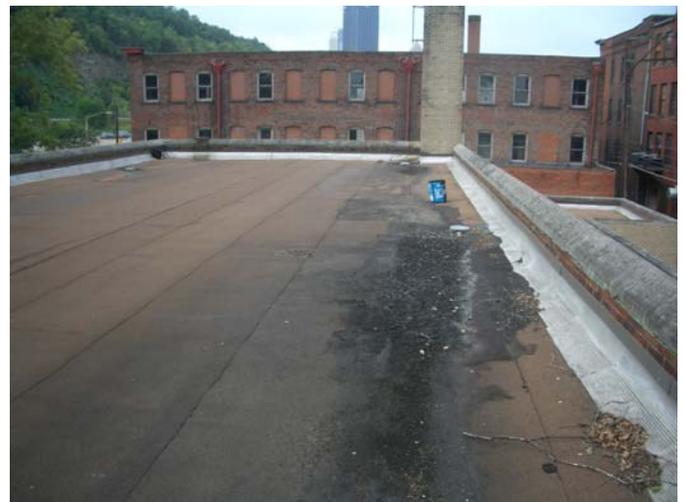
R-12 Truck Bay, looking west, debris and repairs

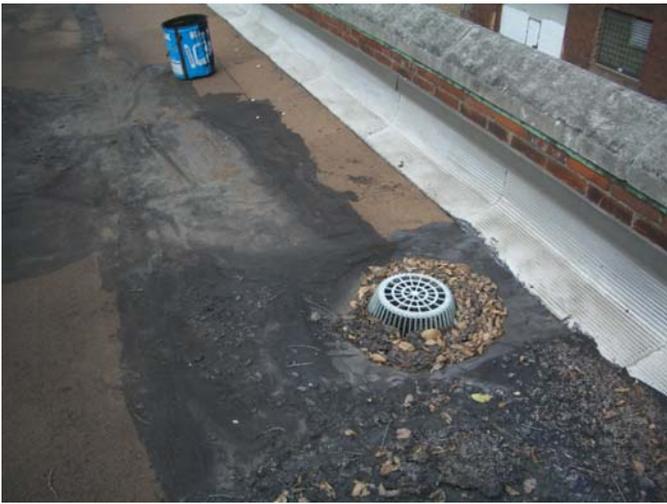
R-13 Truck Bay, Repair at drain and debris

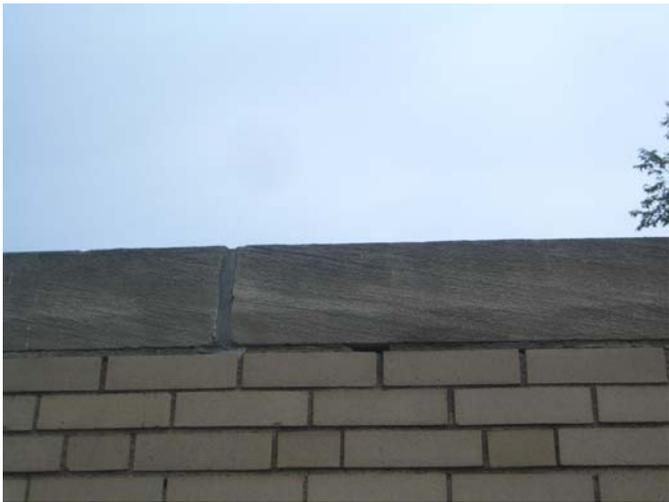
R-28 Main Roof, missing mortar at coping on Truck Bay

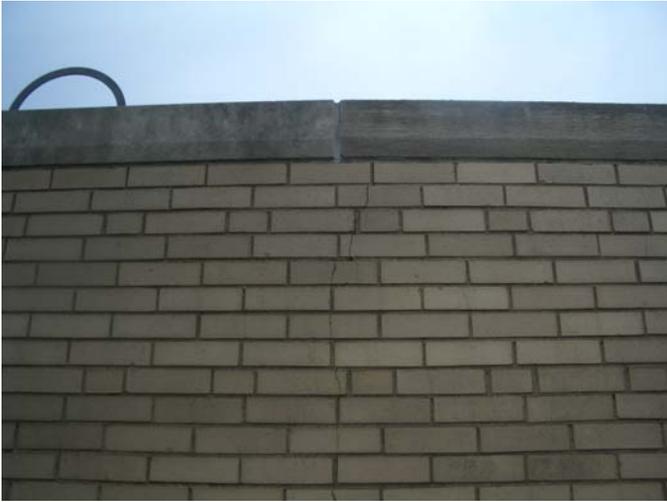
R-27 Main Roof, Cracked brick in Truck Bay wall

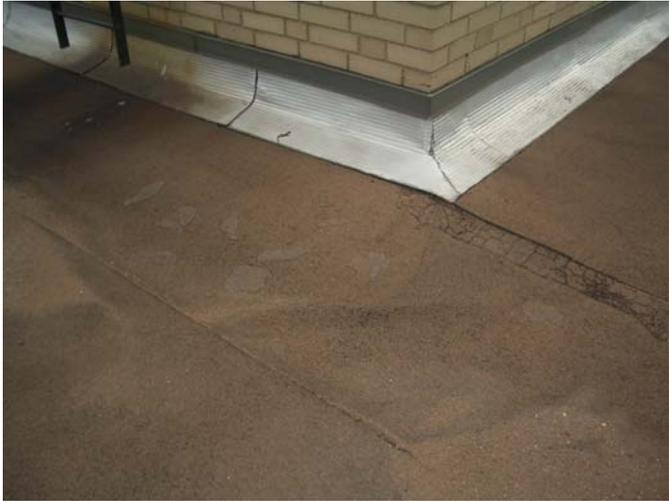
R-30 Main Roof, blisters and ridges in roof membrane

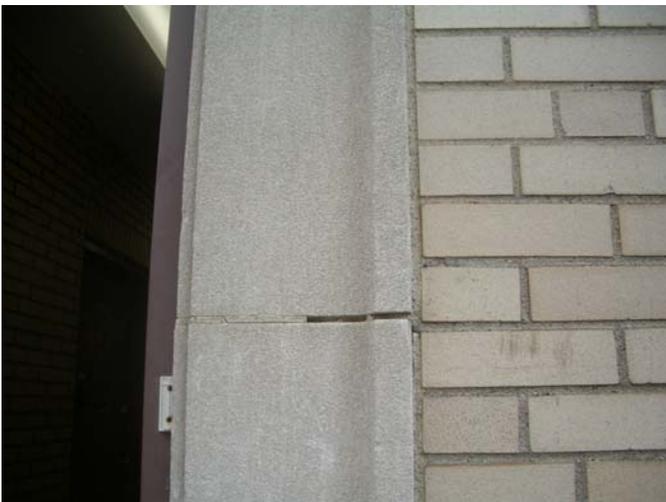
W-2 Missing mortar in west end door trim

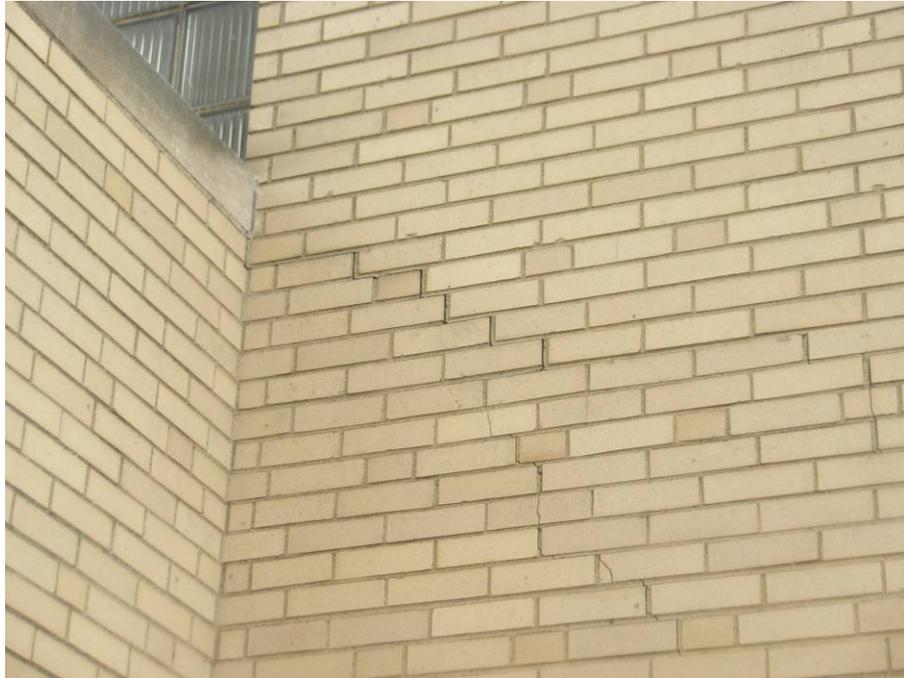
Photo S1

- 1.) Above the southeast man-door entry to the garage, there is a crack in the brick mortar joints. Recommend repointing mortar joints (1 to 5 yrs) **(Photo S1)**

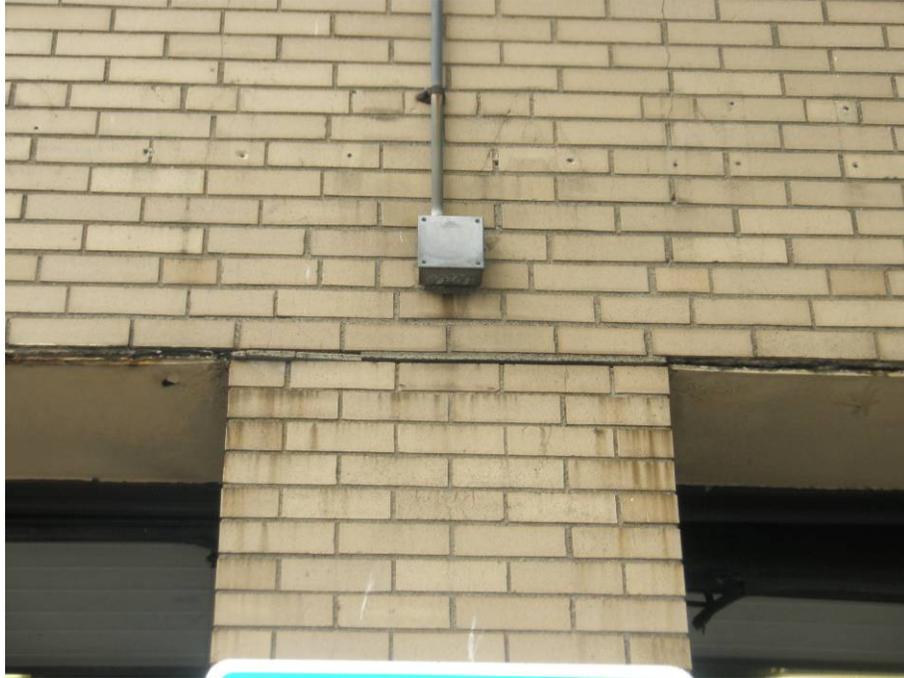
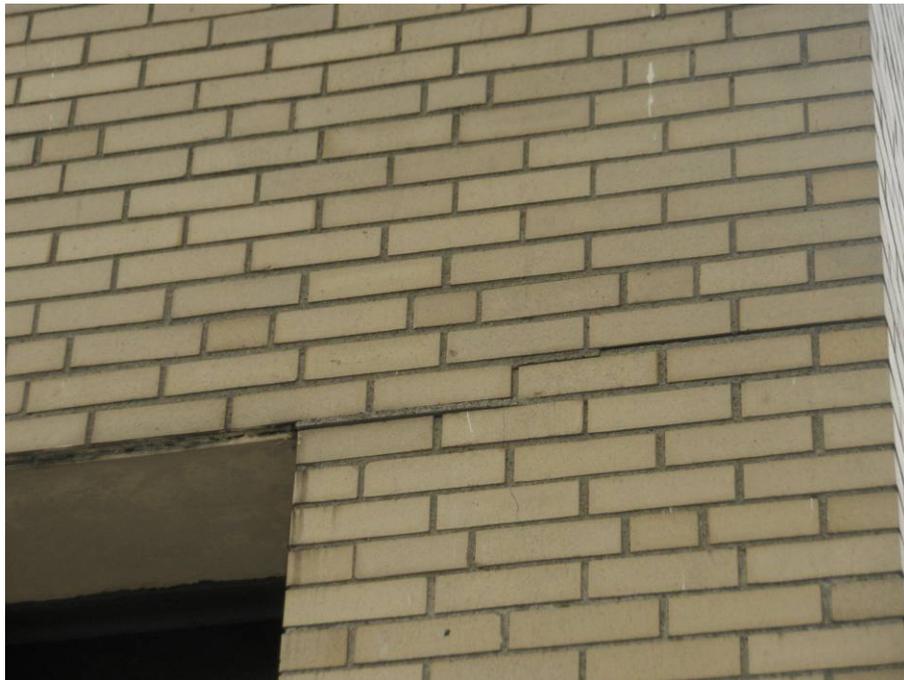
- 3.) Above the garage door jambs, the steel lintel appears to be corroding and causing the mortar and brick to crack and push out. Recommend cleaning lintel and repointing the mortar (1 to 5 yrs) **(Photos S4, S5, & S6)**

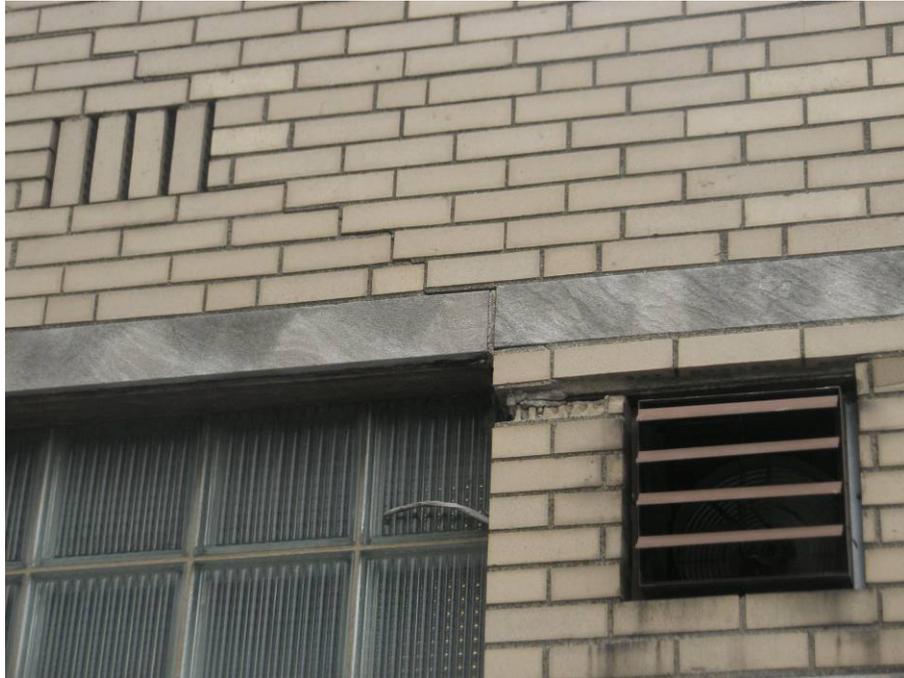
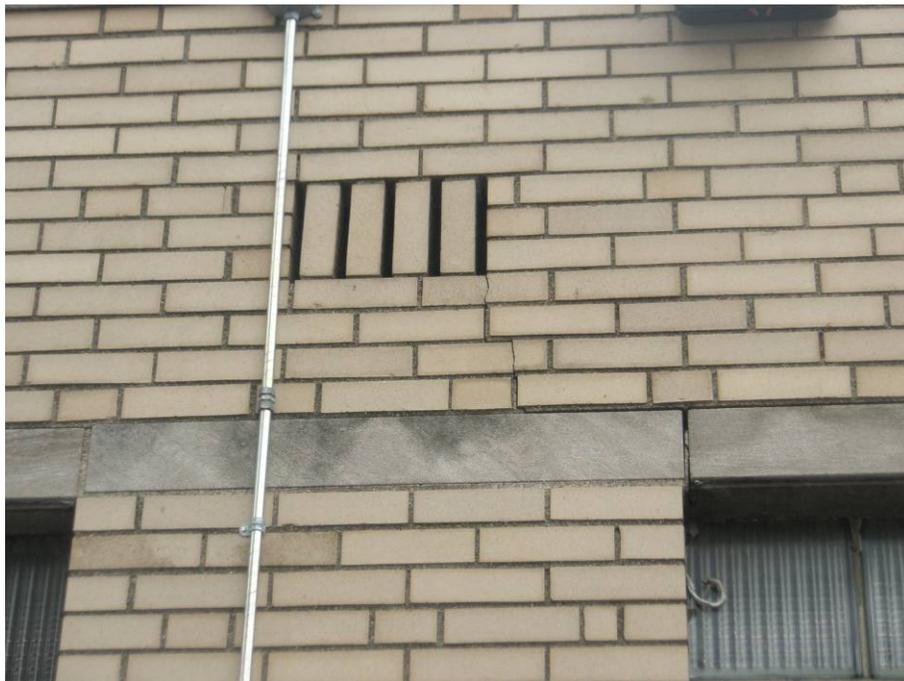
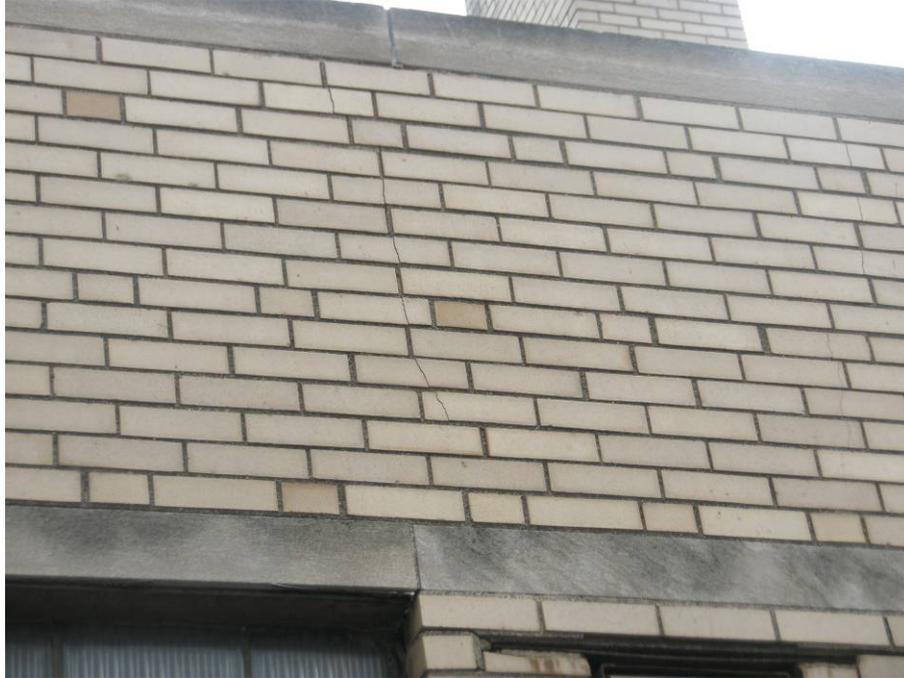
- 4.) On the north face, there are several locations of cracked and broken bricks. Recommend repairing or replacing brick and repointing mortar (1 to 5 yrs) **(Photos S7, S8, & S9)**

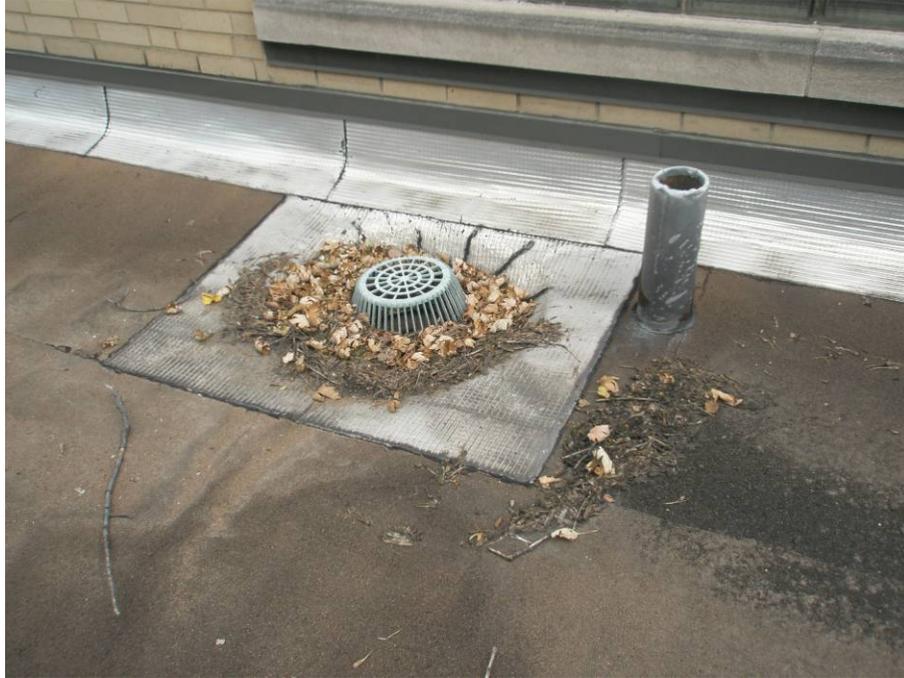
Photo S11

- 6.) Roof drains are all clogged. Recommend cleaning debris from drains (1 yr) **(Photo S11)**
- 7.) Parapet brick and mortar joints are cracked throughout on back face of parapet. Recommend repairing brick and repointing mortar joints. (1 to 5 yrs) **(Photos S12 & S13)**

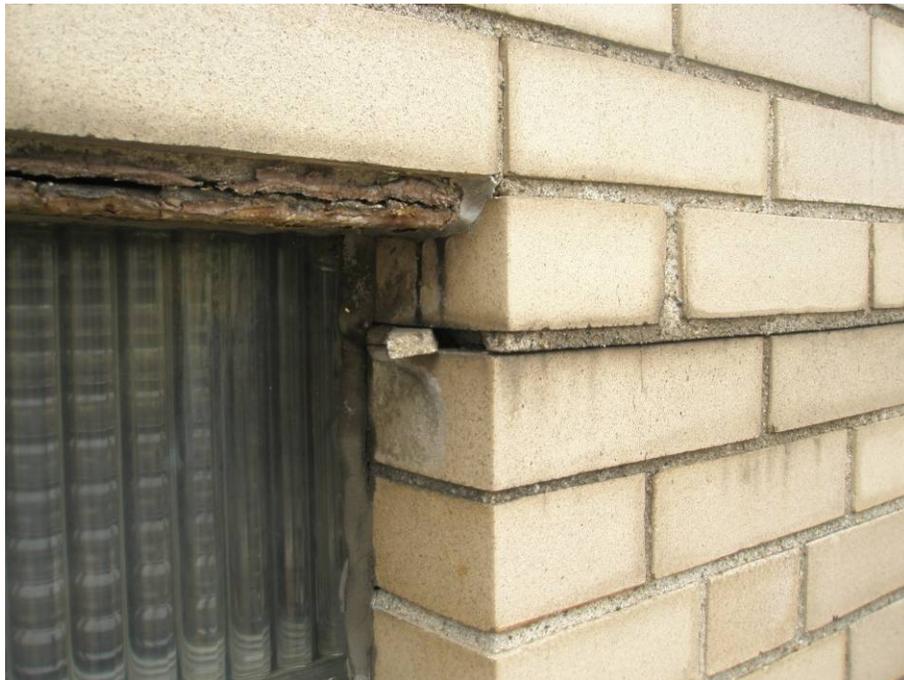
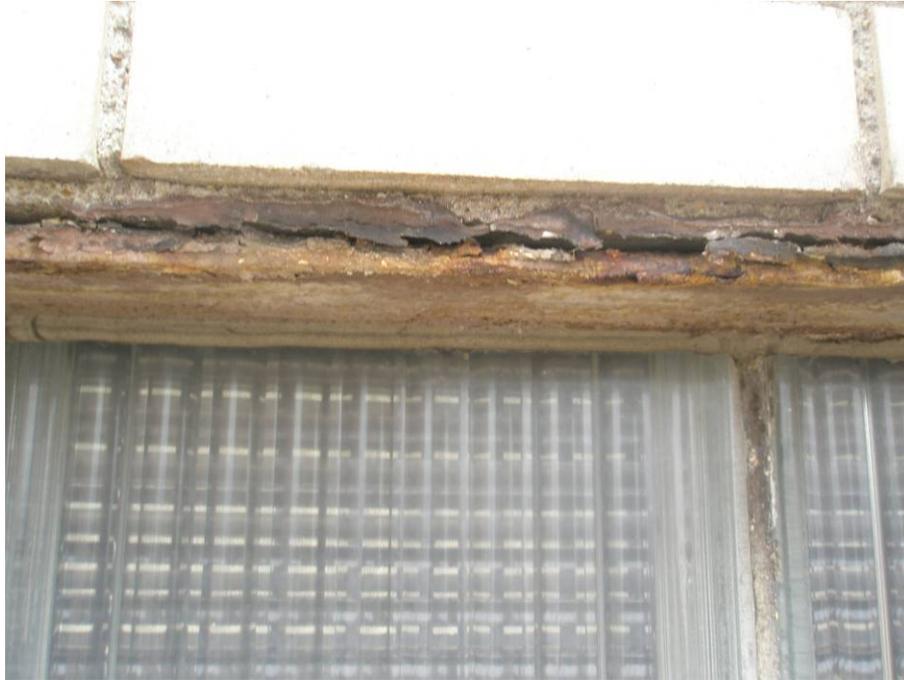
- 11.) The lintels in the high bay windows appear to be partially corroded. Some of the corrosion is starting to push the brick and mortar joints out. Recommend cleaning lintel, and repairing and repointing brick and mortar joints (1 to 5 yrs) **(Photos 18 & 19)**

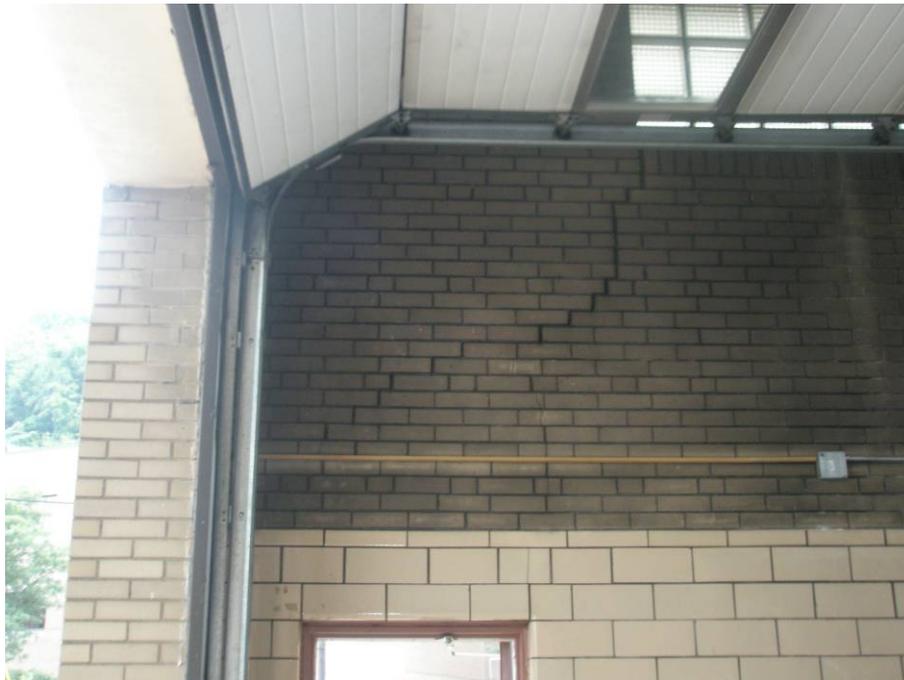
Photo S20

- 12.) Above the southeast man-door entry to the garage, there is a crack in the brick mortar joints. Recommend repointing mortar joints (1 to 5 yrs) **(Photo S20)**
