CITY OF
PITTSBURGH
FACILITY ANALYSIS REPORT

Morningside Senior Center (B094)
644 President Way
Pittsburgh, Pennsylvania 15206

May 5, 2010

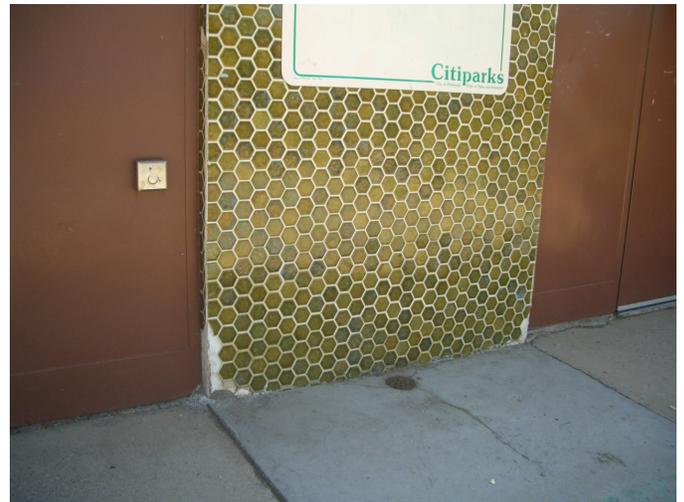
EW-5 Ceramic tile inlay at entry, missing and broken tile

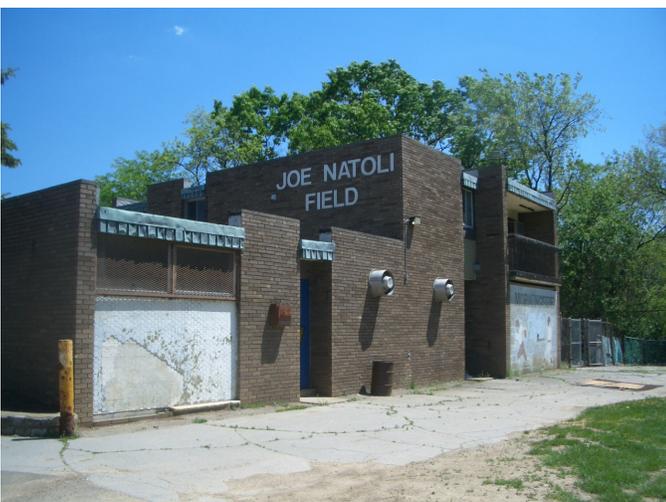
EW-3 Right side, south elevation

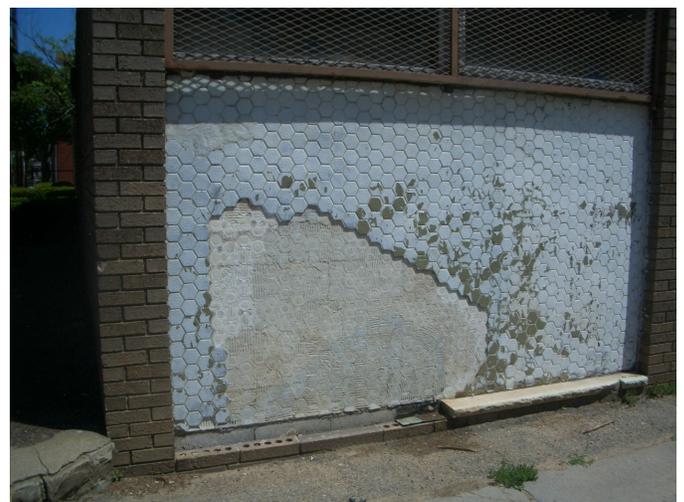
EW-6 Ceramic tile inlay at south wall, missing and broken tile, missing concrete sill plate

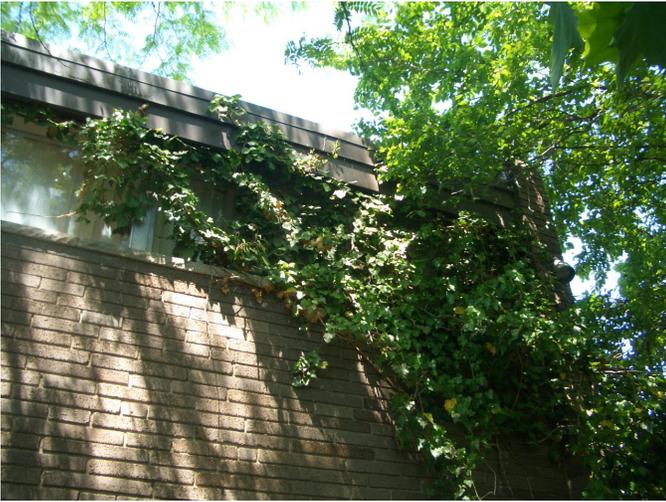
EW-7 Vines growing on NE corner

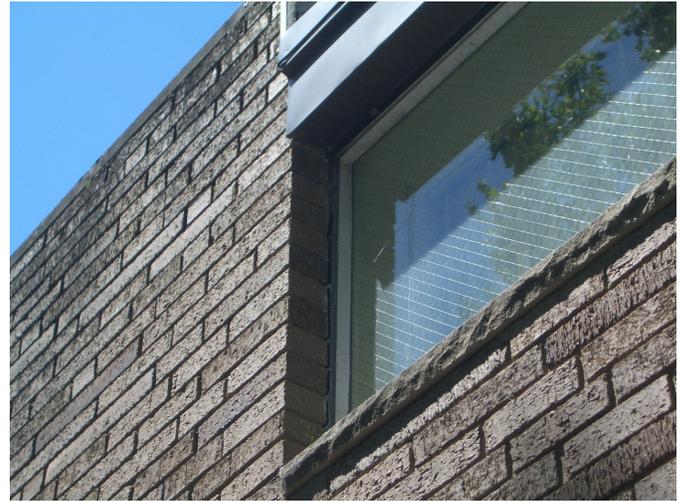
EW-10 Cracked and open caulking at apartment window, typical

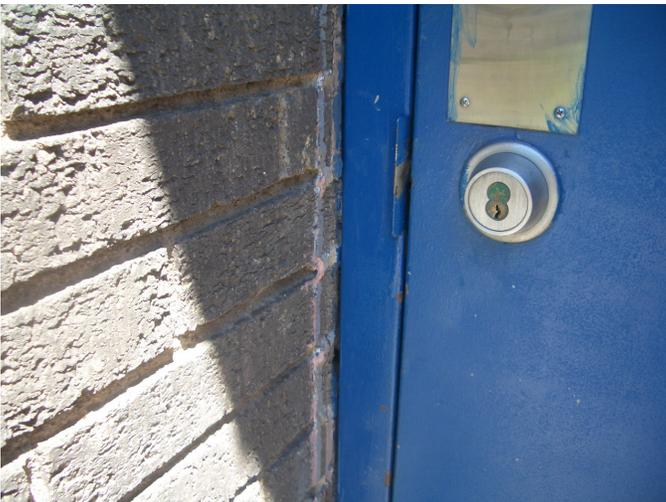
EW-8 Caulking missing at door jamb typical

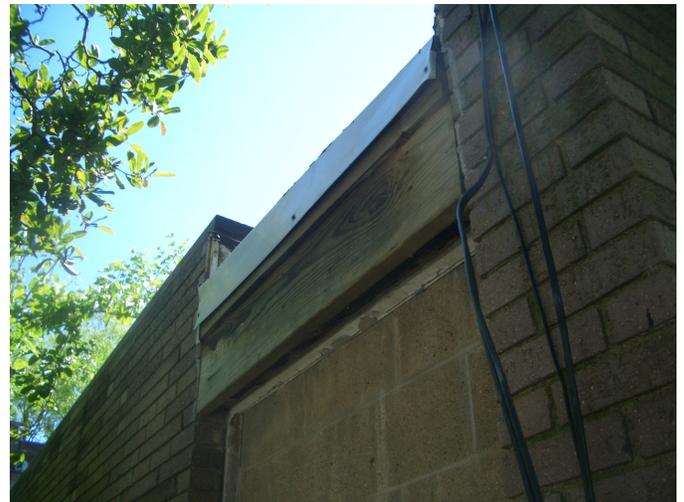
EW-11 Abandoned window infill at north wall, unfinished concrete block and wood

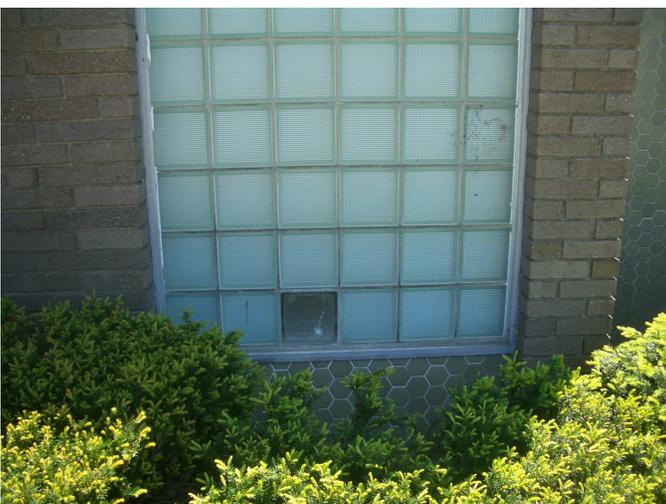
EW-9 Broken glass block at left side of main entry

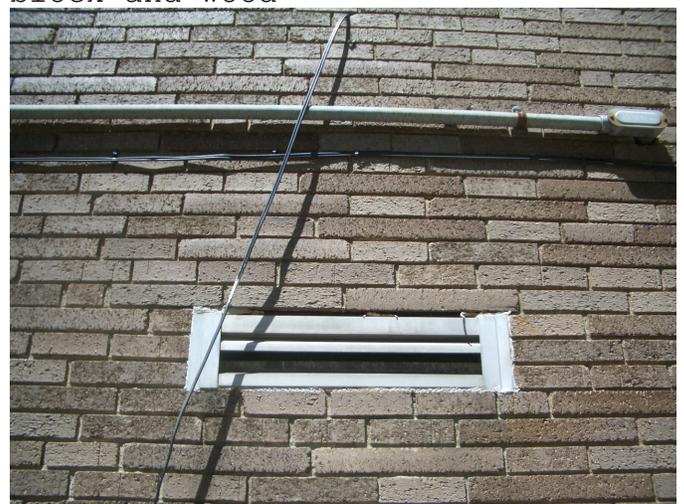
EW-12 Cracked and open caulking at louver, typical

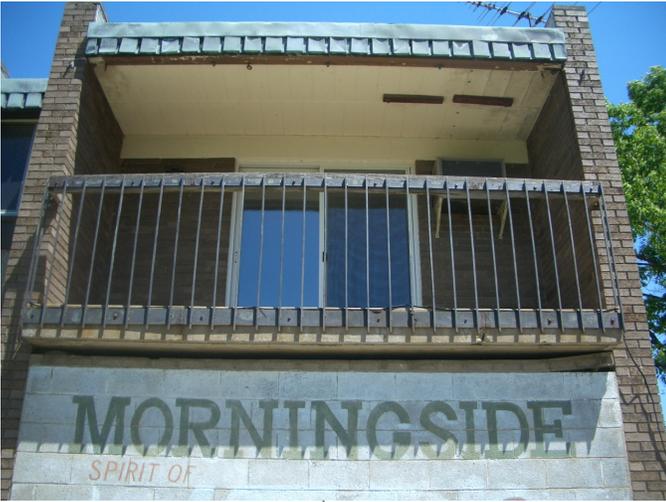
EW-13 Porch on 2nd floor, opening under the concrete slab

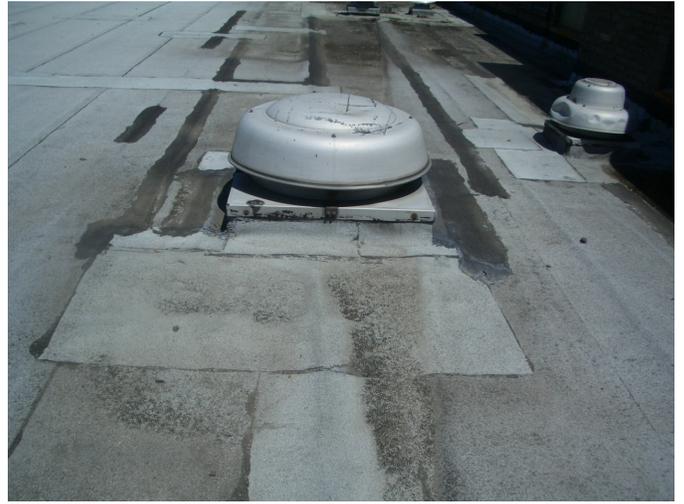
R-4 Typical repairs and patches

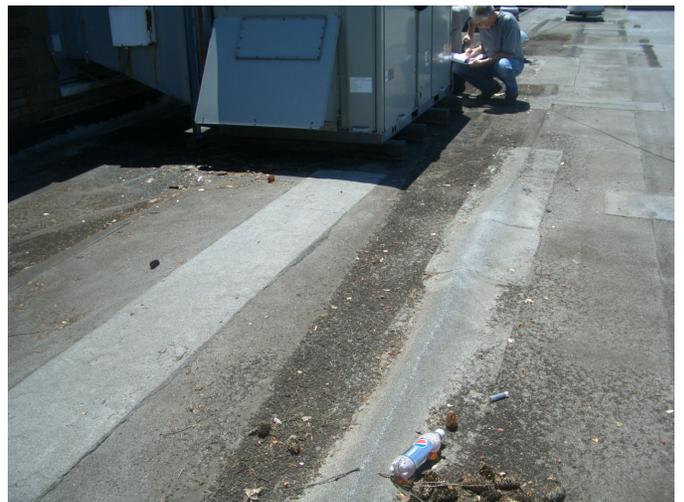
R-6 Office/Entry roof, debris, repairs, HVAC unit

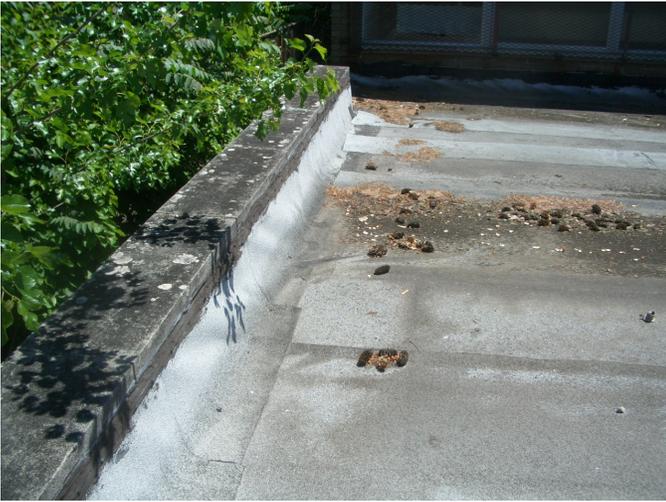
R-7 Coping, wall flashing, typical

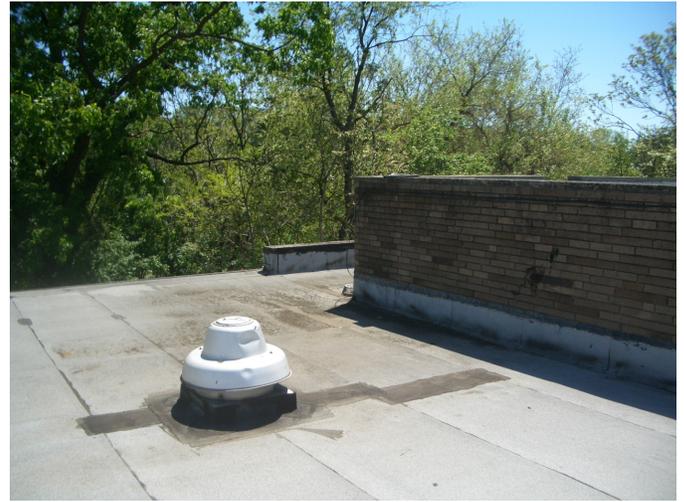
R-10 Community room, roof repairs

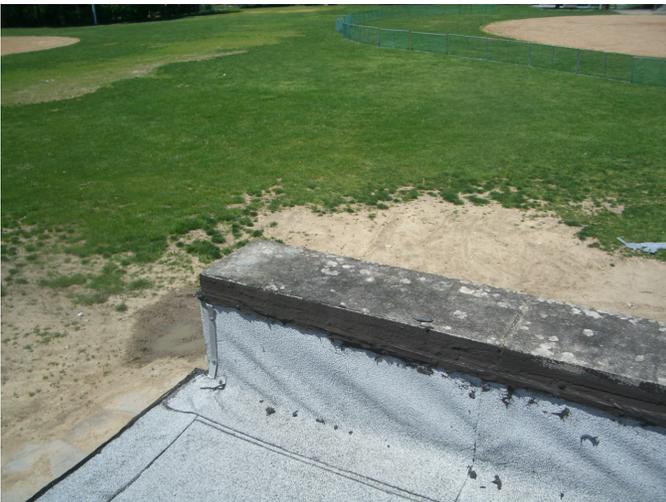
R-8 Coping, buckled wall flashing, Typical

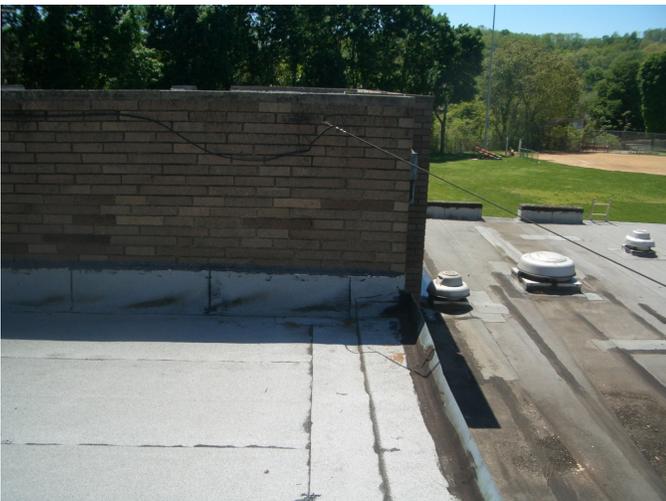
R-9 Wall at community room-apartment, buckled flashing and gravel stop repair

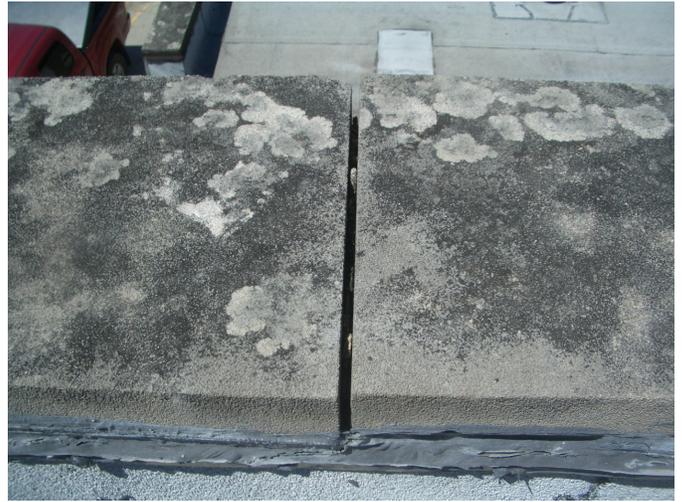
R-16 Missing mortar at coping butt joint, typical

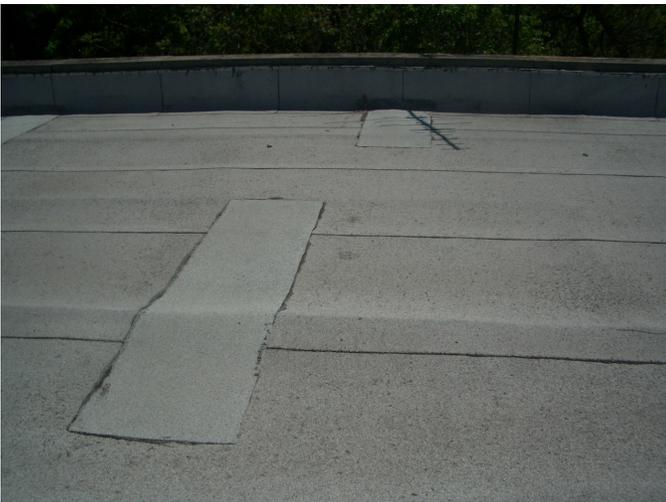
R-14 Apartment roof, blister and repairs

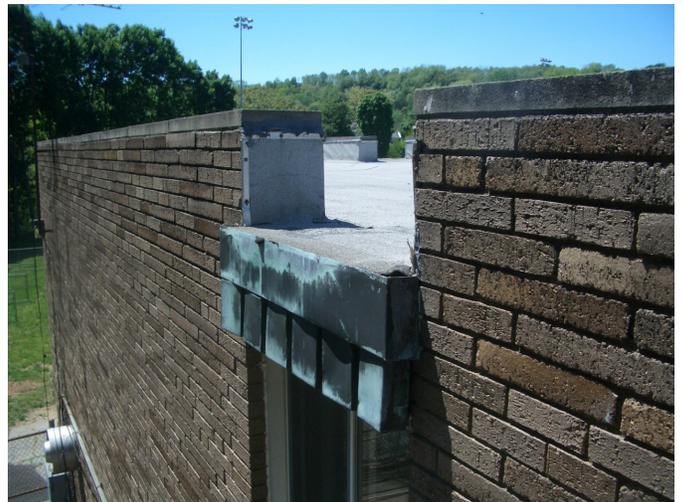
R-17 Copper gravel stop and extender, typical

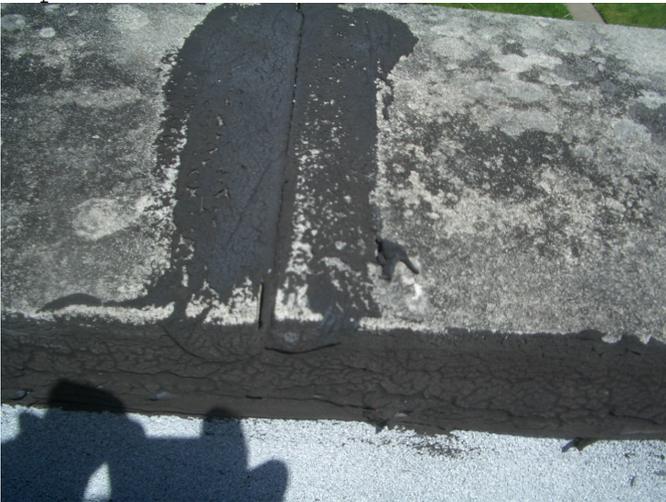
R-15 Asphalt cement repair to coping butt joint, cracked and open, typical

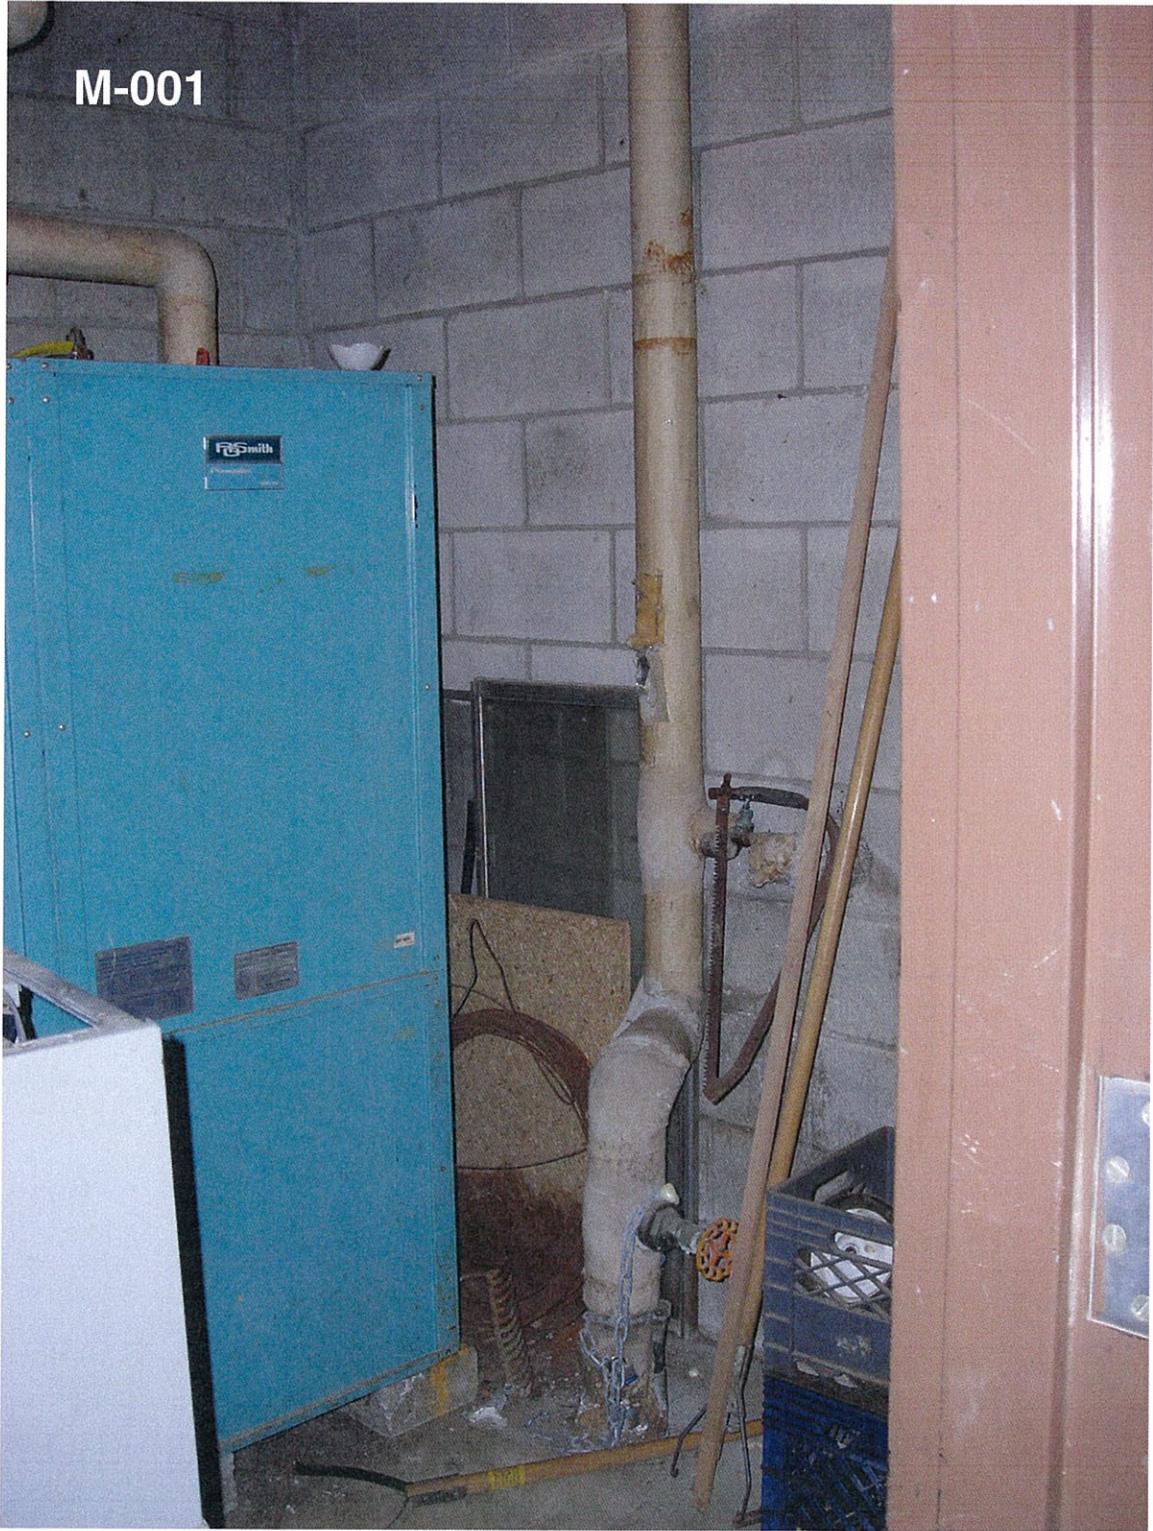
M-001

X	Service Entrance	Notes: 2-inch line through floor of Room 114
	Meter location	Notes: No meter (photo M-001)
	Meter size	Notes:
	Meter condition	Notes:
	Backflow preventer	Notes: No backflow preventer (photo M-001)
	Pressure Reducing Valve	Notes: No pressure reducing valve
	Water Filtration	Notes:
	Water Softener	Notes:
2	Water Heaters	Notes: There are two identical water heaters in Room 114.
	Make AO Smith	Notes:
	Model PVE-120	Notes: These heaters are currently out of service and the
	Serial 69 682 7800011	Notes: disconnect switch os in the off position.
	Age 41 years	Notes:
	Elements 2 @ 13.5 Kw each	Notes:
	Total Capacity 27.0 Kw	Notes:
	Storage Capacity 120 gallons	Notes:
	Expansion Tank	Notes:
	Natural gas	Notes:
X	Electric	Notes: 208V/60Hz/3Ph
	Flue vent	Notes:
	Recirculation Pump	Notes:
	Sump Pump	Notes:

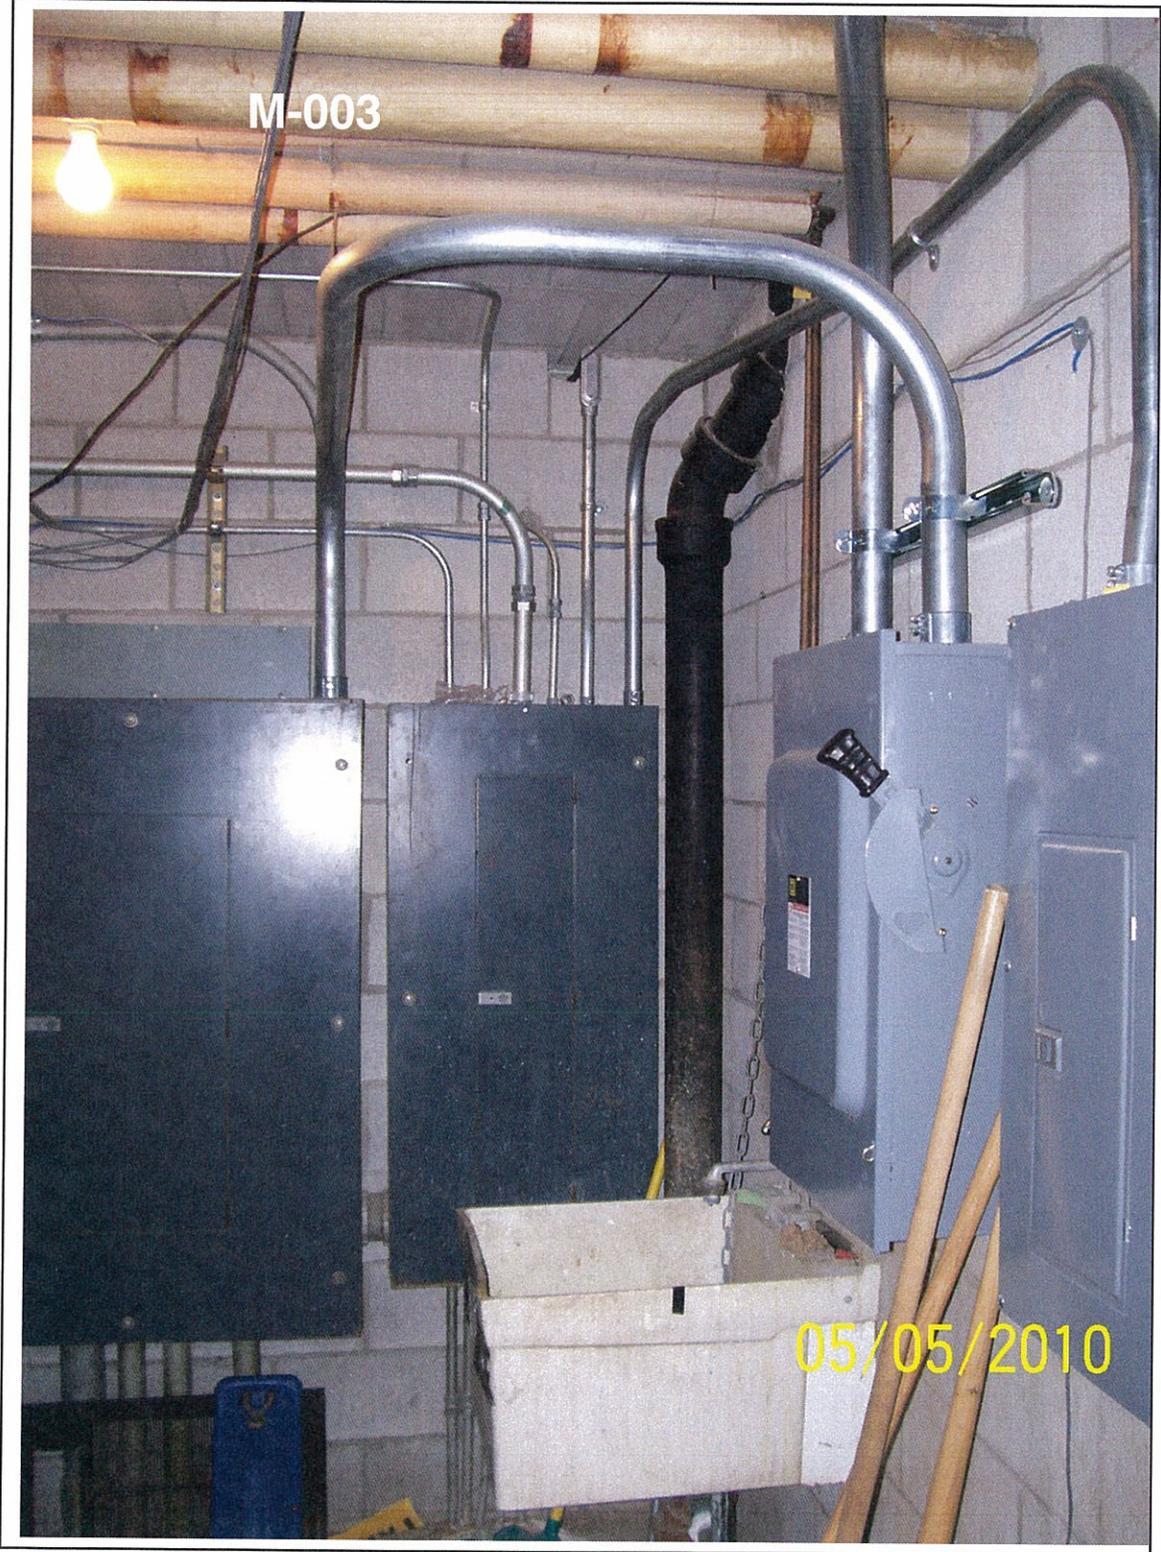
M-003

The janitors service sink in Electrical Room 112 is in bad condition and is a safety hazard. **(photo M-003)**
This sink should be relocated out of this space within 1 year.
