CITY OF
PITTSBURGH
FACILITY ANALYSIS REPORT

Police K-9 Facility
1435 Washington Blvd.
Pittsburgh, Pennsylvania 15206

Police K-9 Facility (B085)
1435 Washington Blvd
Pittsburgh, PA 15206

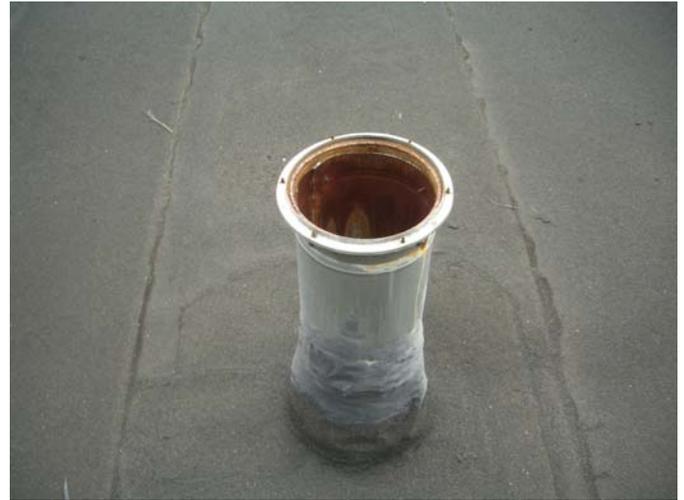
R-4 Missing cap on flue stack causing leak

1 year: Replace missing cap on flue stack. Maintain a pro-active maintenance program. Inspect the roof systems and walls on a regular schedule - minimum twice a year (late spring and late fall). Estimated cost: none (perform in-house)

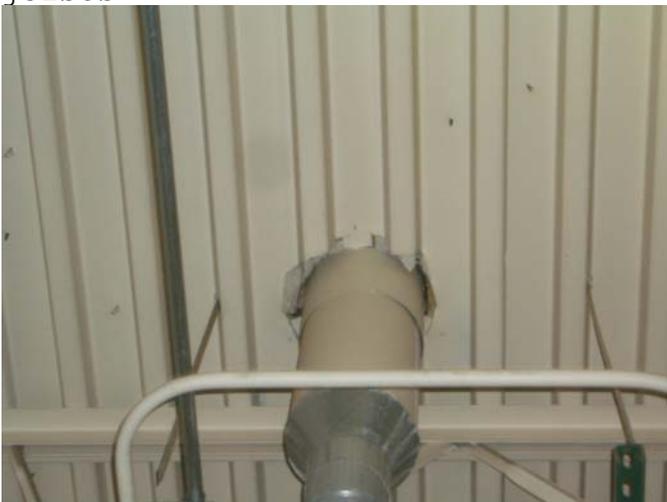
R-2 Underside of training roof at flue - leak location

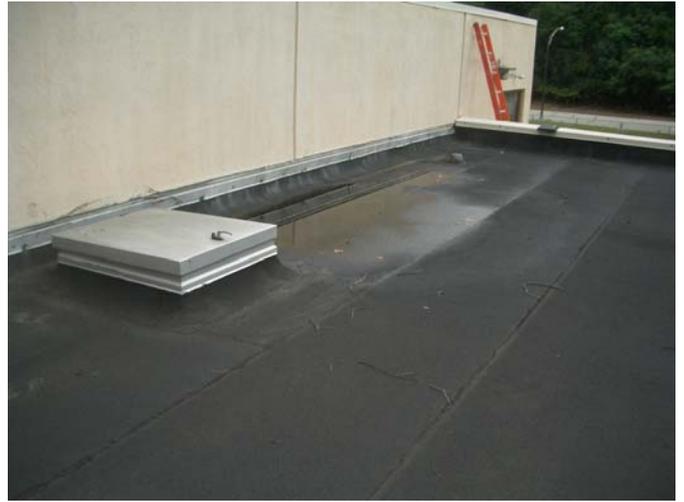
R-7 Training roof south wall looking east, debris at drain

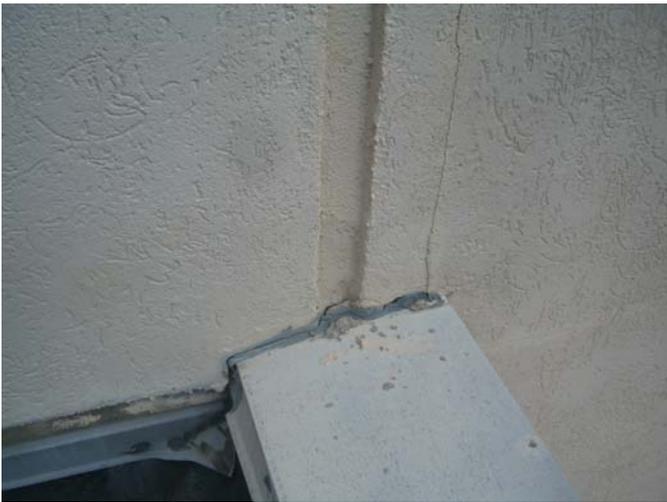
R-13 Parapet wall connection to training room wall, crack in EIFS

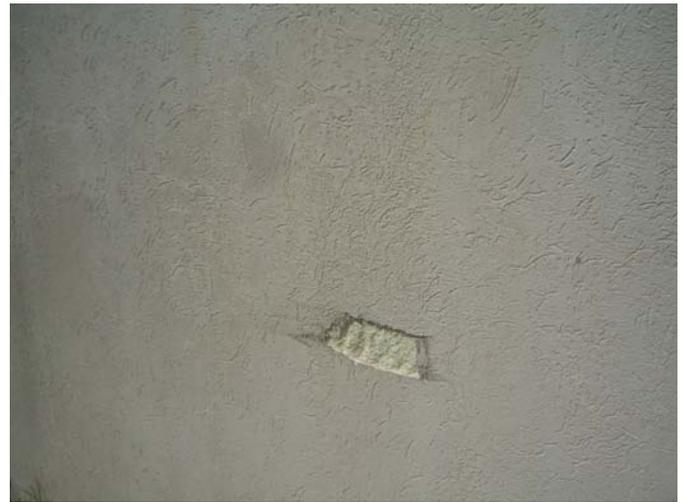
W-3 East wall, damage to EIFS

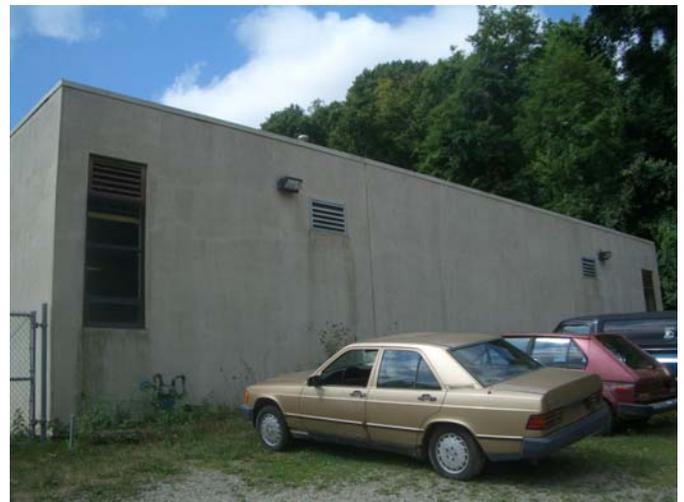
W-4 North wall, some stains
