CITY OF
PITTSBURGH
FACILITY ANALYSIS REPORT

Police Zone 1 (B379)
1501 Brighton Road
Pittsburgh, Pennsylvania 15212

July 23, 2010

Police Zone 1 (B 379)

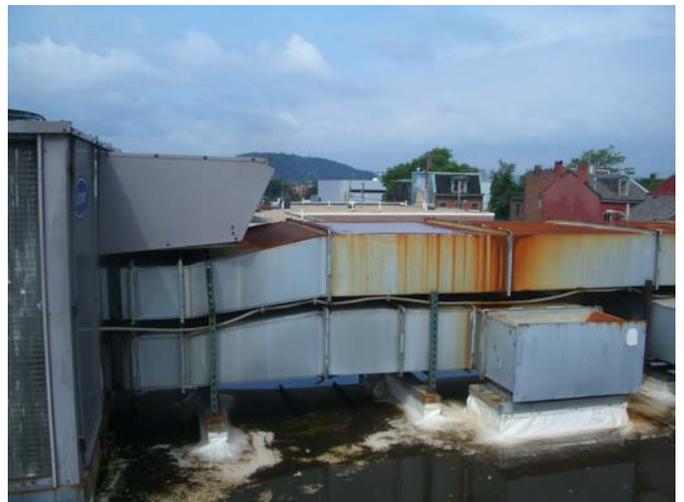
R-2 Ponding water on south end of main roof

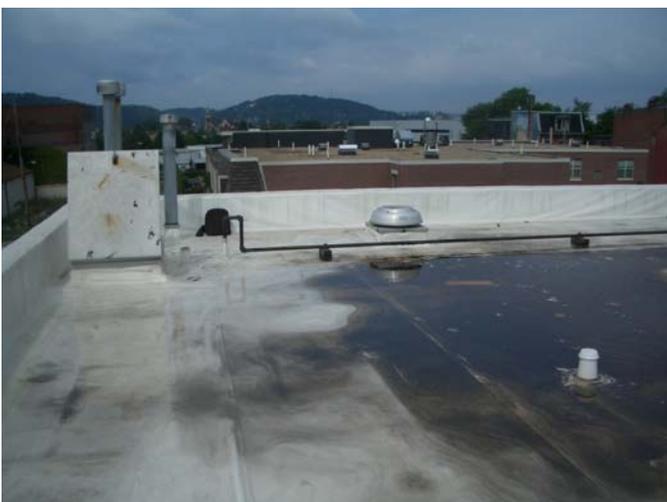
R-5 Pond around HVAC unit and rusted ductwork

The roof top penetrations are in good condition. The ductwork is un-insulated and rusted and should be painted/insulated.

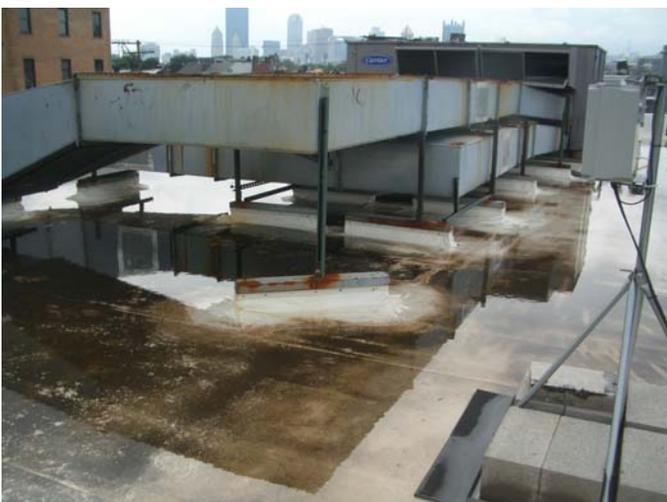
R-17 Rusted ductwork and metal panels stored between ducts

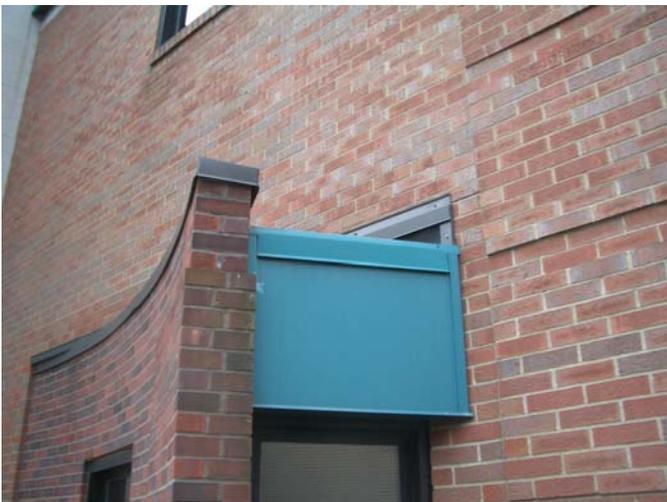
W-4 Caulking missing at front wall

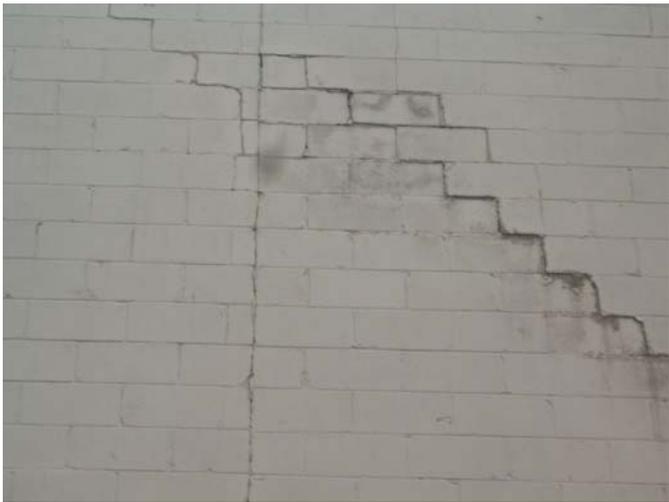
10.1 There are cracked mortar joints in the concrete block walls. The potential for water infiltration is high in these areas.

W-7 Cracked mortar joints in south wall

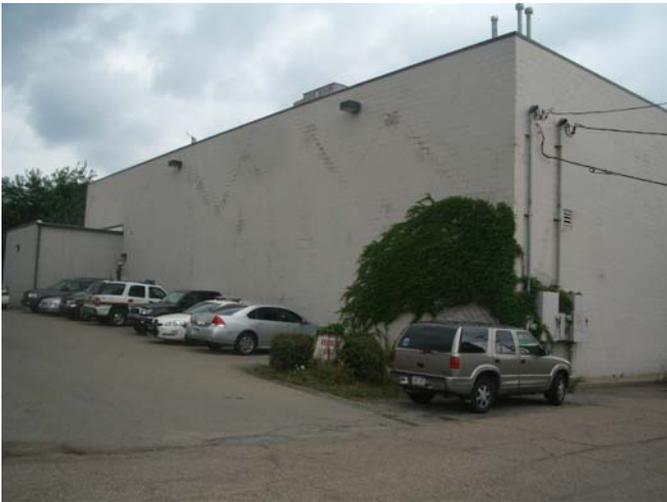
W-10 Cracked mortar joints in west wall

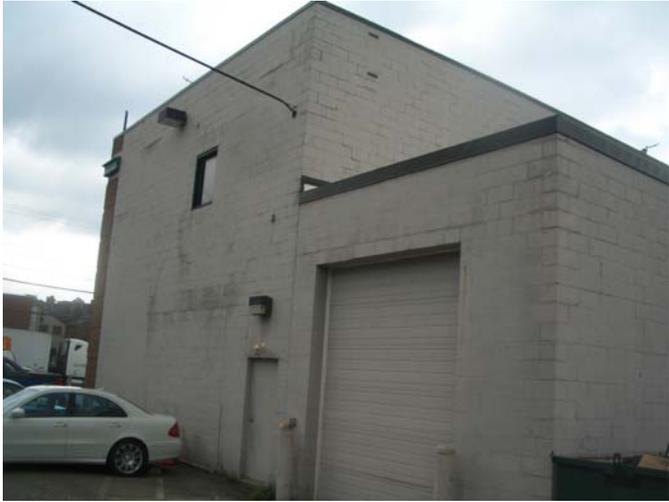
W-9 Cracked mortar joints in west wall
