CITY OF
PITTSBURGH
FACILITY ANALYSIS REPORT

Pittsburgh Police Zone 2 (B108)
2000 Centre Avenue
Pittsburgh, Pennsylvania 15219

July 21, 2010

Police Zone 2 (B 108)
2000 Centre Avenue
Pittsburgh, PA 15219

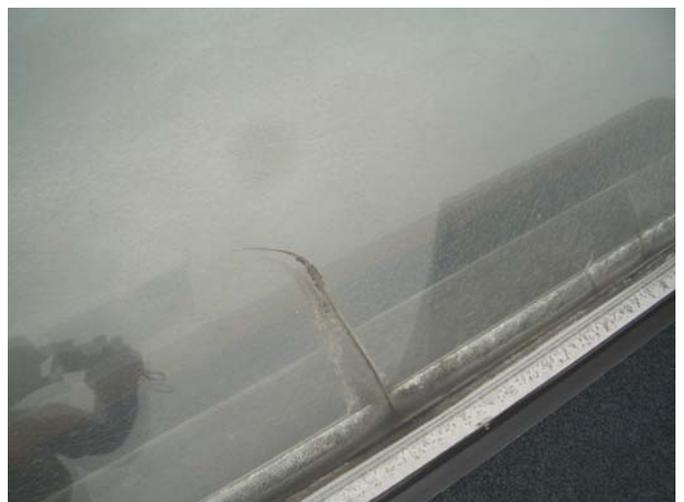
R-18 Cracked dome on skylight

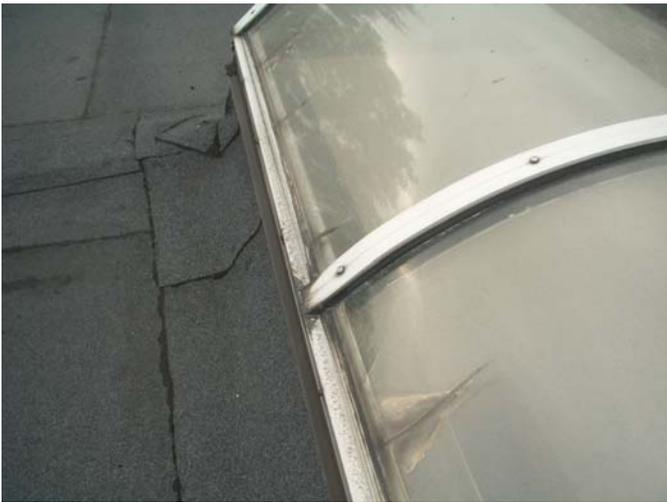
R-19 Cracked domes on skylight

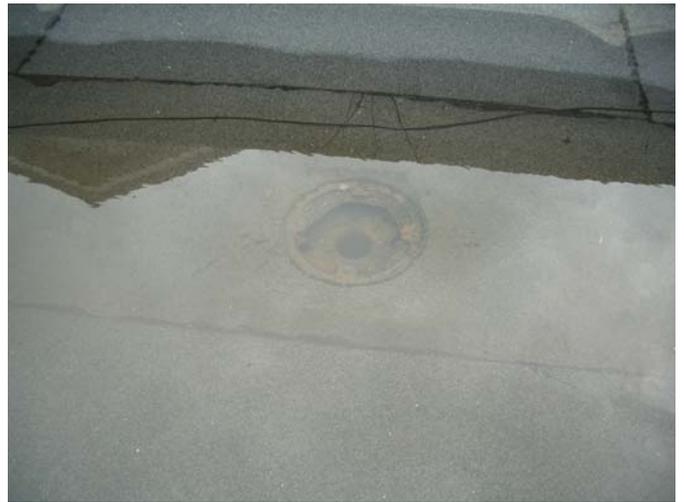
R-22 Clogged roof drain on NE corner

The roof drain covers are in good condition. 1 roof drain is clogged near front corner entrance side of building. Small pond on this part of the roof. Clean clogged roof drain immediately. Clear debris from roof and all roof drains. The rain water sewer pipe below grade should be video inspected and its condition assessed within 5 years.

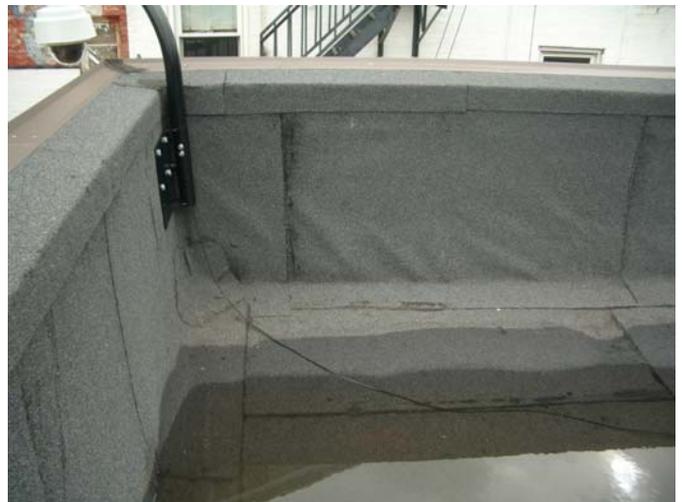
R-23 NE corner, wall flashing loose and buckled

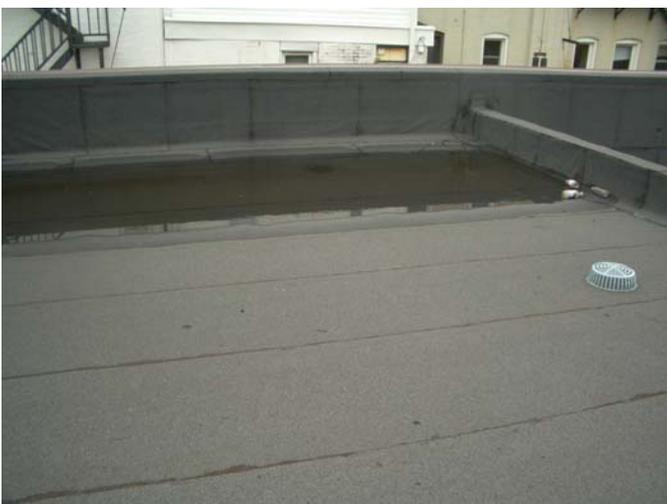
R-21 Pond on NE corner area

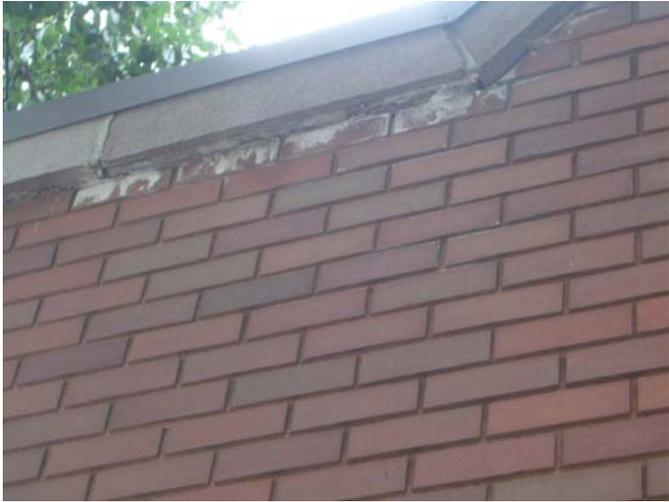
6.2 Condition: The stone coping is in fair condition. The caulking at the butt joints is aged. The cement in the coping bed joint is aged, deteriorated and falling out on the exterior side.

W-2 Deteriorated bed joint on south wall coping

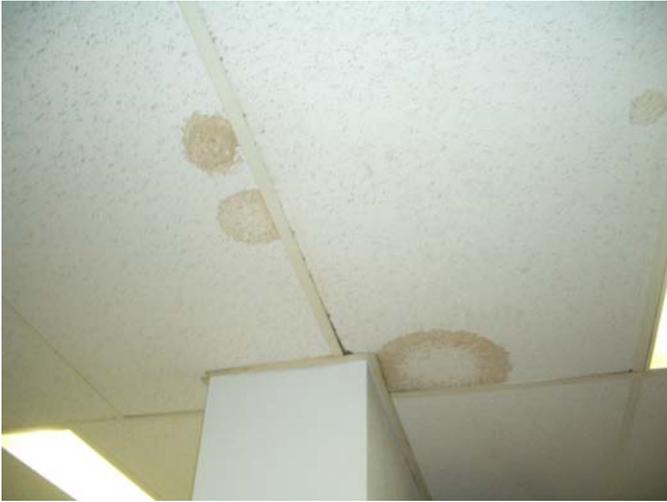
R-27 Old stains from roof leaks

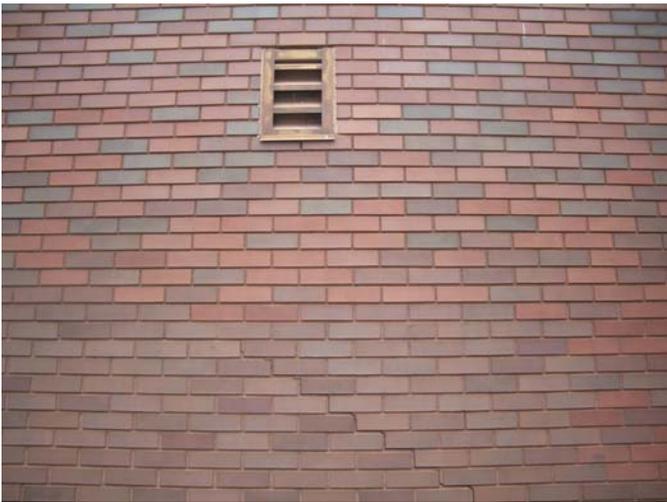
W-7 East Wall

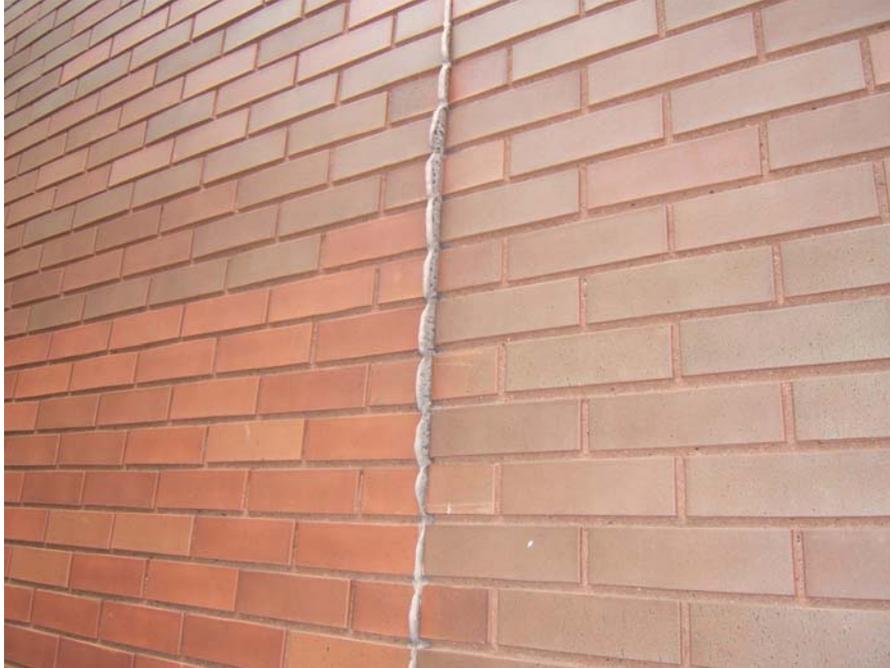
Photo S3

- 3) Control joint filler has been squeezed out of the control joints at the east wall. See photo 3. Recommend removing existing filler and replacing. (1-5 yrs.)

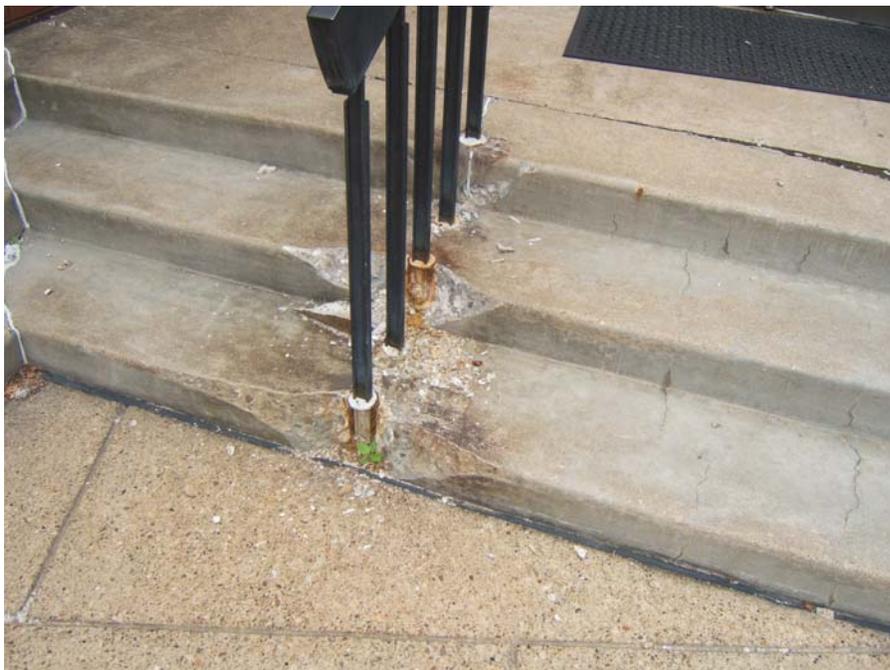
Photo S4

- 4) Concrete is spalling from the exterior stairs on grade at the north entry. See photo 4. Recommend saw-cut removal and partial replacement via patching. (1 yr.)

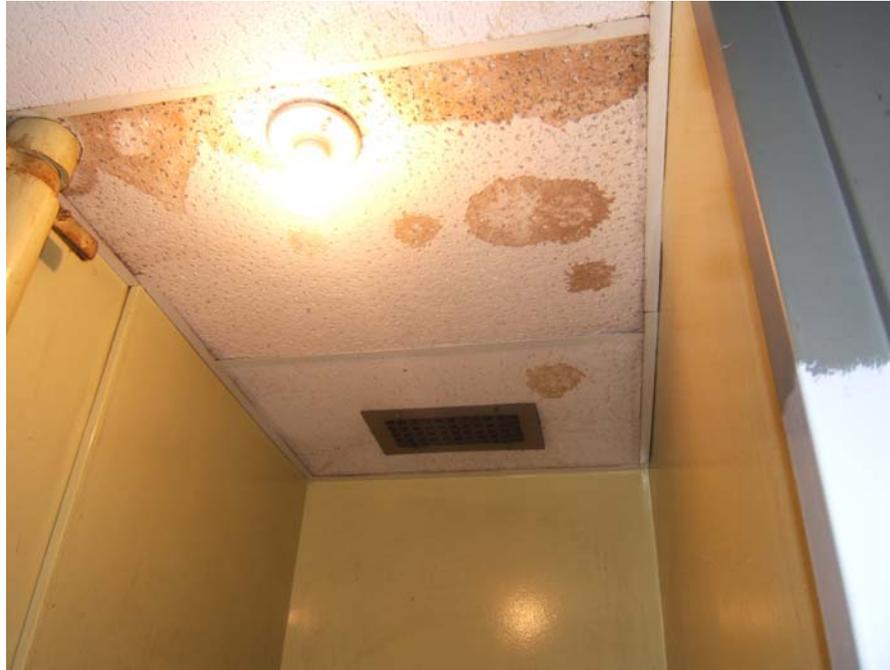
Photo 9

- 8) Water damaged ceiling tile were observed in numerous locations throughout the interior of the building. The water appears to be infiltrating the rolled roofing material. See photos 8 thru 10. Recommend replacing the rolled roofing material with a rubber roof system. See Roofing Report for additional information and recommendations.
