CITY OF
PITTSBURGH
PROPERTY CONDITION REPORT

B405 – Police Zone 3
830 East Warrington Avenue
Pittsburgh, Pennsylvania 15210

June 2014

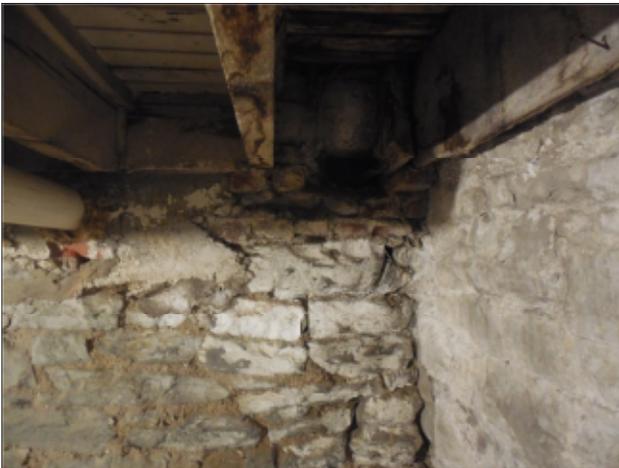
1. Foundation - Constructed of Stone Masonry- No Settlement Issues, but there are voids in the masonry
2. Slab on grade: The basement floor slab has areas of cracking and minor failures but is in Fair condition overall.

SS1 – Foundation wall – open mortar joints,
no evidence of water infiltration

Recommendation: Seal open mortar joints – \$1,500

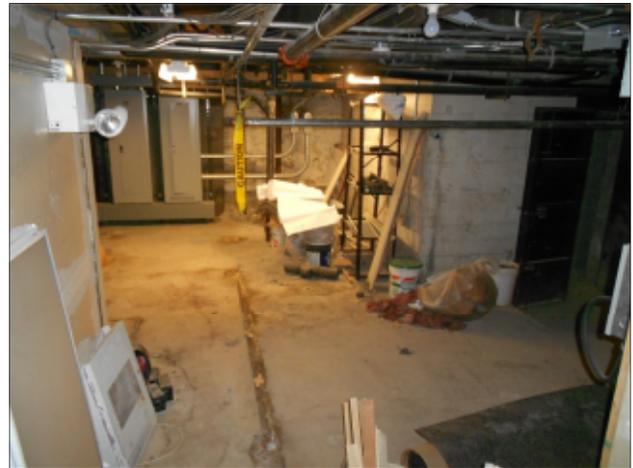
SS2 – Typical basement slab – Fair condition

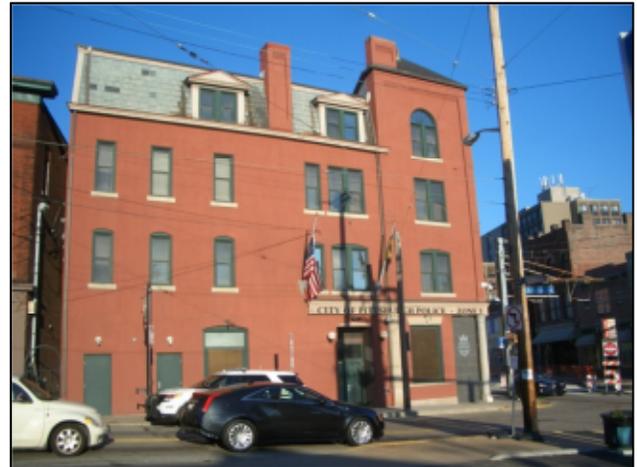
SH4 – East façade

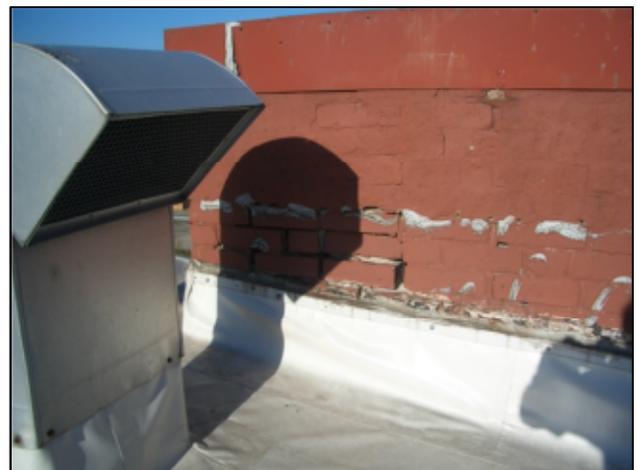
- 3.2. An addition was added to the south with concrete masonry units - good condition
 - 3.3. Chimney – Brick Masonry- has a few open joints in mortar joints

SH6 – Open joints at chimney in NW corner of main roof

1 year: Re-point brick walls as needed (this work will have to bid out). Paint all wood on fourth floor at cornice and mansard (this work will have to bid out). Replace missing downspouts – Estimated cost: \$200. Inspect roofs and walls yearly and remove debris – Estimated cost: None (perform with in-house personnel) Inspect and repair the HVAC units and Exhaust fans for leak causes.

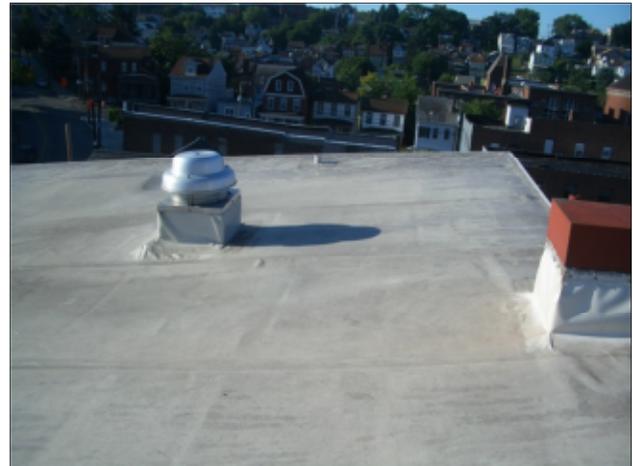
A few leaks are reported on the fourth floor and in the stairwell. The leaks appear to be coming from the HVAC units, the Exhaust fans and masonry cracks. These leaks are active, have not been repaired and do not appear to be roof system related.

SH8 – Main roof , south wall, exhaust fan is above apparent leak at conference room

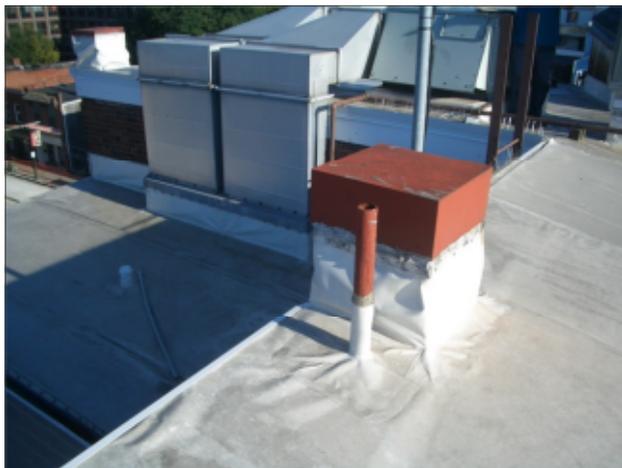
SH9 – West side of main roof, lower main roof at left

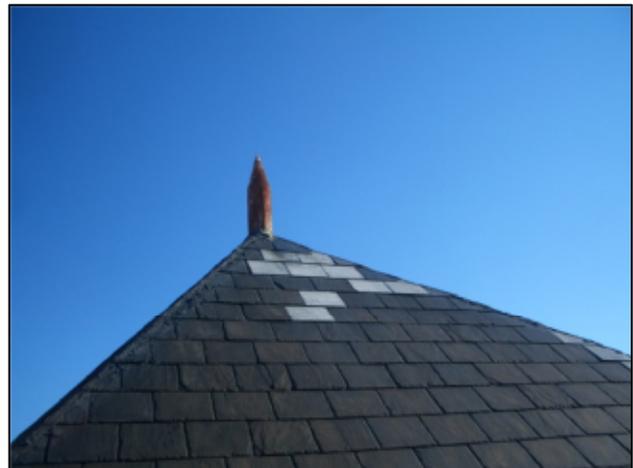
- 6.2. Condition: The TPO roof membranes appeared in good condition. The slate roof system is in poor to fair condition. Some slates have fallen off the mansard. Numerous repairs have been done on the Tower roof. Some repairs to the Tower roof included the use of asbestos synthetic slate.

SH10 – Repairs to tower roof slates, synthetic slates

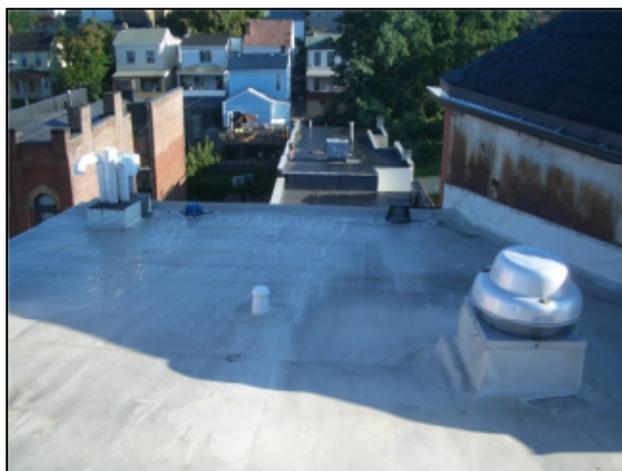
- 7.2. Condition: The membrane flashing systems are in good condition. The metal flashing on the Tower is in poor condition and rusted.

SH11 – NW corner of main roof, rusted wall panels on tower wall at right

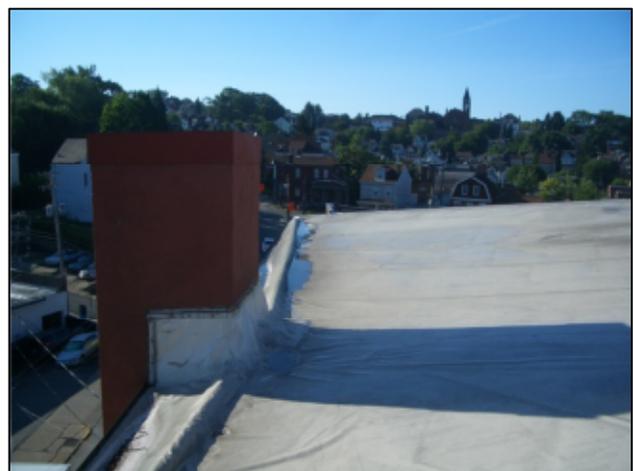
SH12 – East wall of main roof, looking south, ponding water

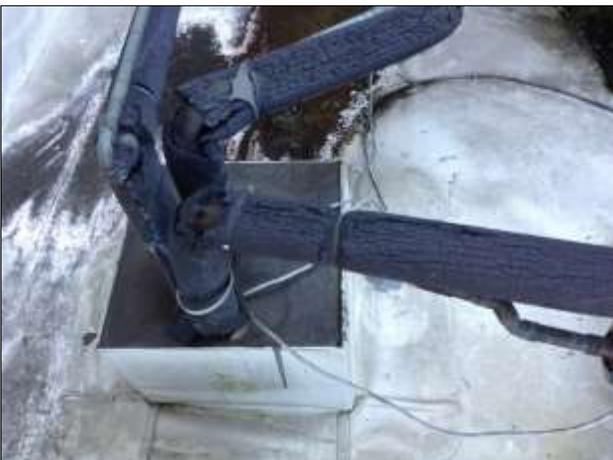
HVAC 11 – Refrigerant piping (deterioration)-2

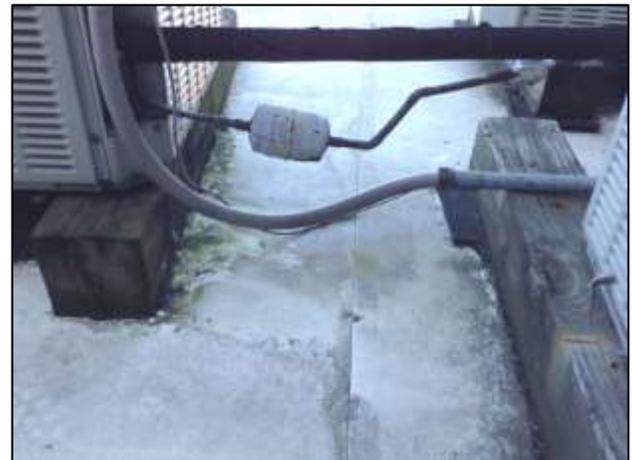
HVAC 12 – Refrigerant piping (reverse pitch)-3

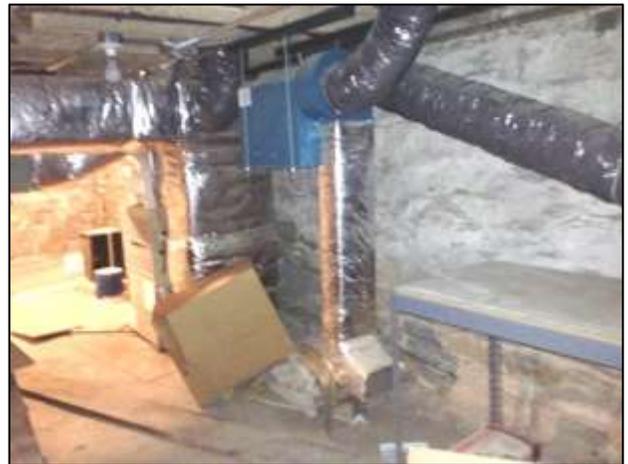
1.1.6.1. Physical Deficiencies:	None reported or observed
1.1.6.2. Functional Deficiencies:	None reported or observed
1.1.6.3. Performance Concern:	Transfer air to basement
1.1.6.4. Maintenance observations:	None reported or observed
1.1.6.5. Remaining useful life observations (RUL):	5-10 years
 - 1.2. 1st Floor HVAC: The space conditioning system for the first floor is comprised of Two (2) Trane furnaces (GFAHU's); Two (2) split system Air Cooled Condensing Units (ACCU); insulated (external), galvanized, low pressure ductwork, room supply diffusers, room return grills, exhaust fan inlet grills, and a thermostat. The AHU's are located in the basement and the ACCU's are located on the low roof.
 - 1.2.1. Construction: Room terminal units – Commercial ceiling mounted multidirectional diffusers and grills. Existing and 2008 renovation.
 - 1.2.2. Condition: Room terminal units - **Fair**

HVAC 16 – Centrifugal fan and flex-duct

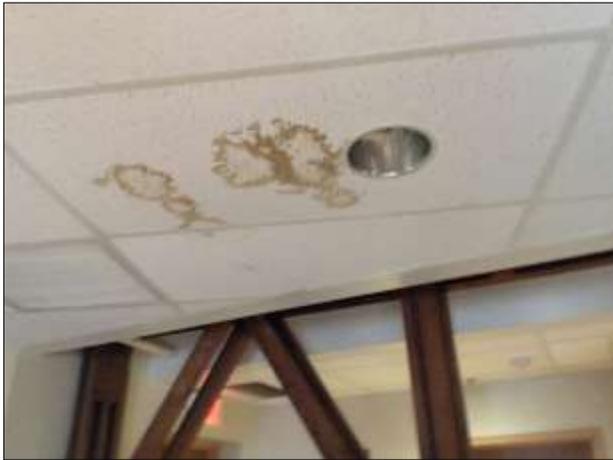
The perimeter terminations are in good condition. The roof top units and penetrations are in fair condition. Leaks reported in the fourth floor are in direct relation to the HVAC units and the exhaust fans.

HVAC 41 – RTU condensate leak
