CITY OF
PITTSBURGH
FACILITY ANALYSIS REPORT

Pittsburgh Police Zone 5 (B402)
1401 Washington Blvd
Pittsburgh, Pennsylvania 15206

June 25, 2010

Executive Summary

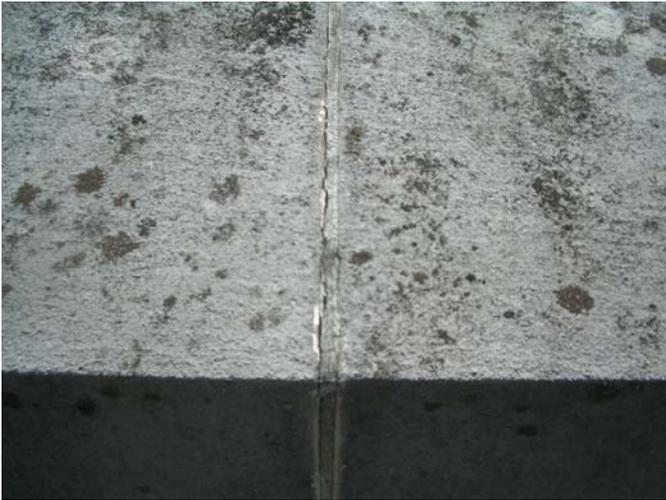
R-12 SE corner of office area, parapet wall
