CITY OF
PITTSBURGH
FACILITY ANALYSIS REPORT

Public Safety Training
1435 Washington Blvd.
Pittsburgh, Pennsylvania 15206

Public Safety Training (B107)

Executive Summary

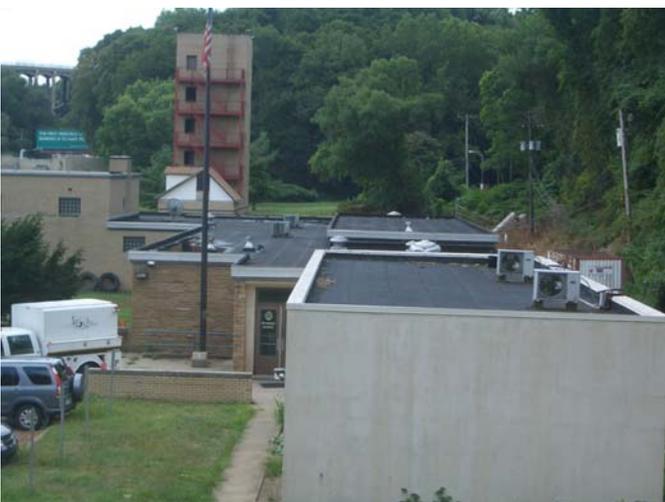
R-5 Truck bay roof, repairs to coping joints

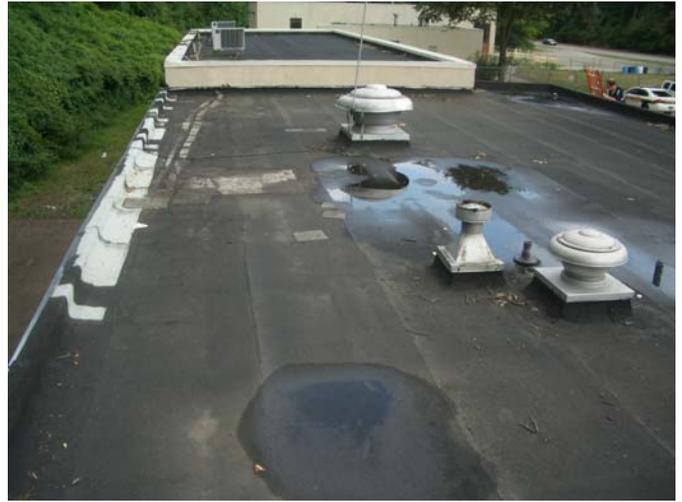
R-19 Main roof, debris at roof drain, typical

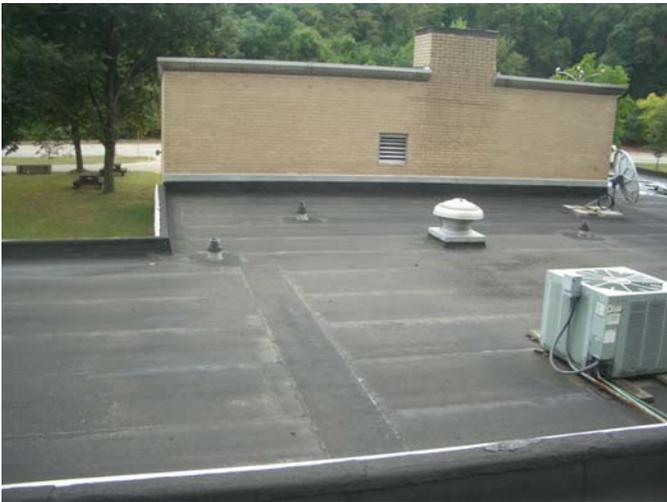
R-22 Main roof, NW corner, repairs from storm damage on west wall

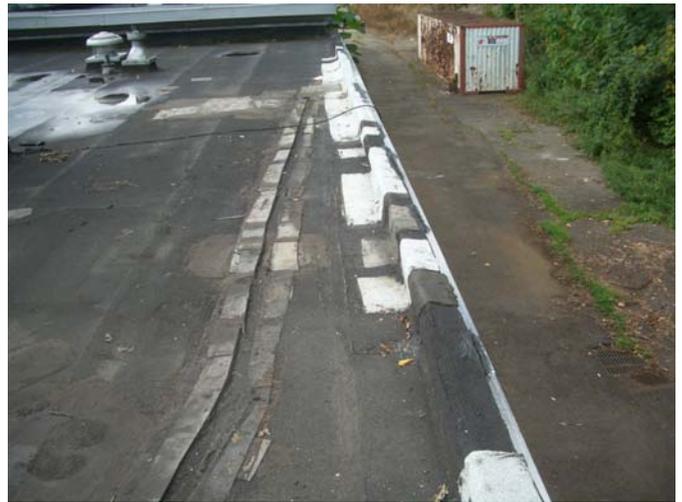
R-25 Main roof, north wall at tie in to classroom, open flashing in corner

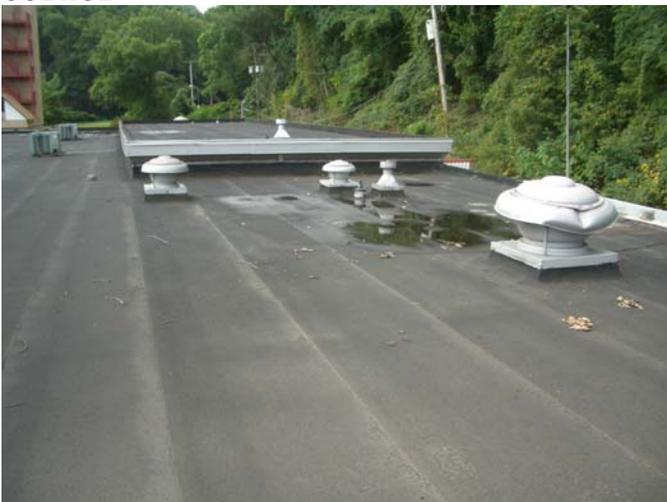
R-28 Main roof, repair to storm damage on west wall

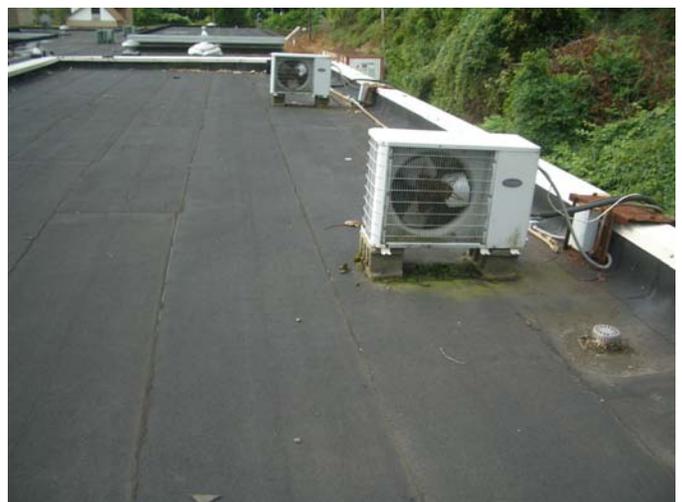
R-27 Main roof, repair to storm damage on west wall
