CITY OF
PITTSBURGH
FACILITY ANALYSIS REPORT

Public Works 1st Division
300 Kilbuck Street
Pittsburgh, Pennsylvania 15214

Public Works 1st Division (B018)

300 Kilbuck Street
Pittsburgh, PA 15214

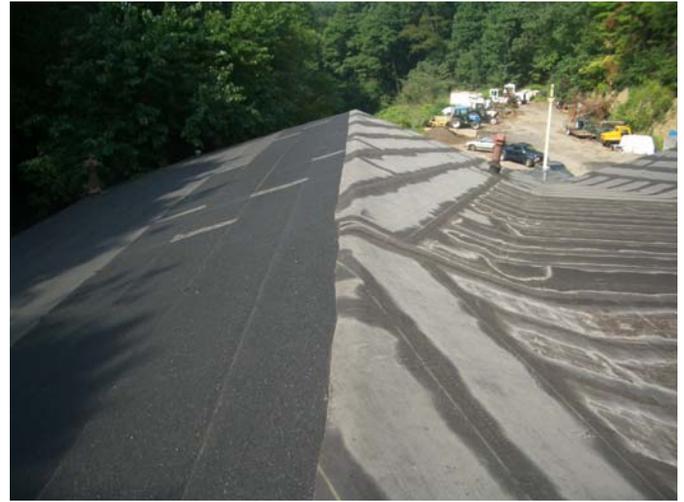
R-10 Rolled roofing repairs and APP membrane installation

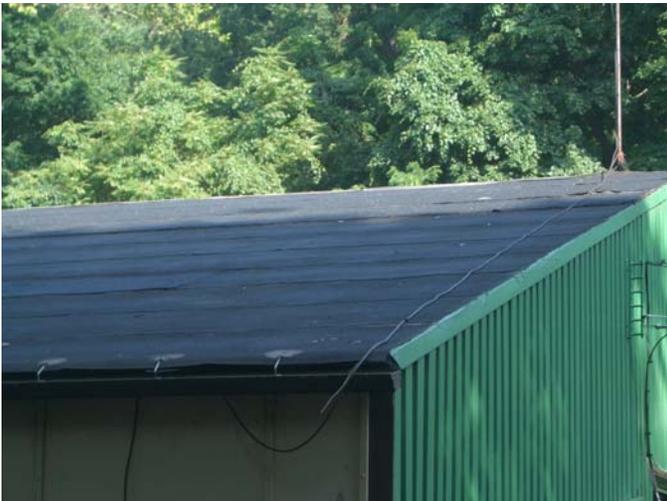
poor condition. The shingles are aged, cracked and deteriorated. The 90# rolled roofing system on the office/storage area is in poor condition. The membrane is aged, cracked, deteriorated and numerous repairs made. The APP roof system is in fair condition and reported installed within the last few years. The APP membrane is uncoated.

R-8 East slope of office/storage area with 90# rolled roofing

It is our opinion the roofing systems on the west slope of the garage (shingles) and the east slope of the office/storage (90# rolled roofing) should be replaced. The balance of the roof systems are in a maintainable condition.

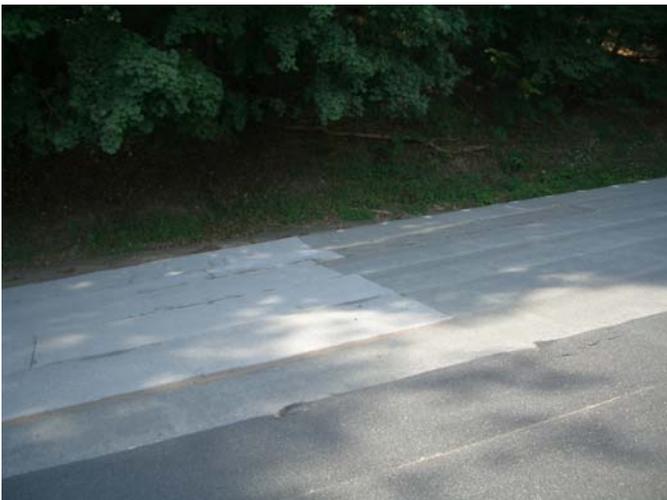
R-9 Repairs to rolled roofing

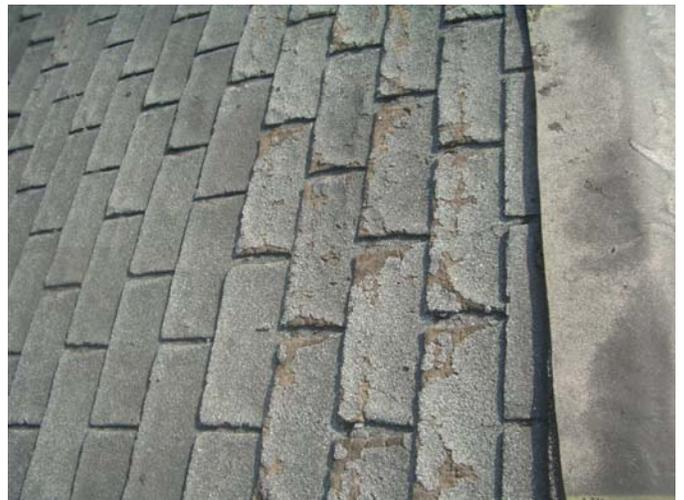
R-18 Deteriorated shingles

1 year: Replace the shingle and 90# rolled roofing roof systems on the main building. Estimated cost: \$30,000 (4,100 SF x \$7/SF + \$1,000 deck repair). Maintain a pro-active maintenance program on the balance of the roof systems. Inspect the roof systems and walls on a regular schedule - minimum twice a year (late spring and late fall) (include cleaning debris from gutters and around drains). Estimated cost: none (perform in-house)

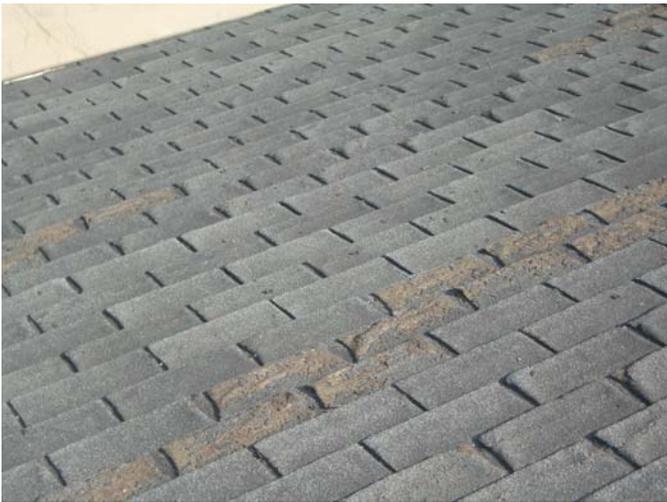
R-19 Deteriorated shingles

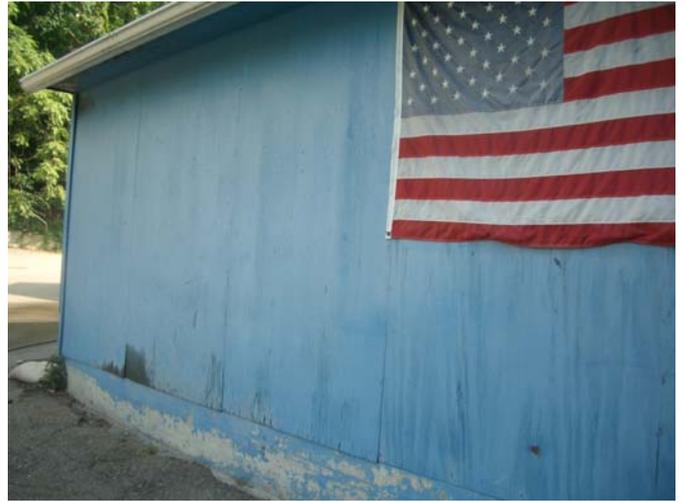
W-11 South wall of Barn with deteriorating pain

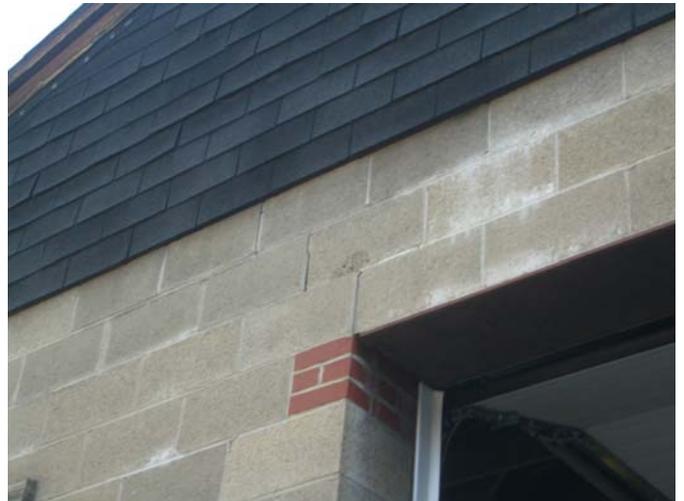
W-12 South end of garage at entry, cracked mortar joint above door

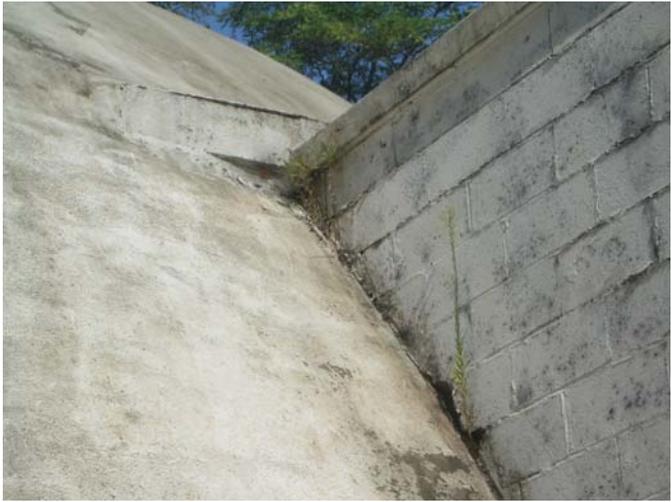
11.2 The building is in poor condition. The roof coating is aged and worn exposing the bare concrete. Some cracks were observed. Vegetation is growing at the entry area.

Other 4 - Salt storage building, deteriorating coating and plants growing in cracks

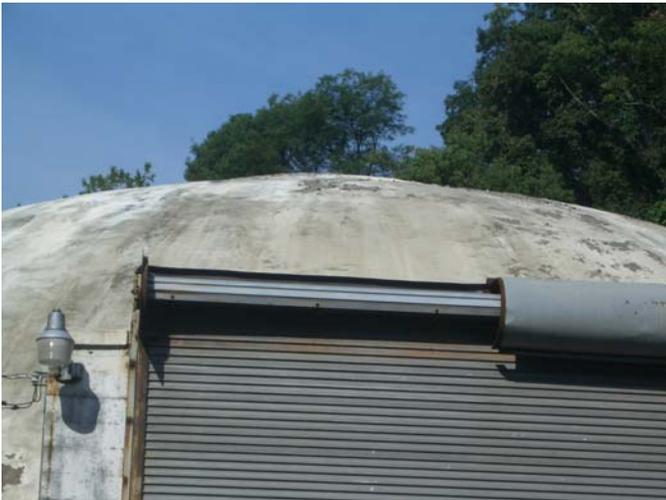
Other 3 - Deteriorating coating on building

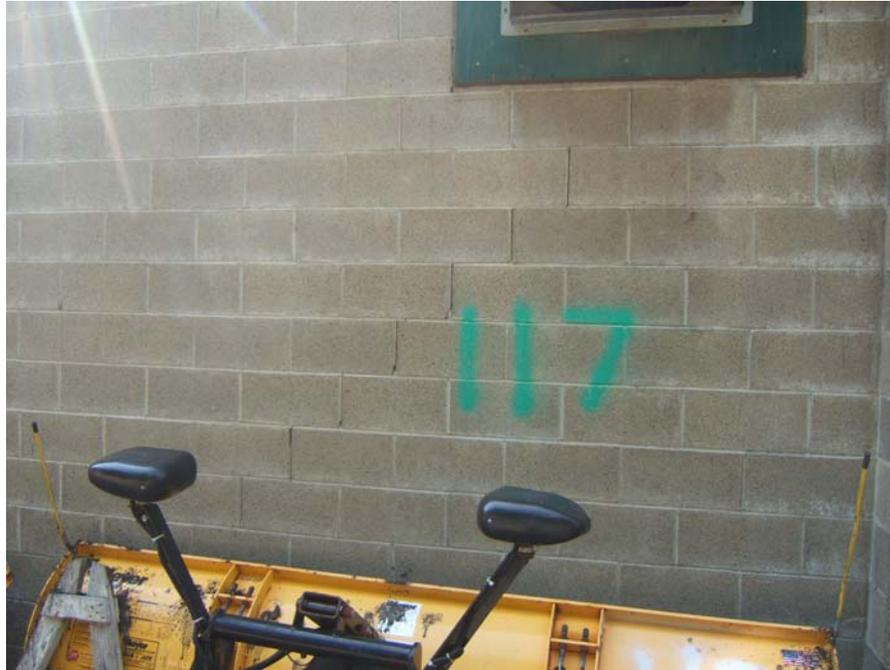
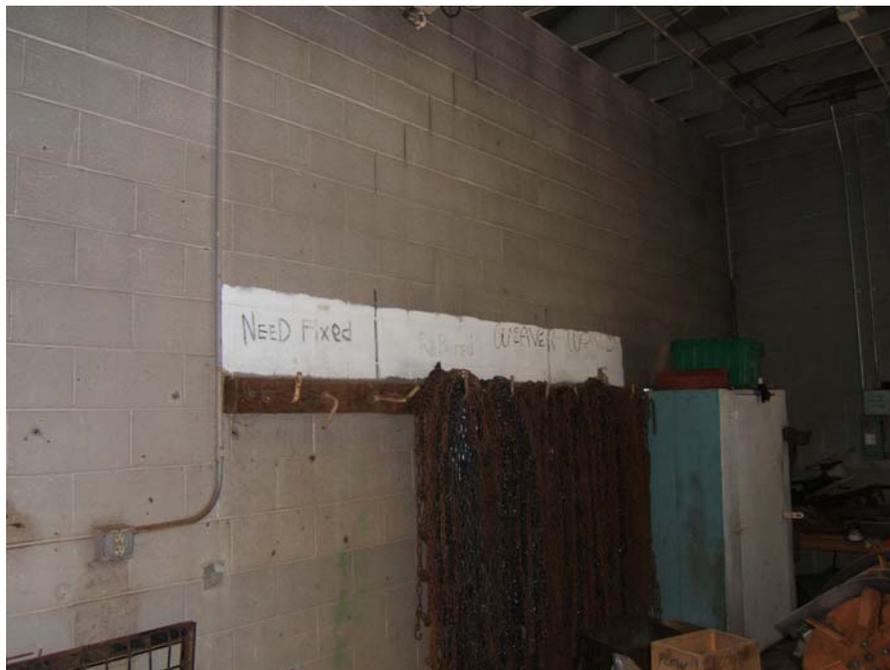
- 4) Stepped cracking in north CMU wall (interior and exterior). See Photos 5 and 6. Believed to be due to settlement of foundation as a result of chains hung from CMU wall. It's likely that neither the wall nor the foundation were designed to support such large, eccentric loads in addition to standard gravity and wind loads. Recommend relocating chain rack to a self-supported assembly designed to rest on a slab on grade that has also been designed to support the large loads. Cracks in CMU wall should be routed and sealed with injected epoxy. (1 yr.)

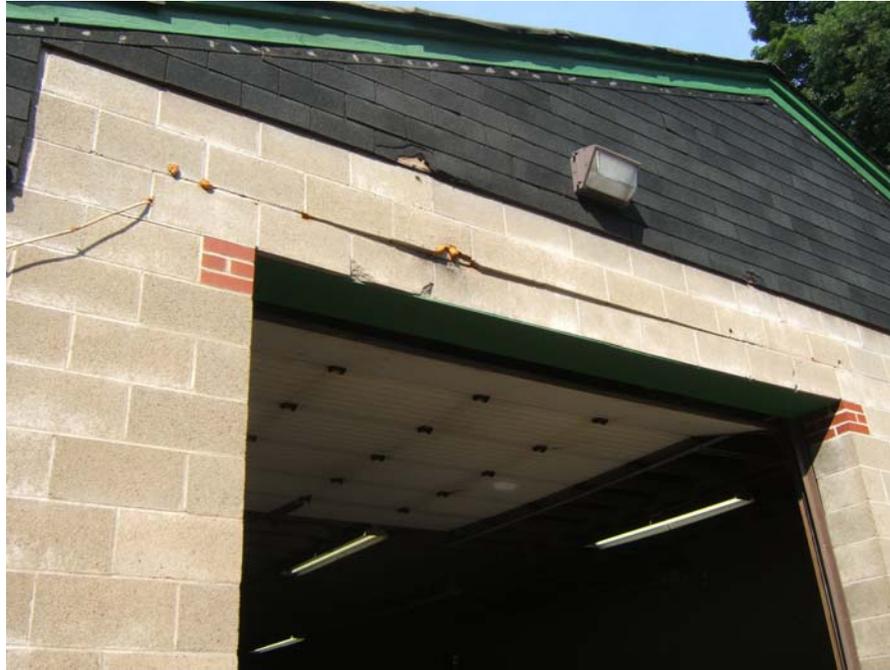
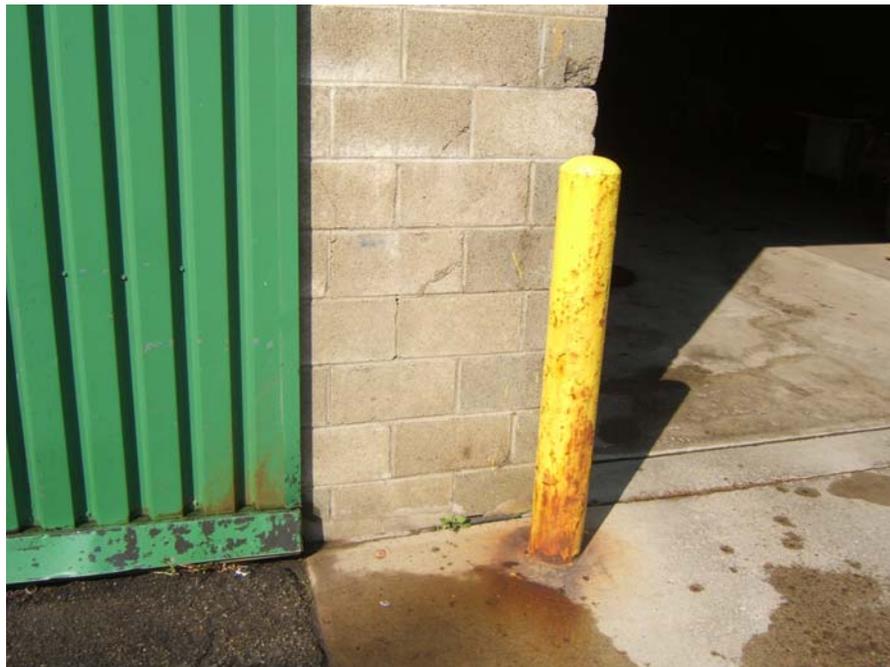
- 7) Masonry cracking above garage door lintel and at garage door jambs of the east face of building. See Photos 7 and 8. Damage appears to be due to vehicular impact(s). Recommend routing and repointing masonry at cracks with replacement CMU installed as required. (1 yr.)

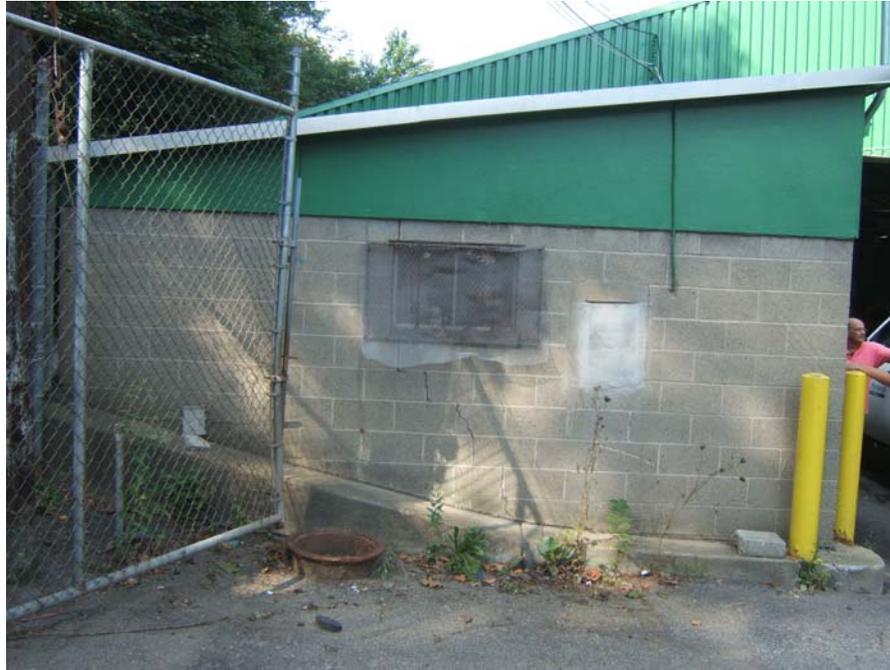
Photo 9

- 8) Vertical and stepped cracking observed at east face of building from foundation to roof. See Photo 9. Cracking may be due to minor foundation settlement. Recommend routing and sealing of cracks with epoxy and periodic crack monitoring to determine if settlement is ongoing. (1 yr.)
