CITY OF  
**PITTSBURGH**  
FACILITY ANALYSIS REPORT

**Public Works 4<sup>th</sup> Division**  
414 Bausmann Street  
Pittsburgh, Pennsylvania 15210

**Public Works 4th Division (B018)**  
414 Bausman Street  
Pittsburgh, PA 15210

**Executive Summary**

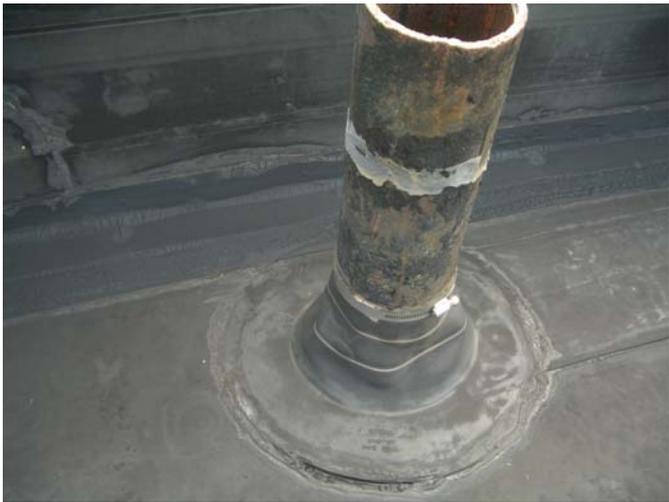
R-4 Loose vent pipe flashing

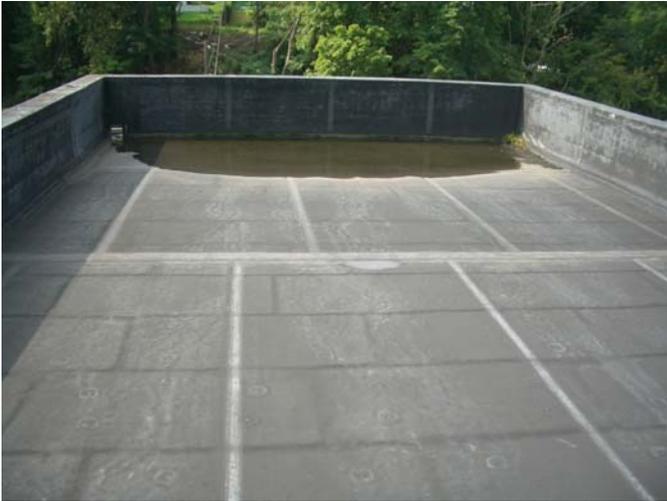
R-2 Penthouse roof looking south, ponding water

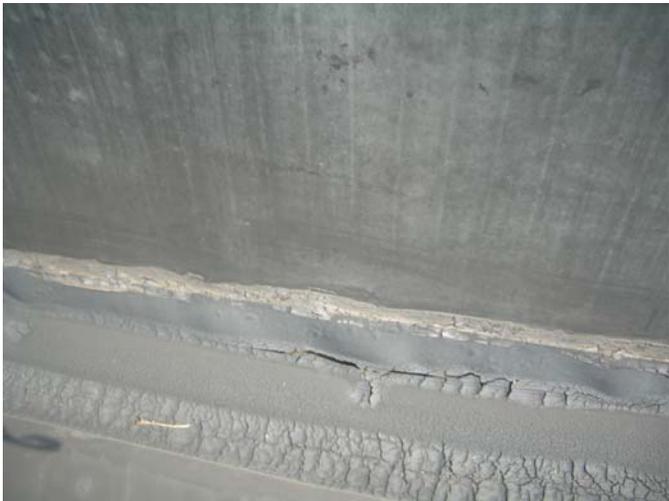
R-5 Deteriorated flashing, crazed and cracked

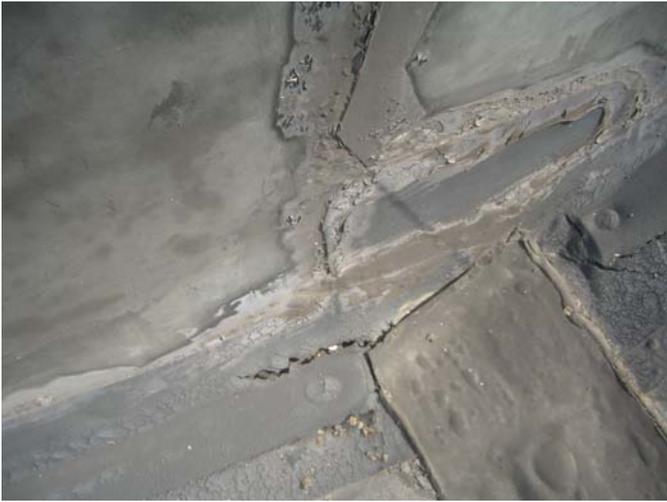
R-13 Deteriorated and cracked flashing

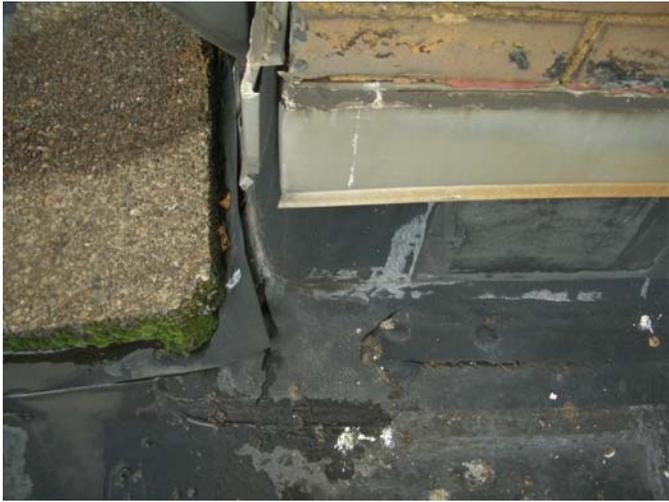
R-16 Open flashing at base of penthouse

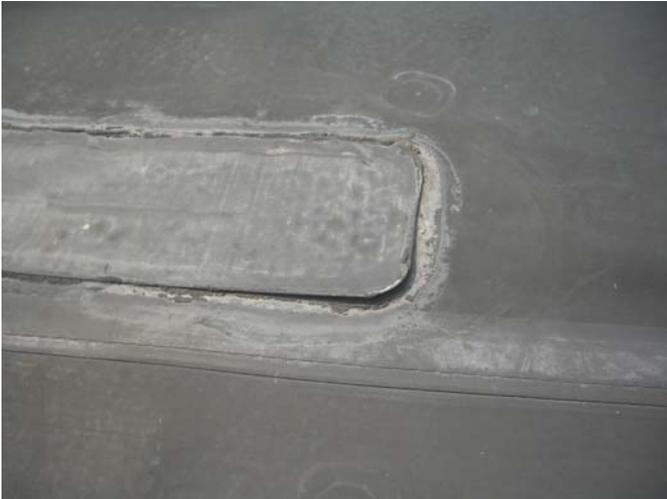
R-14 Loose repair

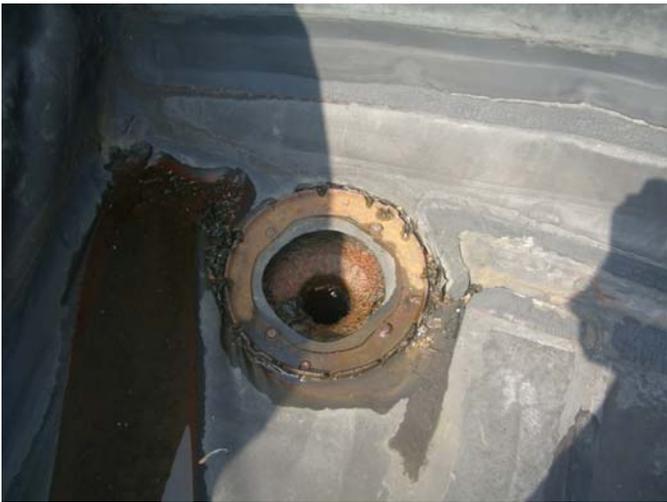
R-19 Bridged flashing, missing dome on drain

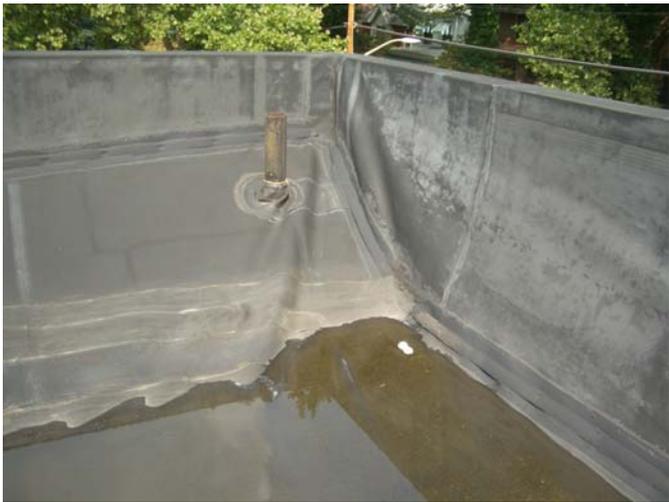
R-22 Bridged and loose flashing

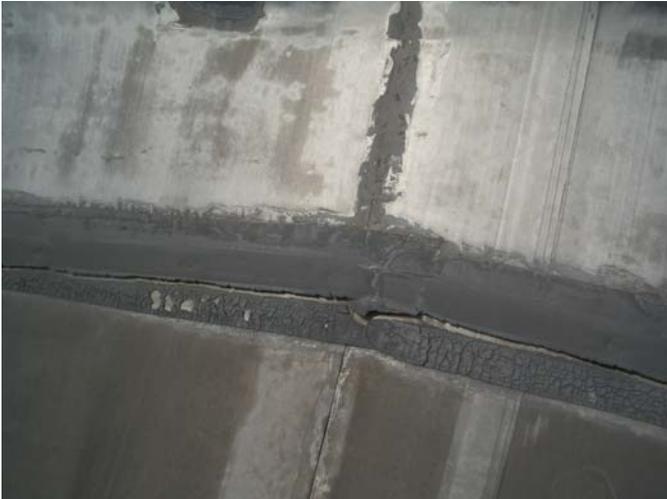
R-20 Open field seam

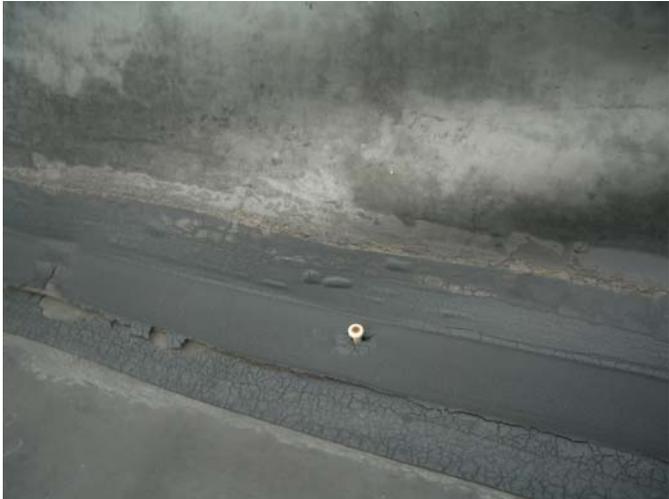
R-23 Nail protruding flashing, open and cracked flashing

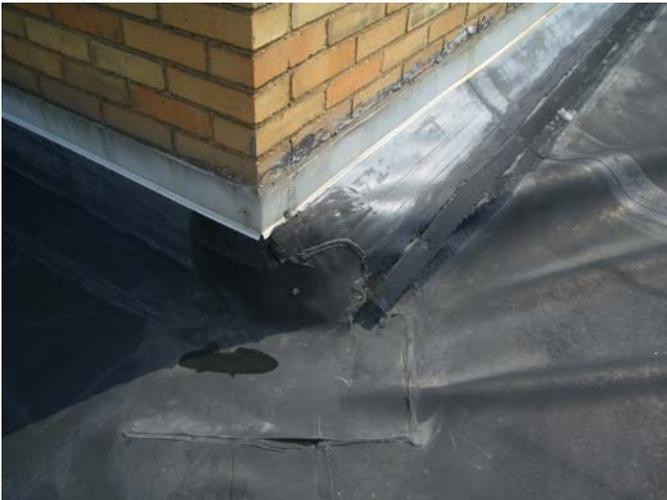
R-21 Open patch and flashing at base of penthouse

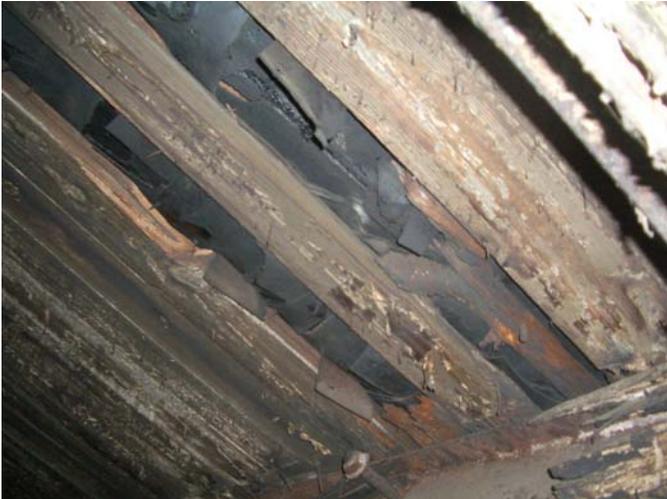
R-26 Underside of Garage roof, rotted and missing sheathing

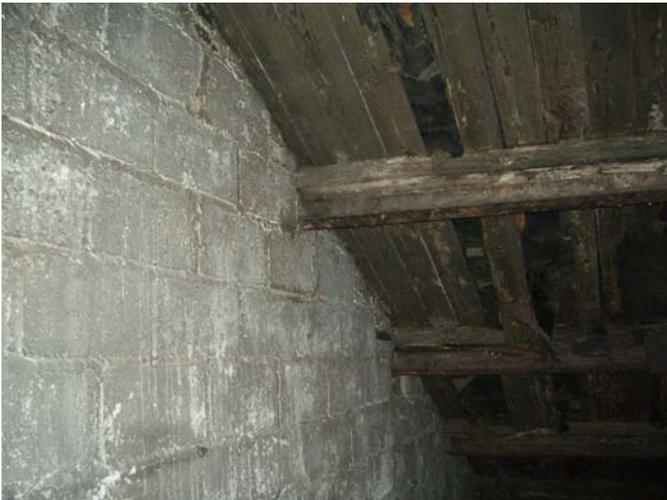
R-27 Underside of Garage roof, rotted and missing sheathing

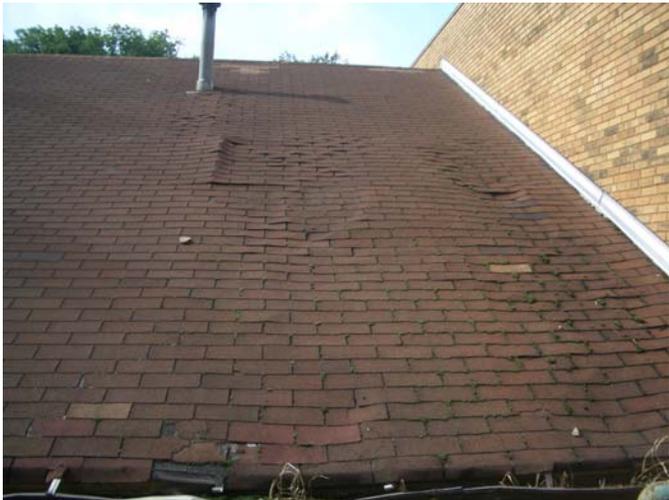
R-30 Northwest corner of garage roof with depressions in roof

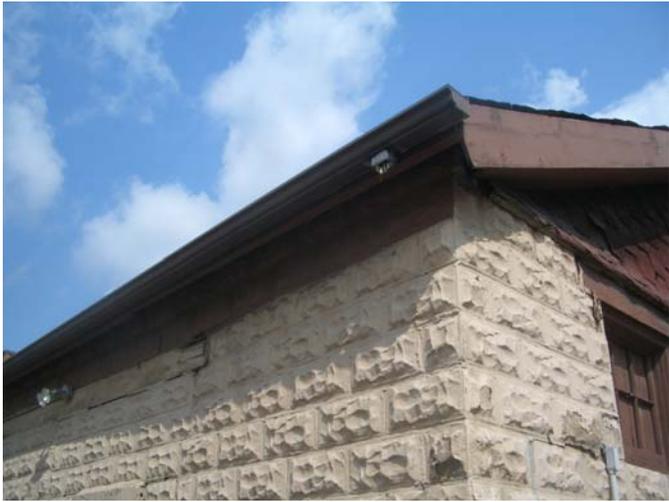
R-34 SE corner of garage, missing downspout

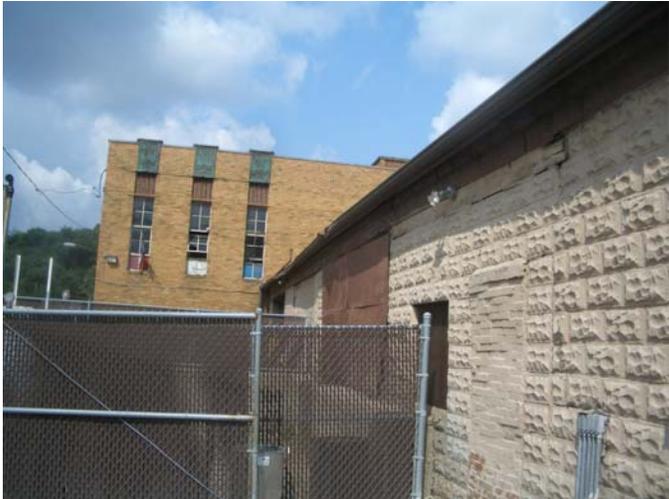
R-35 South eave of garage, damaged gutter

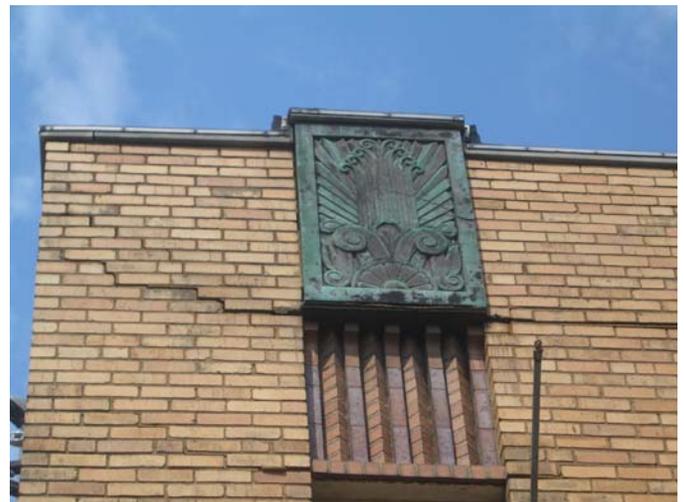
W-5 SE corner of main building, cracked mortar joints

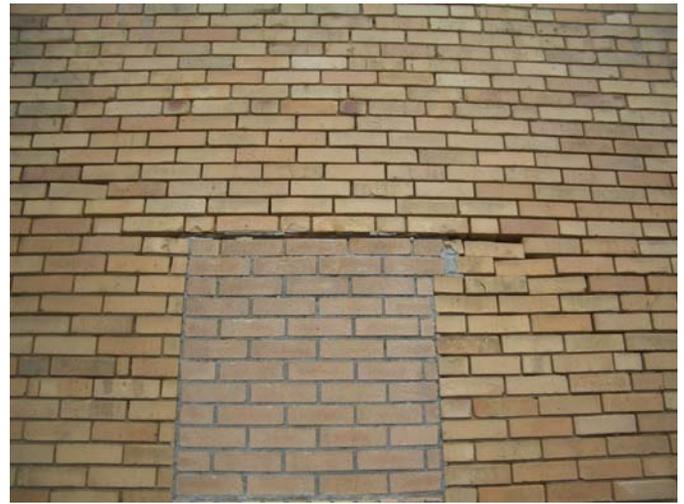
W-10 Crack mortar joints

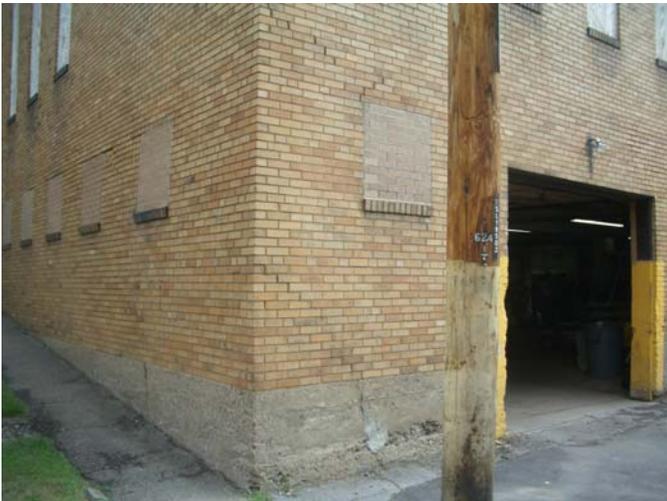
W-8 Cracked mortar joints in SW corner of main building

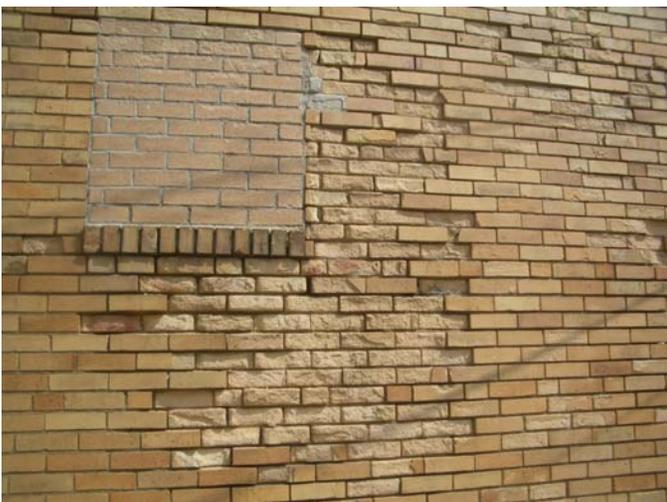
W-9 Spalled brick at rear of building

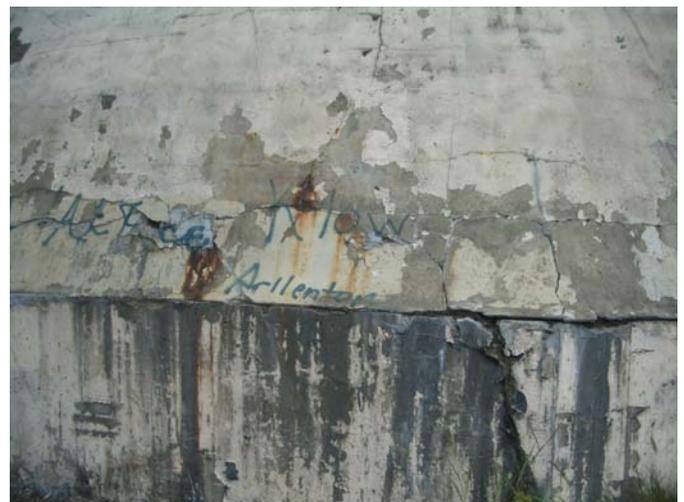
Other - Cracks in concrete of salt containment building
