CITY OF
PITTSBURGH
FACILITY ANALYSIS REPORT

Schenley Park Skating Rink (B 064)

501 Overlook Drive
Pittsburgh, Pennsylvania 15217

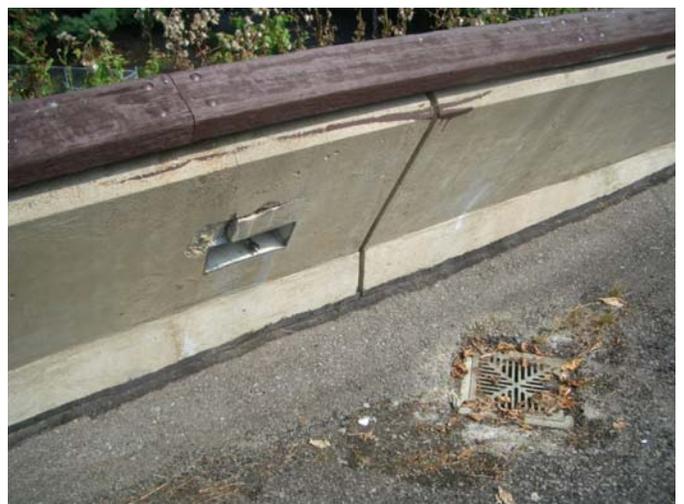
R-3 Parapet wall and paving at Support Building

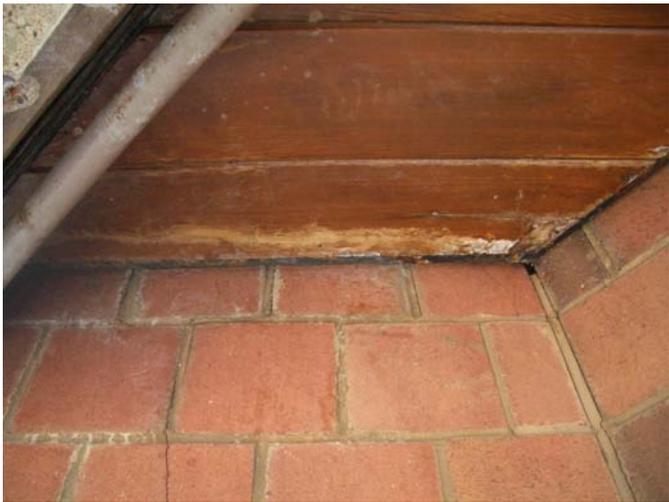
R-7 Underside of deck in kitchen area of Support building

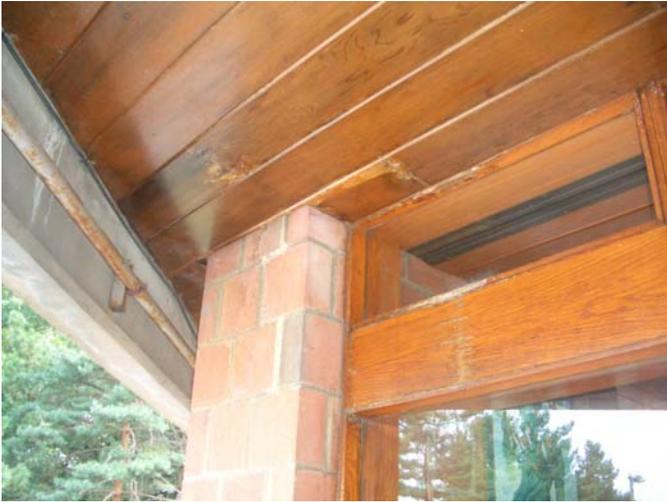
R-10 Leak stains at entry of Support area

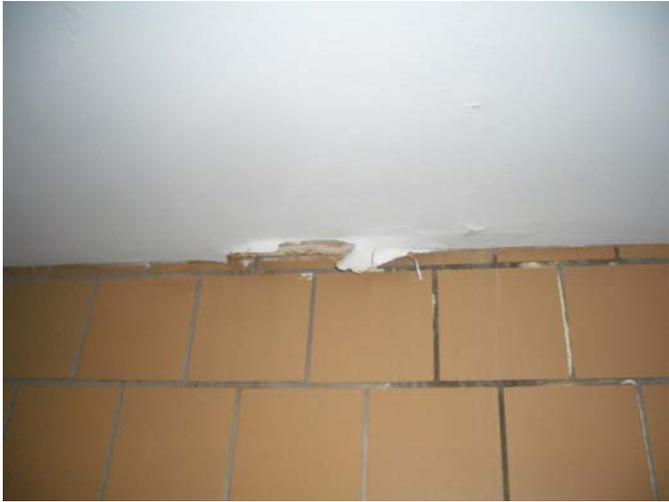
R-8 Leak area at terrace of Support building
