CITY OF
PITTSBURGH
FACILITY ANALYSIS REPORT

South Side Market House
1200 Bingham St.
Pittsburgh, Pennsylvania 15203

South Side Market House

1200 Bingham Street
Pittsburgh, PA 15203

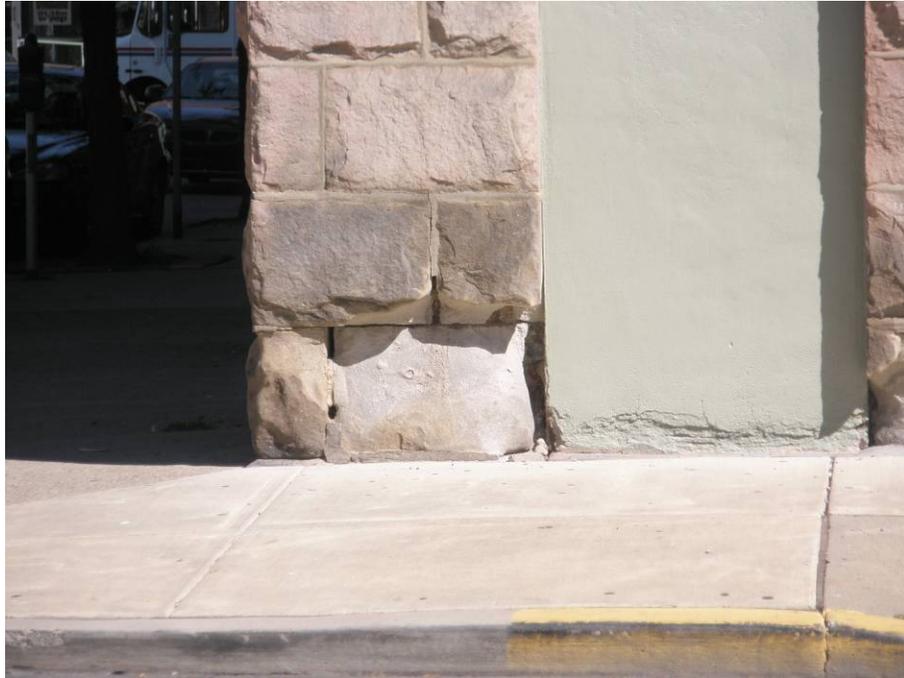
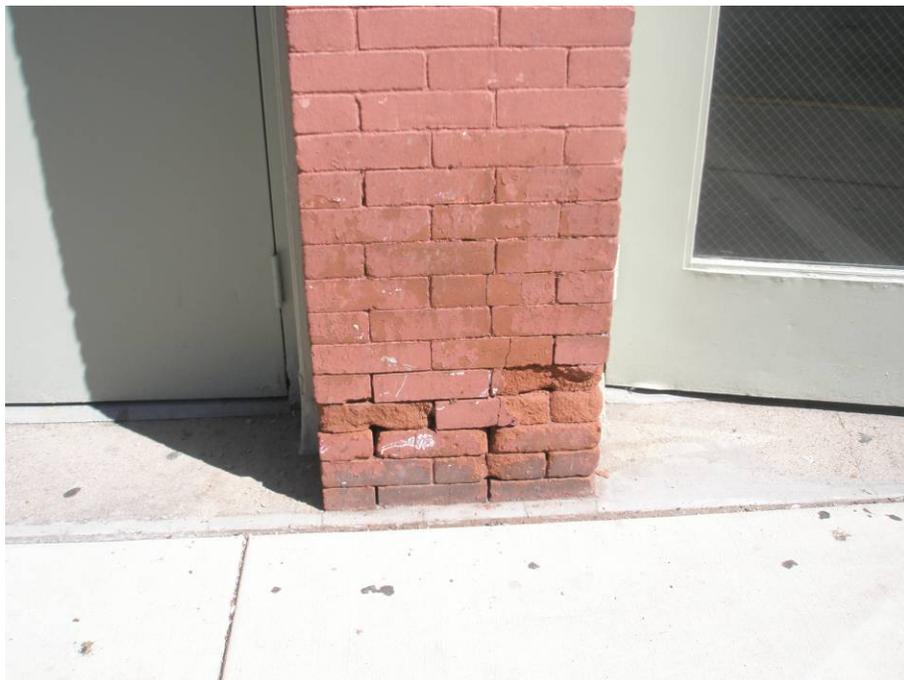
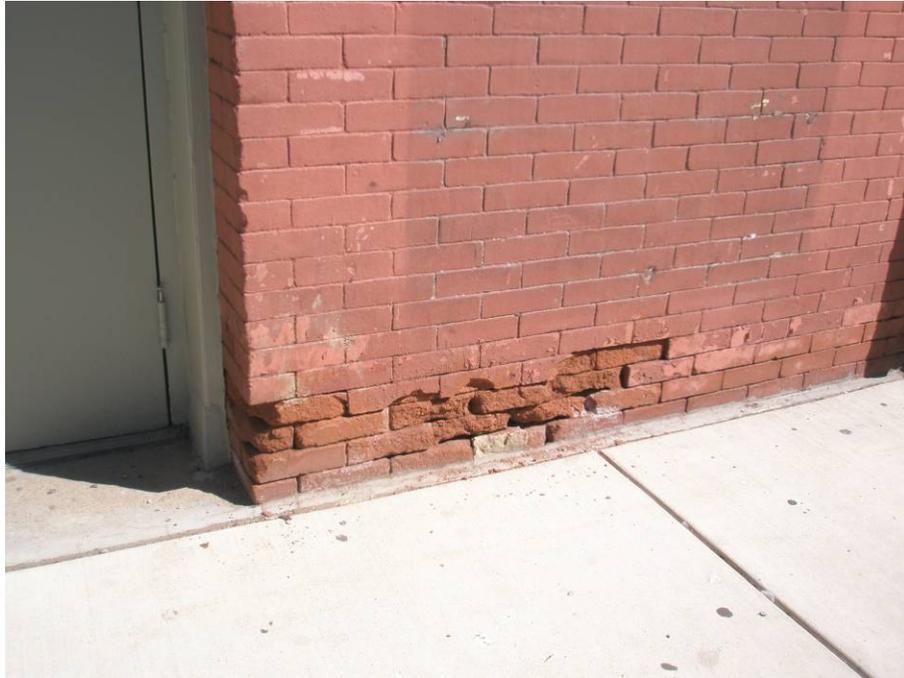
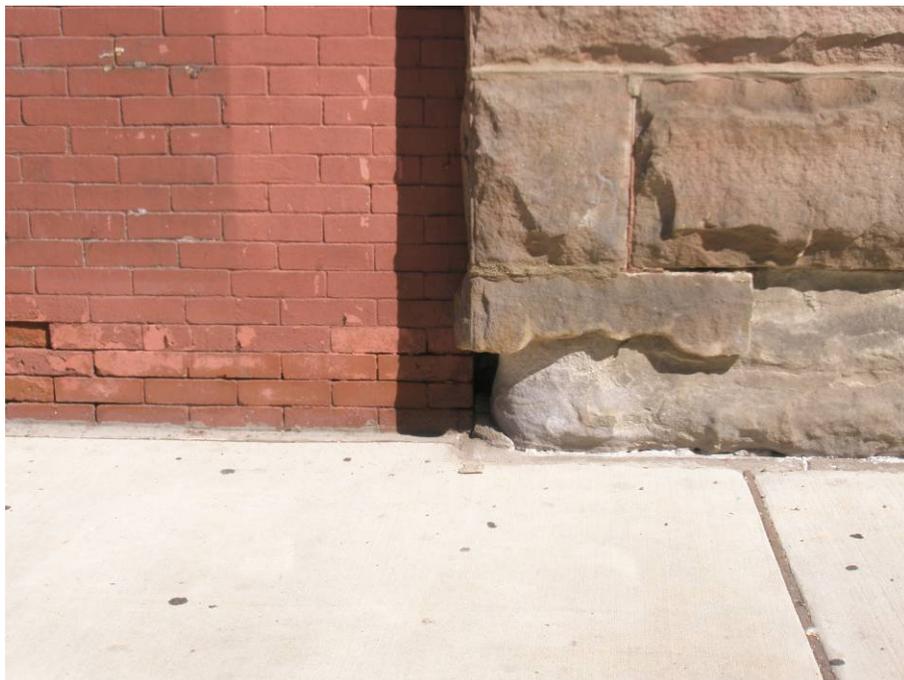
- 1.) On the south face, there are damaged bricks and missing mortar at the base of the piers between the entry doors, and missing stone mortar on the northeast and northwest corners. Recommend replacing bricks and repointing mortar. (1 to 5 yrs) **(Photos S1, S2, S3, & S4)**

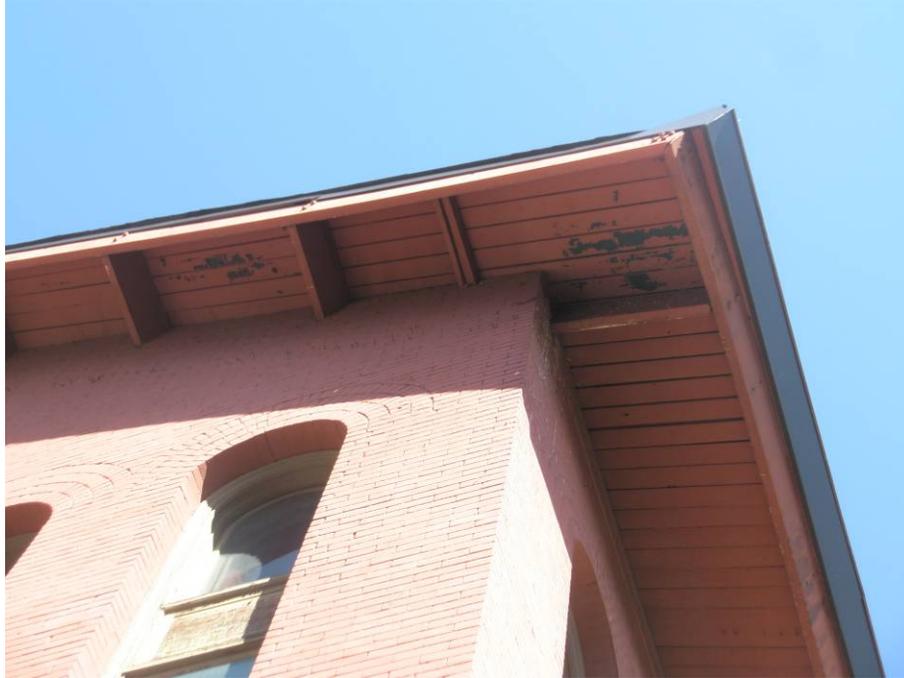
Photo S5

- 2.) On the soffit of the southeast corner eave of the roof, there is peeling paint exposing the roof decking. Recommend repainting the exposed areas. (1 to 5 yrs) **(Photo S5)**

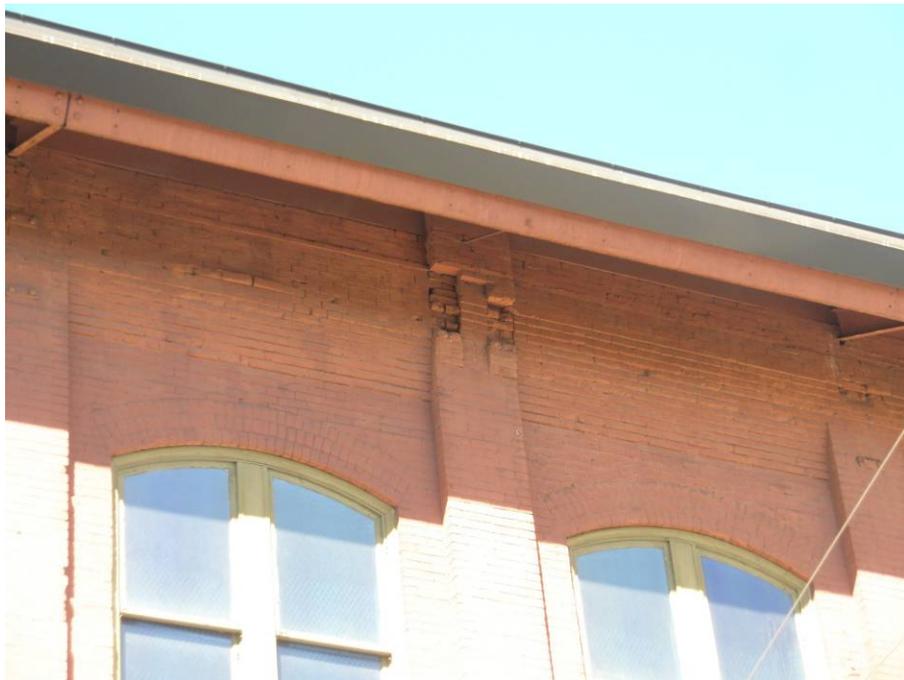
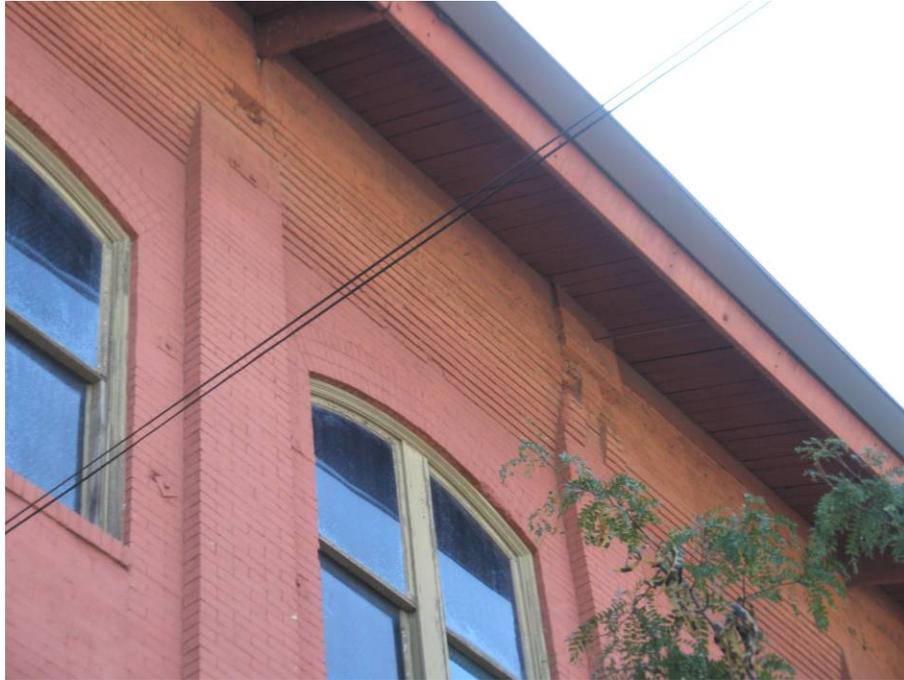
- 3.) On the east and west faces, near the eave, there are three brick pier locations that are missing bricks. Recommend rebuilding missing bricks. (1 to 5 yrs) **(Photos S6 & S7)**

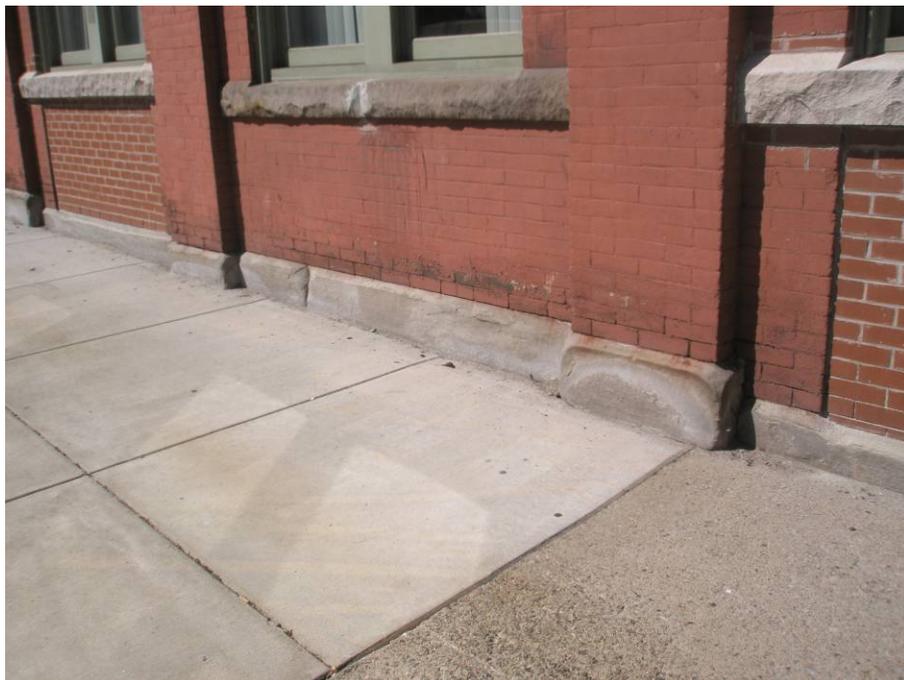
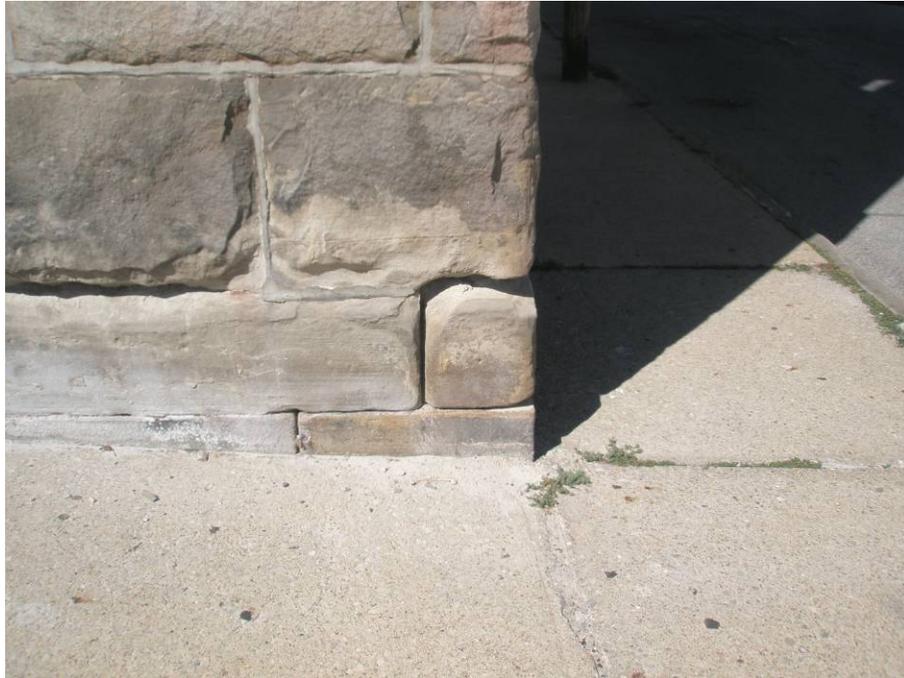
- 4.) On the east face, there are damaged bricks and missing mortar and missing stone mortar at the base of the elevation along its length. Recommend replacing bricks and repointing mortar. (1 to 5 yrs) **(Photos S8, & S9)**

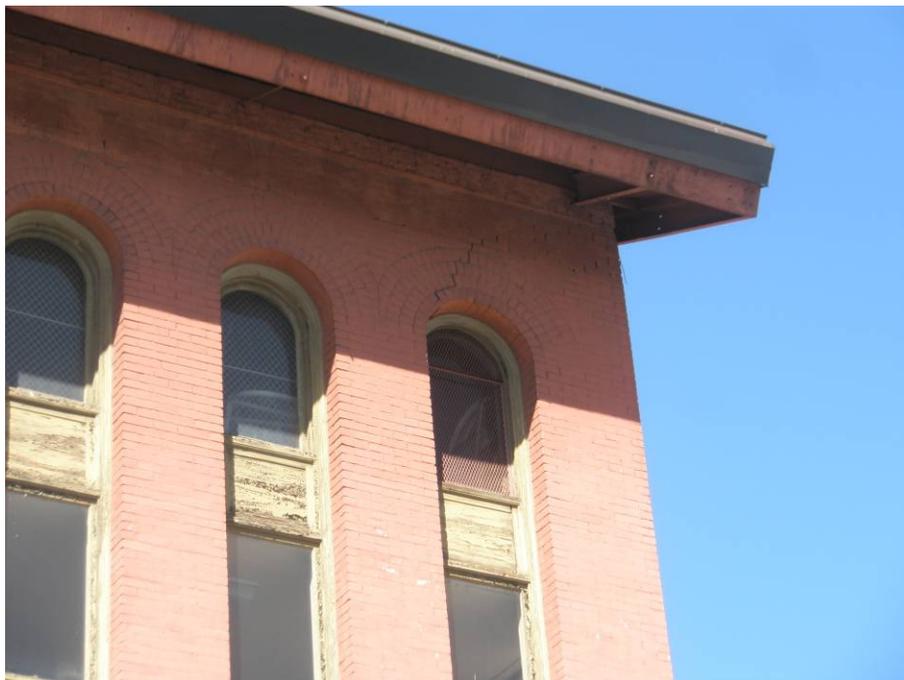
Photo S10

- 5.) On the east face, there is a crack above the window at the northeast corner. Recommend grouting and sealing crack. (1 yr) **(Photo S10)**
- 6.) On the north face, there are damaged bricks and missing mortar and missing stone mortar at the base of the elev. along its length. Recommend replacing bricks and repointing mortar. (1 to 5 yrs) **(Photos S11, S12, S13, & S14)**

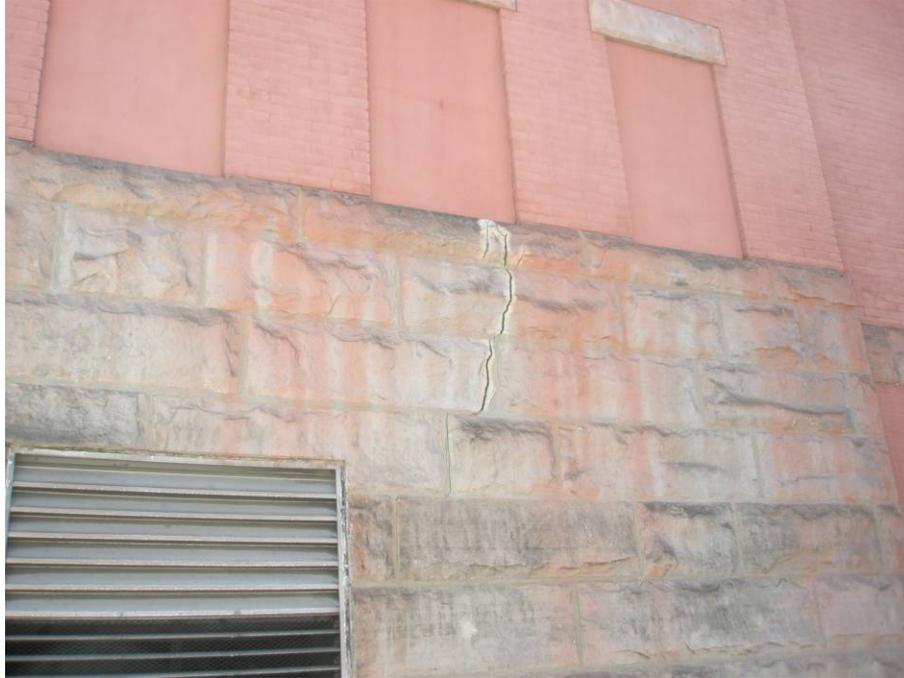
Photo S15

- 7.) On the north face, there is a crack in the stone base of the wall, that appears to have been caulked previously. Recommend grouting and sealing the crack. (1 yr) **(Photo S15)**

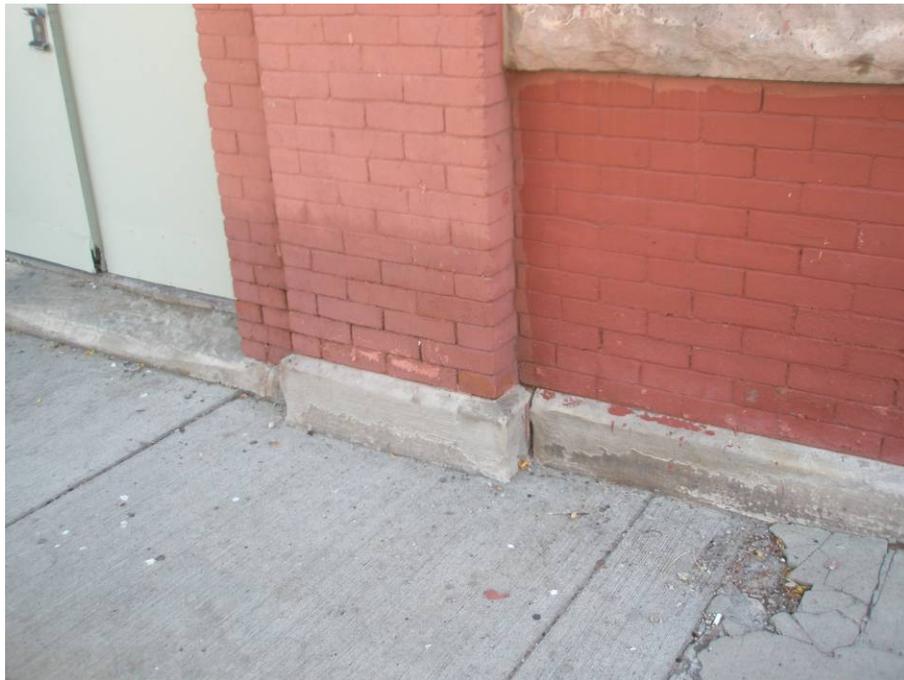
Photo S16

- 8.) On the west face, there are damaged bricks and missing mortar and missing stone mortar at the base of the elev. along its length. Recommend replacing bricks and repointing mortar. (1 to 5 yrs) **(Photo S16)**

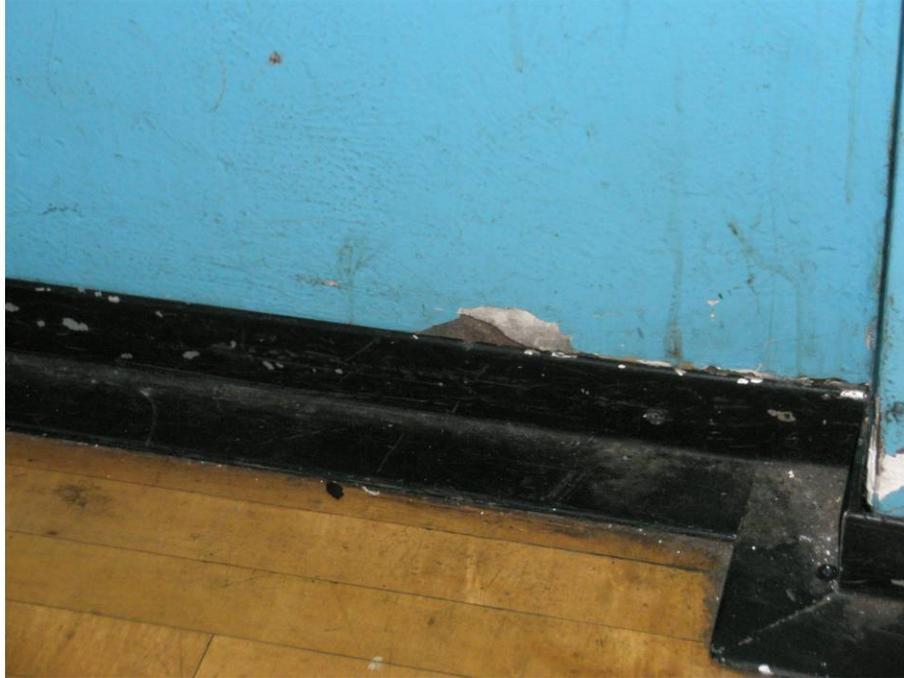
Photo S17

- 9.) In the 2nd floor gymnasium, there are several locations along the base of the wall, that have damaged plaster or drywall. Recommend repairing damaged plaster. (1 to 5 yrs) **(Photo S17)**

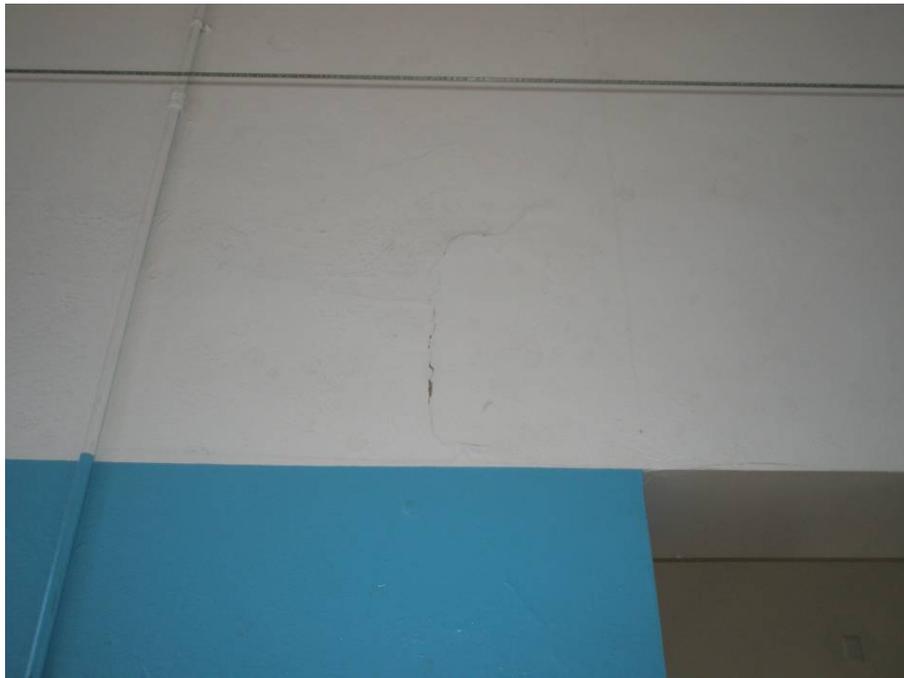
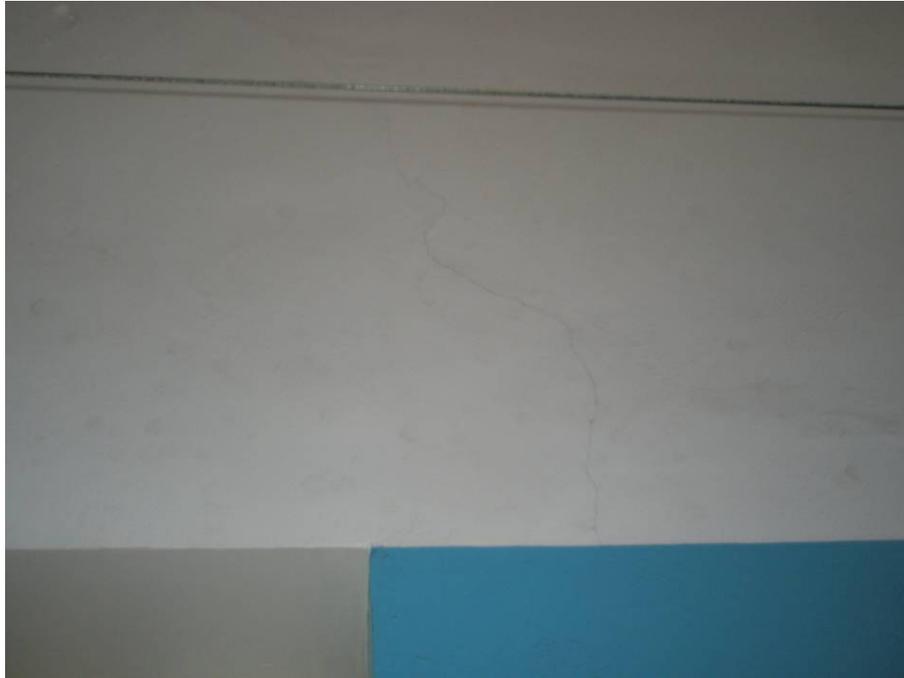
- 10.) At the 2nd floor opening on the south end of the gym court, there are cracks originating at the top corners of the jambs. Recommend grouting cracks and repairing plaster. (1 to 5 yrs) **(Photos S18 & S19)**

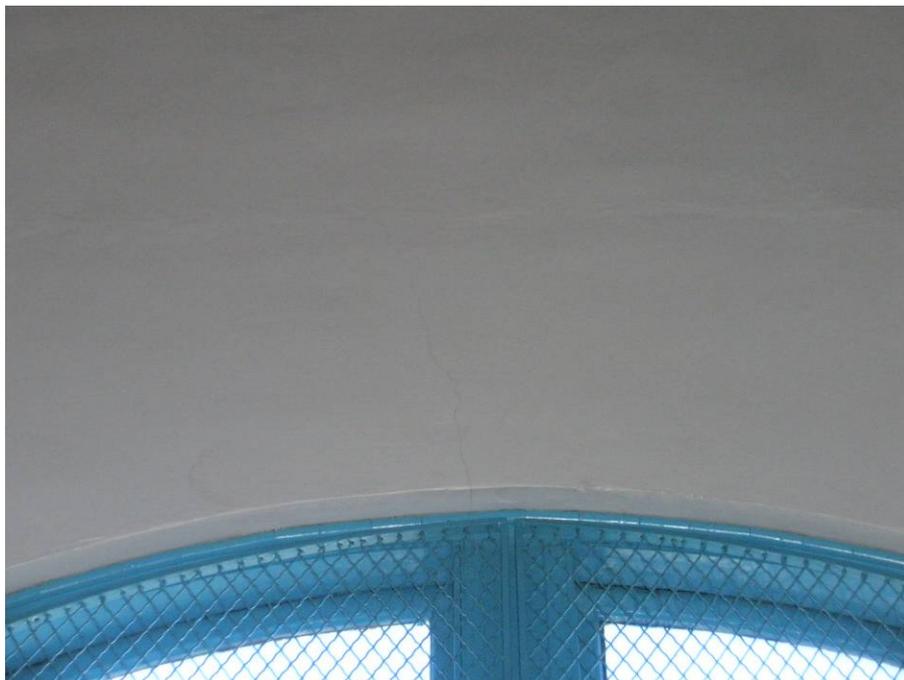
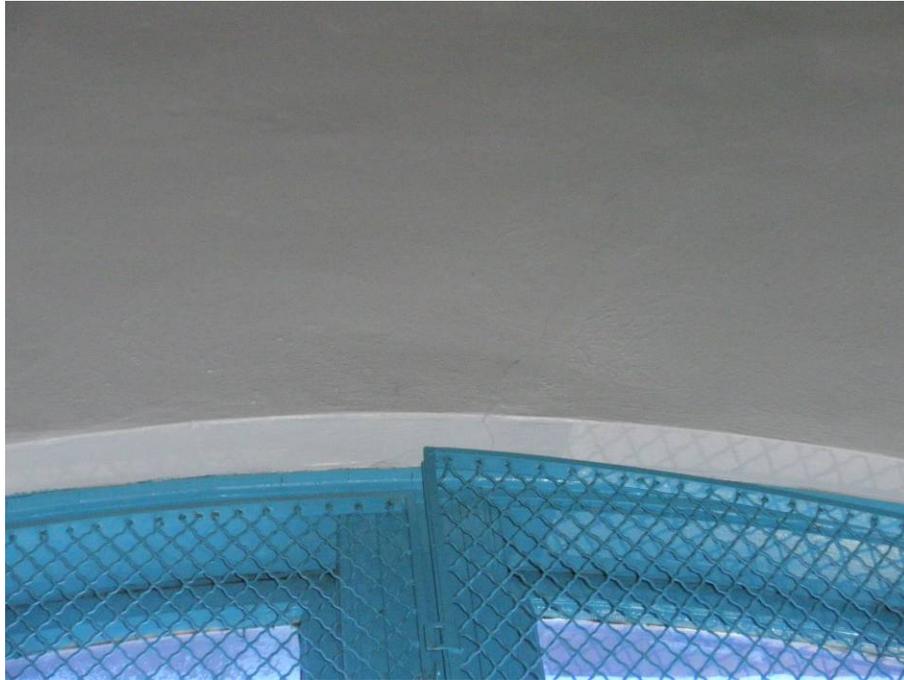
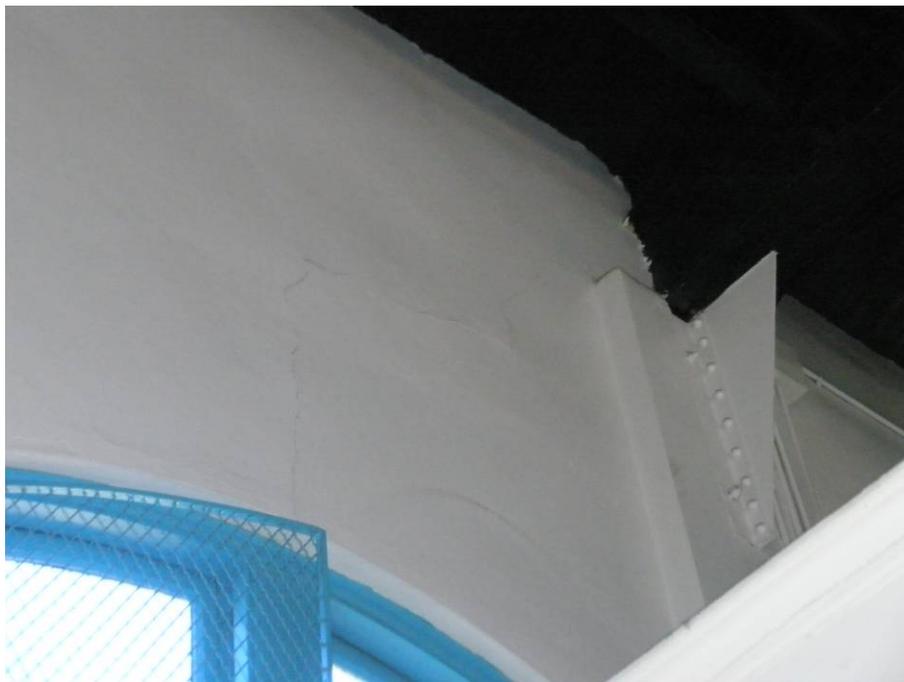
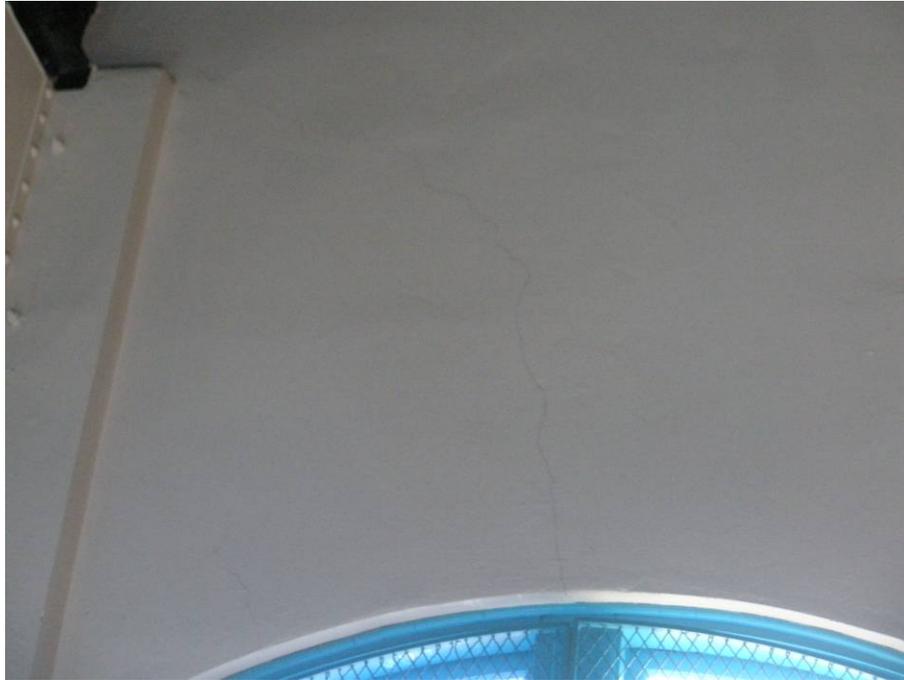
- 11.) Above thirteen windows around the 2nd floor gymnasium, there are cracks in the plaster and presumably the brick masonry wall. Recommend grouting cracks and repairing plaster. (1 to 5 yrs) **(Photos S20 through S25)**

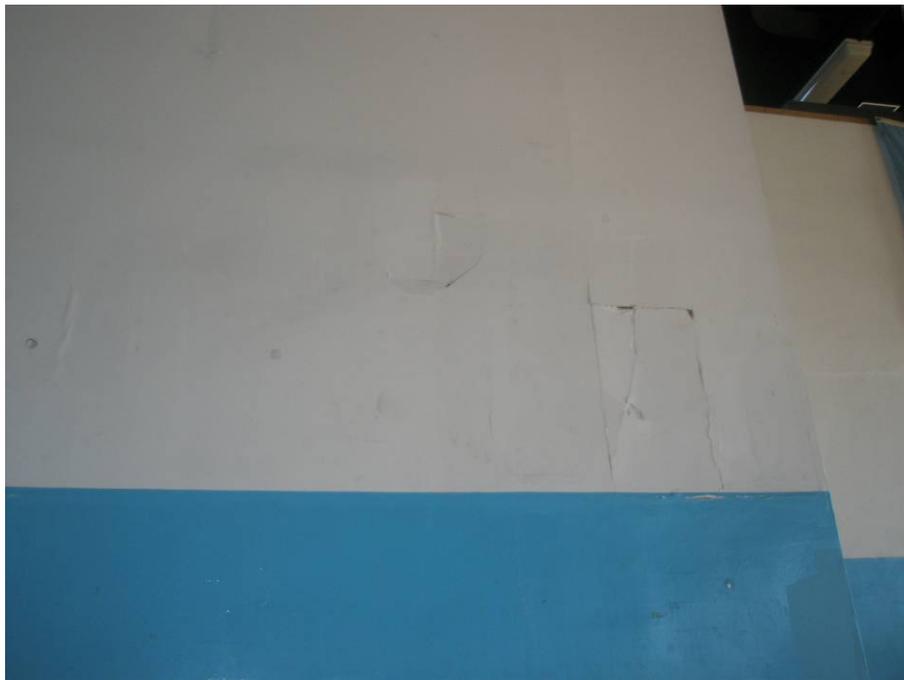
Photo S26

- 12.) There is damaged drywall in the wall at the north end of the gymnasium. Recommend replacing damaged drywall. (1 to 5 yrs) **(Photo S26)**
- 13.) There is damaged and water damaged drywall on the inside of the janitor's closet at the north end of the 2nd floor gymnasium. Recommend repairing drywall. (1 to 5 yrs) **(Photo S27)**

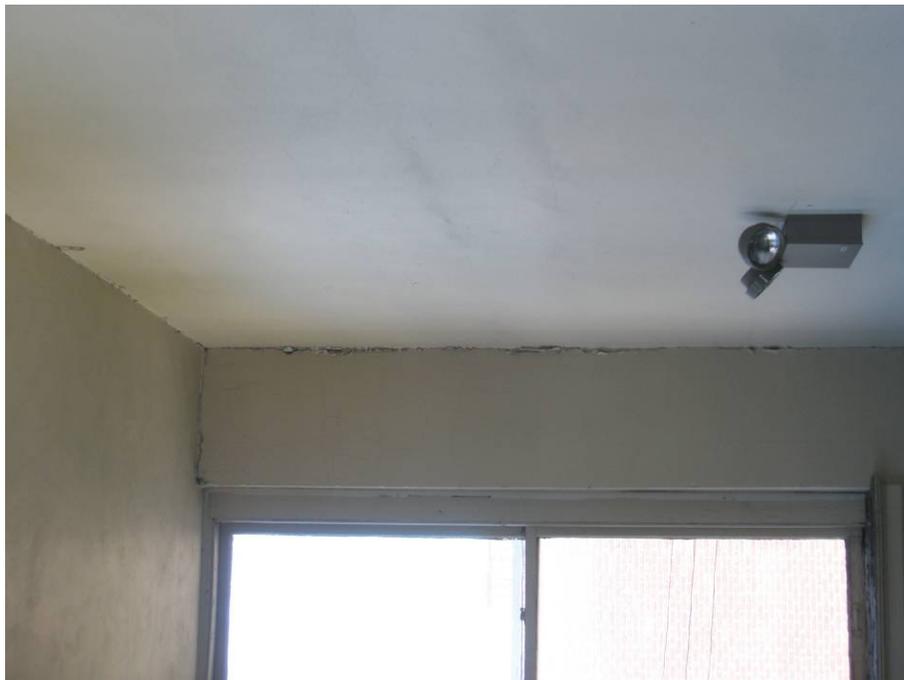
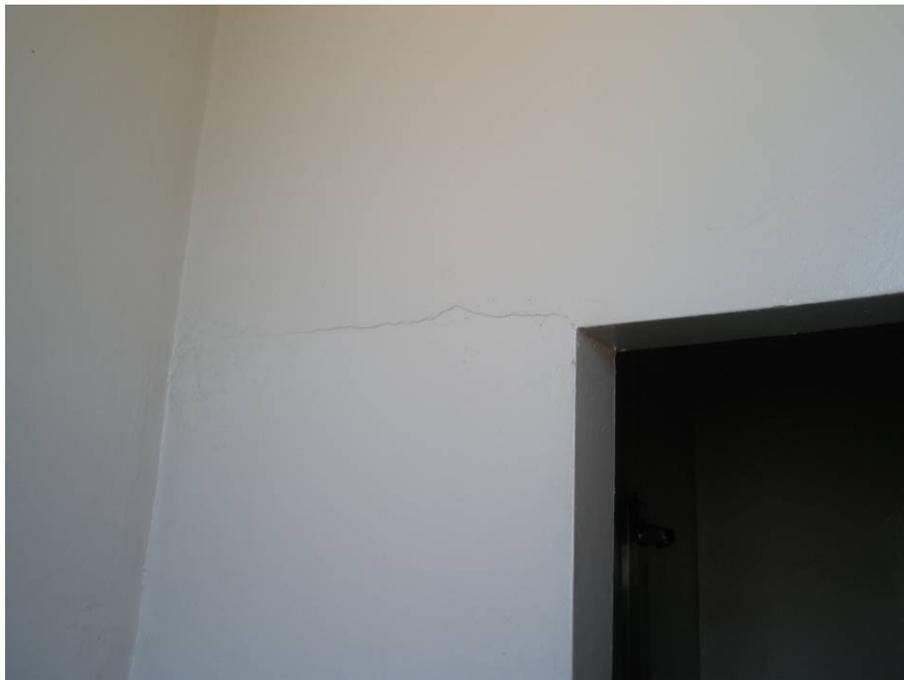
- 15.) There are multiple cracks in the plaster on the walls and ceilings of the 2nd floor men's and women's locker rooms. Recommend repairing cracks. (1 to 5 yrs) **(Photos S29 through S35)**

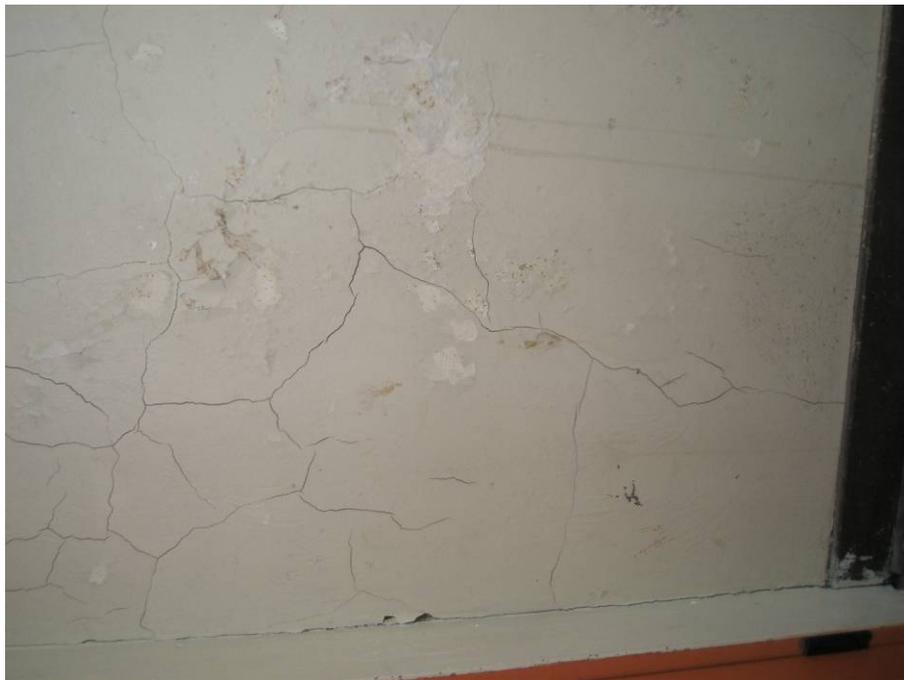
Photo S40

- 16.) There is heaving flooring in the 2nd floor locker rooms. Recommend replacing flooring and floor sheathing. (1 to 5 yrs) **(Photo S36)**
- 17.) In the northwest stairwell, there is significant cracking of plaster and paint peeling. Recommend grouting the cracks in the brick backup and repairing plaster and paint. (1 to 5 yrs) **(Photos S37 through S41)**

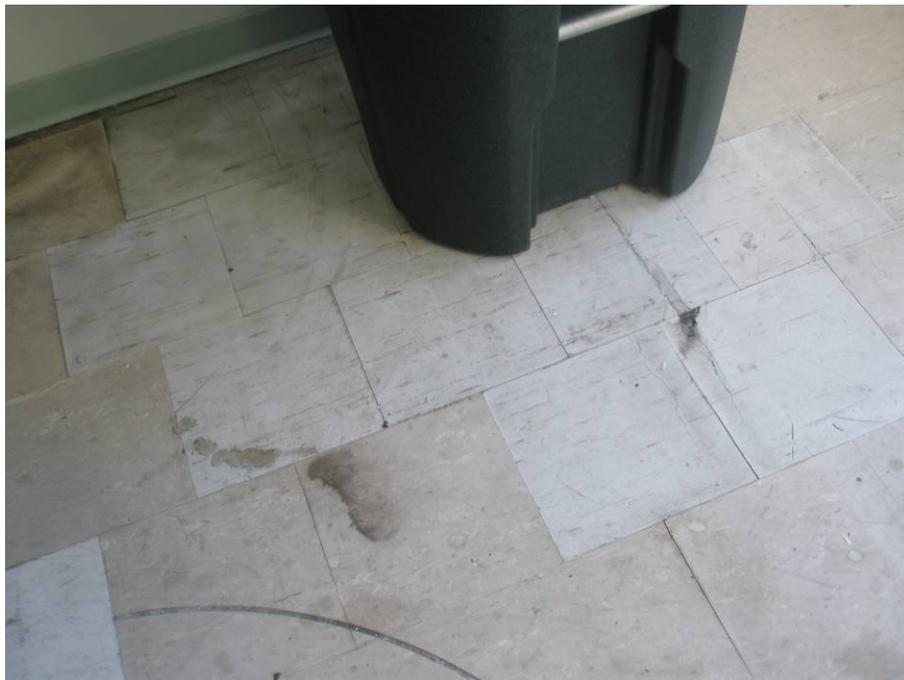
Photo S42

- 18.) There is damaged and heaving flooring at the 2nd floor south entry area to the gymnasium. Recommend replacing flooring and floor sheathing. (1 to 5 yrs) **(Photos S42 and S43)**

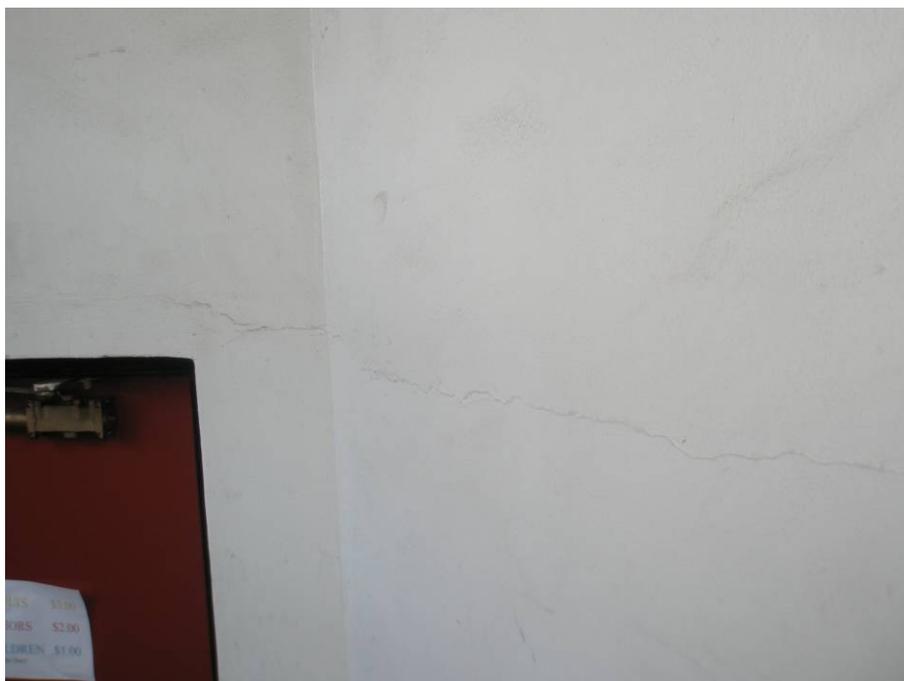
Photo S46

- 19.) There are cracks in the walls of the southeast stairwell. Recommend grouting cracks in brick backup and repainting and repairing plaster. (1 to 5 yrs) **(Photos S44, S45, & S46)**
