Planning Commission Briefing for demolition and consolidation at Boulevard, First and Market
Submitted June 9, 2020

ASSESSMENT OF BUILDING CONDITIONS

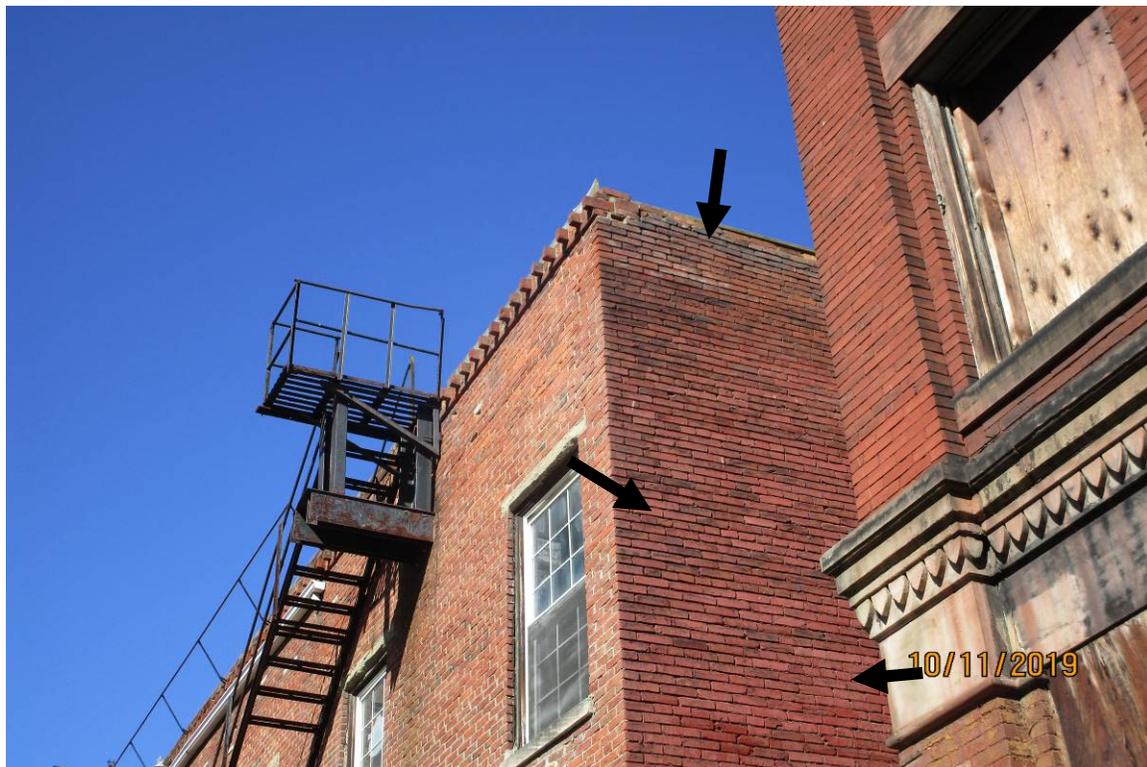
PHOTOGRAPH #7
The right wall of 100-102 Market Street.

PHOTOGRAPH #8
The right rear corner of the 2-story portion of the building. Note the deteriorated and missing mortar in the joints of the brick work over the entire area of the rear brick wall shown.

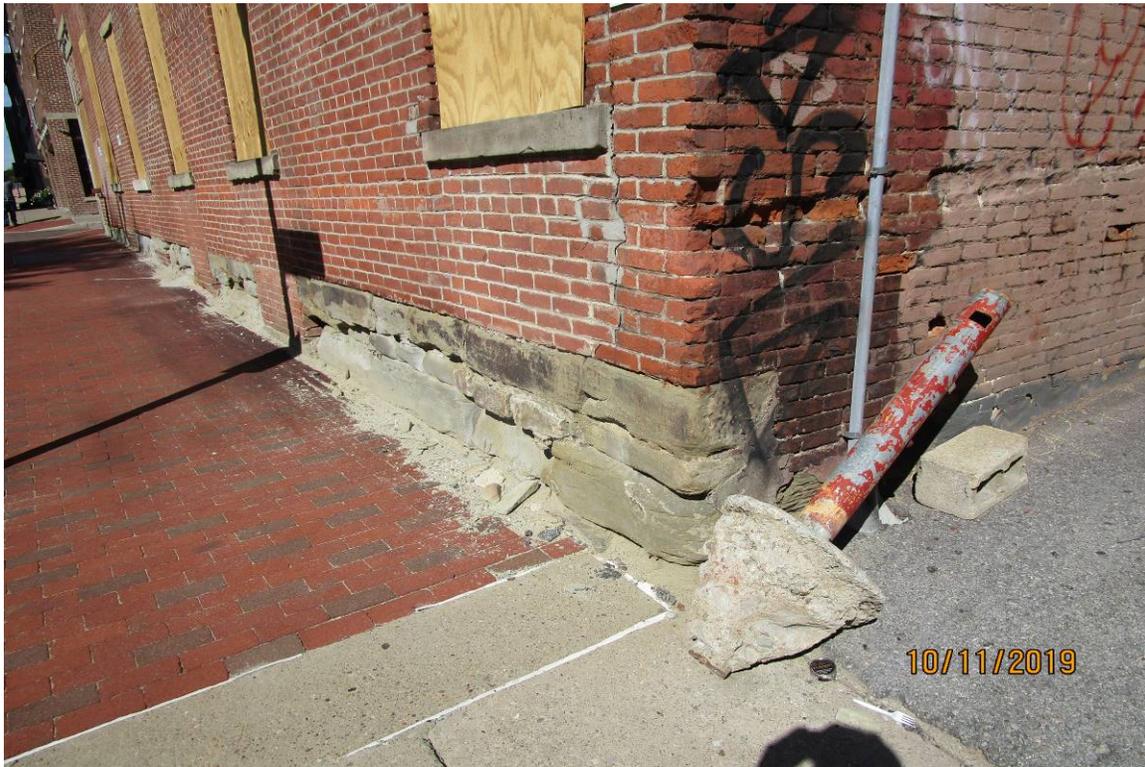
PHOTOGRAPH #9

Extremely weathered foundation stones along the sidewalk and under the right brick bearing wall of the 2-story portion of the building. Note the weathered soft bricks and missing mortar in the brick work of the rear bearing wall.

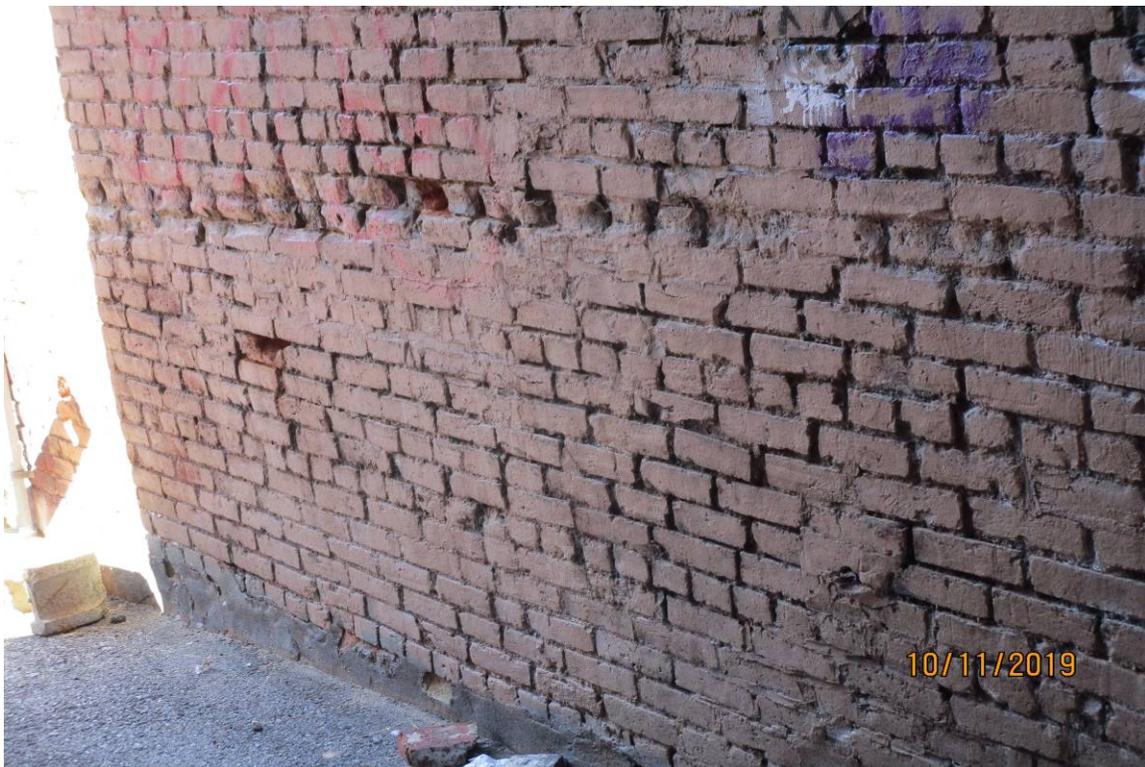
PHOTOGRAPH #10

The base of the rear wall of the 2-story portion of the building near the right end of the wall. See Photograph #9. Note the deteriorated and missing mortar in the joints of the brick work over the entire area of the rear brick wall shown.

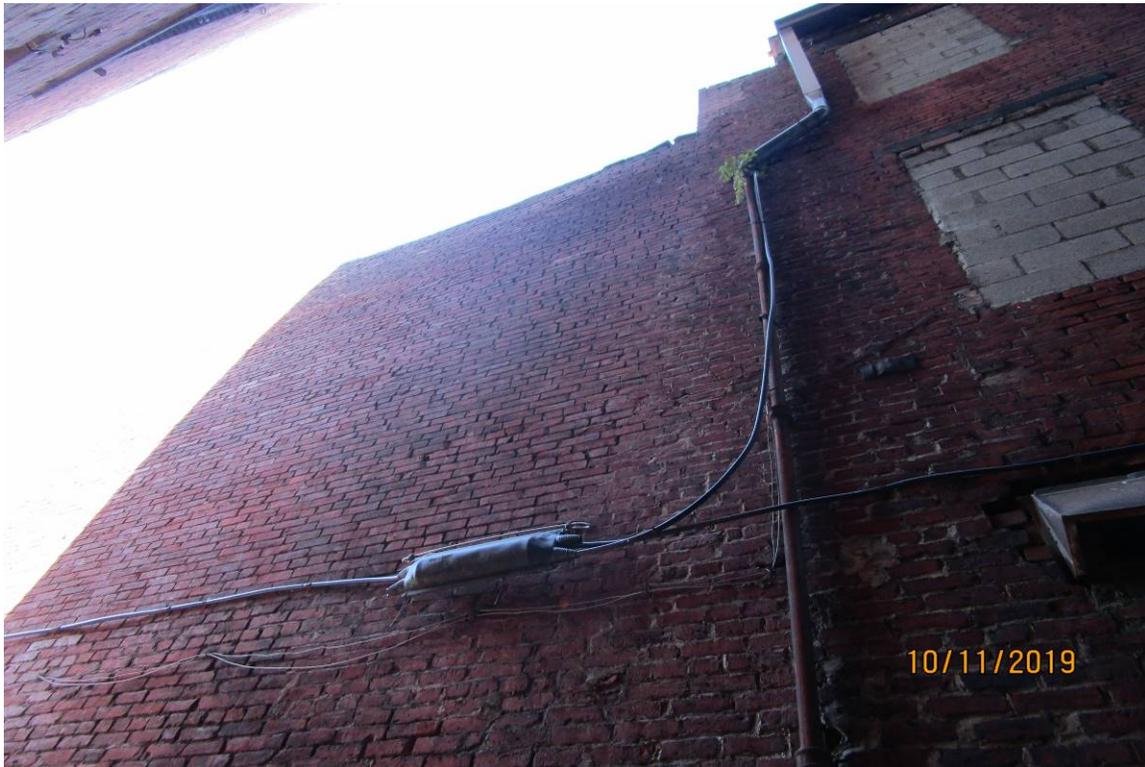
PHOTOGRAPH #11

The upper portion of the rear wall of the 2-story portion of the building. Note the deteriorated and missing mortar in the joints of the brick work over the entire area of the rear brick wall shown. See Photograph #8.

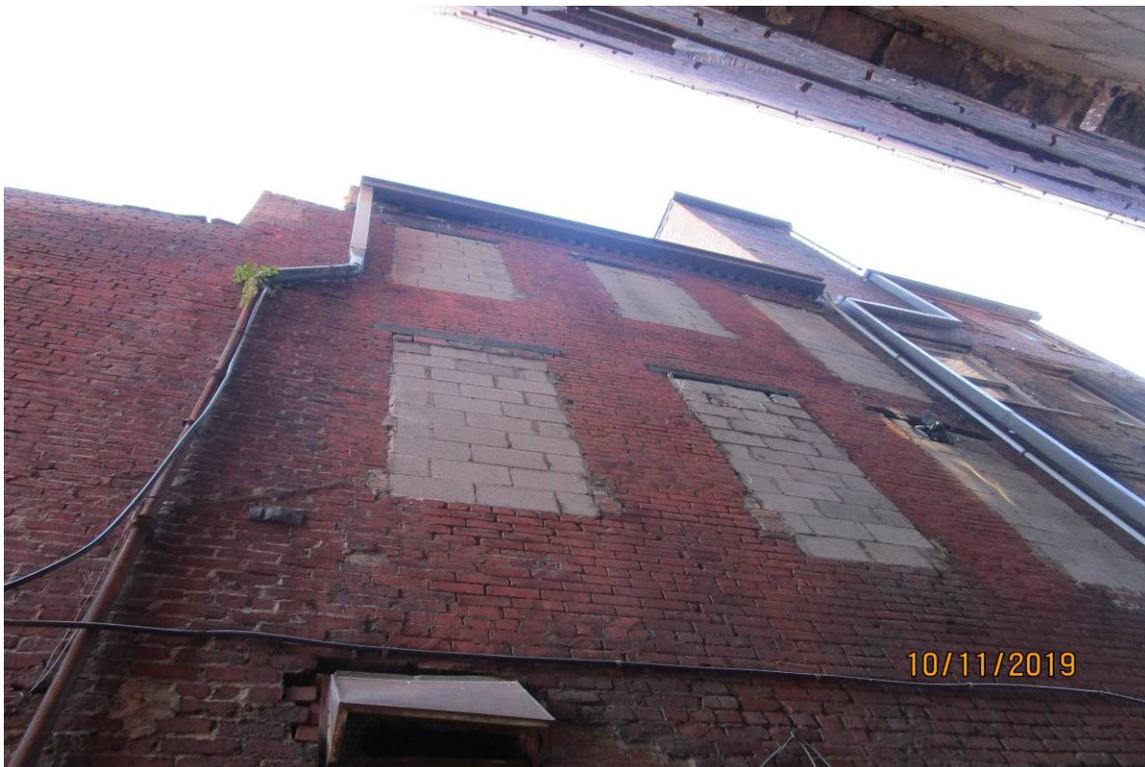
PHOTOGRAPH #12

The rear wall of the 3-story portion of the building. Note the deteriorated and missing mortar in the joints of the brick work over the entire area of the rear brick wall shown.

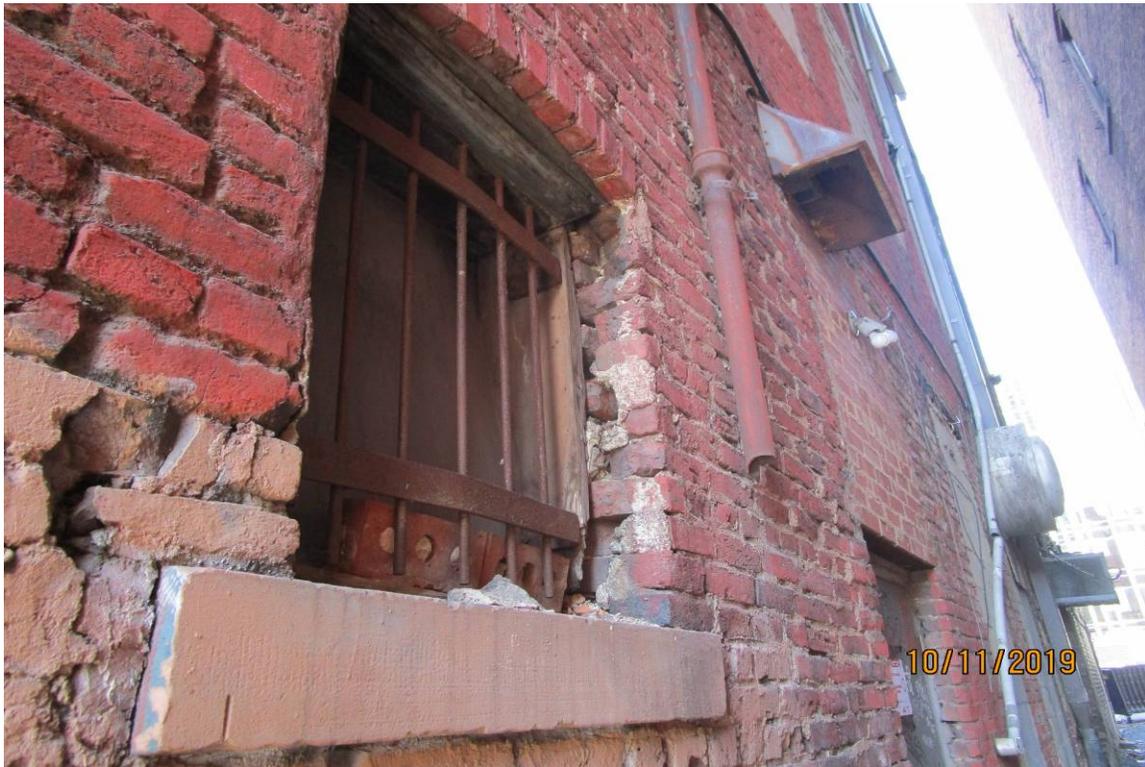
PHOTOGRAPH #13
Deteriorated mortar and joints without mortar at a window in the 3-story portion of the building.

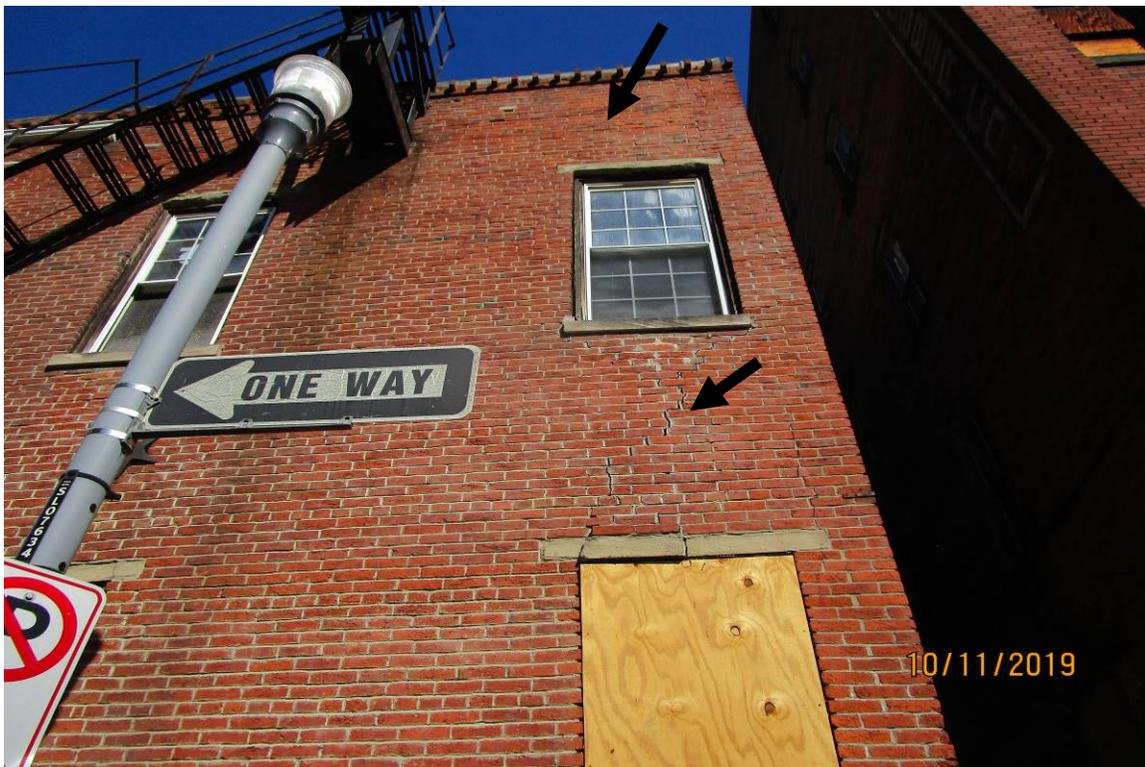
PHOTOGRAPH #14
Deteriorated mortar, missing mortar, deteriorated brick and cracking in the brick work of the right bearing wall.

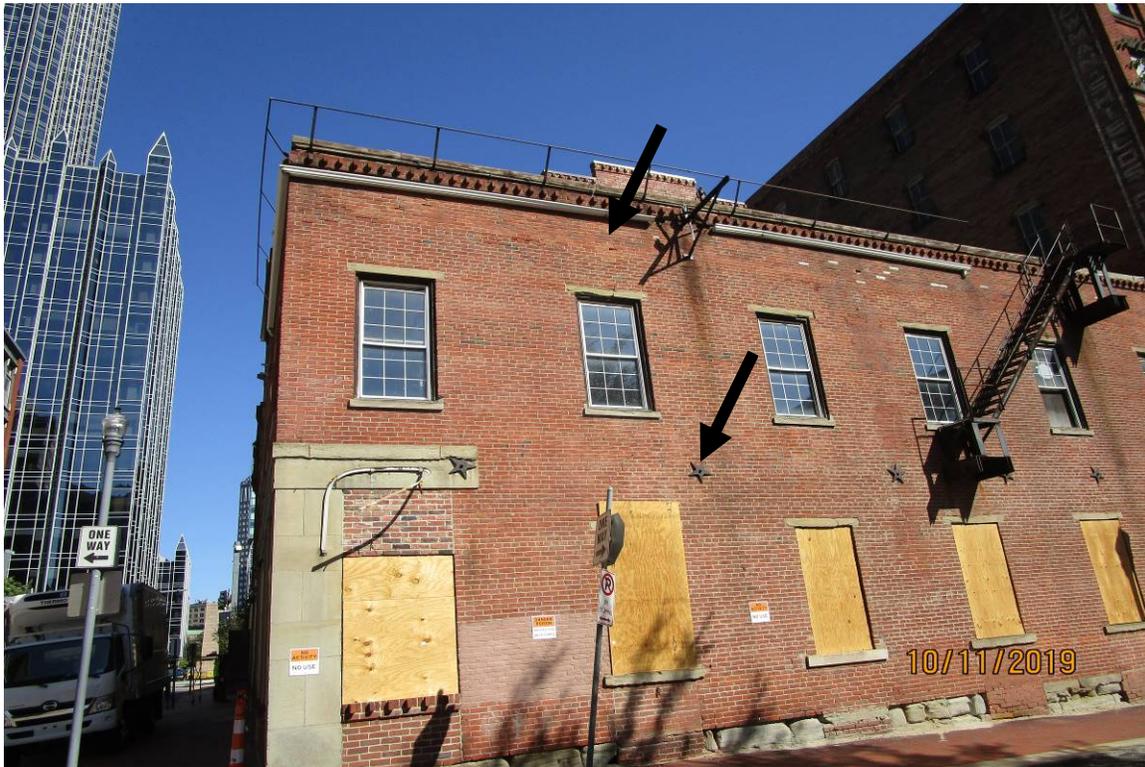
PHOTOGRAPH #15

Deteriorated mortar, missing mortar, and deteriorated brick in the brick work of the right bearing wall. Note the severe deterioration of the stones along the top of the foundation under the wall. Note the "star bolts" installed in the past to stabilize the brick bearing wall.

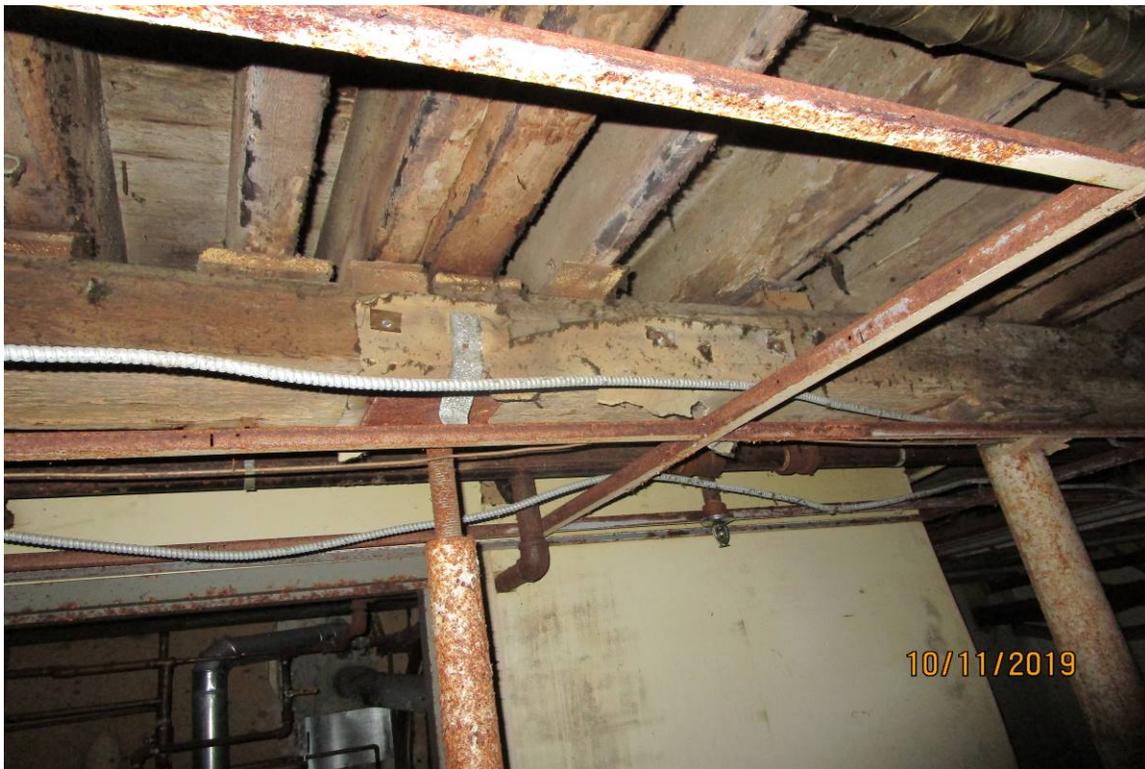
PHOTOGRAPH #25

A mixture of steel and wood members that were installed in the past to provide required structural support of an indeterminate load capacity.

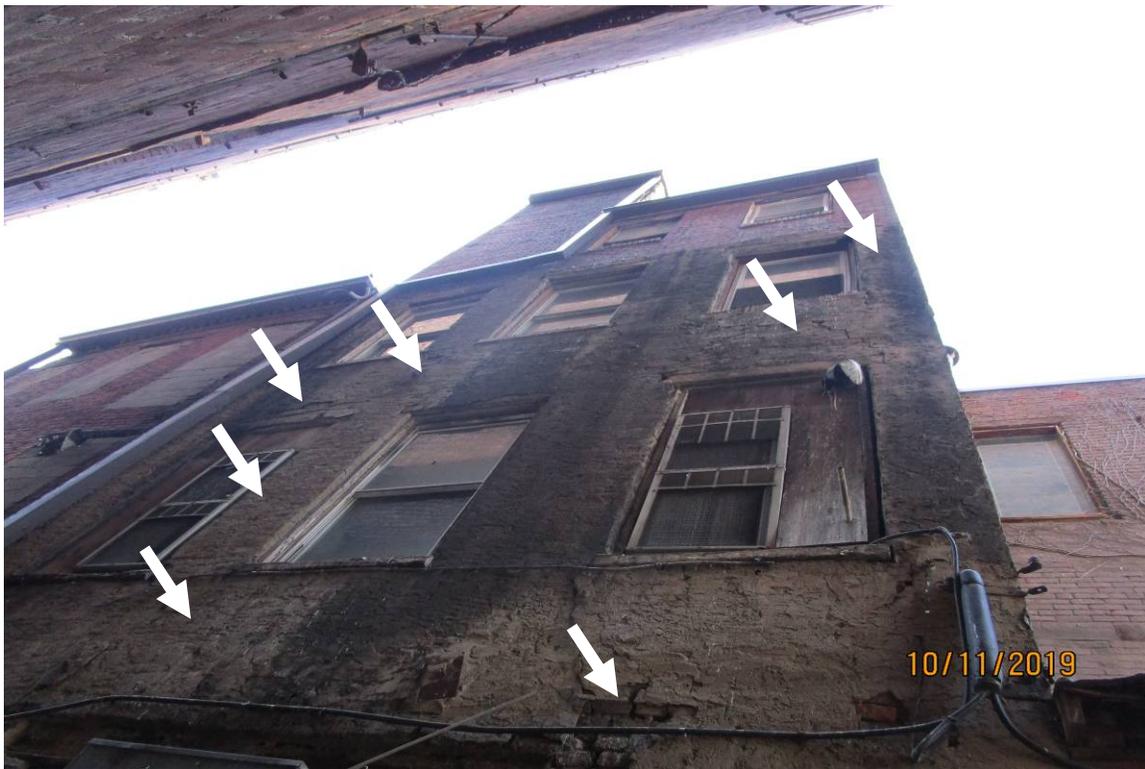
PHOTOGRAPH #5

The upper portion of the rear wall. Note the extreme deterioration of the mortar in the joints of the brick work of the entire wall area shown and the missing mortar in the joints. Note the parging covering the very deteriorated brick and mortar in some areas of the wall.

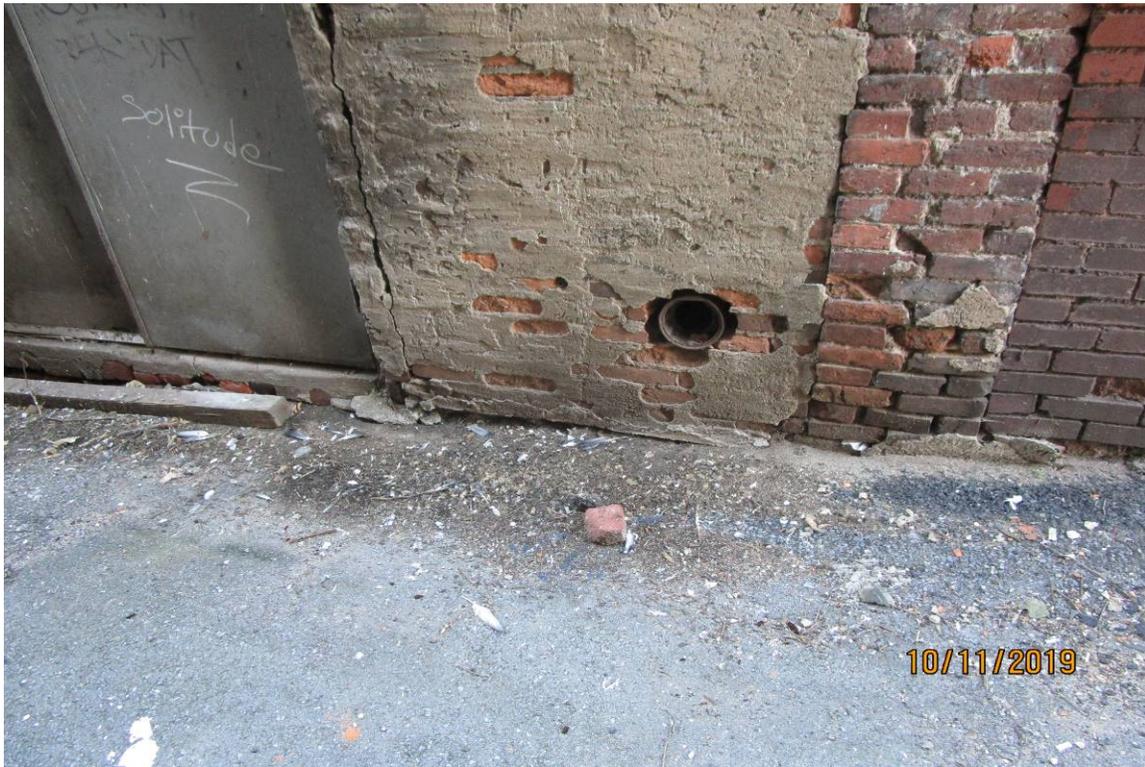
PHOTOGRAPH #9
Extremely deteriorated and missing mortar under the parging applied to the face of the wall in the past.

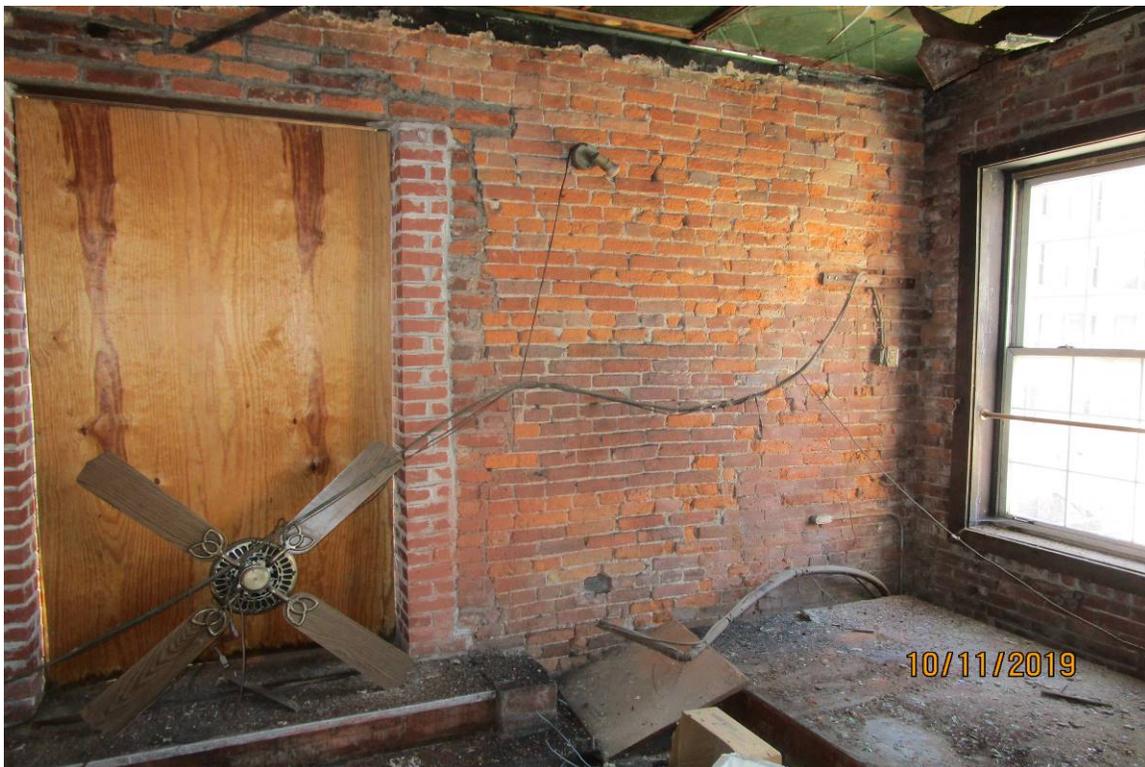
PHOTOGRAPH #10
A large section of brick bearing wall. Note the high percentage of low strength orange-colored brick (salmon brick/pumpkin brick) in the wall.

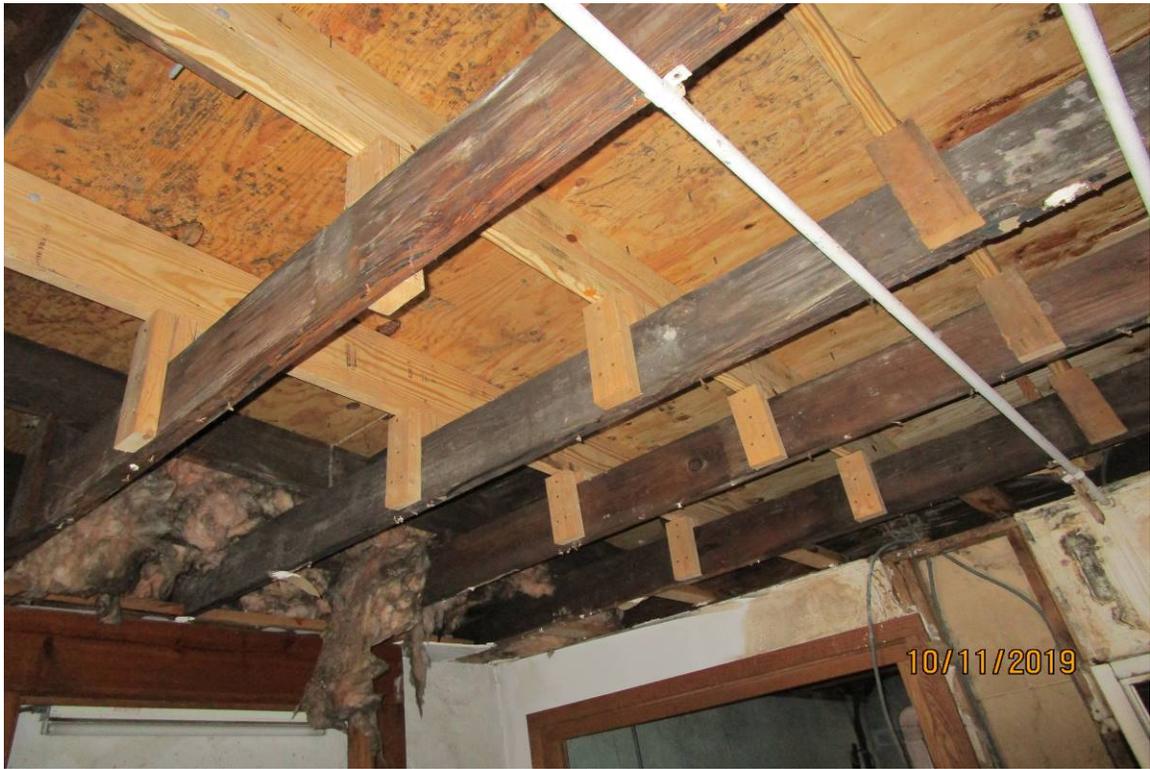
PHOTOGRAPH #13
An area of repaired roof sheathing and added wood roof joists.

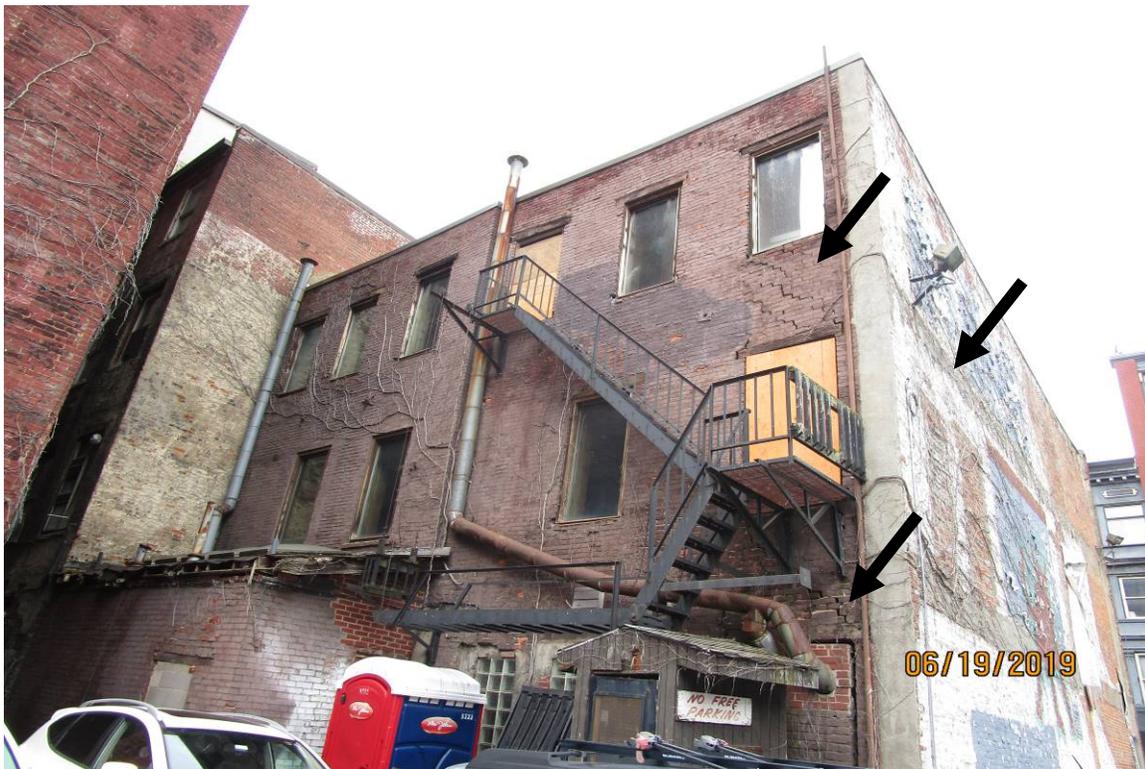
PHOTOGRAPH #6
Structural damage in the brick construction of the rear wall and left wall of 106-108 Market Street. Note the deteriorated brick work below the 3rd story window and below the fire escape landing on the rear wall, and the extreme inward bowing of the brick work of the left wall. Note the "star bolts" installed in the past to stabilize the rear brick wall.

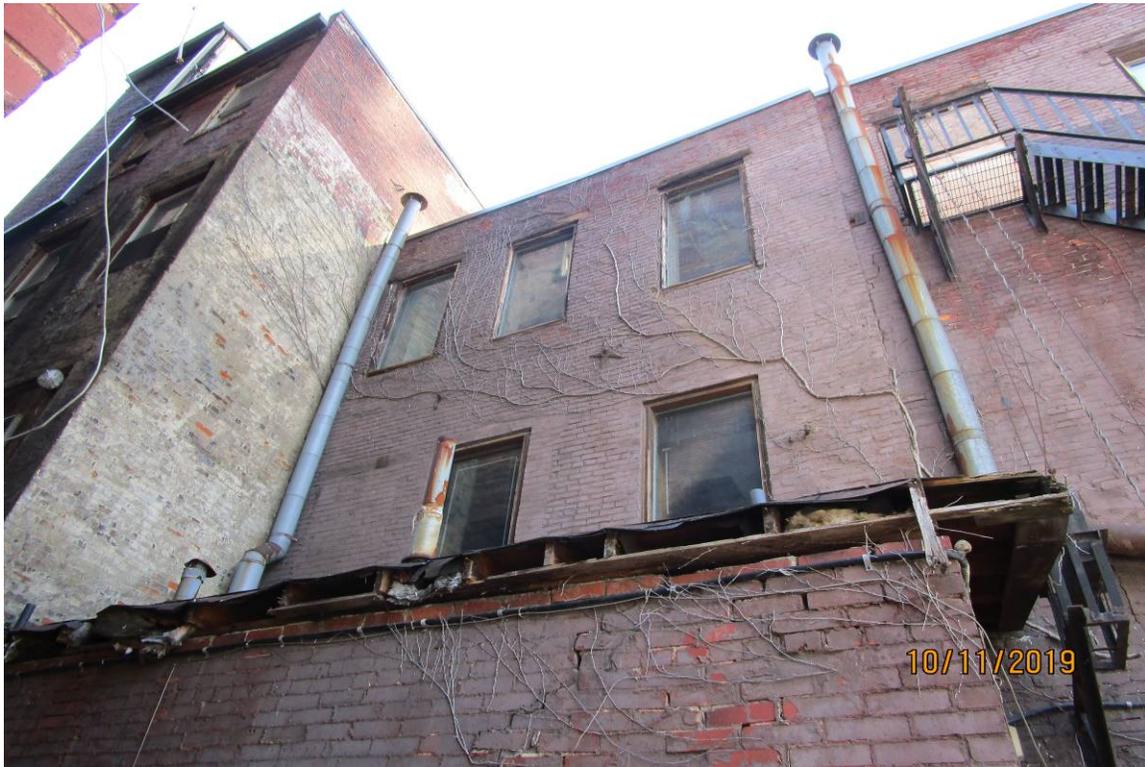
PHOTOGRAPH #7

The right portion of the rear wall of 106-108 Market street and the adjacent left wall of 104 Market Street. Note the "star bolts" installed in the past to stabilize the brick bearing wall.

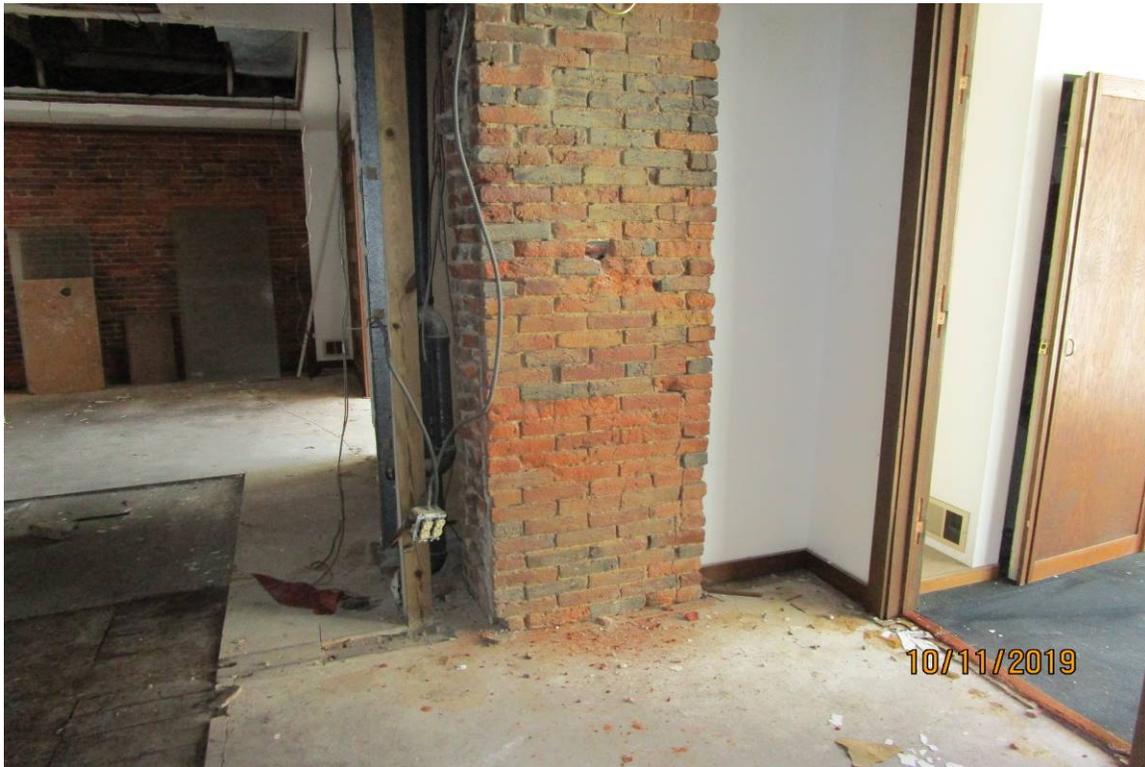
PHOTOGRAPH #12

A visible section of an isolated brick pier. Note the high percentage of low strength orange-colored brick (salmon brick/pumpkin brick) in the pier. Note the advanced deterioration of the mortar in the joints of the brick.

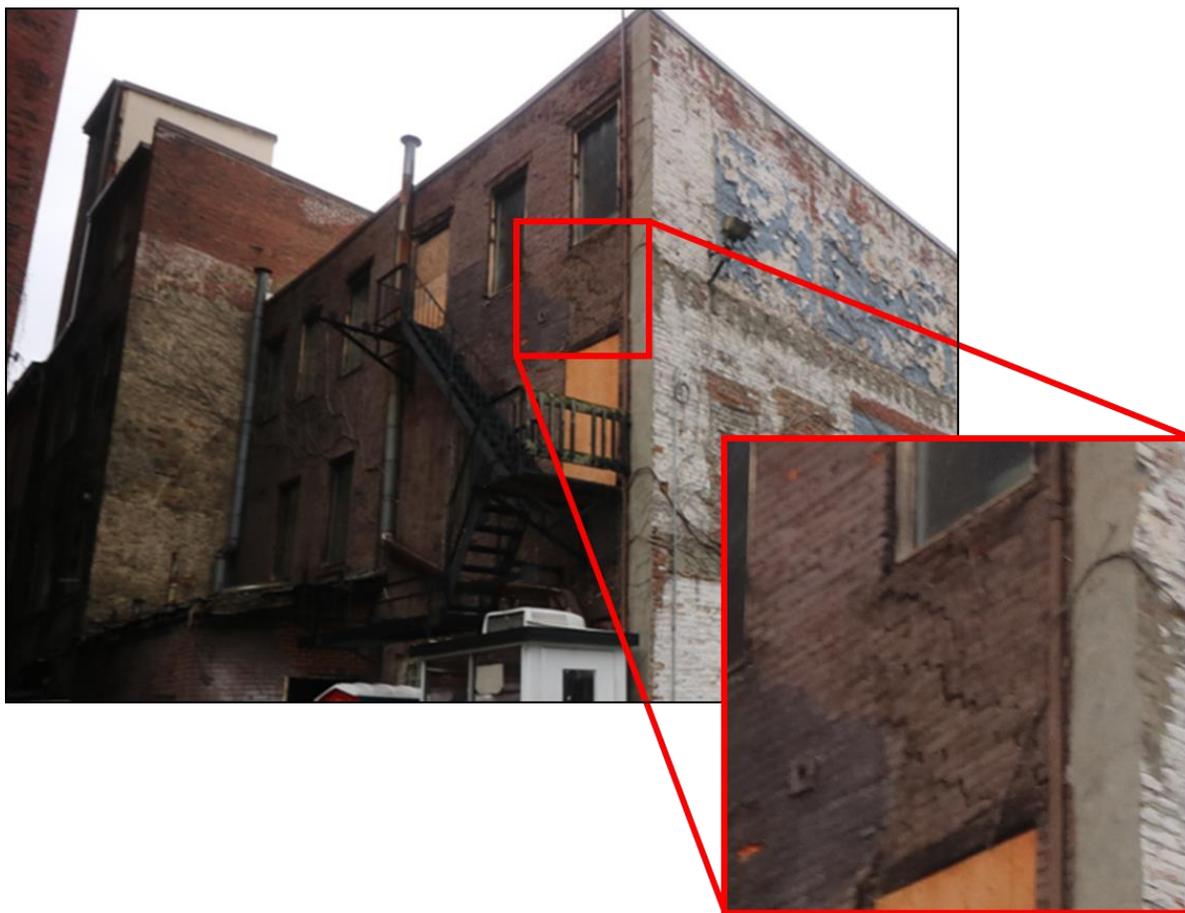
Rear elevation of subject building at 106 Market Street. Note the step cracks in the brick, especially below the third story northwest corner window.

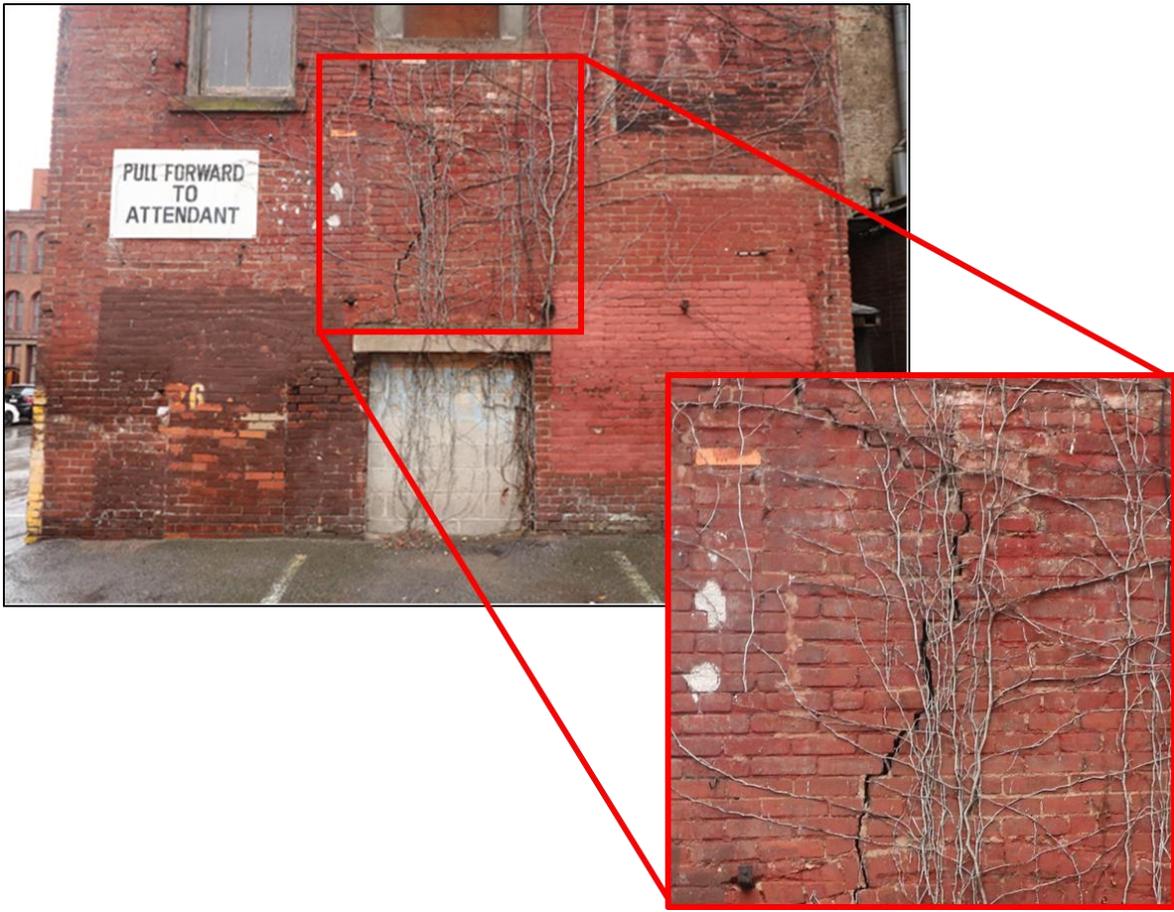
Rear elevation of subject building at 209 First Avenue. Note step cracks in the brick.

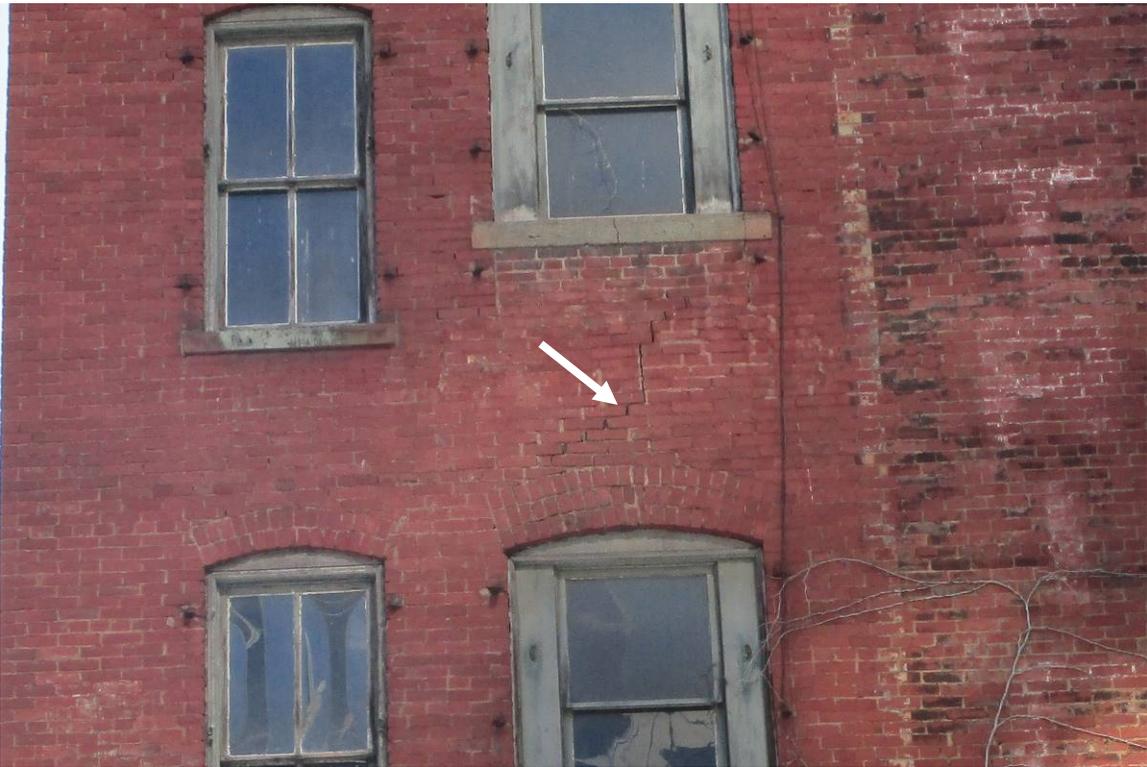
PHOTOGRAPH #9
Cracking in the brick work of the rear wall.

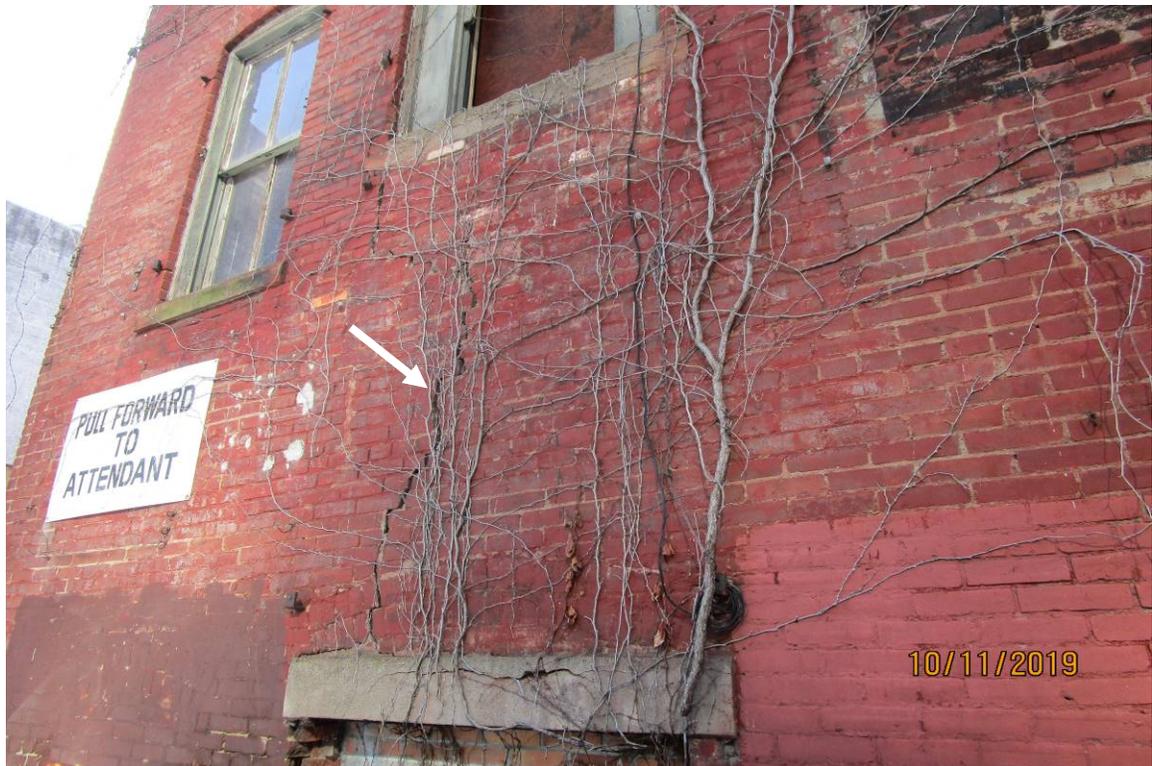
PHOTOGRAPH #10
Cracking in the brick work of the rear wall.

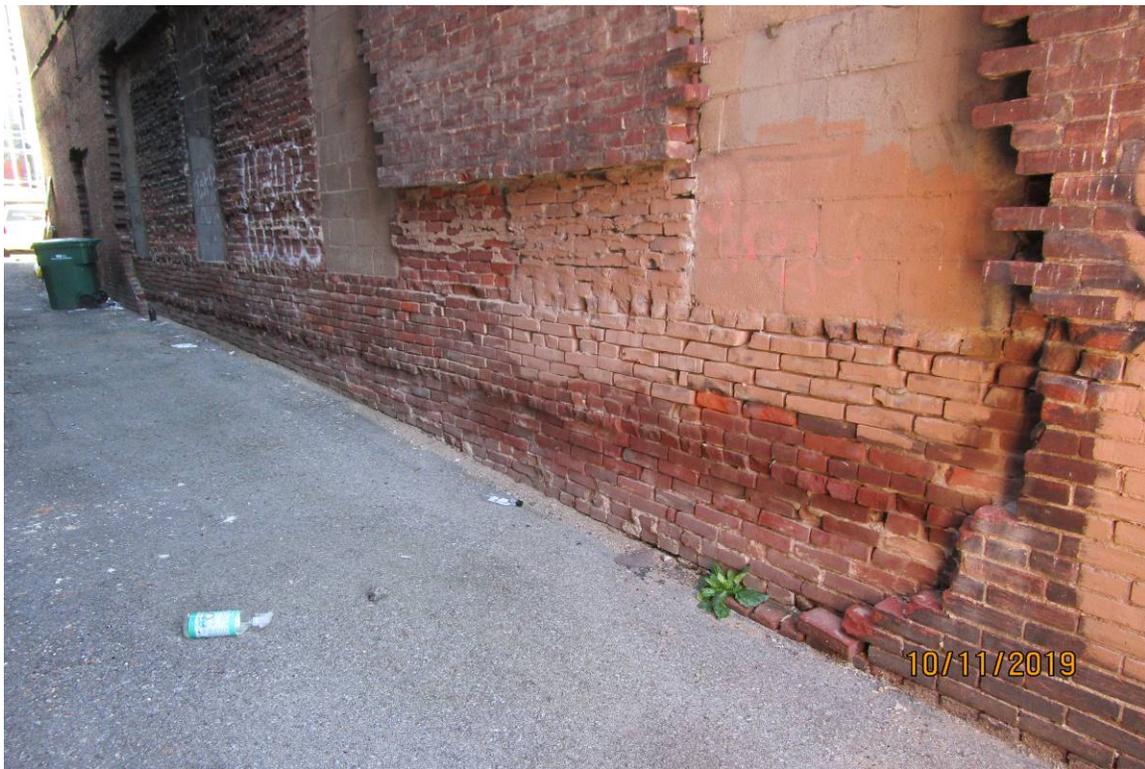
PHOTOGRAPH #11

Looking to the rear along the left wall of the building. The exterior wythe (4" width) of the brick bearing-wall has been removed in this area; exposing the interior wythes of the wall. Note the complete deterioration and absence of mortar in the interior wythes of the bearing wall.

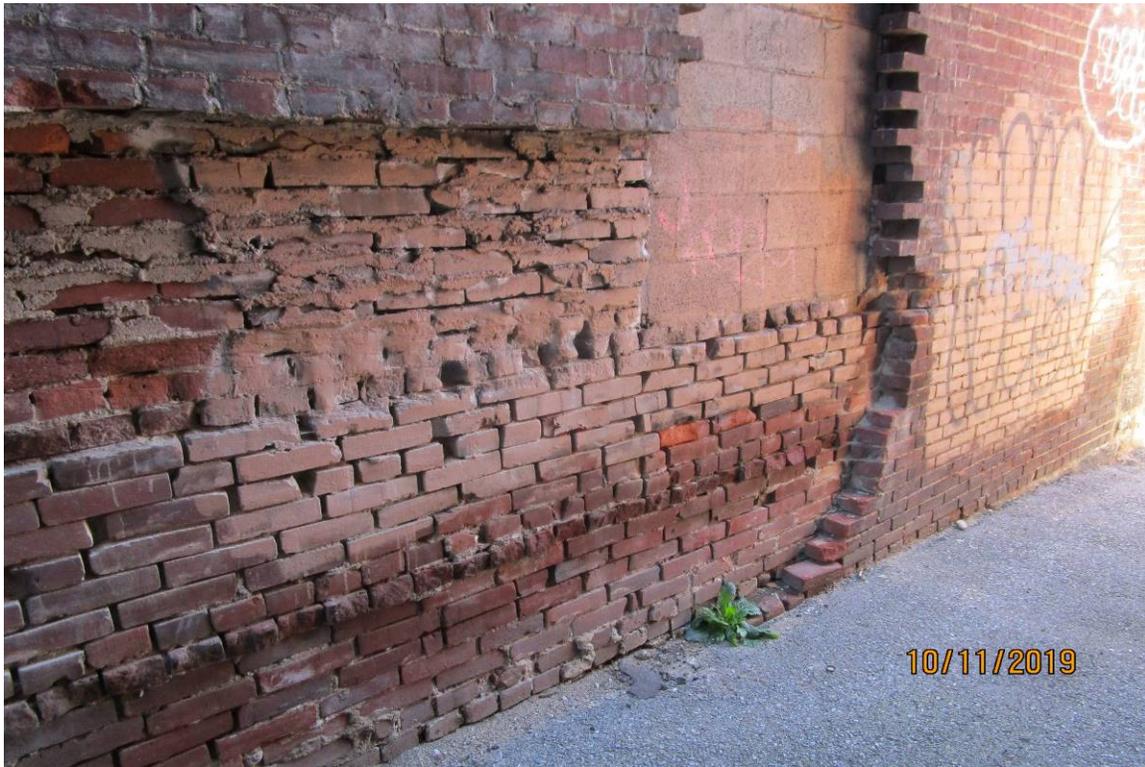
PHOTOGRAPH #13

The exterior wythe of the brick bearing-wall has been removed in this area; exposing the interior wythes of the wall. Note the complete deterioration and absence of mortar in the interior wythes of the bearing wall.

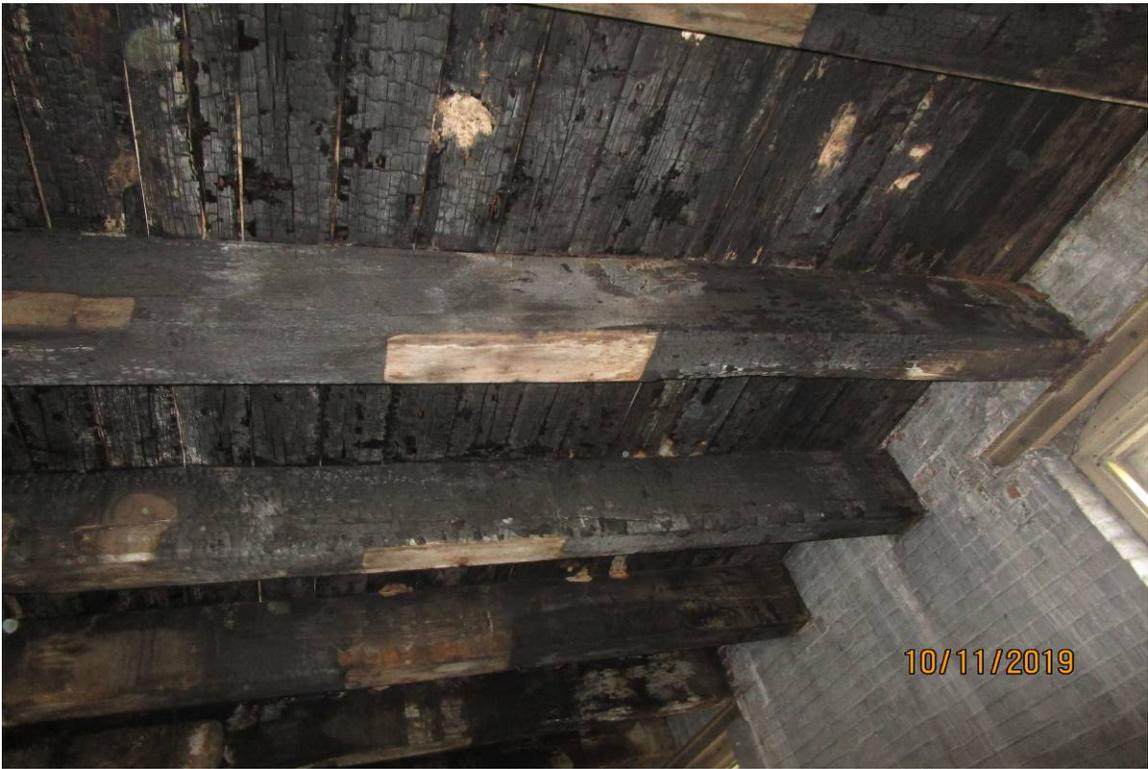
PHOTOGRAPH #19
An area of fire damaged wood floor beams.

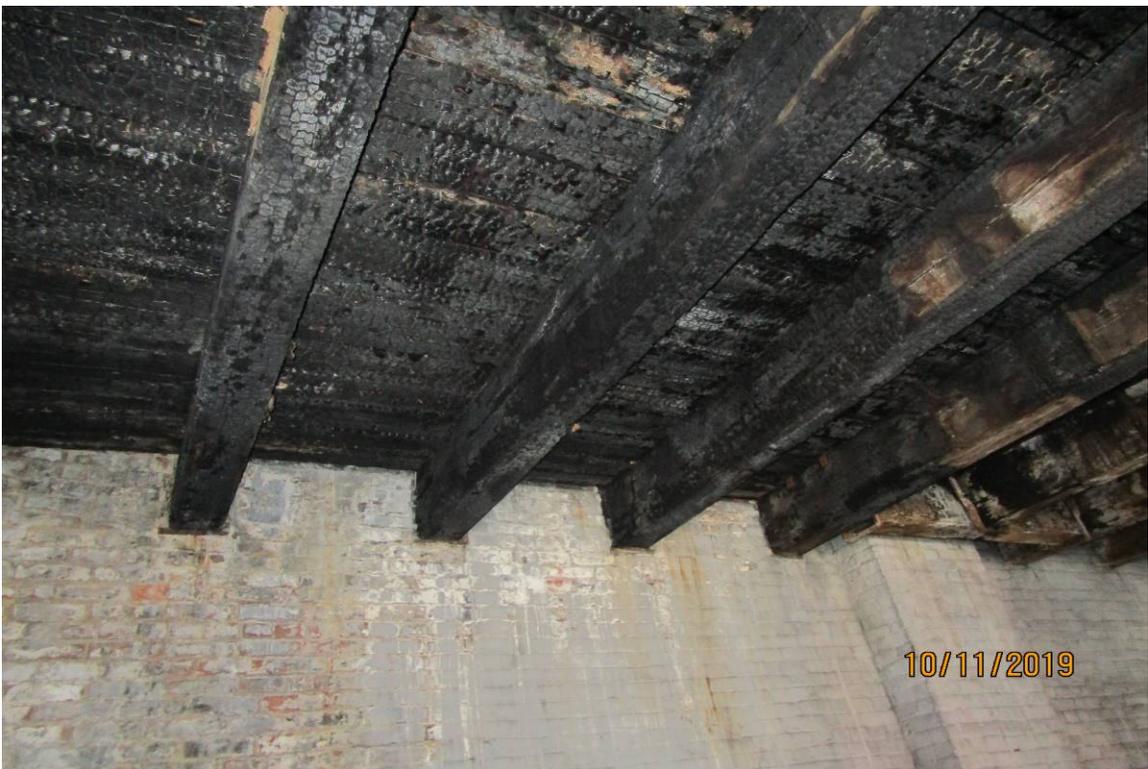
PHOTOGRAPH #20
An area of fire damaged wood floor beams.
