Planning Commission Briefing for demolition and consolidation at Boulevard, First and Market
Submitted June 9, 2020

ASSESSMENT OF BUILDING CONDITIONS

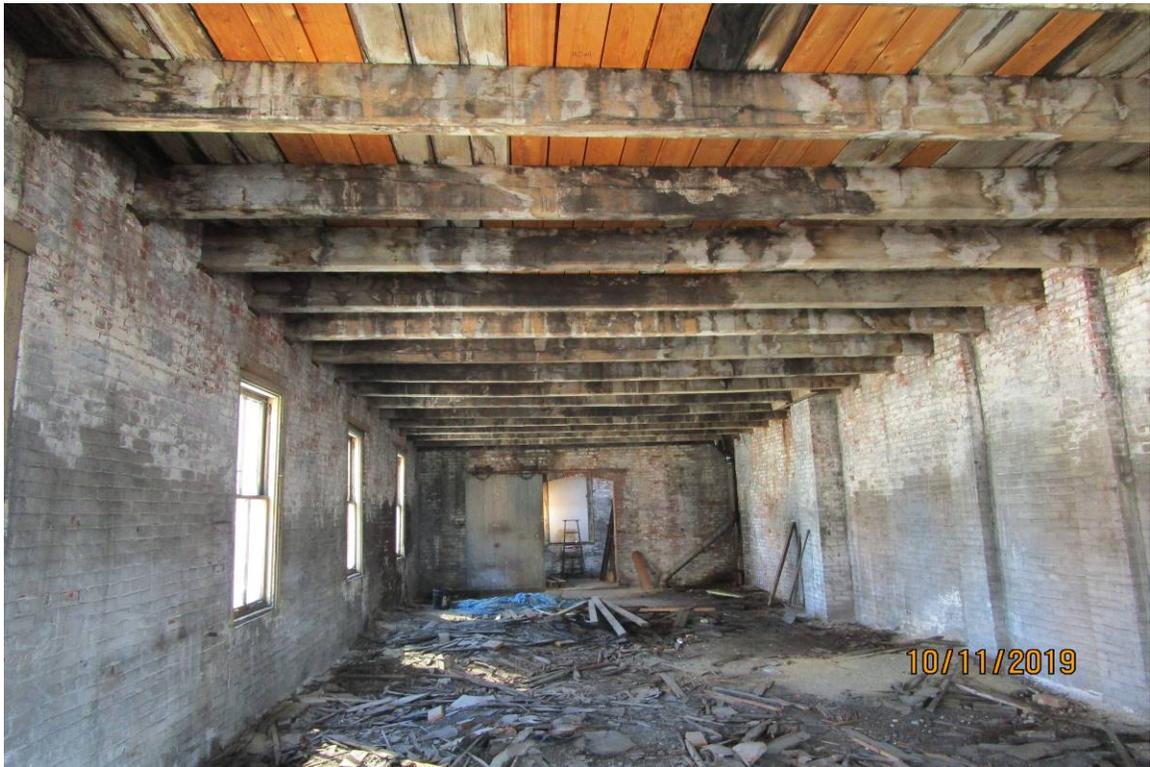
PHOTOGRAPH #21
Looking to the rear at typical water damaged roof beams.

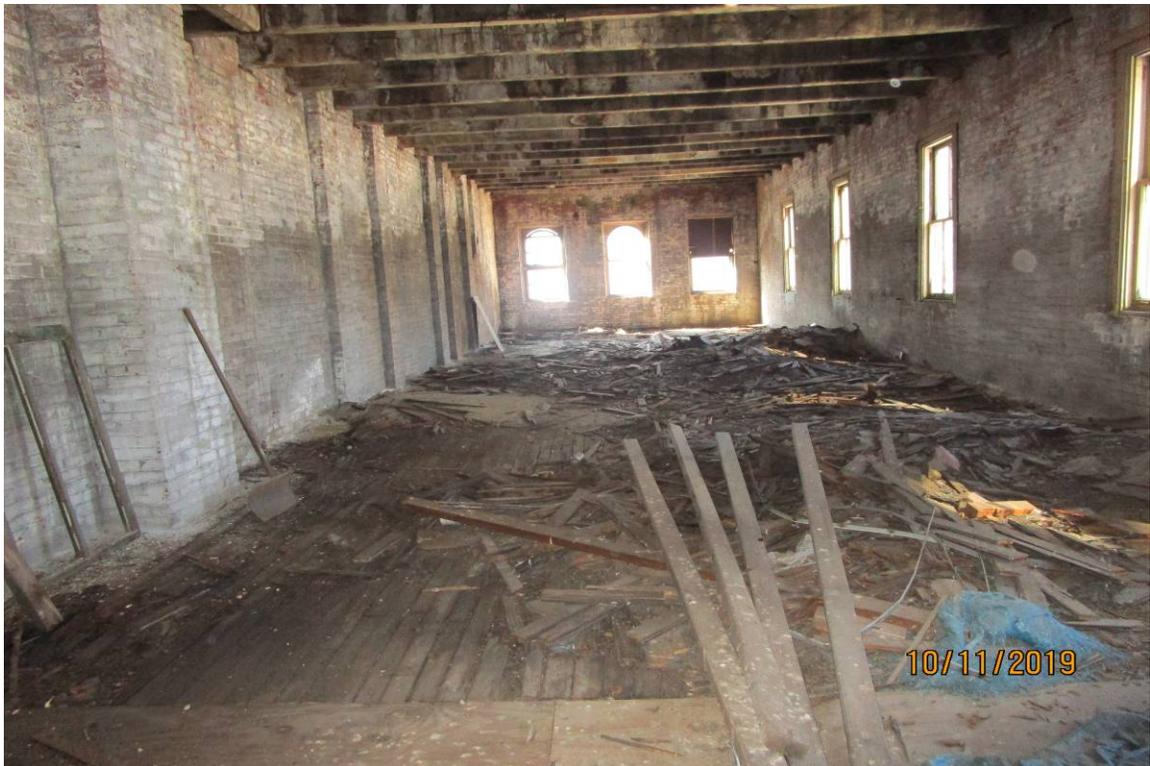
PHOTOGRAPH #22
Looking to the front at typical water damaged roof beams.

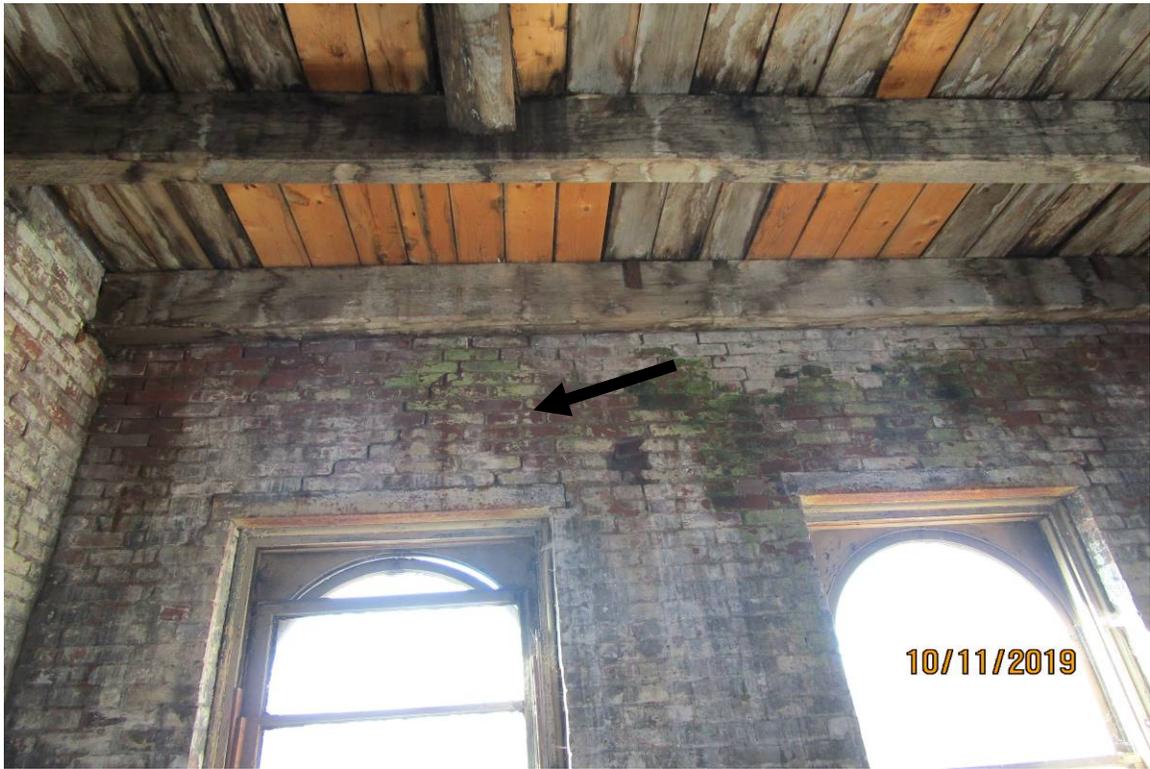
PHOTOGRAPH #23
**Cracking and deteriorated mortar in the interior wythe of brick
in the front wall on the top floor.**

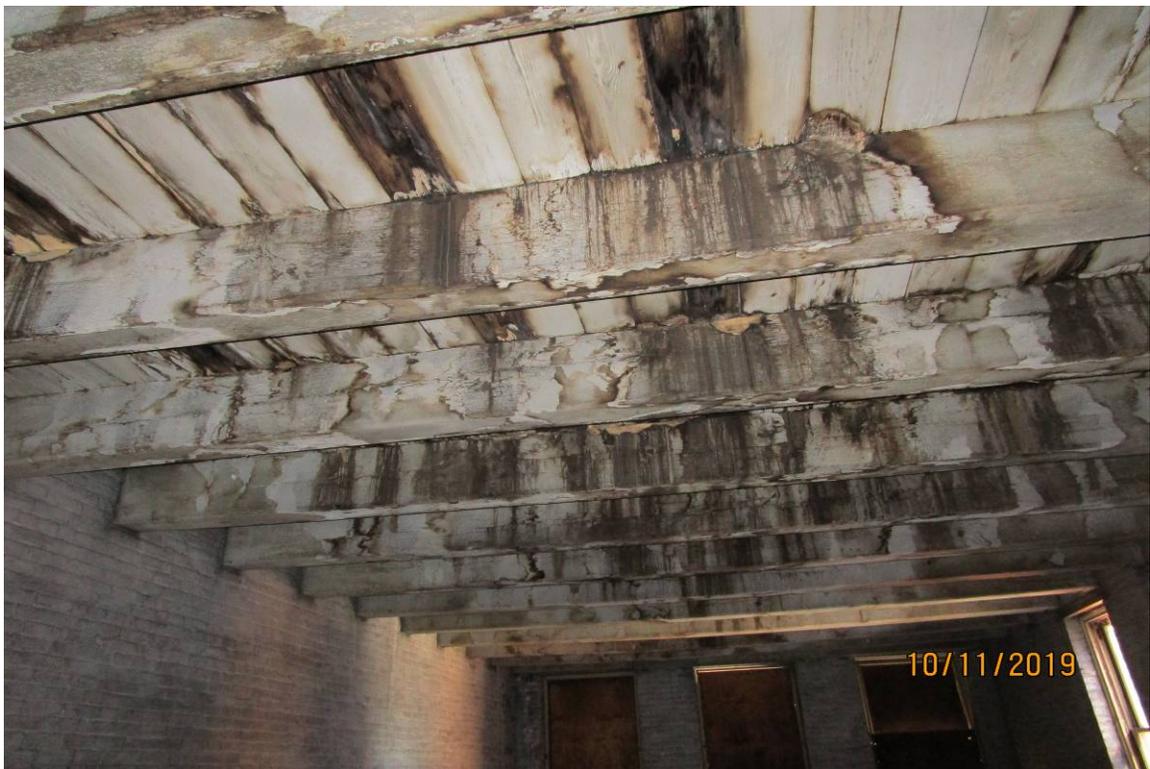
PHOTOGRAPH #24
Typical water damaged floor beams and flooring.

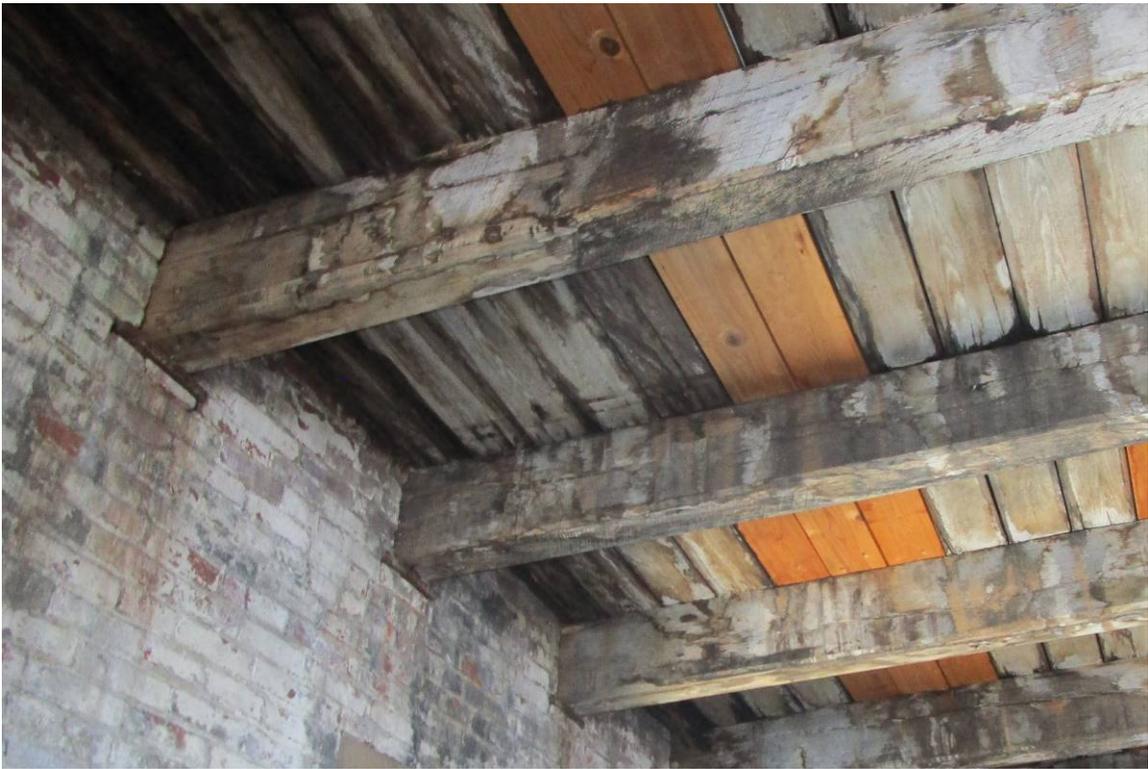
PHOTOGRAPH #25
Cracked and structurally unsound floor beams.

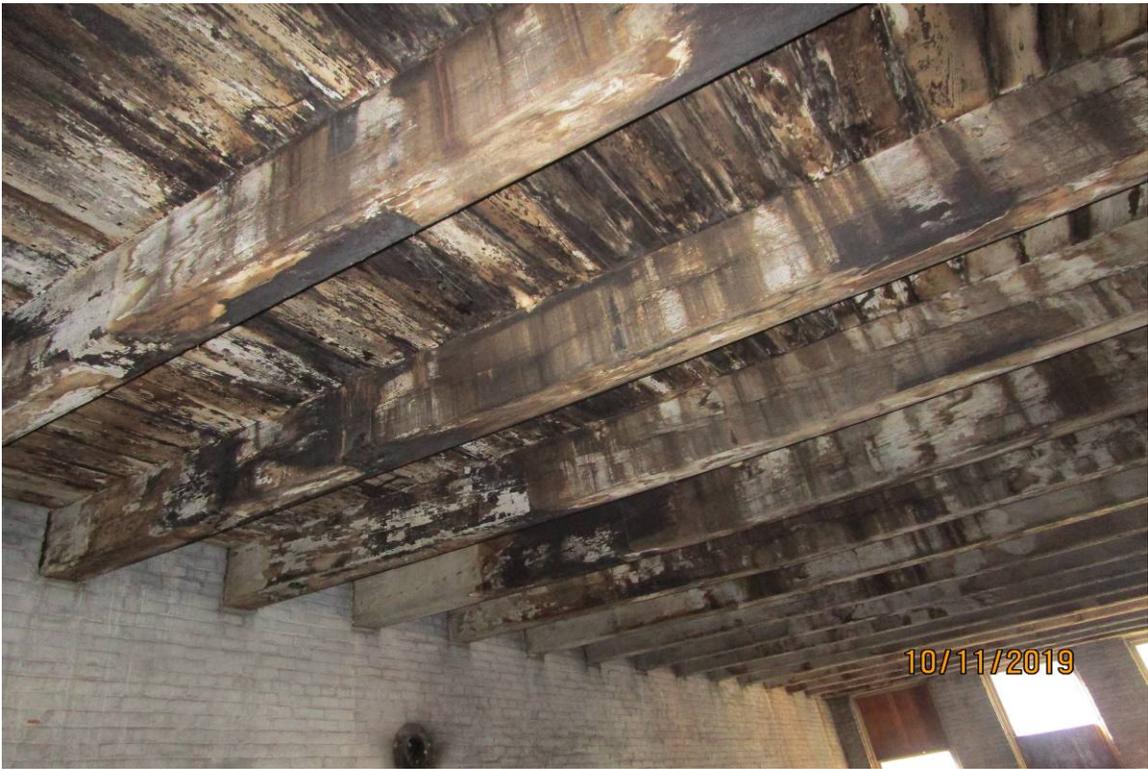
**PHOTOGRAPH #27
Typical water damaged floor beams and flooring.**

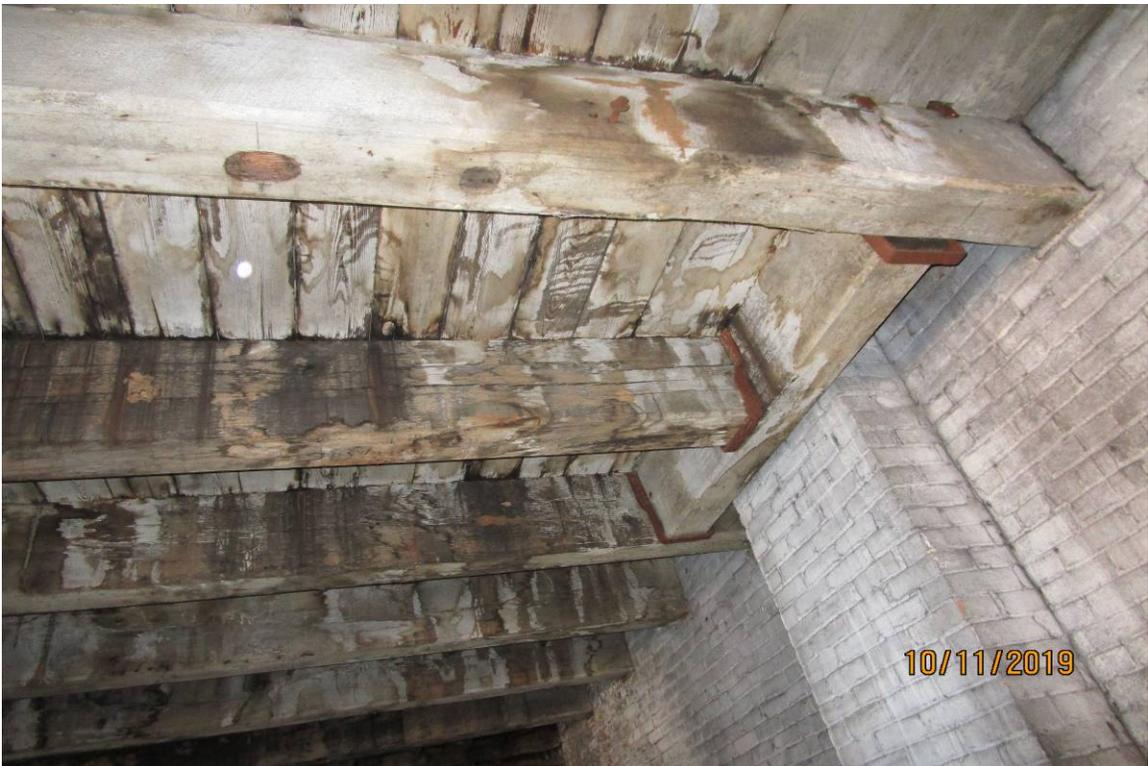
**PHOTOGRAPH #28
A cracked, structurally unsound, wood floor joist and adjacent water damaged floor beams.**

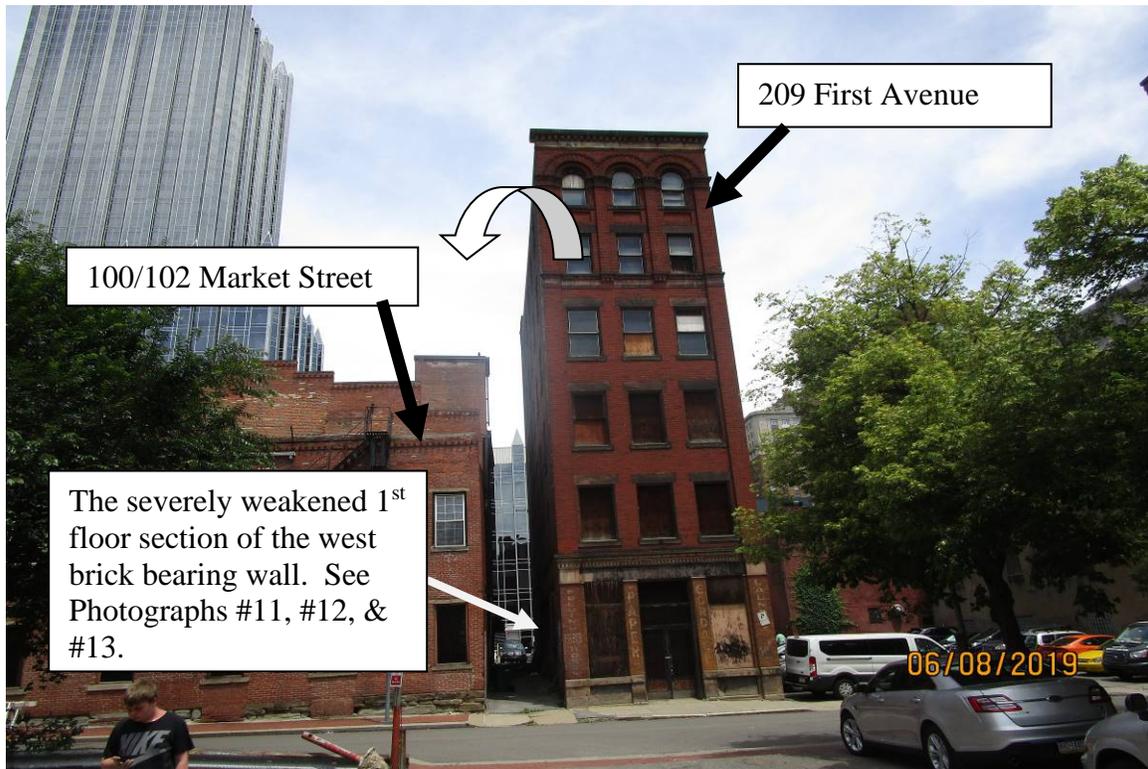
PHOTOGRAPH #5

The front of the 6-story building at 209 First Avenue. Note that the collapse of the severely weakened 1st floor section of the west brick bearing wall of the 6-story building at 209 First Avenue would cause that 6-story building to collapse westward and fall onto (and against) the buildings at 100/102 Market Street. See Photographs #11, #12, & #13.

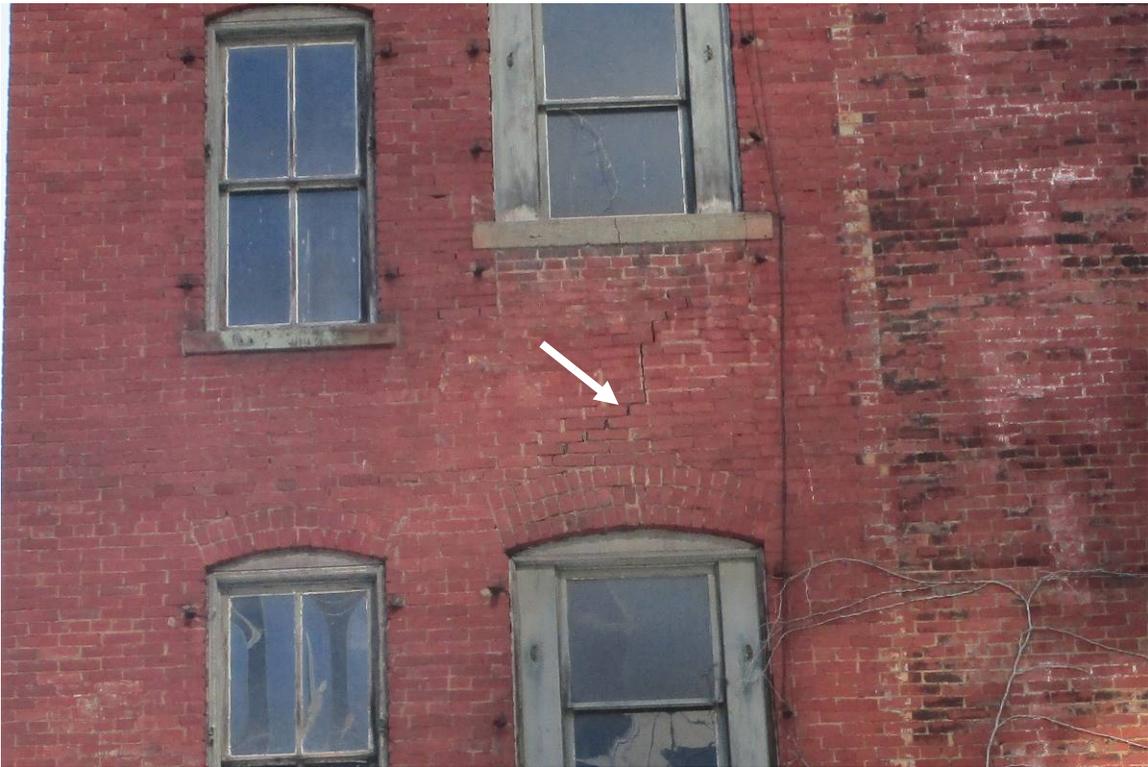
PHOTOGRAPH #9
Cracking in the brick work of the rear wall of 209 First Avenue.

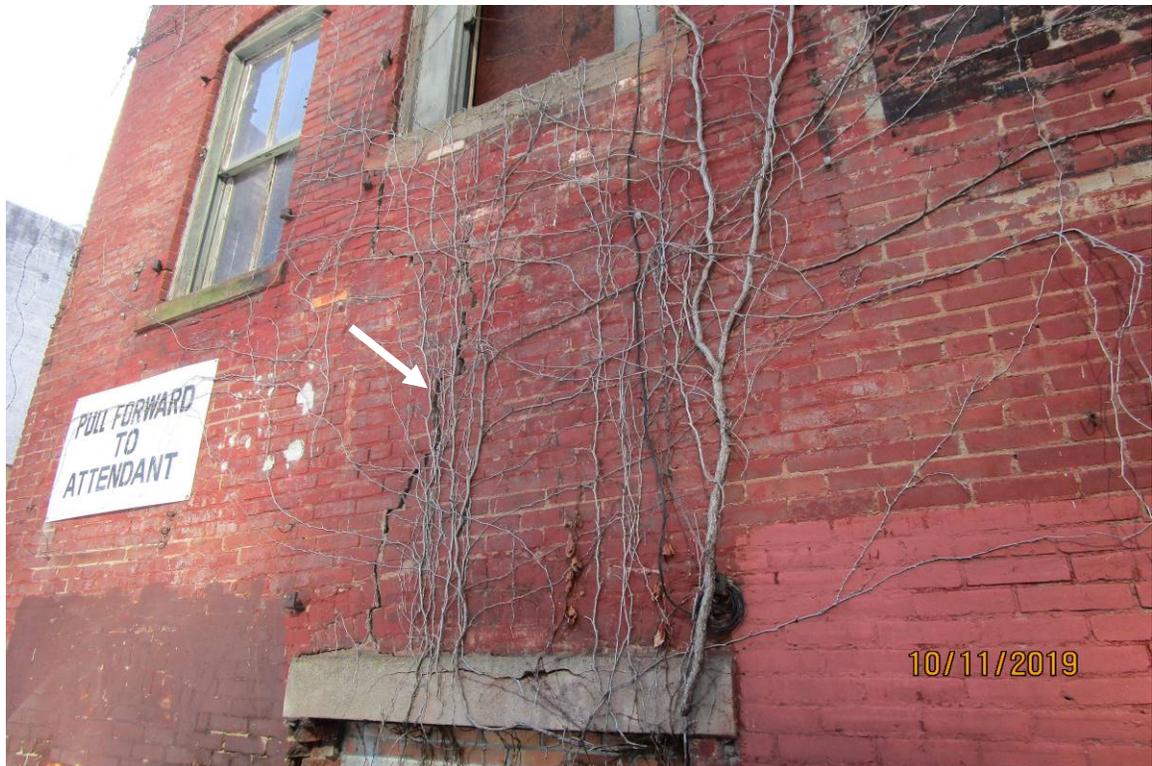
PHOTOGRAPH #10
Cracking in the brick work of the rear wall of 209 First Avenue.

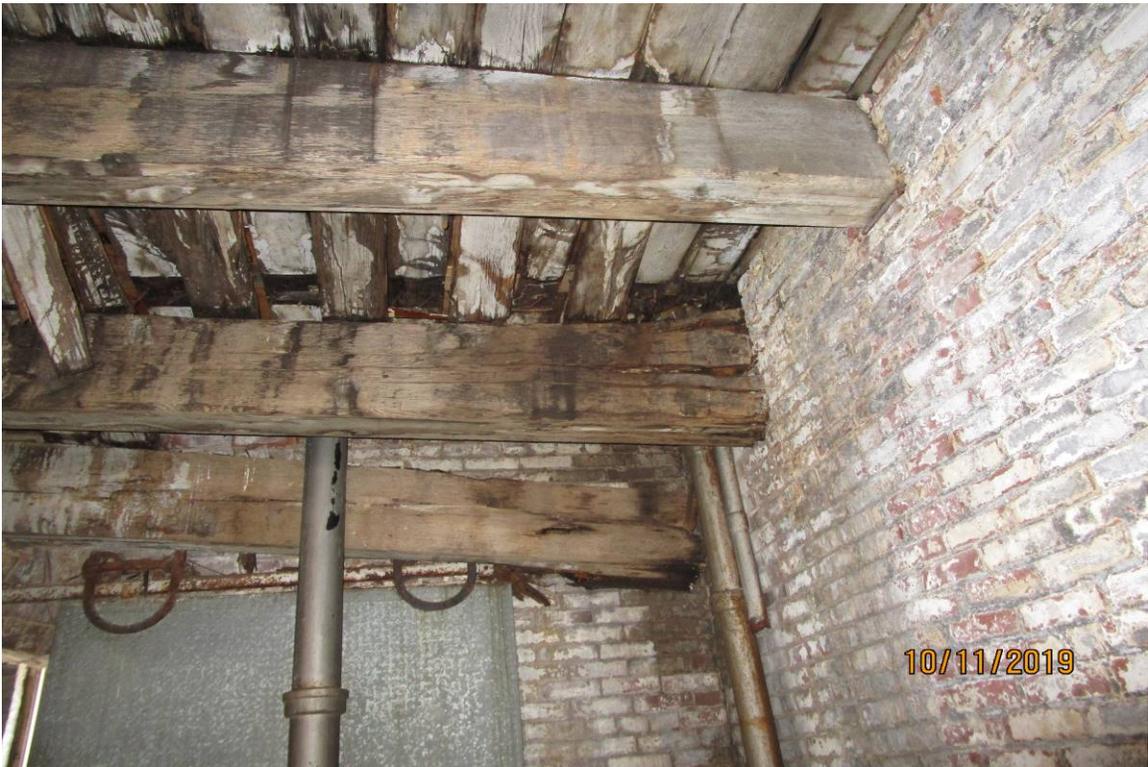
PHOTOGRAPH #18
Cracked, structurally unsound, and water damaged floor beams
along the right bearing wall.

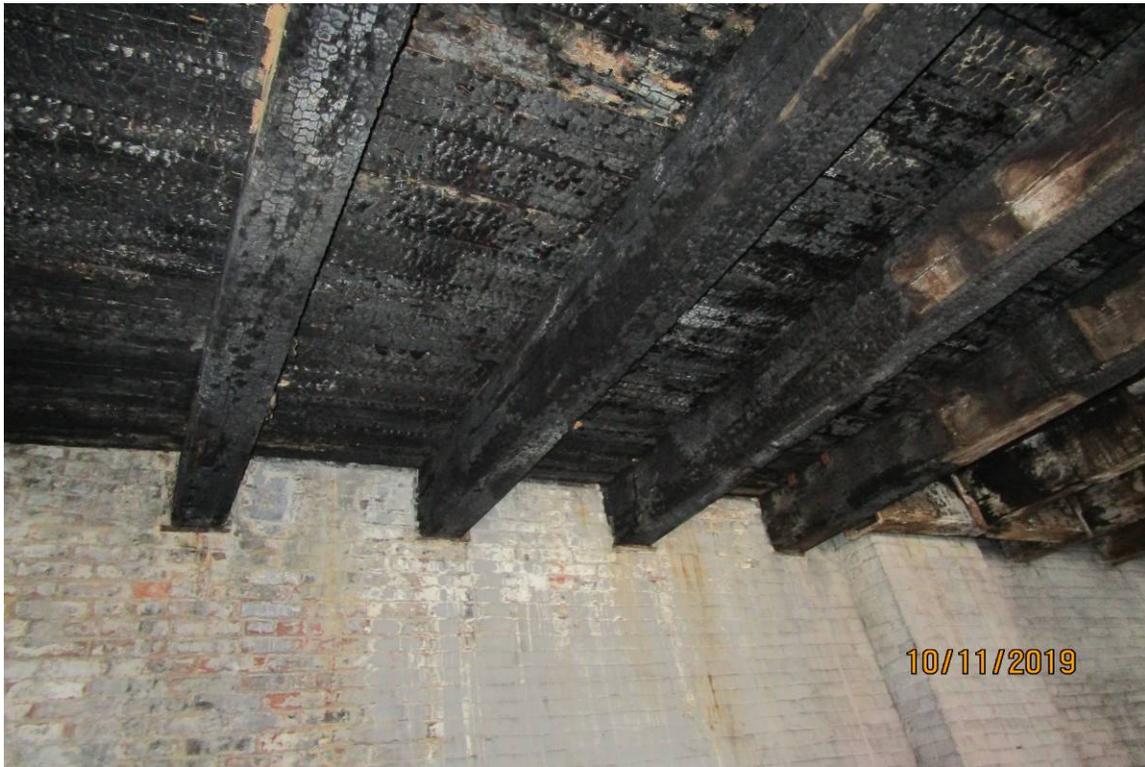
PHOTOGRAPH #20
An area of fire damaged wood floor beams.

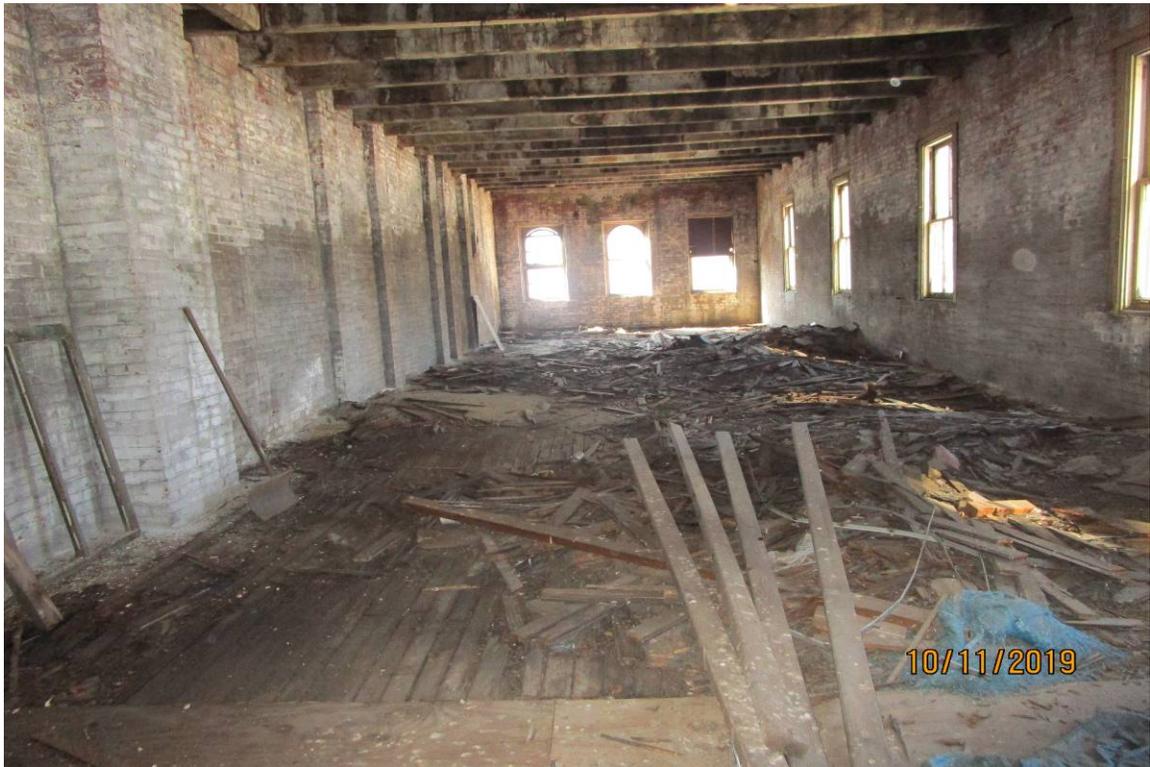
PHOTOGRAPH #22
Looking to the front at typical water damaged roof beams.

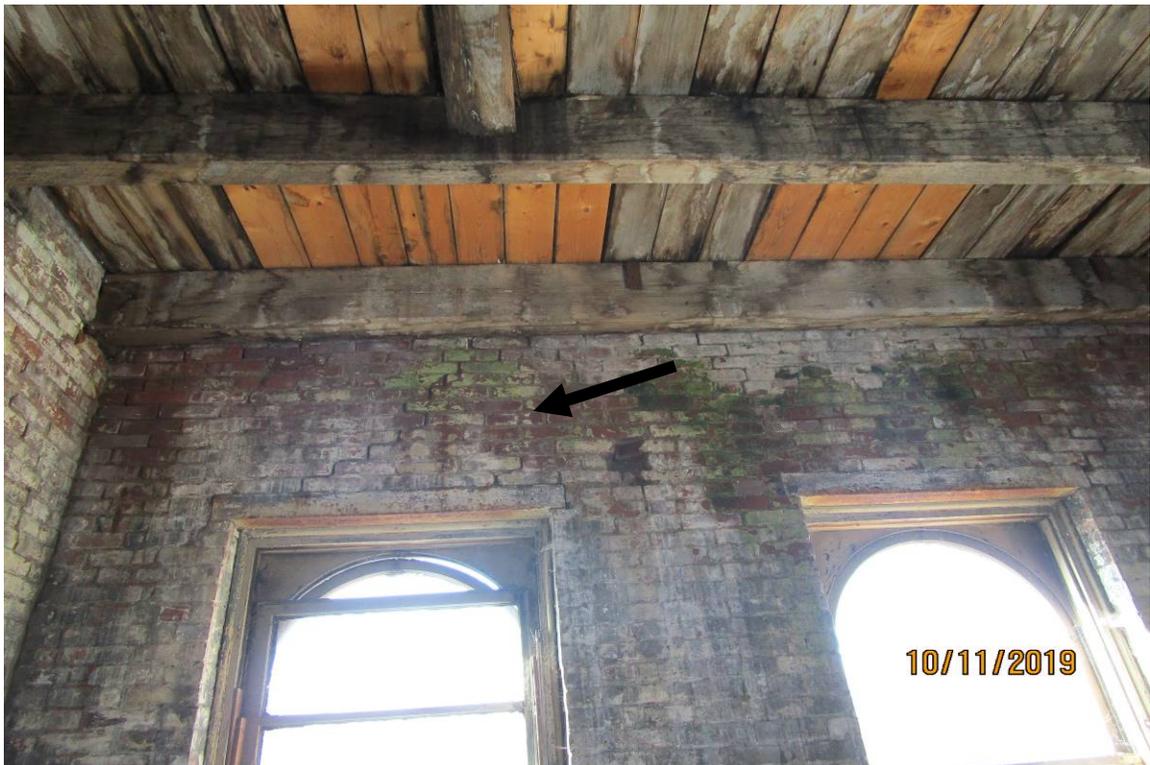
PHOTOGRAPH #23
**Cracking and deteriorated mortar in the interior wythe of brick
in the front wall on the top floor.**

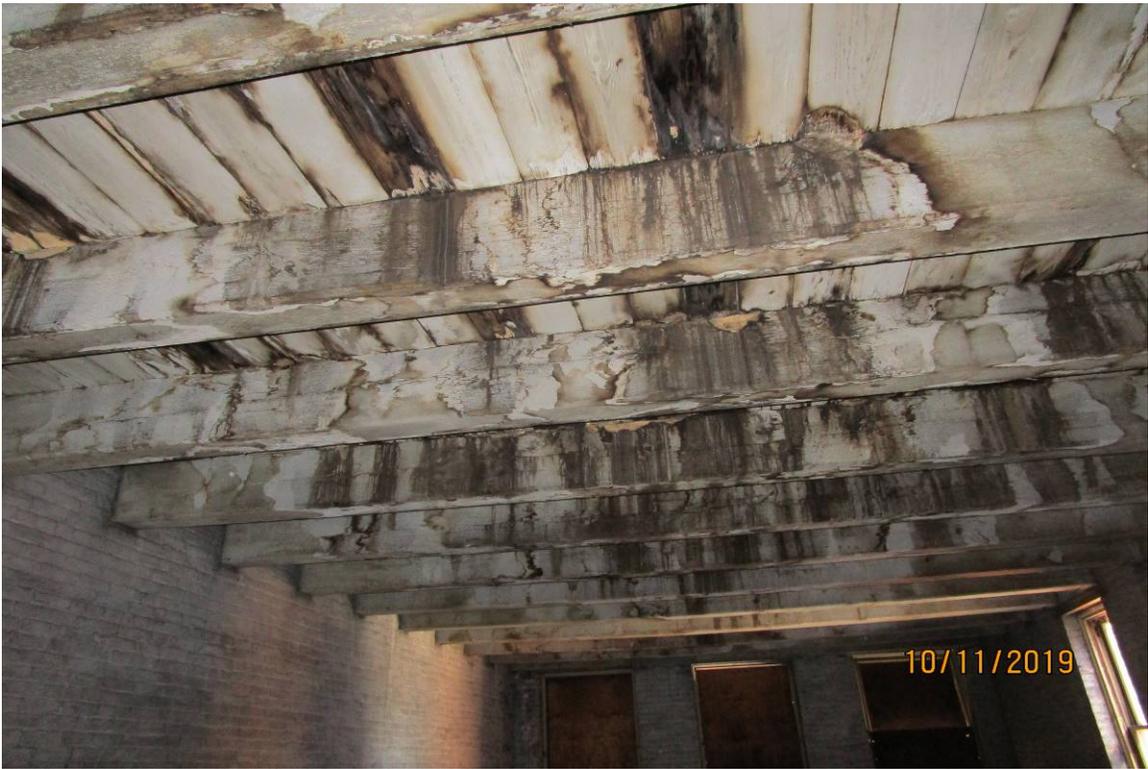
PHOTOGRAPH #24
Typical water damaged floor beams and flooring.

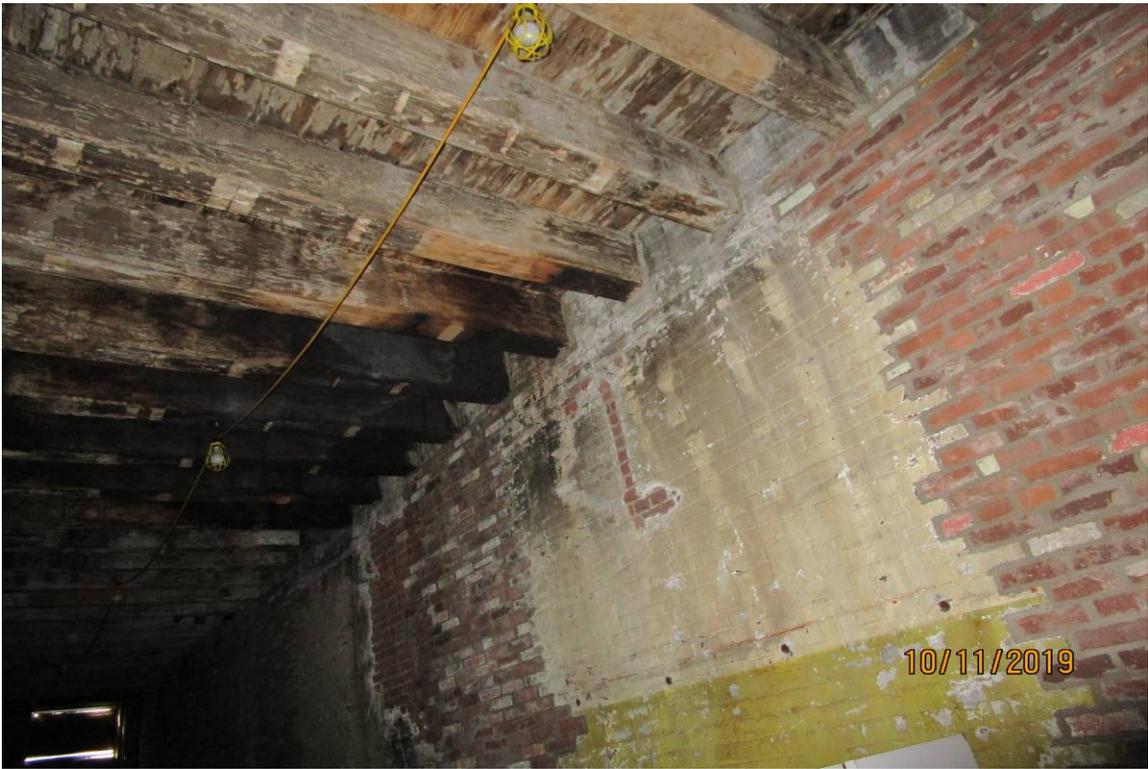
PHOTOGRAPH #26
An area of unsound fire damaged wood floor beams.

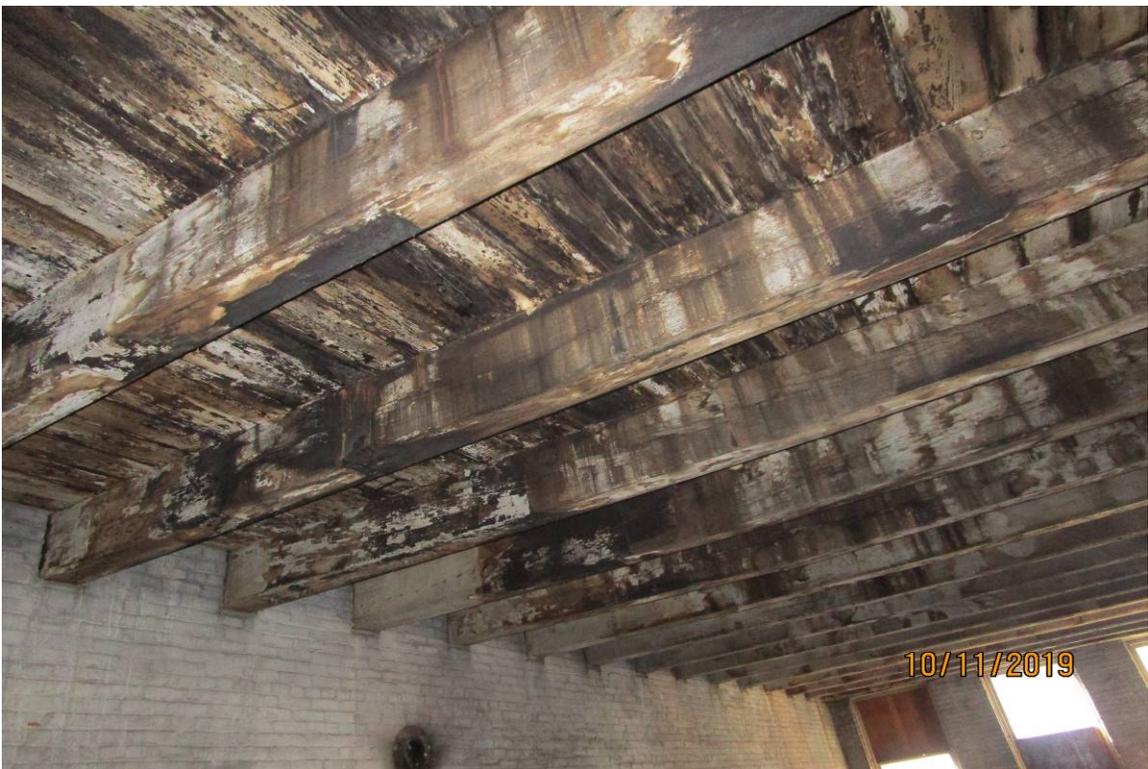
PHOTOGRAPH #27
Typical unsound water damaged floor beams and flooring.

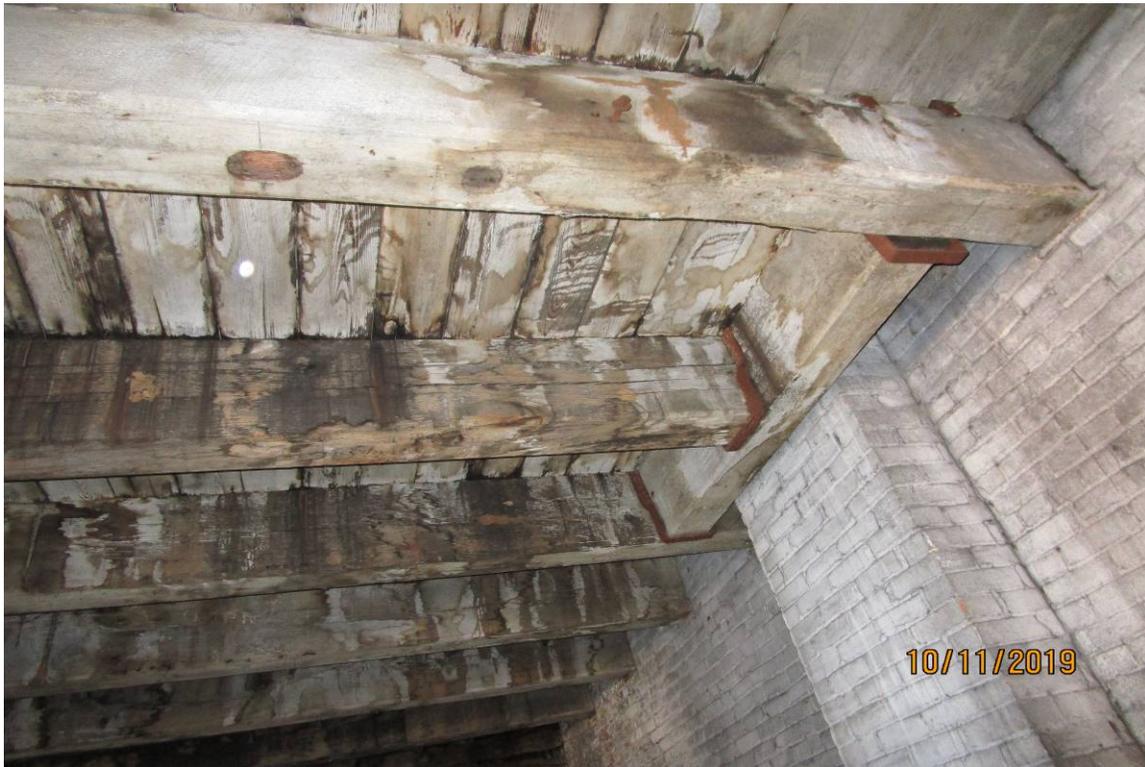
PHOTOGRAPH #28
A cracked, structurally unsound, wood floor beam and adjacent unsound water damaged floor beams.
