Southwestern Pennsylvania Commission Shady Avenue from Penn Avenue to Monitor Street Road Safety Audit

Shady Avenue from Penn Avenue to Monitor Street
Allegheny County
City of Pittsburgh

Road Safety Audit Conducted October 2019

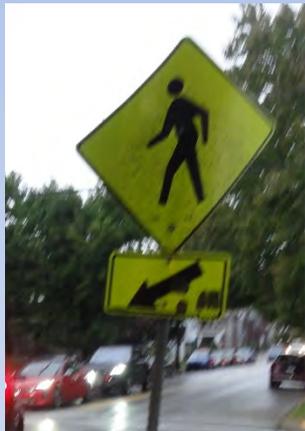
OBSERVATIONS: Some signs in the corridor have been damaged, defaced, or are faded. Some stop signs are undersized. Many use the obsolete Type I retroreflective sheeting. Many signs are blocked by vegetation or other obstructions.

Damaged sign

- Replace damaged, defaced and faded signs with new retroreflective signs.
- Replace undersized 24" by 24" STOP signs with 30" by 30" signs.
- Trim vegetation near signs.
- Utilize a separate support for each sign, ensure that nothing is blocking line of sight to signs.

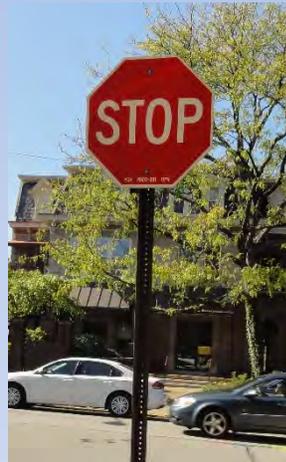
Small
STOP sign

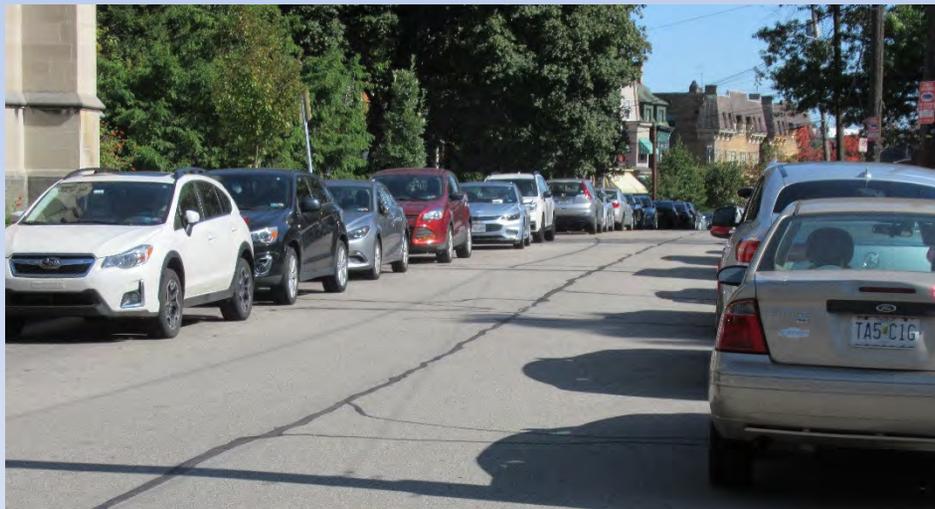
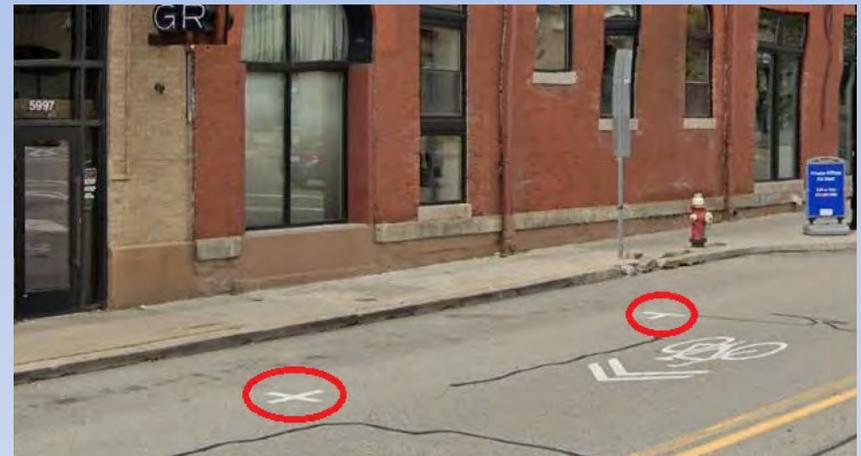
EXPECTED FREQUENCY	EXPECTED SEVERITY	RISK RATING	B
Rare	Low	Moderate-Low	
OBSERVATIONS: On street parking spaces are not defined. Speeding was observed in parts of the corridor where parking was not defined.

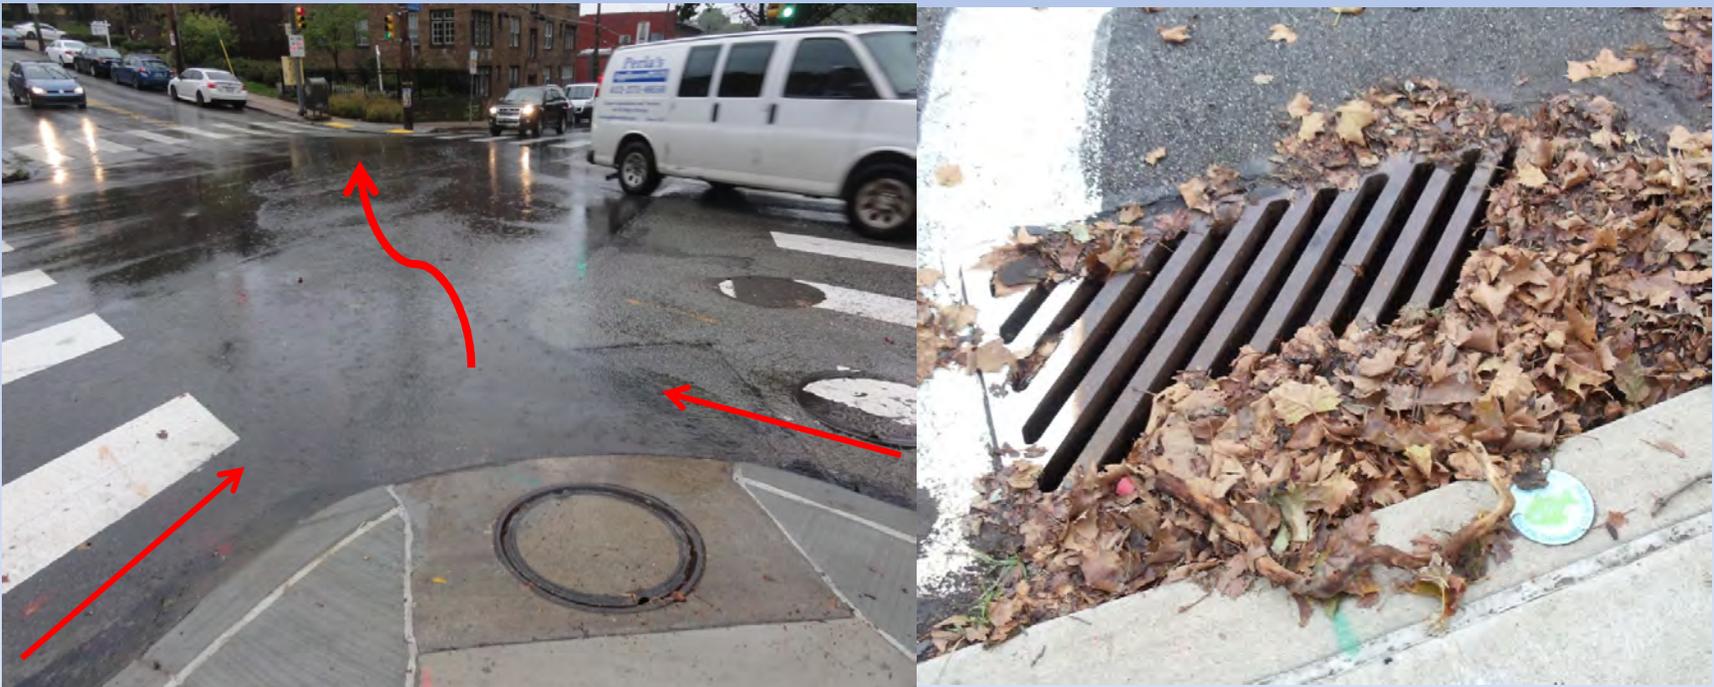
OBSERVATIONS: Some of the drainage inlets through the corridor are blocked by debris. Storm water is being diverted back into the roadway. Several of the inlet grates are not bicycle safe. The inlet on the corner at Allderdice H.S. is blocked causing the storm water to pond at the intersection of Shady Avenue and Forward Avenue.

- SUGGESTIONS:
- Clean the debris from the inlets.
 - Add bicycle safe inlets where needed.

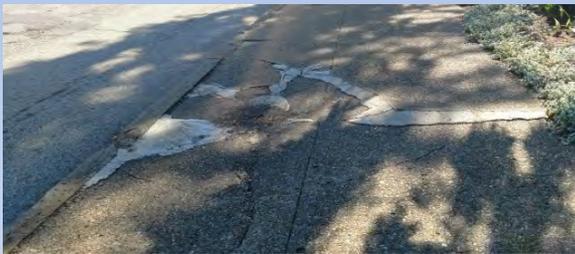
Near Solway Street

EXPECTED FREQUENCY	EXPECTED SEVERITY	RISK RATING	B
Occasional	Low	Moderate-Low	
<p>OBSERVATIONS: The sidewalk network is complete, but many sections of sidewalk along the corridor are in poor condition. Distress includes fractured concrete, surface wear, tree root upheaval, and other uneven surfaces. In addition to the examples shown below, poor sidewalk conditions were also noted at Aurelia Street, Wilkins Avenue and several other locations along the corridor.</p>

- Repair or replace damaged sections of sidewalks and bring sidewalks up to ADA compliance.

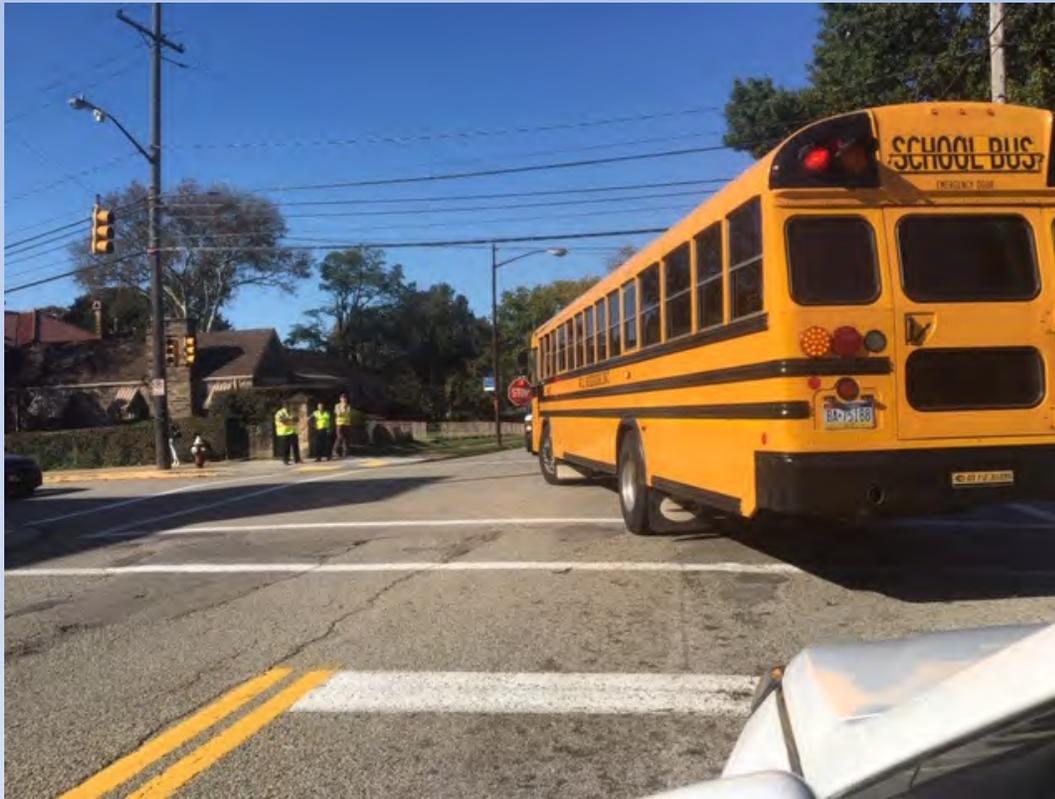
EXPECTED FREQUENCY	EXPECTED SEVERITY	RISK RATING	D
Occasional	Medium	Moderate-High	
OBSERVATIONS: It was observed and mentioned in the stakeholder interviews that drivers were not stopping when school buses were dropping students off. Homes, trees, and parked cars may obstruct the visibility of school bus stop locations.

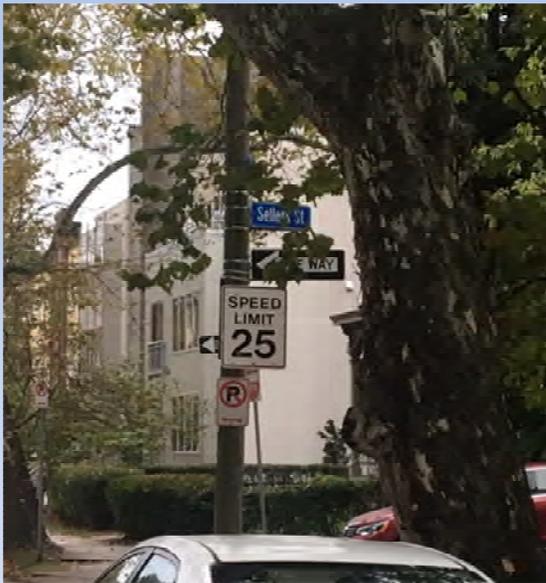
SB at Sellers Street

EXPECTED FREQUENCY	EXPECTED SEVERITY	RISK RATING	D
Occasional	Medium	Moderate-High	
<p>OBSERVATIONS: There are 17 speed limit signs southbound and 11 northbound and all are posted at 25 mph. The majority of the signs are in good condition with sufficient retro reflectivity. However, several signs are obstructed by overgrown vegetation. Speeding was observed and was mentioned in the stakeholder interviews.</p>

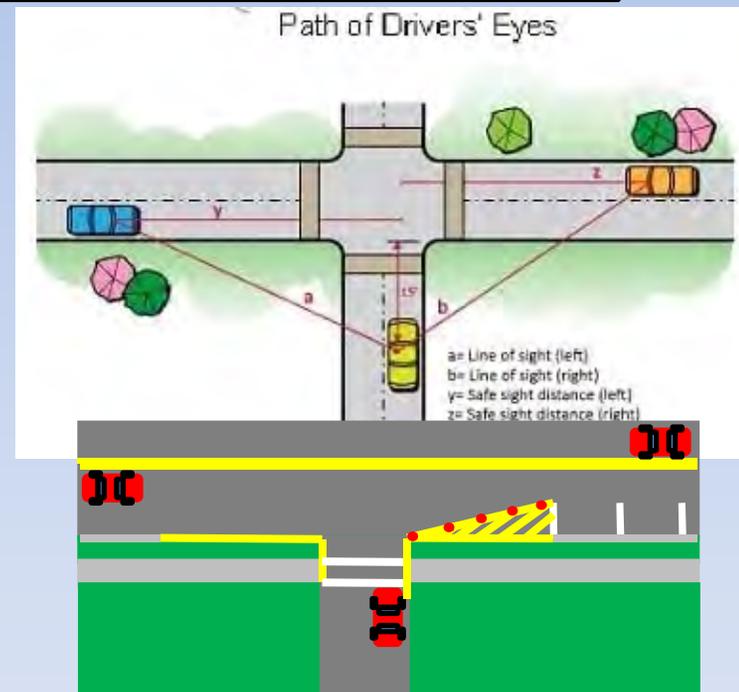
OBSERVATIONS: Parking, trees, landscaping, and signs infringe upon the driver's sight cone at the following unsignalized intersections: Marchand Street, Alder Street, Sellers Street, Howe Street, Kentucky Avenue, Mellon Park Road, Parkton Place, Highmont Road, Braeburn Place, Devereaux Lane, Hastings Street, Marlborough Road, Darlington Road, Bartlett Street, Hobart Road, Douglas Street, Nicholson Street, Pittock Street, Sherbrook Street, Alderson Street, Burchfield Avenue. These parked vehicles also block bus stops.

- SUGGESTIONS:
- Remove or relocate trees, landscaping, and signs out of the drivers sight cone.
 - Restrict parking inside the drivers sight cone and enforce parking restrictions.

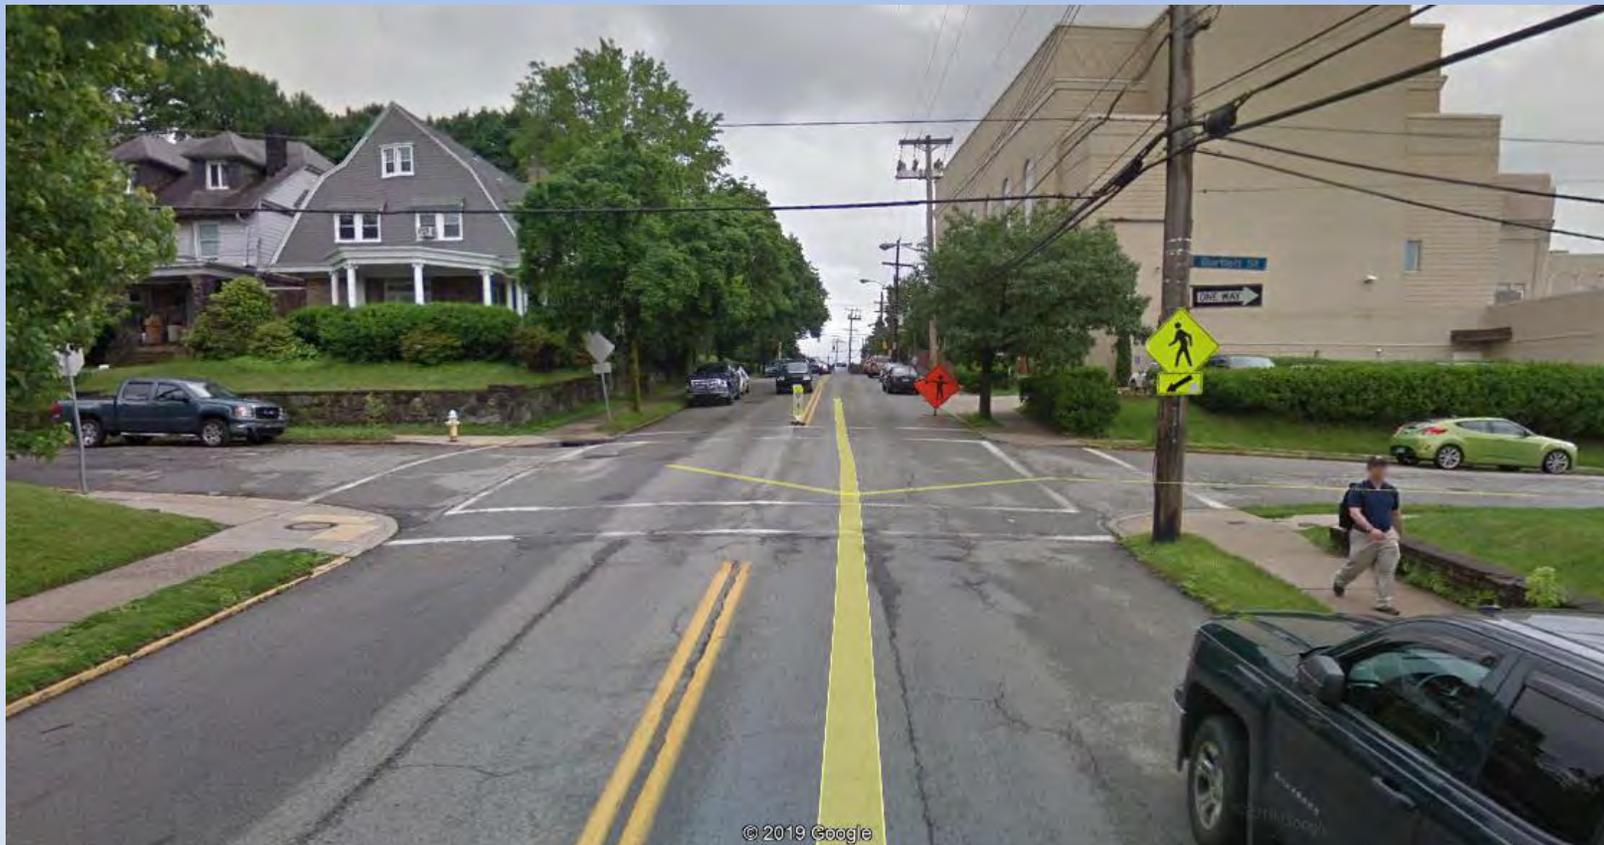
Bartlett Street example

EXPECTED FREQUENCY	EXPECTED SEVERITY	RISK RATING	D
Occasional	Medium	Moderate-High	
OBSERVATIONS: Signage is not consistent for the unsignalized marked pedestrian crossings. Many lack advance signage.

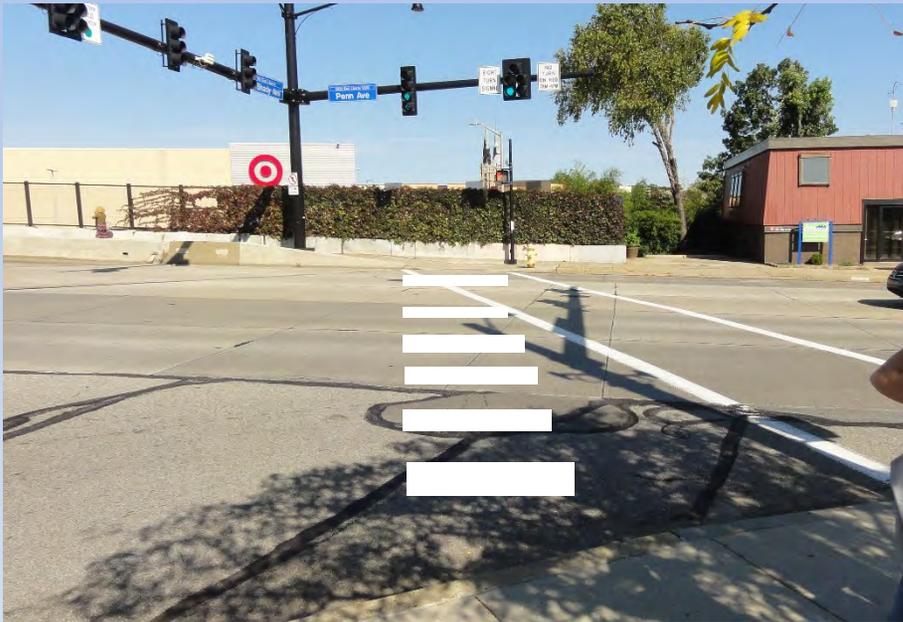
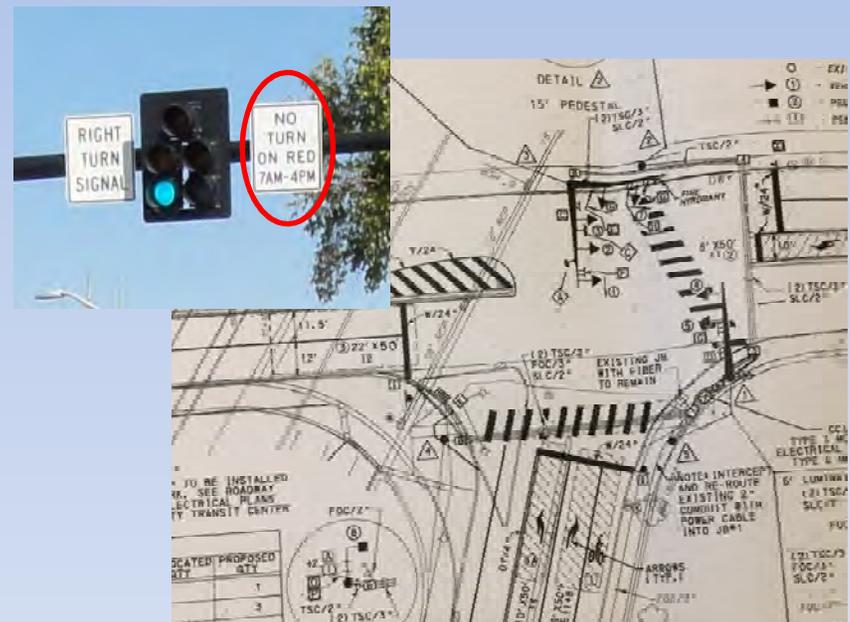
OBSERVATIONS: The crosswalk spanning the east leg is at a significant skew, the pedestrian phase crossing Shady appears to come up every cycle, the timings do not seem effective, the crosswalk spanning Penn is not a high visibility style, the NO TURN ON RED restriction is in effect from 7:00 am to 4:00 pm but is violated frequently.

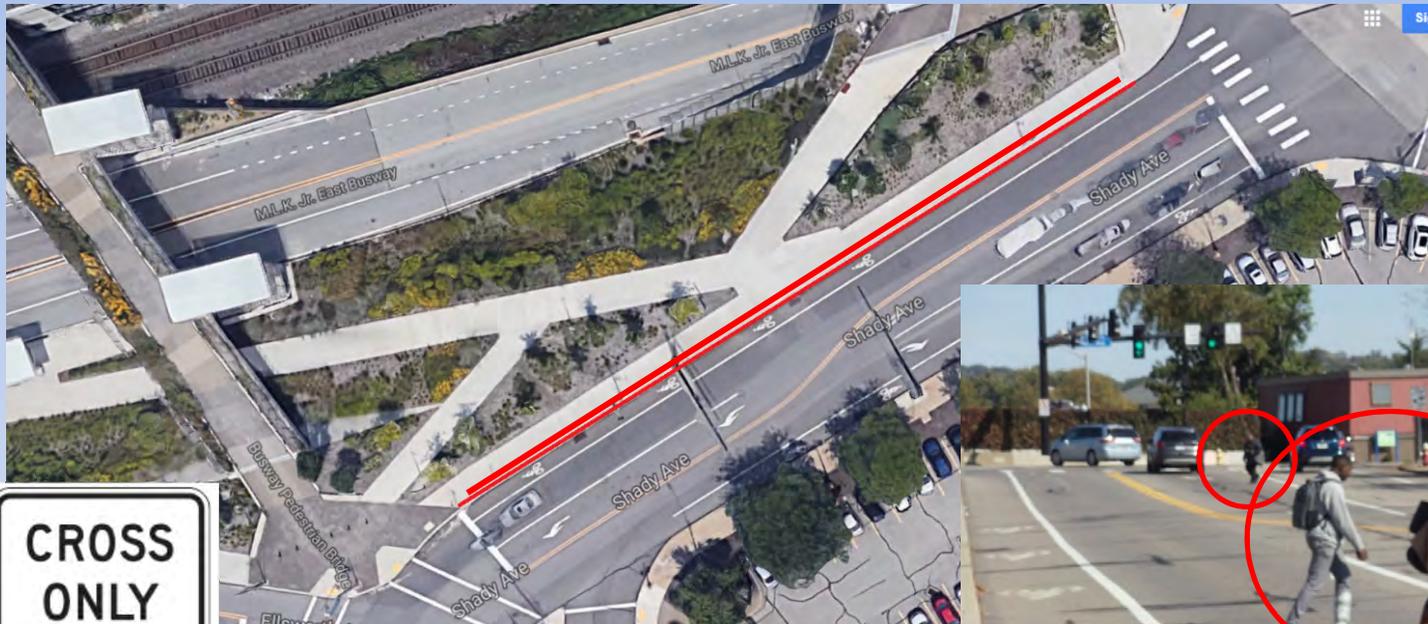
EXPECTED FREQUENCY	EXPECTED SEVERITY	RISK RATING	C
Occasional	Low	Moderate	
OBSERVATION: Pedestrians are crossing midblock from the East Busway towards the shopping center.

- SUGGESTIONS:
- Short term: Install signing to encourage pedestrians to cross at established crosswalks.
 - Long term: Install railing along this section of Shady Avenue to channelize pedestrians to established crossings.

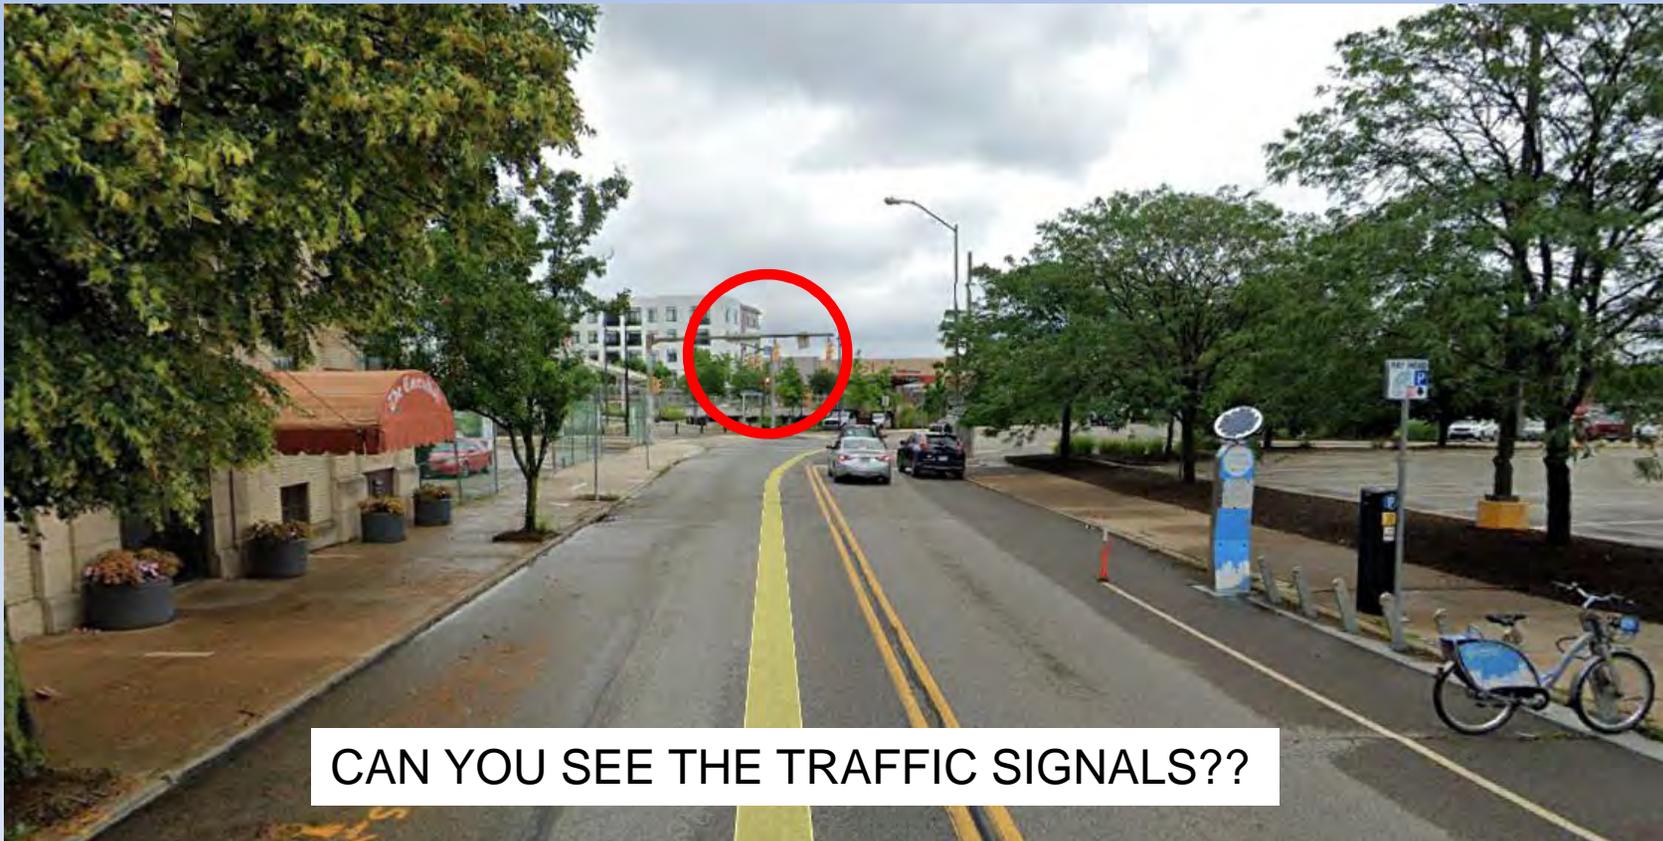
EXPECTED FREQUENCY	EXPECTED SEVERITY	RISK RATING	D
Occasional	Medium	Moderate-High	
OBSERVATIONS: Giant Eagle driveway is wide and not pedestrian friendly. There are no pedestrian signals. Crosswalk markings are outdated. Drivers may have difficulty seeing the northbound signals.

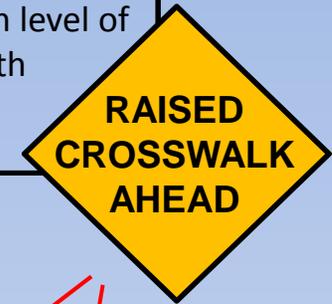
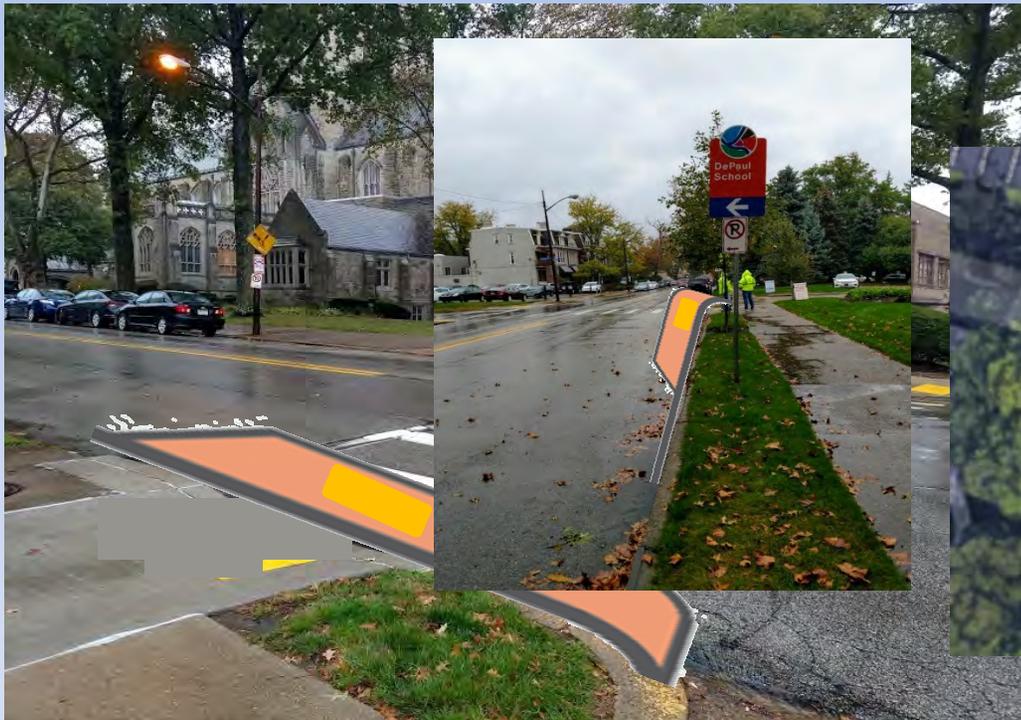
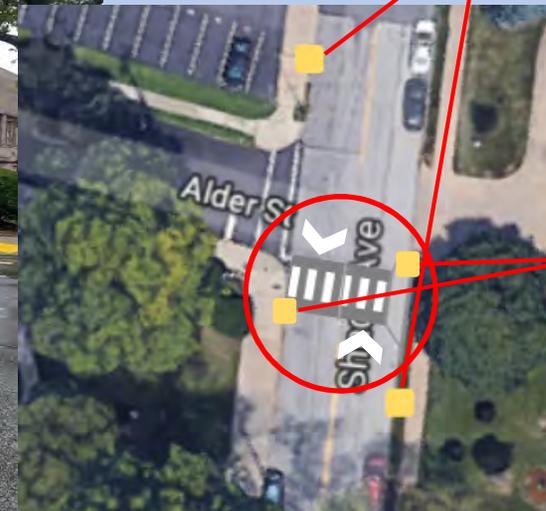
OBSERVATIONS: Several pedestrian generators are located at this intersection and a high level of pedestrian activity was observed. No controlled stop locations exist between Ellsworth Avenue and Walnut Street.

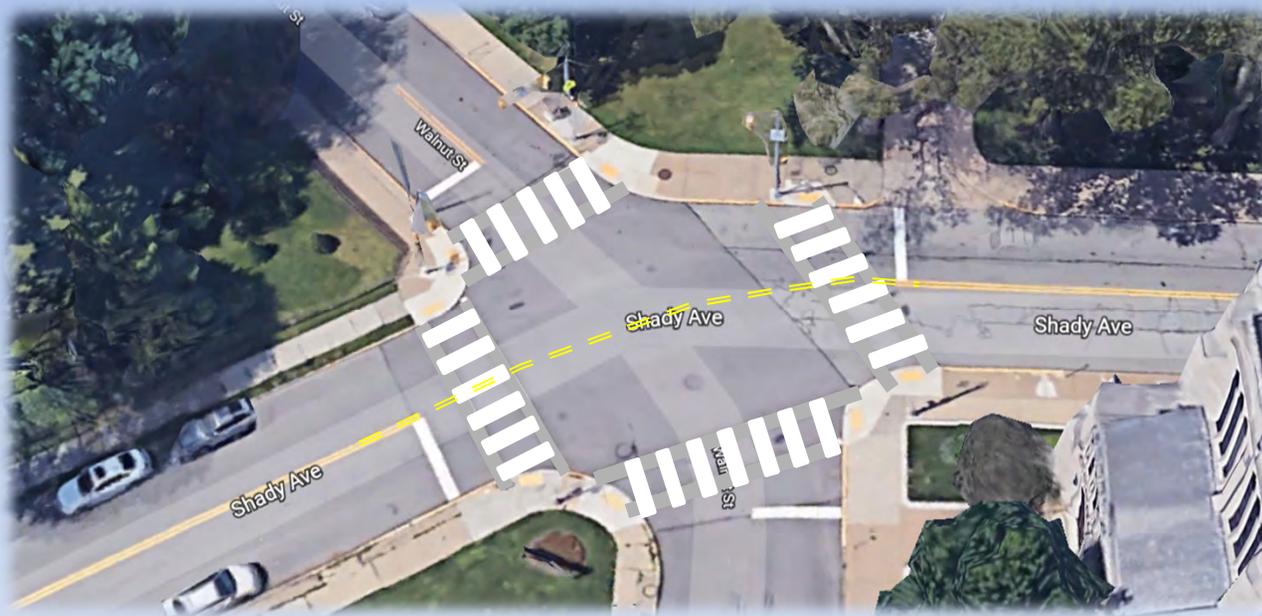
EXPECTED FREQUENCY	EXPECTED SEVERITY	RISK RATING	C
Occasional	Low	Moderate	
OBSERVATIONS: The traffic signal installation at Walnut Street is outdated. NO TURN ON RED restrictions are not consistent with other intersections. Signs need replaced and moved.

- Install traffic signal equipment upgrades to include audible traffic signals.
- Replace NO TURN ON RED signing and consider using a consistent message corridorwide.
- Consider installing high visibility crosswalks and broken yellow extension markings.
- Remove the “Y” symbol sign (W2-5).
- Move the chevrons to their own sign posts.

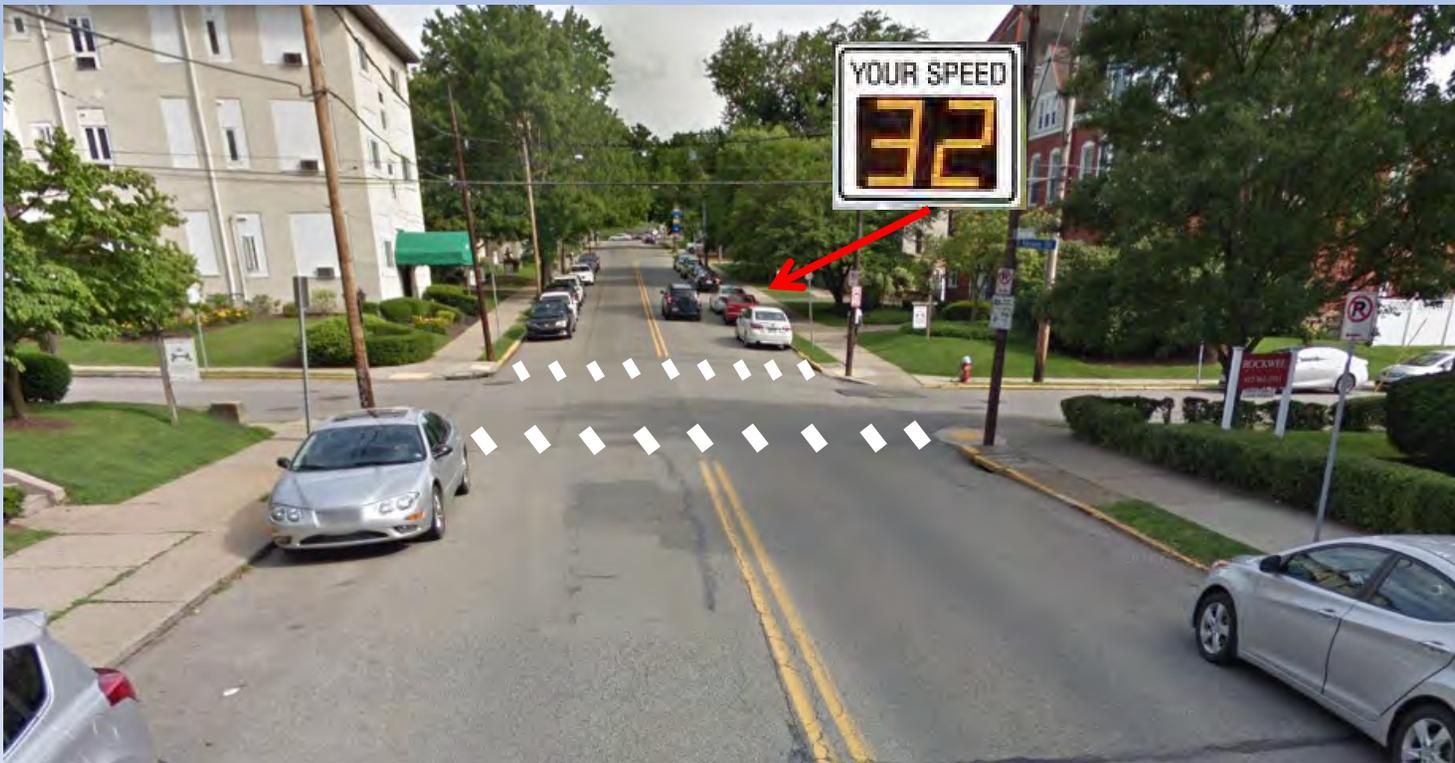
OBSERVATION: There is limited sight distance on side street approaches, no indications where the intersection is, and vehicles were observed traveling over the posted speed in the area.

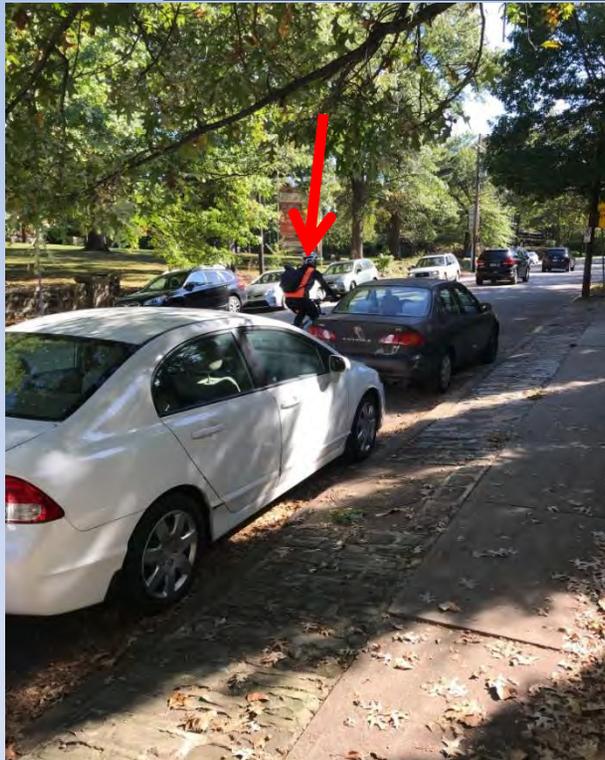
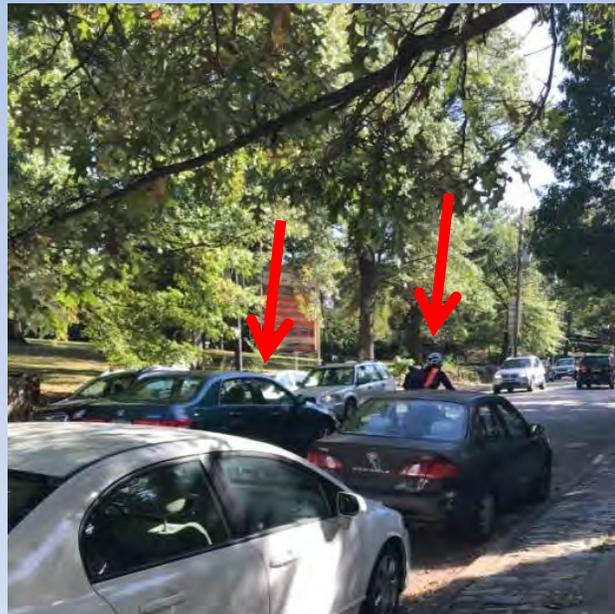
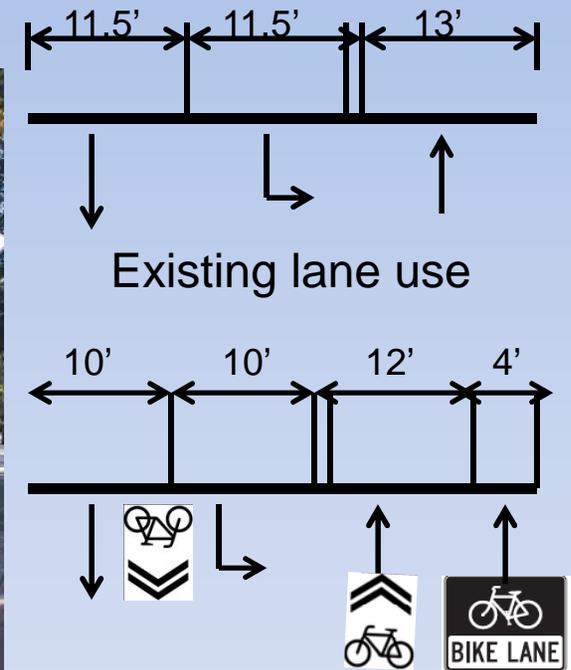
EXPECTED FREQUENCY	EXPECTED SEVERITY	RISK RATING	E
Occasional	High	High	
OBSERVATIONS: Bicyclists were observed riding on Shady Avenue near Fifth Avenue on a significant uphill grade. Drivers were growing impatient and not providing bicyclists with adequate buffer space.

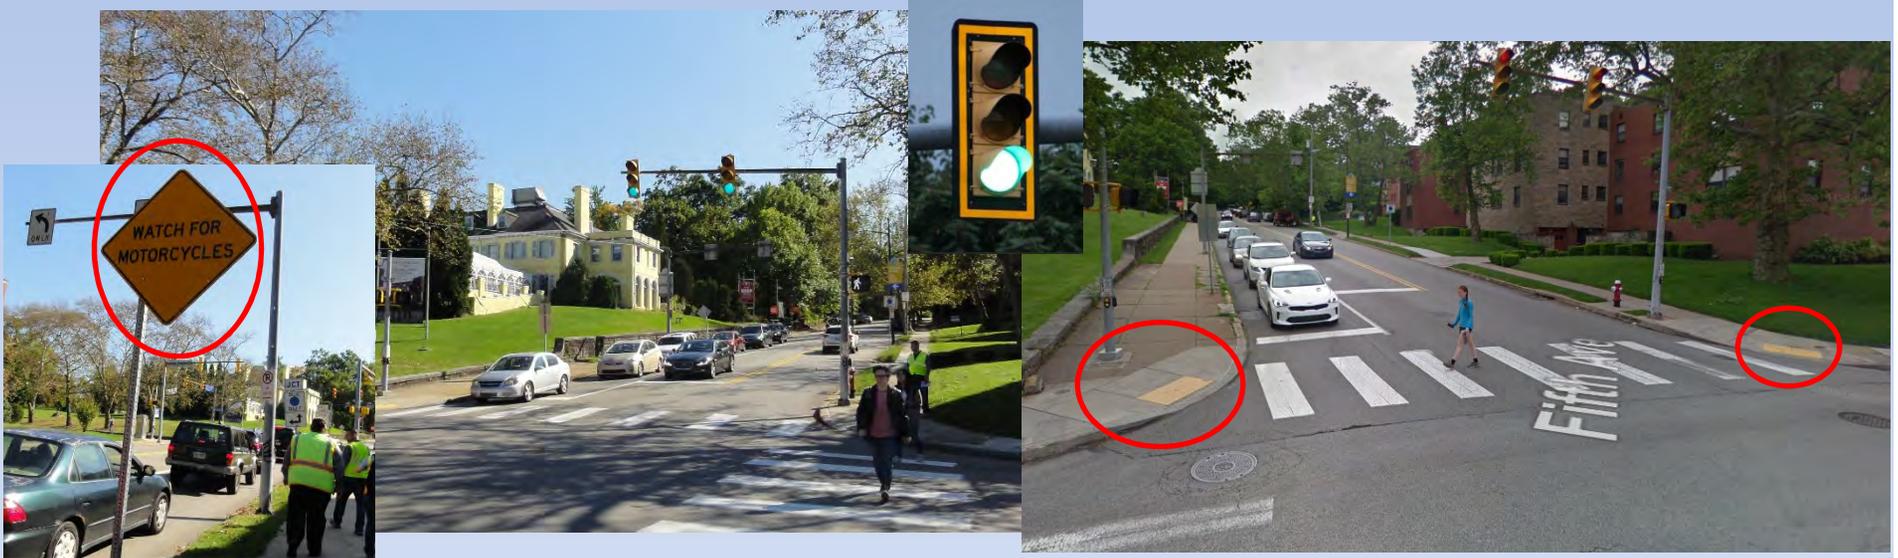
OBSERVATIONS: The signal is old and lacks detection. The lead pedestrian interval in place for the northbound and southbound crossings is too short. Only the westbound approach has left-turn phasing. Lane-use control signing is not in place for 5th Avenue. Stop bar locations may be too close for large vehicles. Unneeded signing is present. Street name signs should be on mast arms. The signal is not ADA compliant.

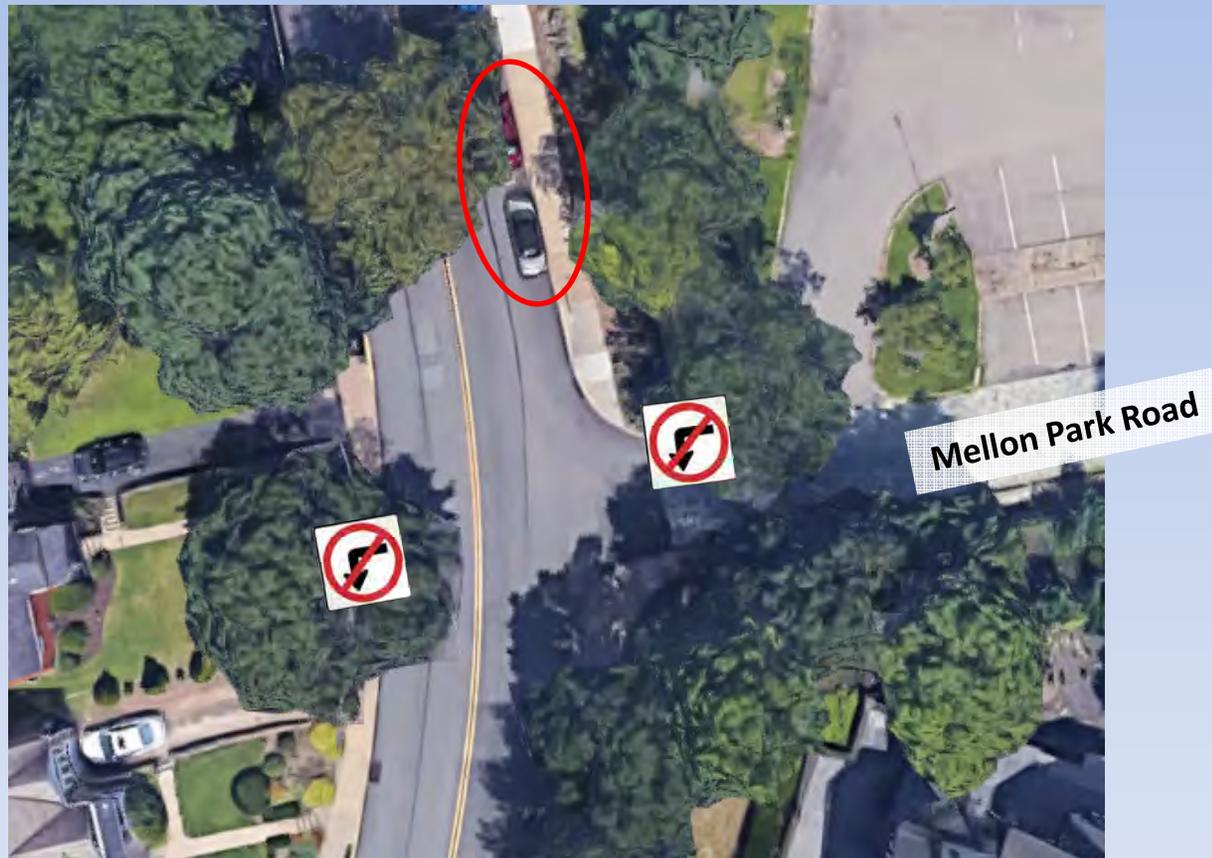
EXPECTED FREQUENCY	EXPECTED SEVERITY	RISK RATING	E
Frequent	Medium	High	
OBSERVATIONS: Parked cars along Shady Avenue block the sight cone of vehicles wanting to make a left turns onto Shady Avenue. There are several accidents noted at this location.

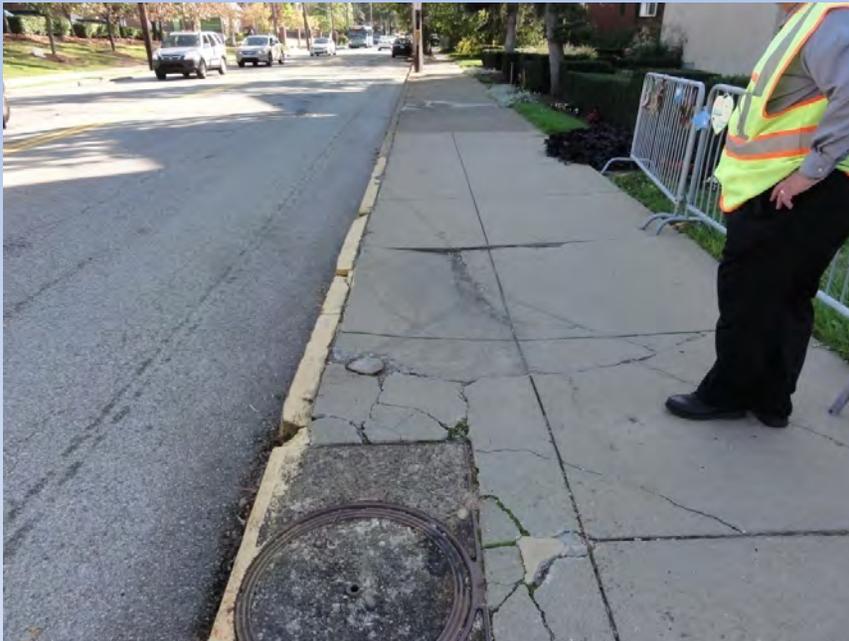
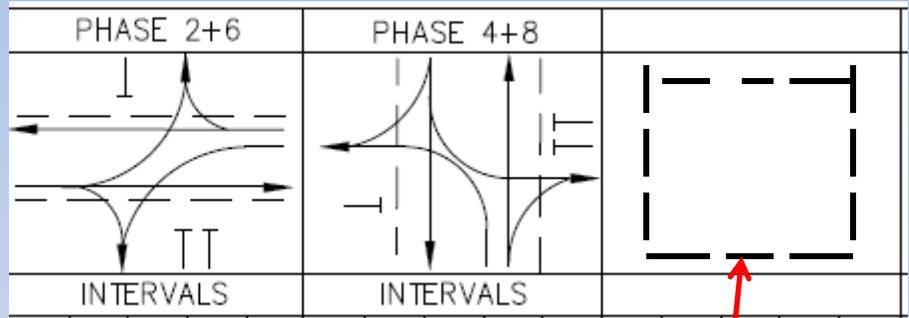
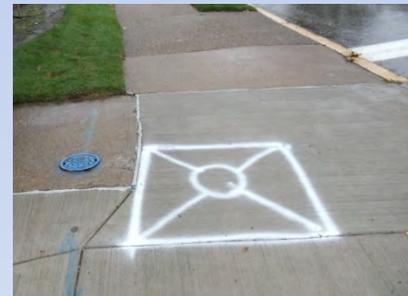
EXPECTED FREQUENCY	EXPECTED SEVERITY	RISK RATING	D
Frequent	Low	Moderate-High	
OBSERVATIONS: Pavement and sidewalk just south of the Wilkins Avenue intersection is in poor condition. This intersection has high pedestrian activity, including school children. City of Pittsburgh is planning to completely upgrade this traffic signal.

- SUGGESTIONS:
- Consider repairing the pavement and sidewalk in this area.
 - Due to the high pedestrian activity, consider an exclusive pedestrian phase as part of the new signal plan.
 - Incorporate new ped phase as part of cycle length (recalled every cycle)
 - New signal should be ADA compliant and have new pedestrian signal heads.
 - Verify marked signal pole locations versus new permit drawing.

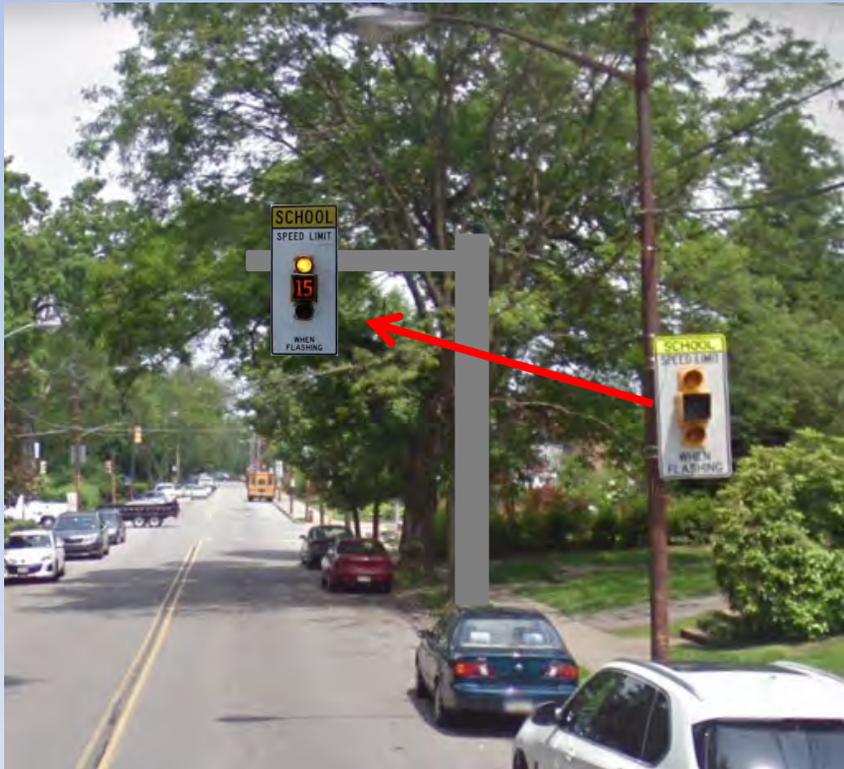
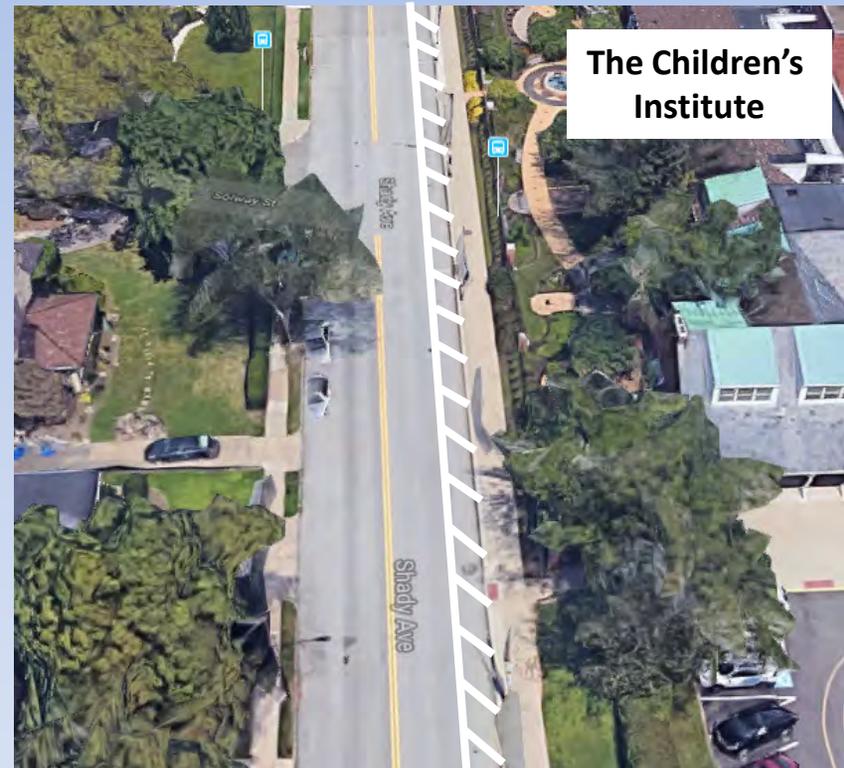
EXPECTED FREQUENCY	EXPECTED SEVERITY	RISK RATING	E
Occasional	High	High	
OBSERVATIONS: The school zone flashers are obstructed by overgrown vegetation or parked cars. The restricted parking and wide pavement in front of The Children's Institute leads to vehicles traveling at higher speeds.

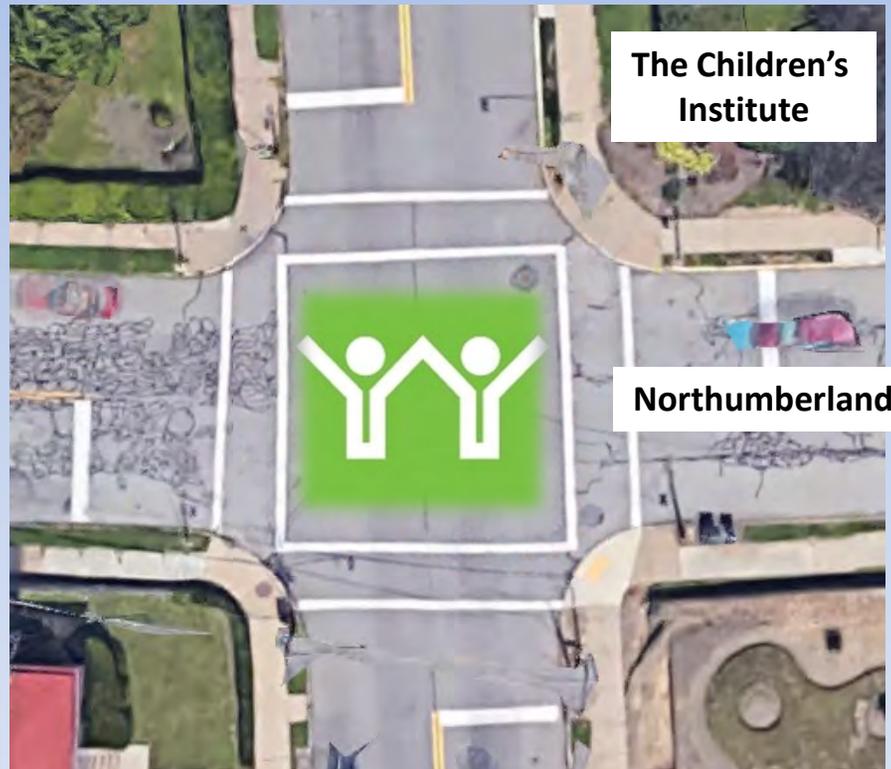
EXPECTED FREQUENCY	EXPECTED SEVERITY	RISK RATING	C
Occasional	Low	Moderate	
OBSERVATION: The restricted parking and wide pavement in front of The Children's Institute leads to vehicles traveling at higher speeds.

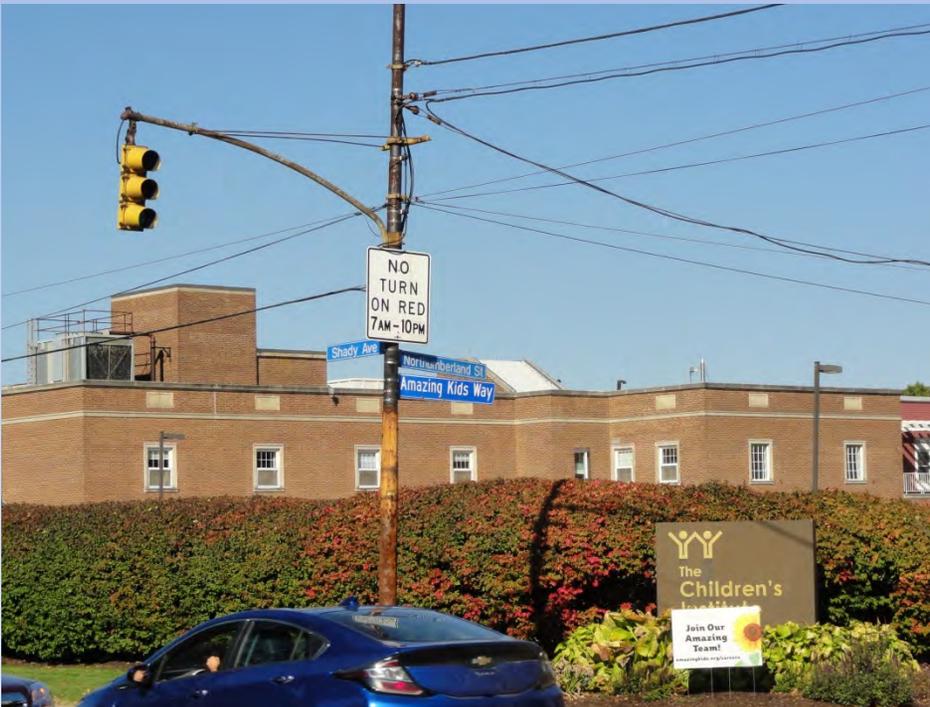
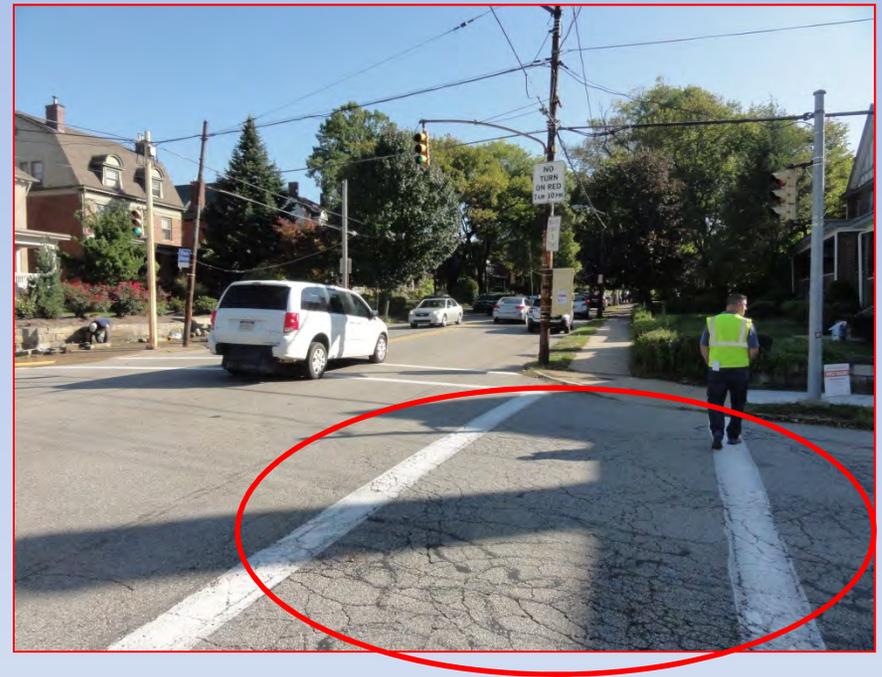
EXPECTED FREQUENCY	EXPECTED SEVERITY	RISK RATING	D
Occasional	Medium	Moderate-High	
OBSERVATIONS: Traffic signal is outdated and in poor condition. Pavement area in crosswalks is cracked. This area has high pedestrian activity, including school children.

- Consider repairing the pavement in this area.
- Consider an exclusive pedestrian phase as part of the new signal plan.
- Incorporate new ped phase as part of cycle length (recalled every cycle).
- New signal should be ADA compliant and have new pedestrian signal heads.
- Consider bulbouts to shorten crosswalks and as a traffic calming measure.

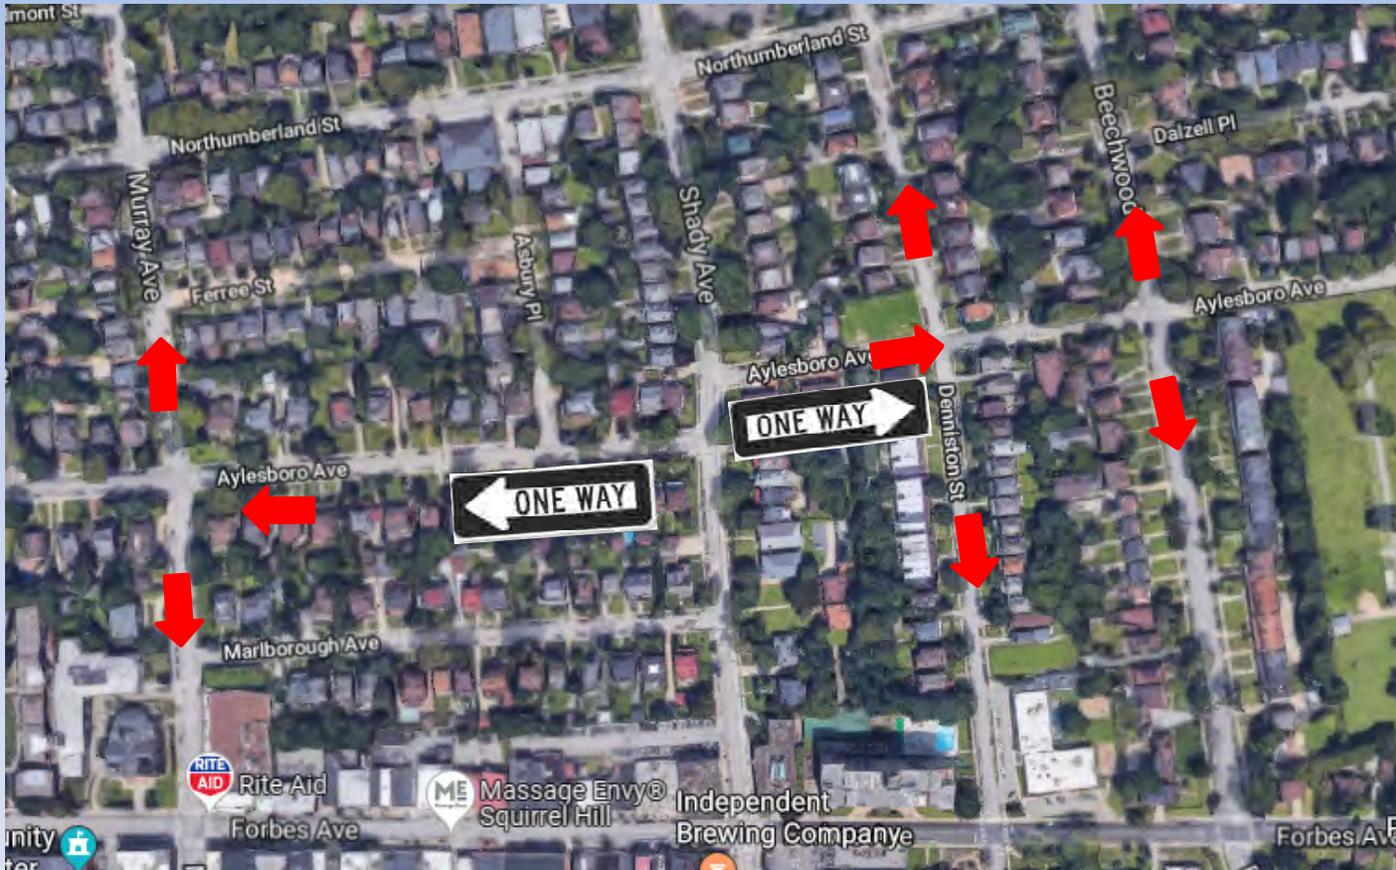
EXPECTED FREQUENCY	EXPECTED SEVERITY	RISK RATING	D
Frequent	Medium	Moderate-High	
OBSERVATIONS: The Aylesboro intersection is offset with Shady Avenue with limited sight distances due to the roadway geometry. There are several reported accidents.
