Southwestern Pennsylvania Commission Shady Avenue from Penn Avenue to Monitor Street Road Safety Audit

Shady Avenue from Penn Avenue to Monitor Street
Allegheny County
City of Pittsburgh

Road Safety Audit Conducted October 2019

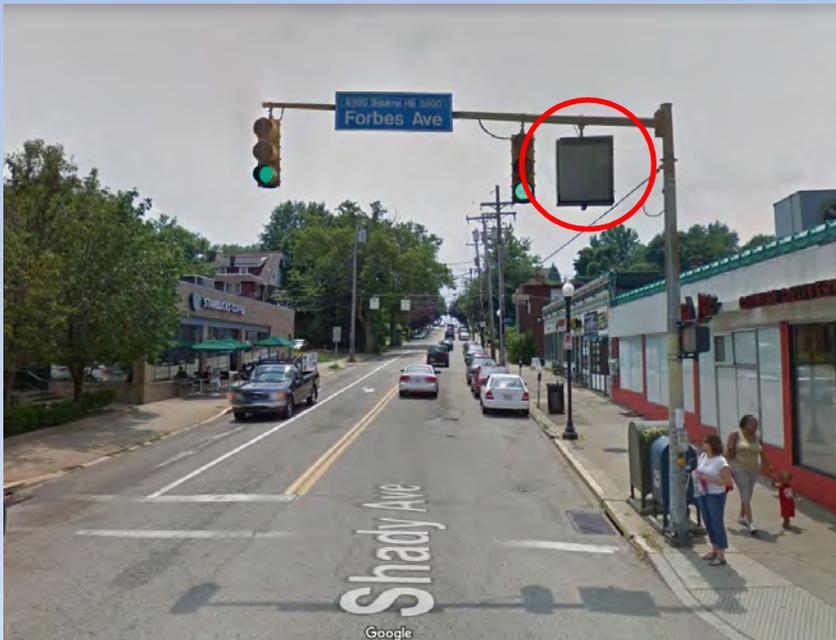
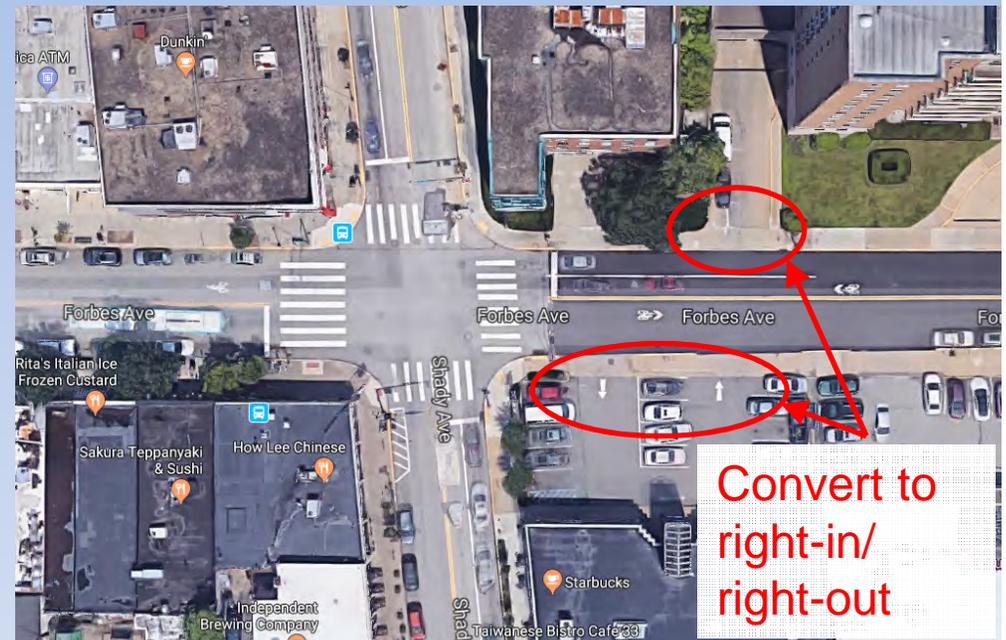
OBSERVATIONS: The signal is old and lacks detection. Left turn lanes are present, but no phasing. The Blank-Out signs appear to be discolored. There is significant pedestrian activity here. Vehicular conflicts were observed with the close driveway to the east of the signal.

- SUGGESTIONS:
- Upgrade signal, add detection, consider adding left-turn phasing.
 - Evaluate changing the exclusive pedestrian phase to a recall setting, to come up all cycles to better accommodate the significant pedestrian volumes.
 - Consider making the NTOR restriction permanent, replace the blank out signs.
 - Work with property owners to prohibit left-turn access to and from the driveways close to the signal.

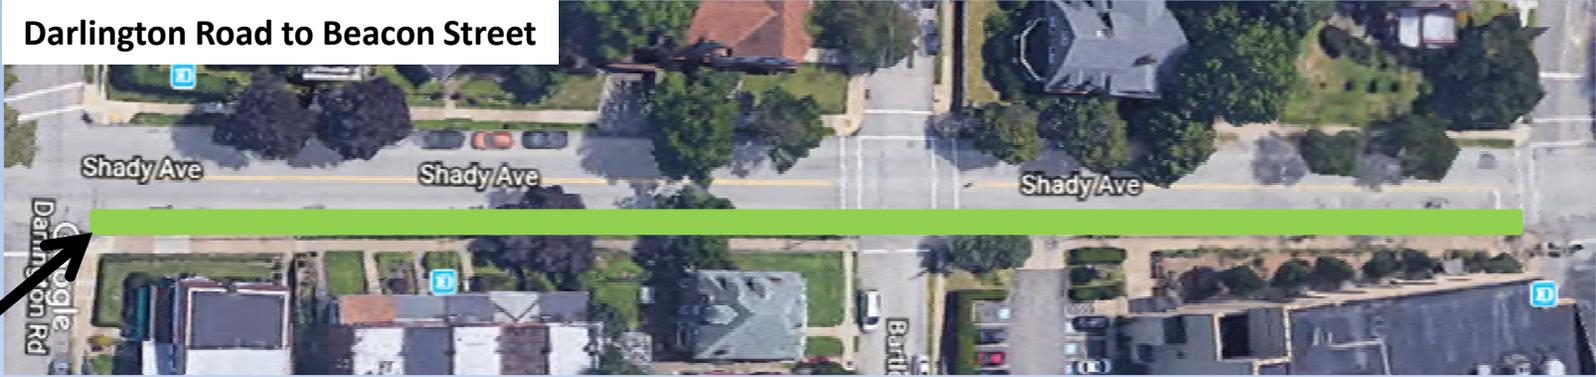
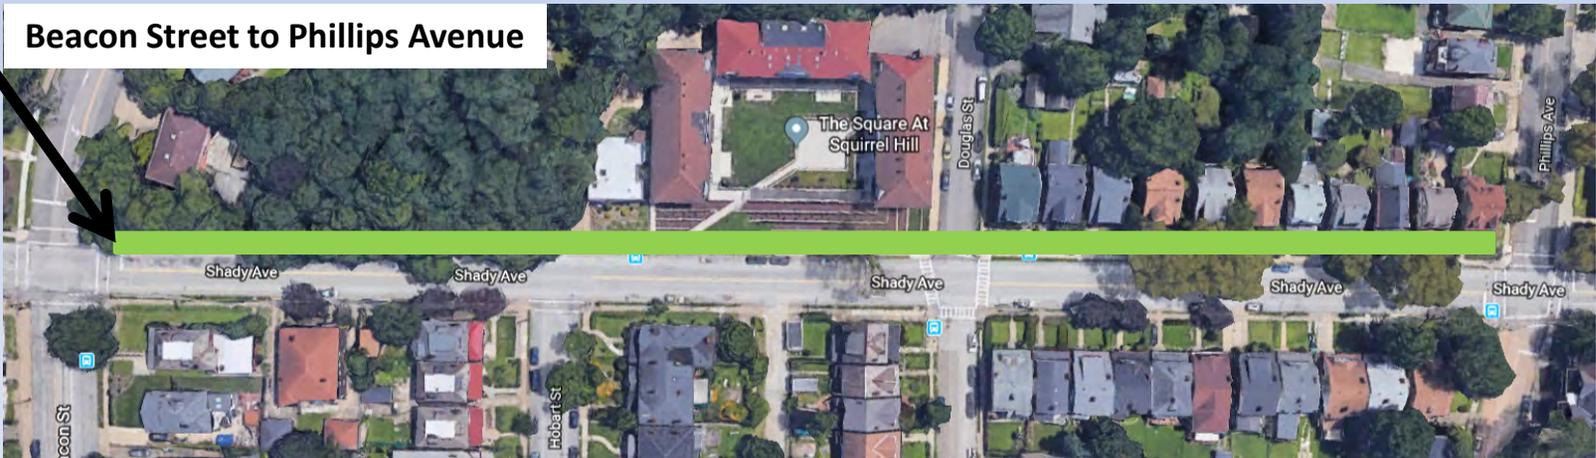
OBSERVATIONS: Parking throughout this section of the corridor is not as heavily utilized. Bicyclists are not able to travel uphill with the flow of traffic.

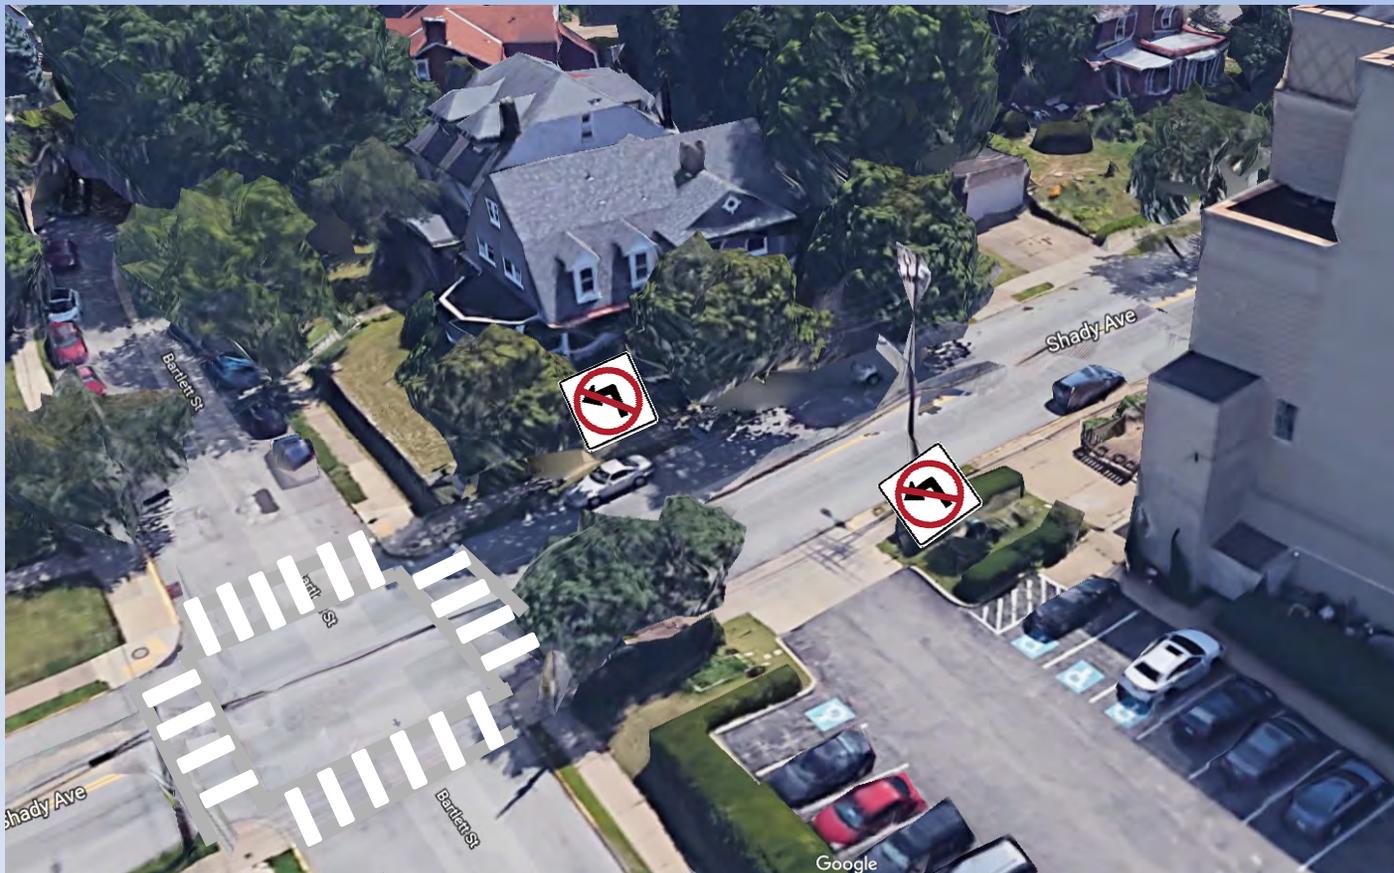
EXPECTED FREQUENCY	EXPECTED SEVERITY	RISK RATING	B
Rare	Low	Moderate-Low	
OBSERVATION: It is difficult for drivers to see around the queue in the SB lane and make lefts out of the school parking lot.

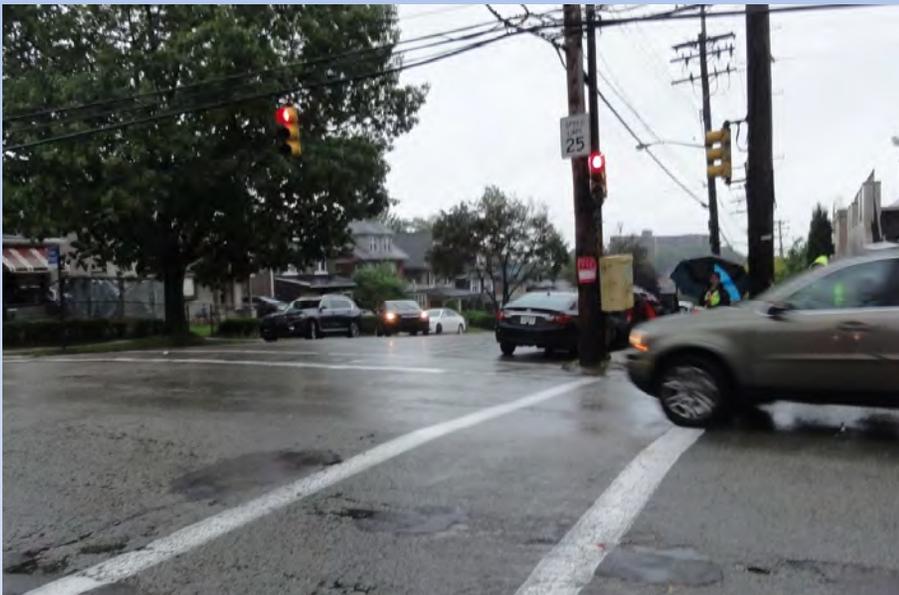
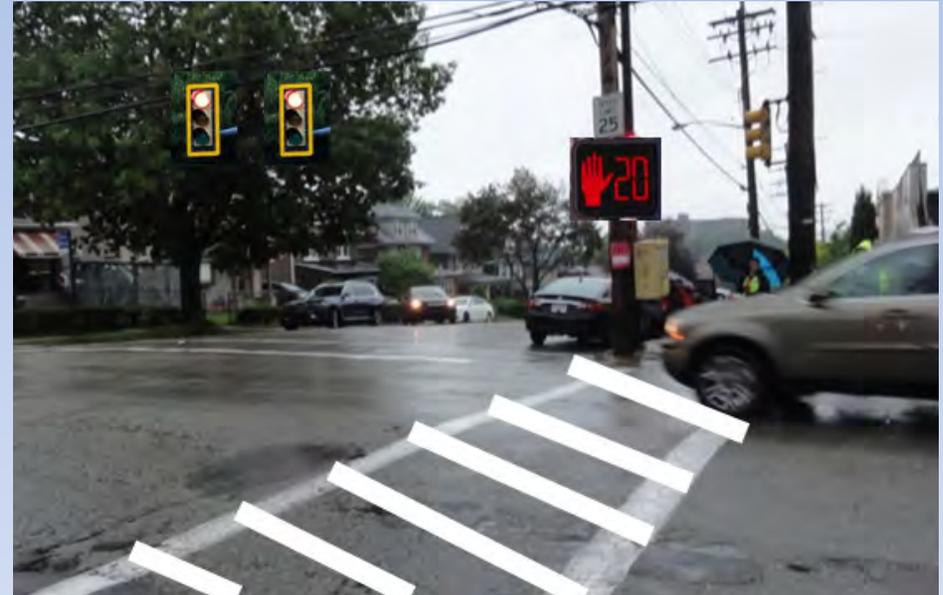
EXPECTED FREQUENCY	EXPECTED SEVERITY	RISK RATING	D
Occasional	Medium	Moderate-High	
OBSERVATIONS: Traffic signal is outdated and in poor condition. Crosswalks are not high visibility type. Intersection is not ADA compliant. There is only one overhead signal head per approach crossing here.

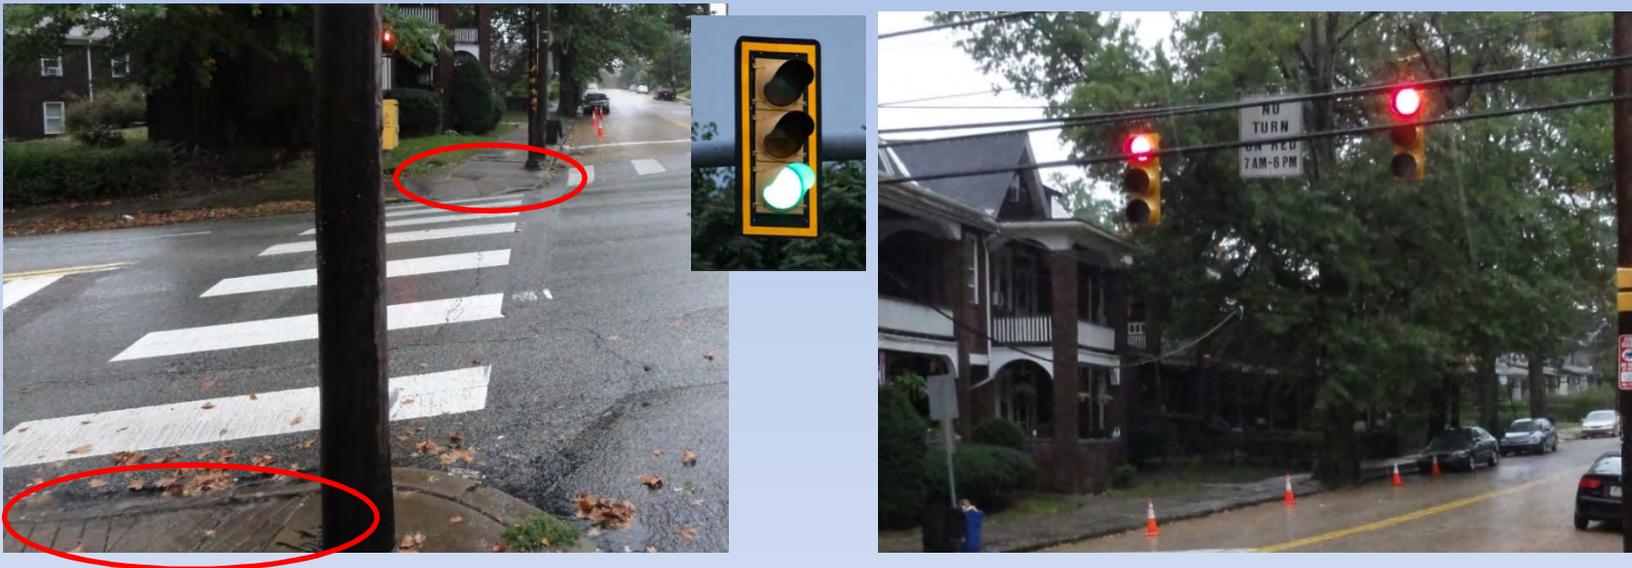
OBSERVATIONS: Two intersections operate from one traffic signal controller. The signal is old and lacks detection. Shady Ave turns as it travels through the intersection with Tilbury, which lacks warning and is unexpected by unfamiliar drivers. The intersection with Tilbury lacks crosswalks across all approaches. ADA accommodations are not adequate.

- SUGGESTIONS:
- Upgrade signal, add detection. Use 12" indications with retroreflective backplates.
 - Short-term: Add dotted extension line through intersection to show path for Shady Ave.
 - Upgrade ADA for all crosswalks.
 - Use consistent NTOR time period for corridor.
 - Replace southbound signal heads at Tilbury with optically programmed signals.
 - Long-term: Realign the southern intersection to a traditional T-intersection. Eliminate southbound right-turn lanes.

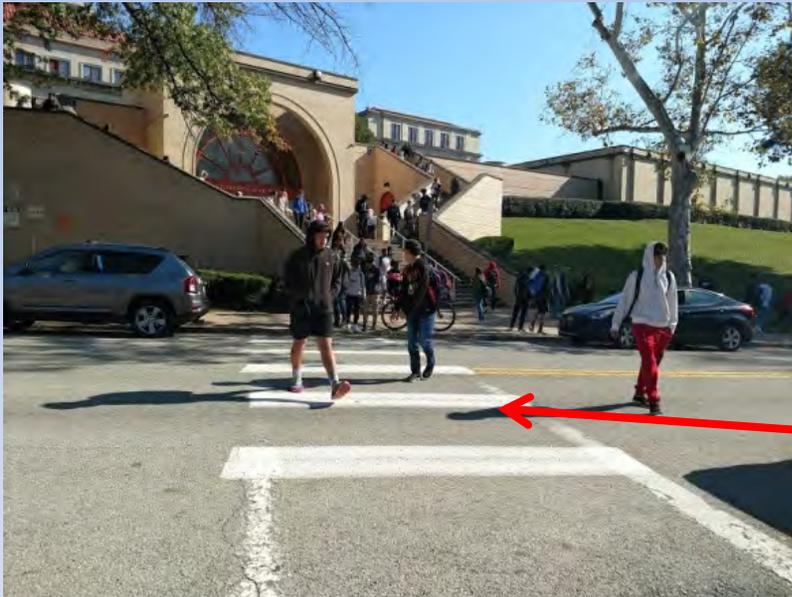
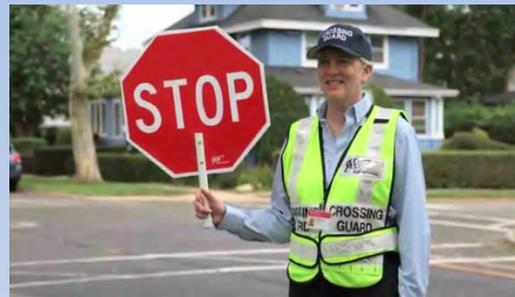
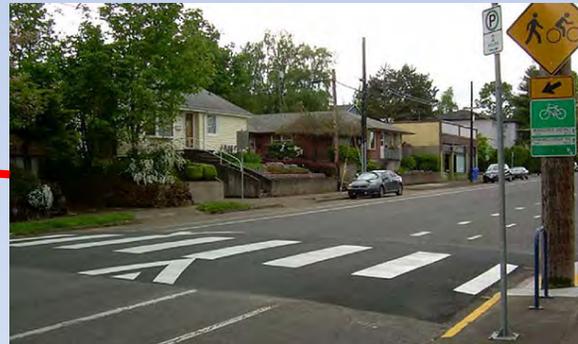
EXPECTED FREQUENCY	EXPECTED SEVERITY	RISK RATING	D
Occasional	Medium	Moderate-High	
OBSERVATIONS: The crossing is heavily utilized by students during dismissal. The school zone signs are side mounted, making them difficult to see. Parents park on the sidewalk near Pittock to pick students up. Drivers were observed not yielding to the students.

<p>SUGGESTIONS:</p> <ul style="list-style-type: none"> • Mount school zone signs overhead. • Add a crossing guard. • Implement a raised crosswalk with a bulbout to shorten the crossing distance. • Develop a school circulation plan for student pickups. • Study the need for RRFB at Pittock and Sherbrook.
--

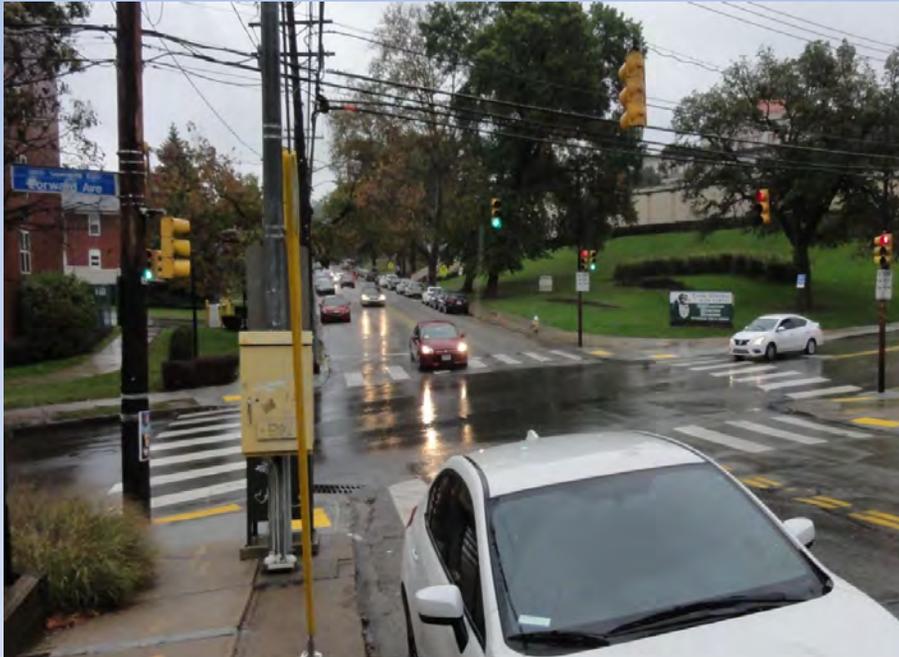
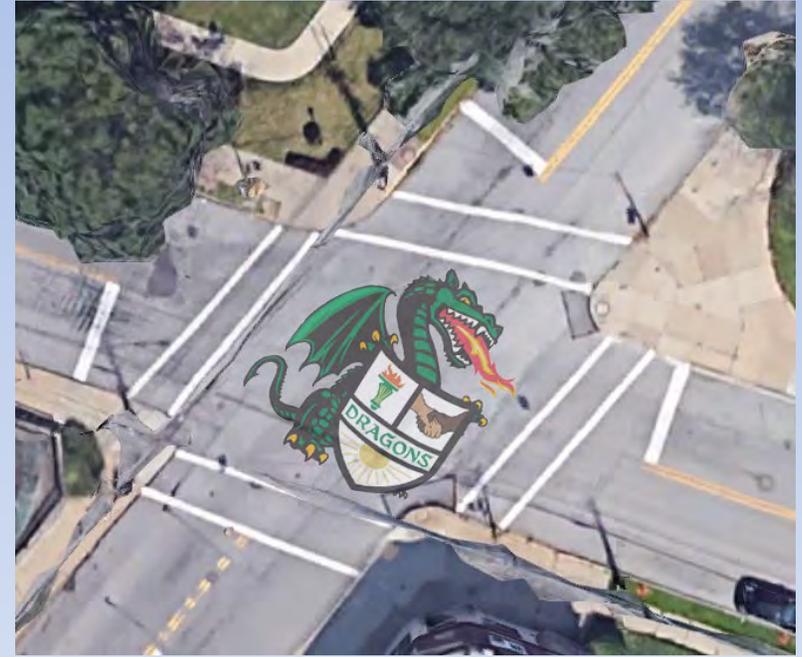
EXPECTED FREQUENCY	EXPECTED SEVERITY	RISK RATING	D
Occasional	Medium	Moderate-High	
OBSERVATIONS: Traffic signal is outdated. Several vehicles speeding and running red lights were observed.

- SUGGESTIONS:
- Completely upgrade the traffic signal to include ADA compliance, LED pedestrian countdown signals with LPI.
 - Add artwork to intersection between crosswalks to alert drivers to the proximity of the school/pedestrian traffic.
 - Potential intersection for pilot ARLE, automated red light enforcement. In the interim, increase enforcement of red-light running.

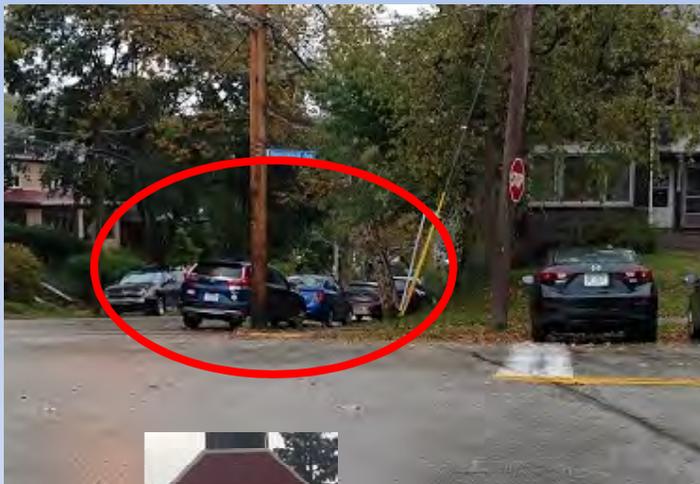
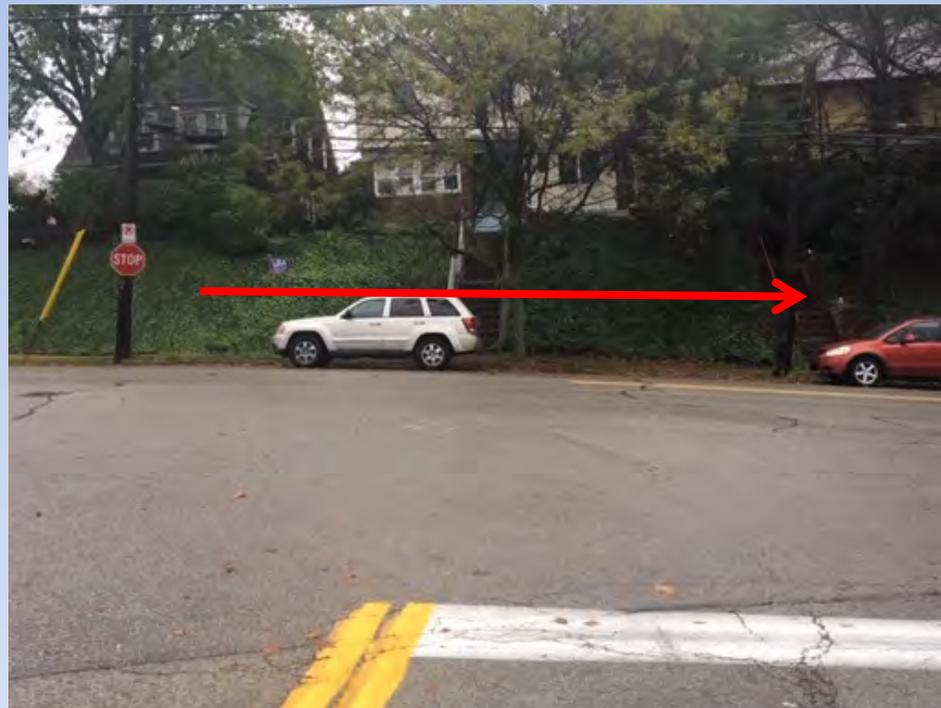
OBSERVATIONS: The intersection configuration is confusing for drivers. The eastbound approach sight distance is hindered due to landscaping and parked cars. Three way stop placards are obsolete per the MUTCD. The supplemental stop sign is located out of sight for drivers.

- SUGGESTIONS:
- Remove/enforce parking restrictions and trim landscaping to allow for adequate sight cone.
 - Replace THREE WAY with ALL WAY supplemental placards.
 - Relocate supplemental stop sign for Morrowfield Ave.

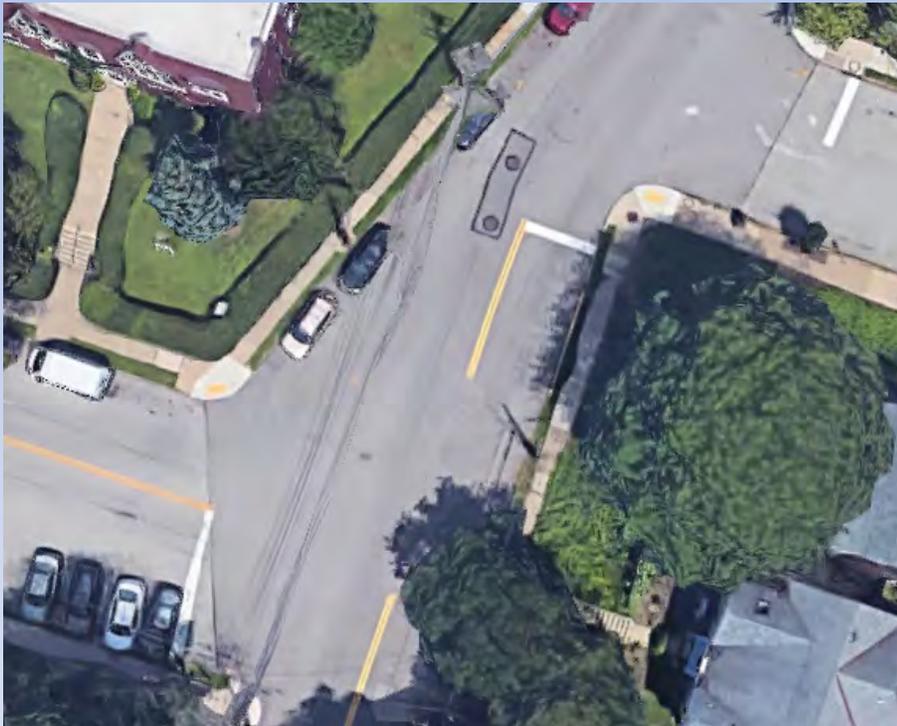
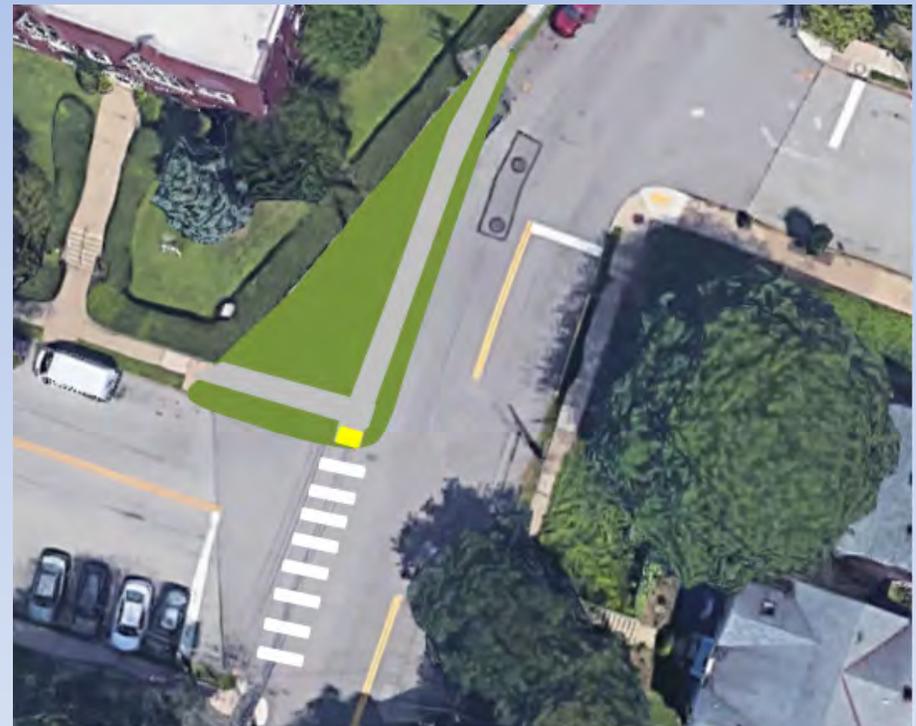
EXPECTED FREQUENCY	EXPECTED SEVERITY	RISK RATING	D
Frequent	Low	Moderate-High	
OBSERVATIONS: The intersection configuration is confusing for drivers. The crosswalk on the western side of the intersection is very long.
