Re: Public Works Facility Structural Assessment  
Division 4 Public Works Facility  
414 Bausmann Street, Pittsburgh, PA  
Walter P Moore Project No. D01.17017.00

**DIVISION 4 PUBLIC WORKS FACILITY  
STRUCTURAL ASSESSMENT**

414 Bausmann Street  
Pittsburgh, PA

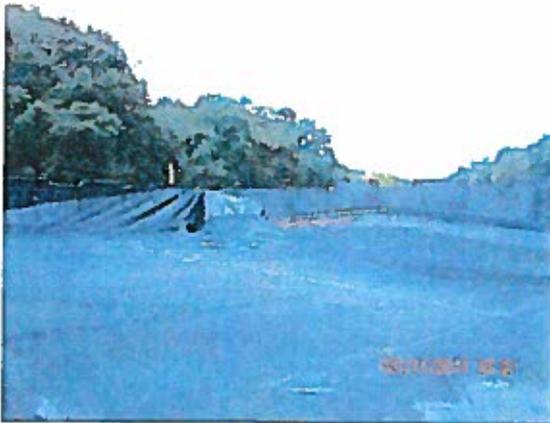
Photo 12 - Waterproofing membrane pulling away from termination bar.

The gable roof (above the attic and attached garage) is constructed with steel purlins that span between the truss top chords, which run east to west, and wood planking that span between the purlins running north to south. The shingles on this roof are aged, cracked, and deteriorated. The flashing, gutters, and down spouts of this roof are in poor condition or missing. The lack of proper drainage components is allowing water through the roof and into the building.

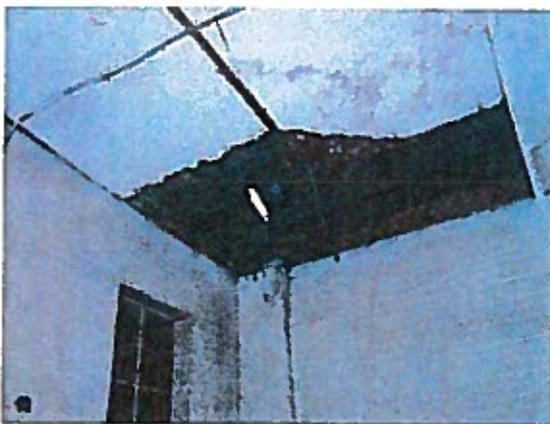
Photo 13 - Daylight seen in roof.

The flat roof above rooms 100 and 200 is constructed with wood joists and wood sheathing. The flashing, gutters, and down spouts of this roof are in poor condition or missing. The waterproofing membrane is deteriorated and has open seams/rips in some areas. Water leaks have caused the wood deck at the south-west corner of the roof to collapse, resulting in a hole in the roof.
