Pittsburgh Step Survey Field Guide

Bicycle/ Pedestrian Office

The Survey Process

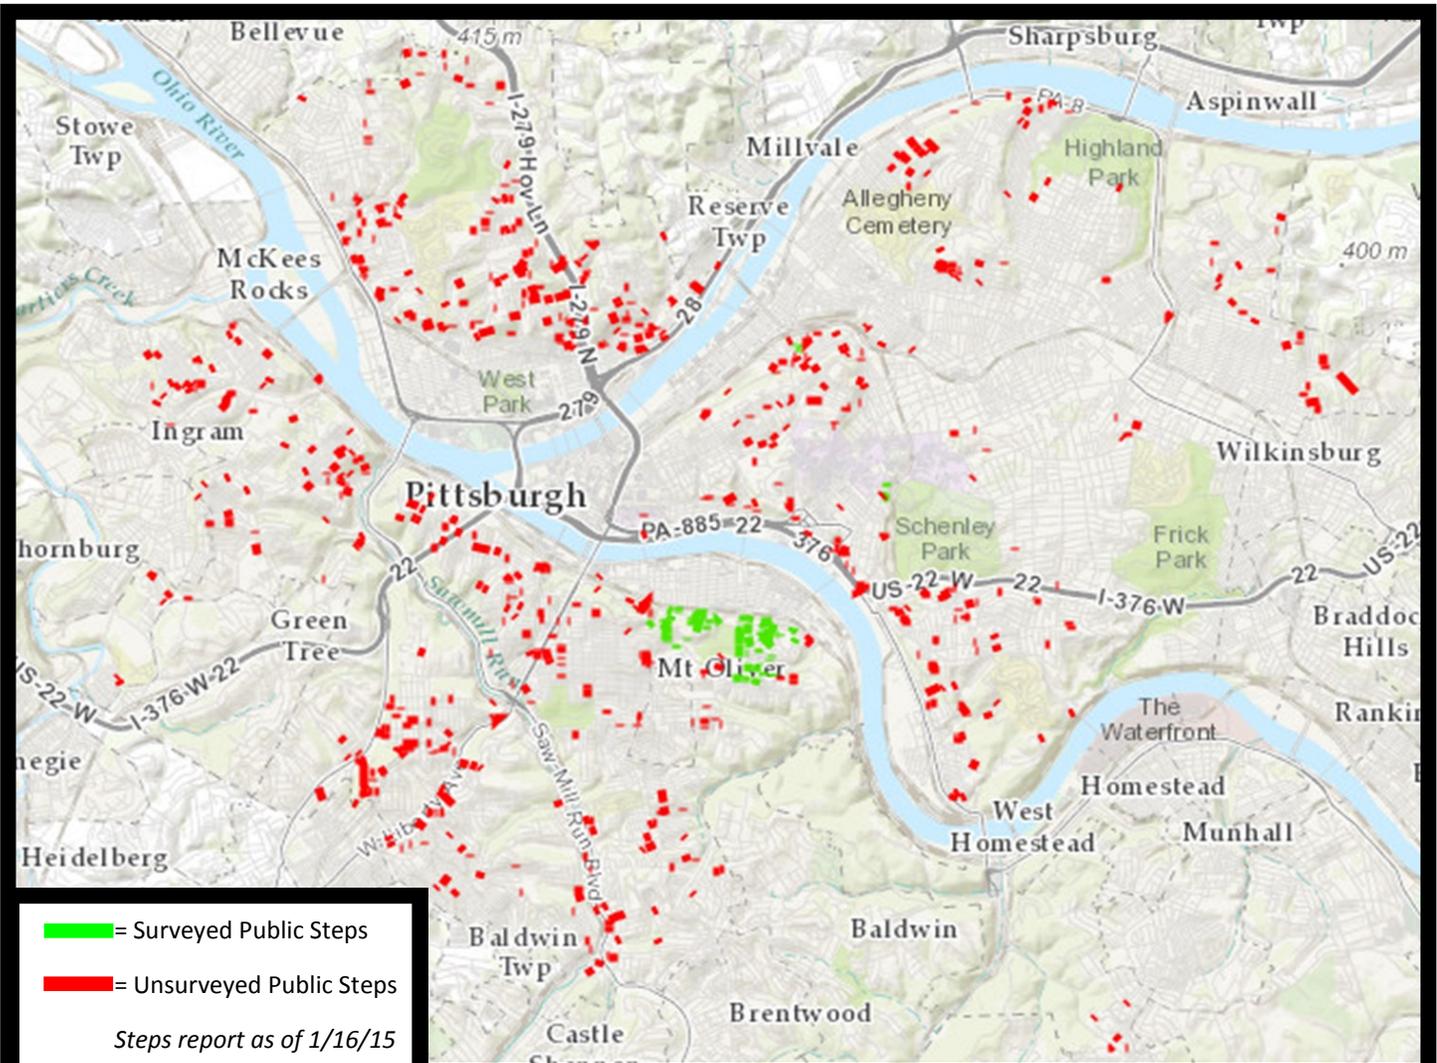
The City of Pittsburgh has over 700 staircases which need to be cataloged. Above is a map of Pittsburgh's network of public stairs. Lines in green indicate a set of steps which has been surveyed. The lines in red indicate sets of steps which remain to be surveyed. Much work remains to be done, but with the help of volunteers, the survey process will be expedited.

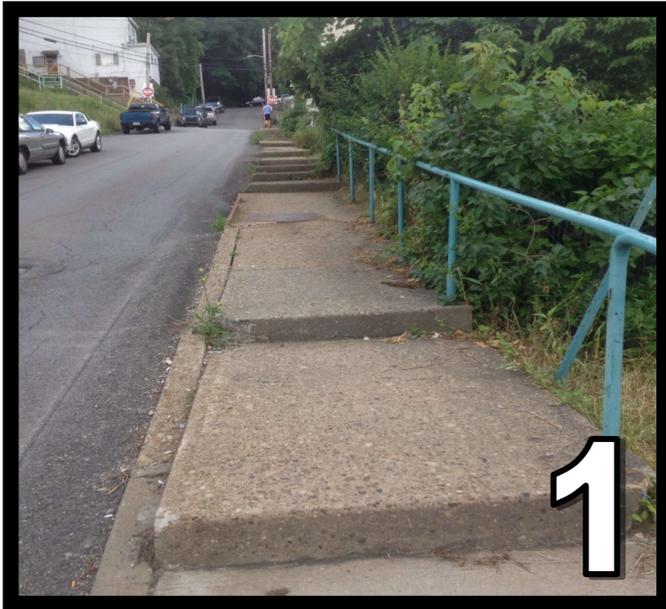
Picture 1: The flat surface of each step is over 4 feet, therefore each step also qualifies as a landing and should be counted as a step and as a landing.

of landings: total number of flat surfaces after a riser that are longer than approximately 4 feet (steps consist of a riser and a tread of less than 4 feet). See Pictures 1,2, and 4.

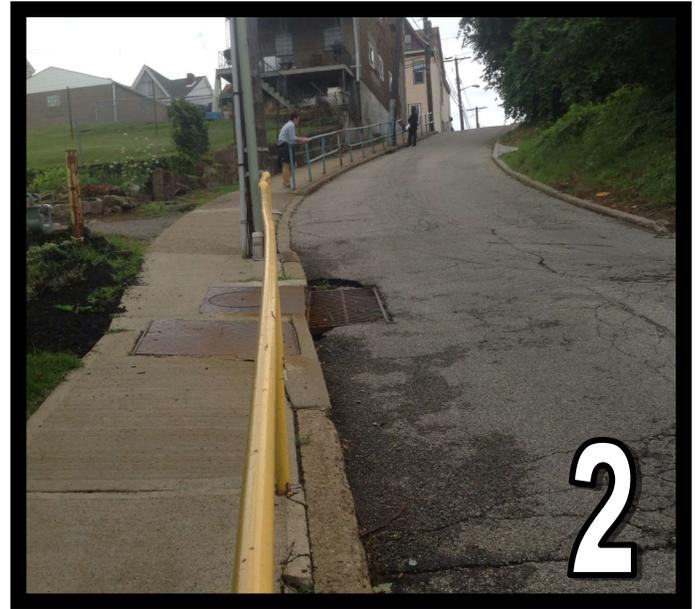
Picture 2: This sidewalk with a railing begins with a single step. The bottom is considered a staircase with 1 step and 1 five foot landing.

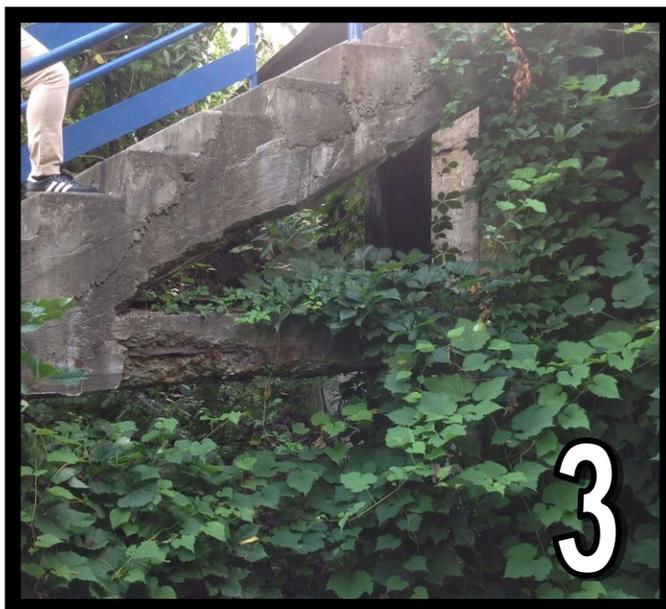
Picture 3: This staircase is built on piers, elevated from the ground below.

Type: Piers or On-Grade. Most steps with very steep inclines are on piers; they are not level with the surrounding earth or pavement. On Grade steps are built into the hill side. See Pictures 3 and 4.

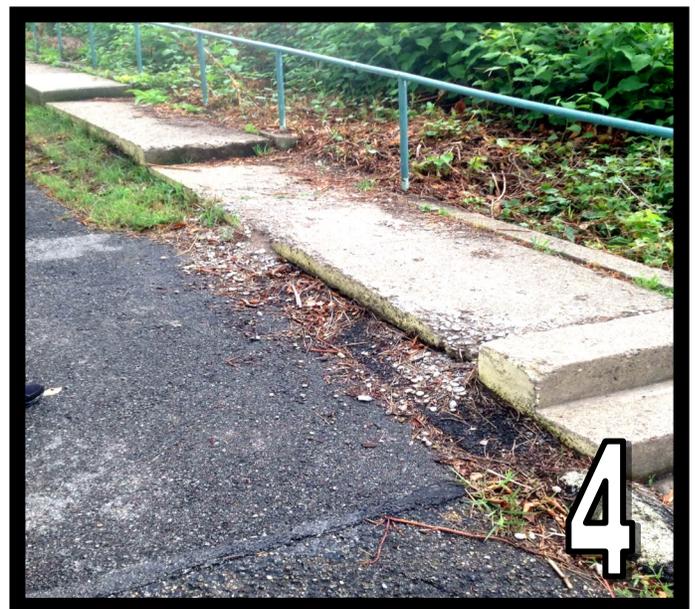
Picture 4: This staircase is built on grade, laid directly into the contour of the ground.

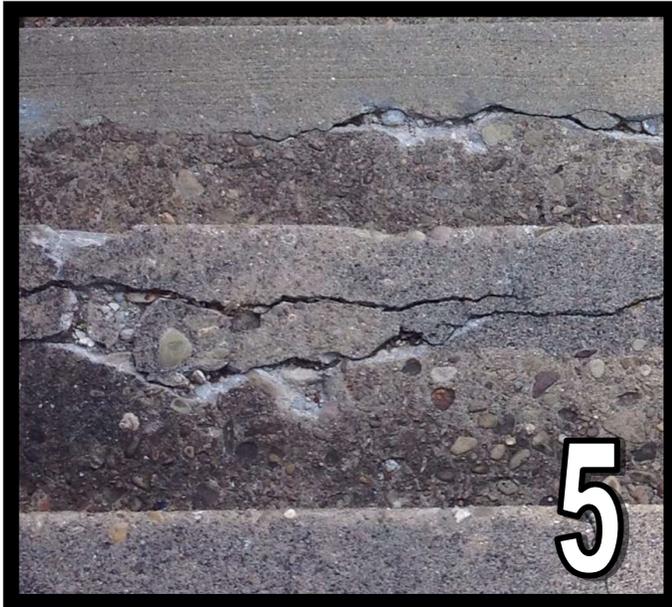
Picture 5: Cracking in the tread on two steps.

Tread Cracking: Each instance of cracking, in severe cases may be combined with TR Chipping and TR Spalling. See Picture 5.

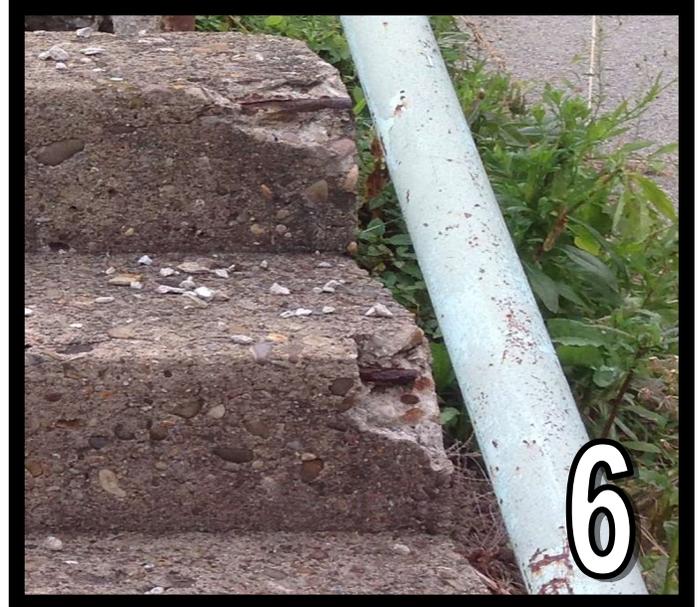
Picture 6: Two instances of chipping on the corners. Note the exposed rebar as well.

Tread Chipping: Each instance in which a chunk or chip of concrete or other material is missing, note the difference from spalling. See Picture 6.

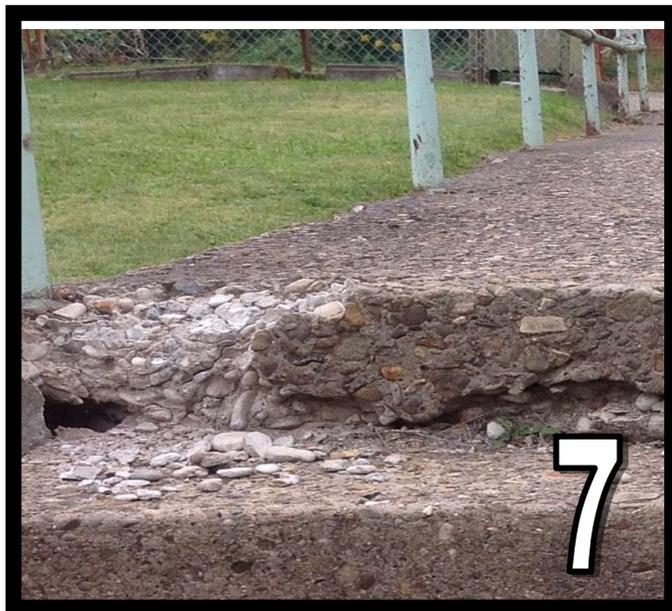
Picture 7: One instance of severe spalling, step is beginning to erode.

Tread Spalling: Each instance in which a layer(s) of surface material is removed, similar to chipping but over more expansive areas of the surface. See Picture 7.

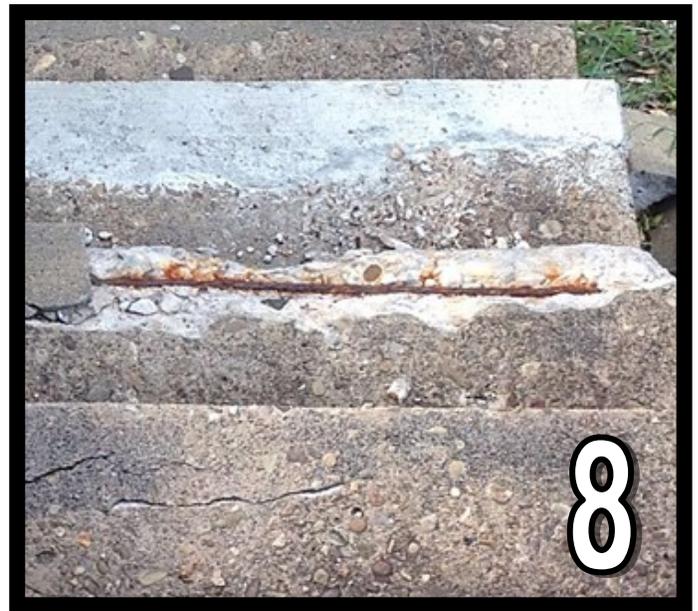
Picture 8: One instance of exposed rebar in the tread.

Tread Exposed Rebar: Each instance of visible steel structure meant to be contained within the surface material, usually concrete. Exposed rebar comes hand in hand with chipping, spalling, cracking, and rust/staining. See picture 8.

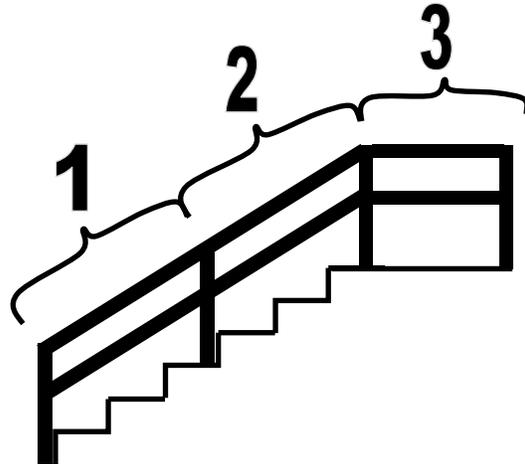
R Total Sections: Total number of railing sections, defined as the area between two vertical supports. The diagram below shows how each section is counted. Remember to count both sides of the railing, in the example below two handrails would lead to 6 sections.

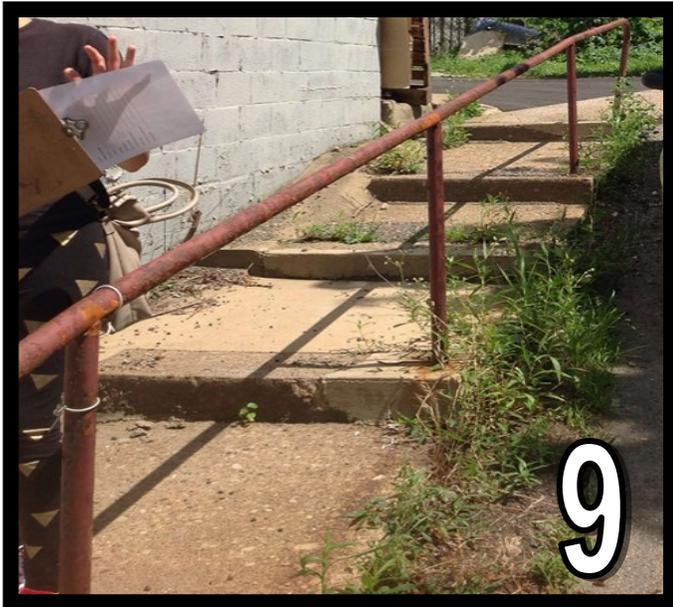
Picture 9: 100 % rusting. Note that not all rusting is this extreme.

Rail Rusting : Where the paint has been chipped, spots of rusting, or unpainted rails occur. Severity of the rusting may vary from mild to extreme, mark a percentage for the degree of rusting.

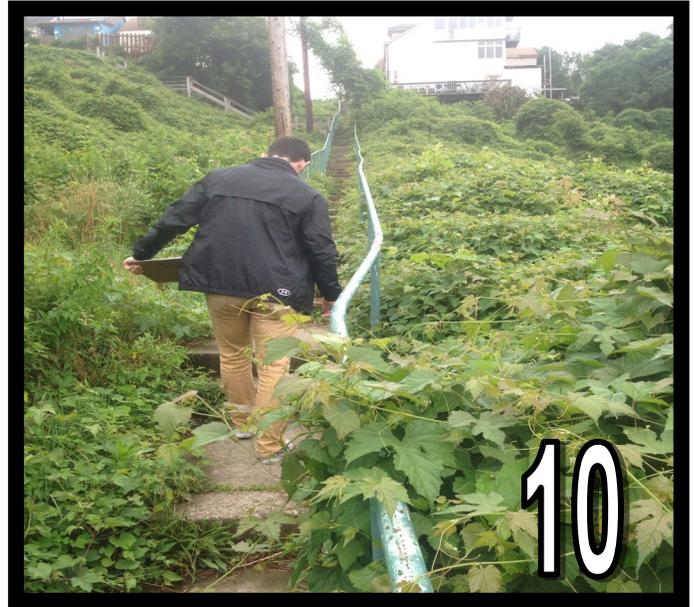
Picture 10: Note the bend in the railing beside the pedestrian as well as successive bends up the hill.

Rail Bent: A bend in the rail where the staircase continues straight. See Picture 10.

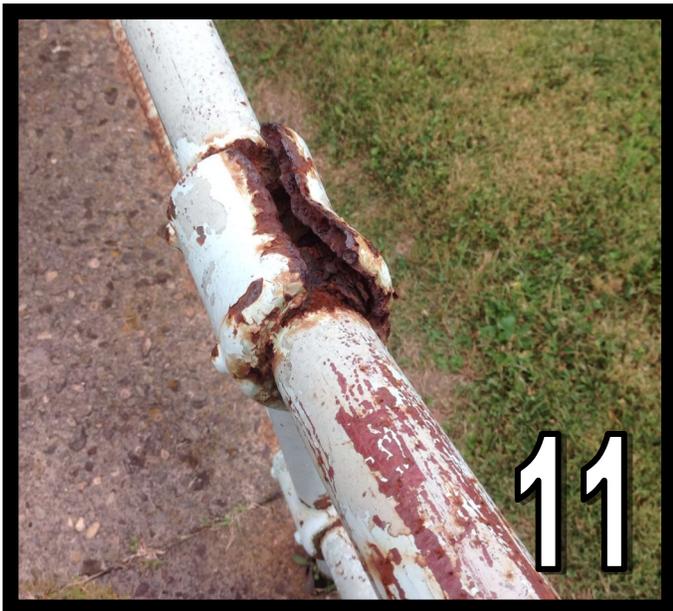
Picture 11: Cracked rail joint. Remember to inspect the joint as well as the base for each section of railing.

Rail Cracked Base/Joint: Joints are where railing pieces are adjoined and a base is where a railing support is attached to earth or pavement. Remember to inspect each railing base as it is easy to miss bases in bad condition in overgrown areas. See Picture 11.

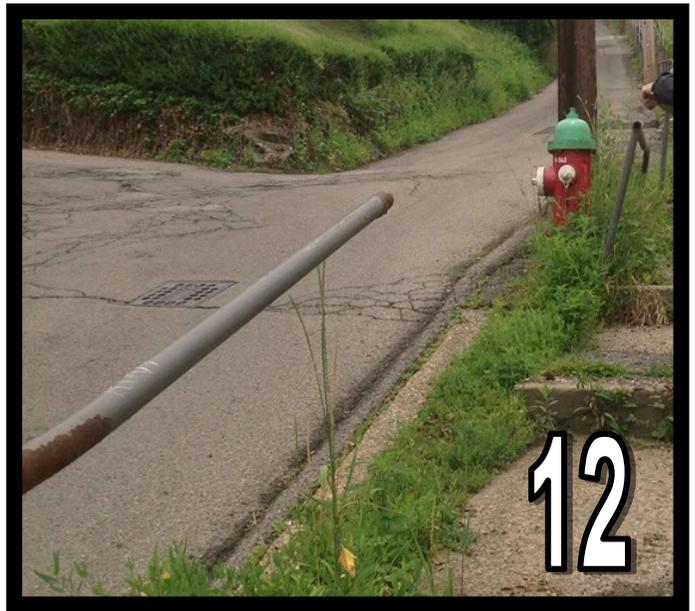
Picture 12: Missing railing. All railings should have a proper baluster at their ends. In this photo, it appears the railing is missing several components.

Rail Nonexistent: Each instance of railing missing where there should be a railing. Railings belong on all slopes, unless there is an entrance to a building or garage in which case there should be an appropriate gap. It is easy to pass by areas with missing railing sections without ever noticing there should be a railing there. See Picture 12.

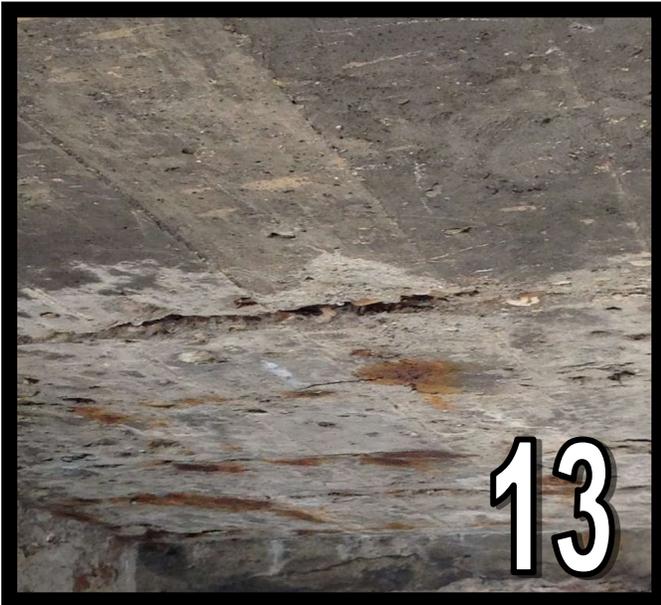
Picture 13: Underside of the staircase shows signs of wear. Rust staining, cracking, and chipping are all evident and suggest damage to the support structure.

Structural Support cracking: same criteria as TR Cracking, except for the support structure visible from side and/or internal/underneath angles. See picture 13.

Structural Support Chipping: Each instance in which a chunk or chip of concrete or other material is missing from the structural support. See picture 13.

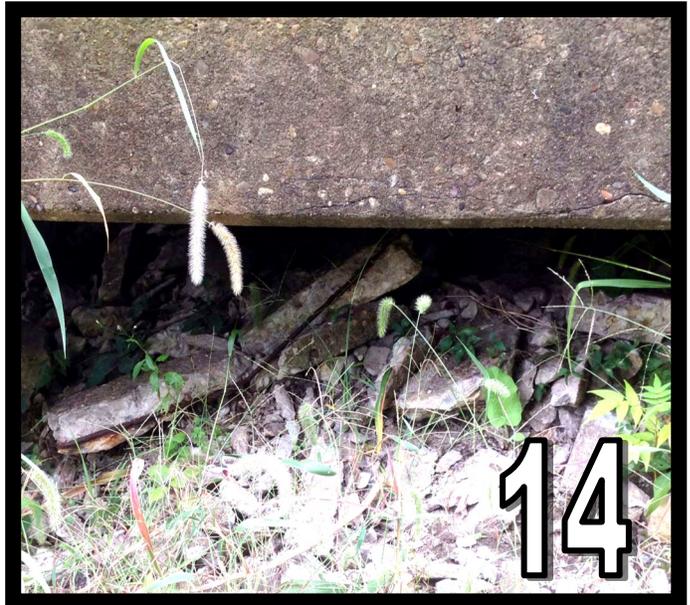
Picture 14: While difficult to examine the structural support of many steps, spalling is evident in the rubble and debris.

Structural Support Spalling: Each instance in which a layer(s) of surface material is removed, similar to chipping but over more expansive areas of the surface. see picture 14.

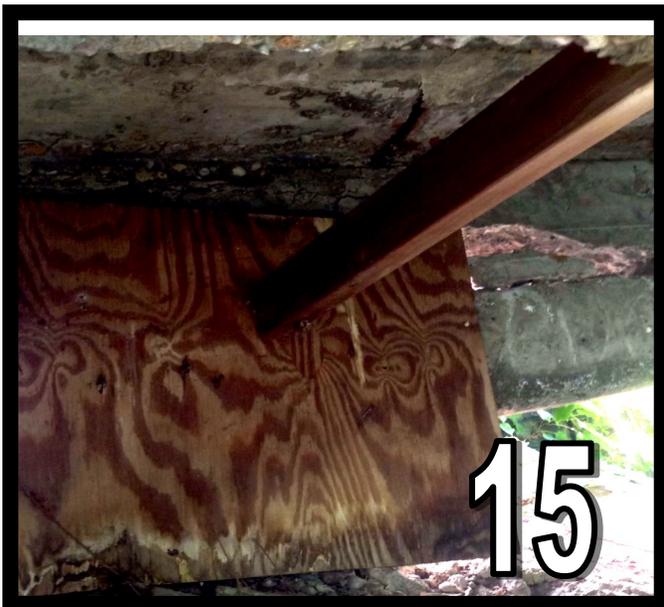
Picture 15: This photo demonstrates a temporary repair to a deformed staircase. Note the deformed concrete behind the plywood.

Structural Support Deformed Bending: Structural components are deformed, collapsed or bent. See picture 15

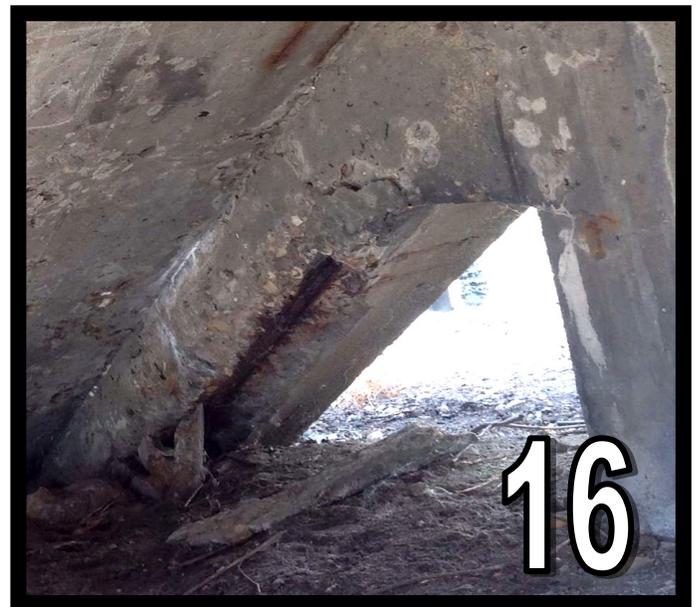
Picture 16: Exposed rebar accompanies chipping.

Structural Support Exposed Rebar: Self-explanatory, usually refers to exposed support rebar or wooden staircases. See picture 16.

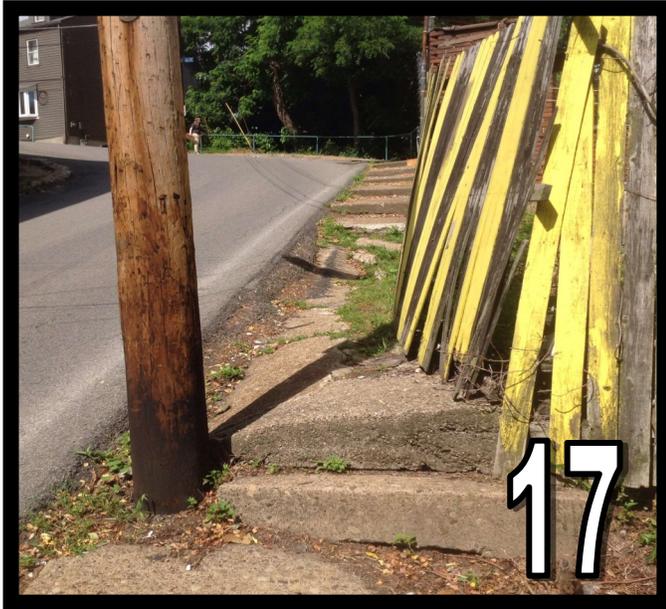
Picture 17: A fence obstructs the pedestrian path.

Obstruction: Anything that would significantly hinder travel up or down a staircase such as excessive overgrowth, private property signage, etc. See Picture 17.

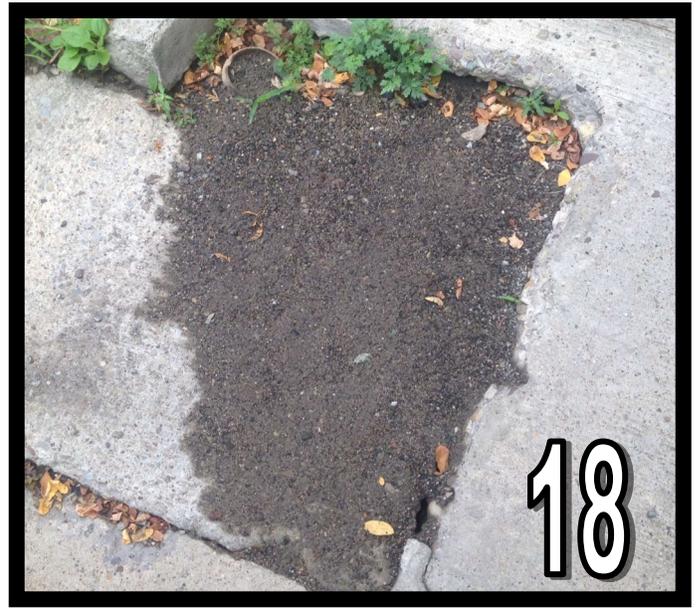
Picture 18: Sediment deposit. Look for deposit on depressed steps or on the side of the structural support.

Runoff Deposit: The result of erosion, record each instance of sediment build-up, usually from flooding events. See picture 18.

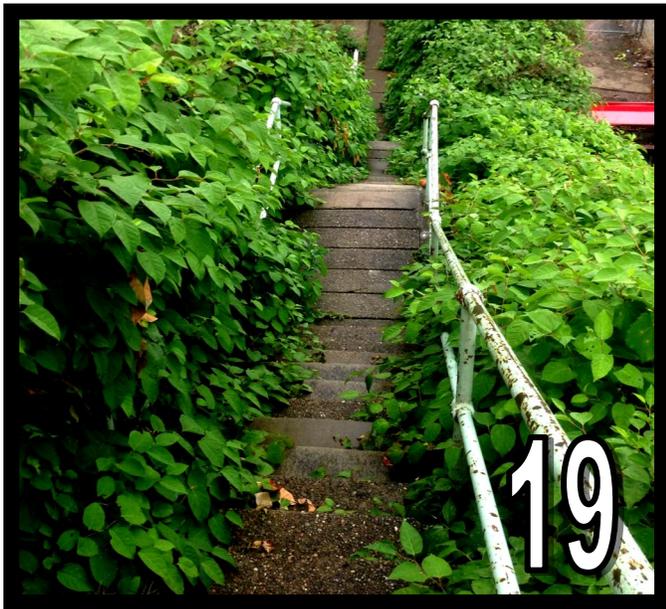
Picture 19: Overgrowth at 100%. Any plant reaching within 6 inches of the railing is considered overgrowth. Estimate for an additional two months of growth. Mark how much of the staircase is covered in 25 percent increments.

Overgrowth: Percent overgrown: 0%,25%, 50%, 75%, 100% See Picture 19.

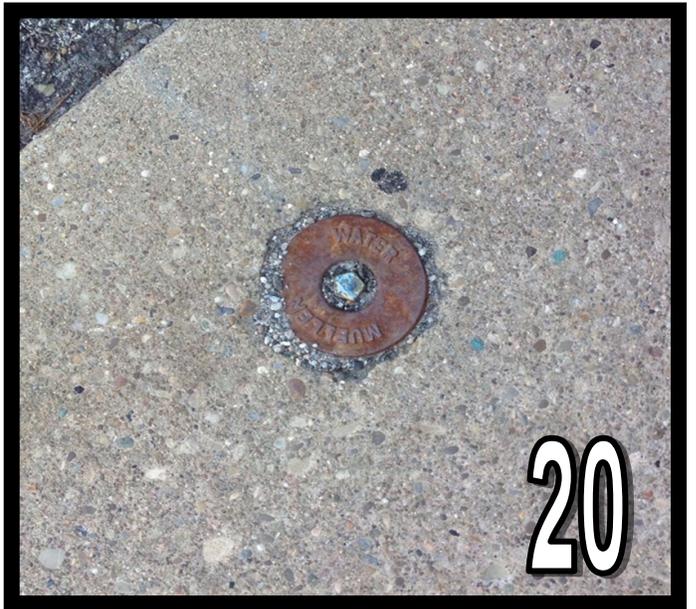
Picture 20: Access to a water line. Note any adjacent utilities such as gas, sewage, drainage, or anything in the direct path of the staircase.

Utilities: Gas, Water, Electric, etc in the direct path way of the stairs. See Picture 20.

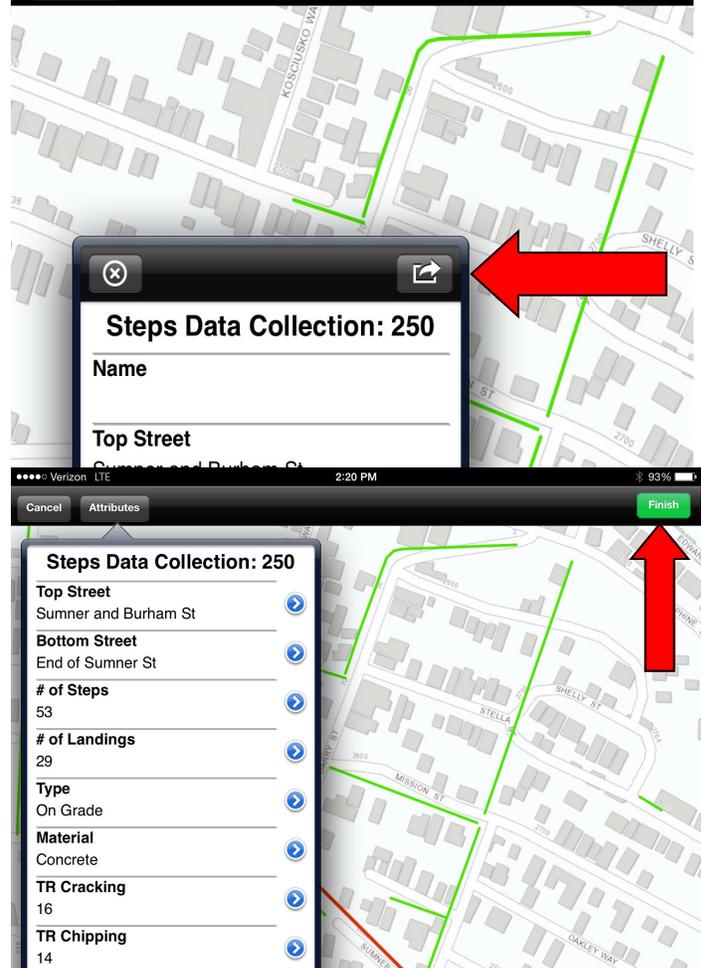
Entering data into the form and taking pictures:

1. Click directly on the step set you want to record data
2. The window will pop up
3. To edit click the icon in the upper right hand corner of the window
4. Enter data into each section according to the manual entries
5. Only numbers can be entered in questions expecting number answers. Text answers can be numbers or text.
6. To add photos click on the attachment button on the bottom of the edit form.
7. Click "Add"
8. Click "Take Photo"
9. Select "use photo"
10. Remember to hit 'FINISH' in the upper right hand corner
