## **South Side Presbyterian Church**

### **City of Pittsburgh Historic Landmark Nomination**

**Prepared by Preservation Pittsburgh for the South Side Presbyterian Church**

December, 2018.

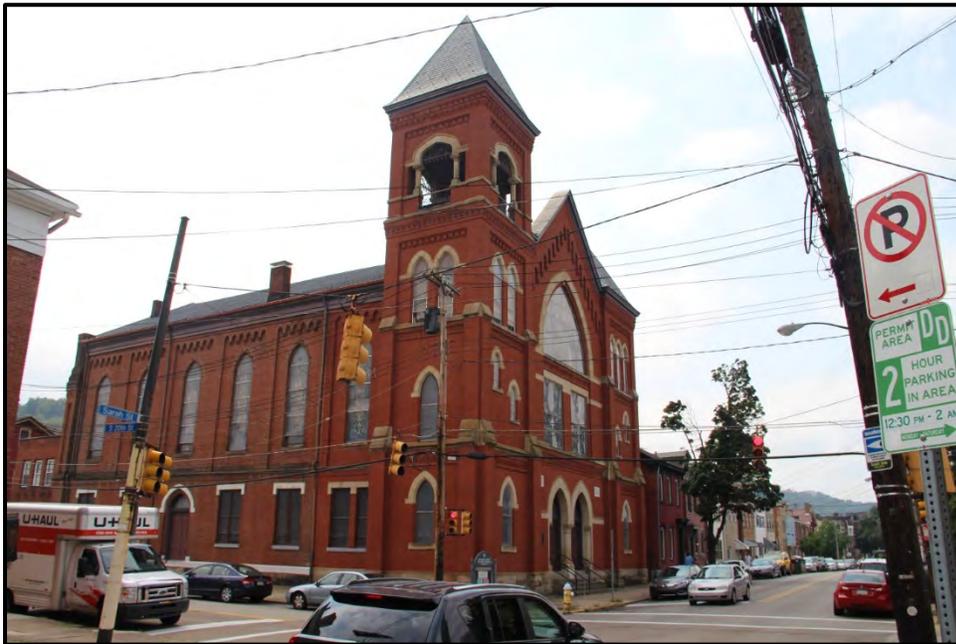
*Photo 1: South Side Presbyterian Church (August 2018). View southwest from corner of S. 20th and Sarah streets showing an overview of the east (side) and north (front) façades.*

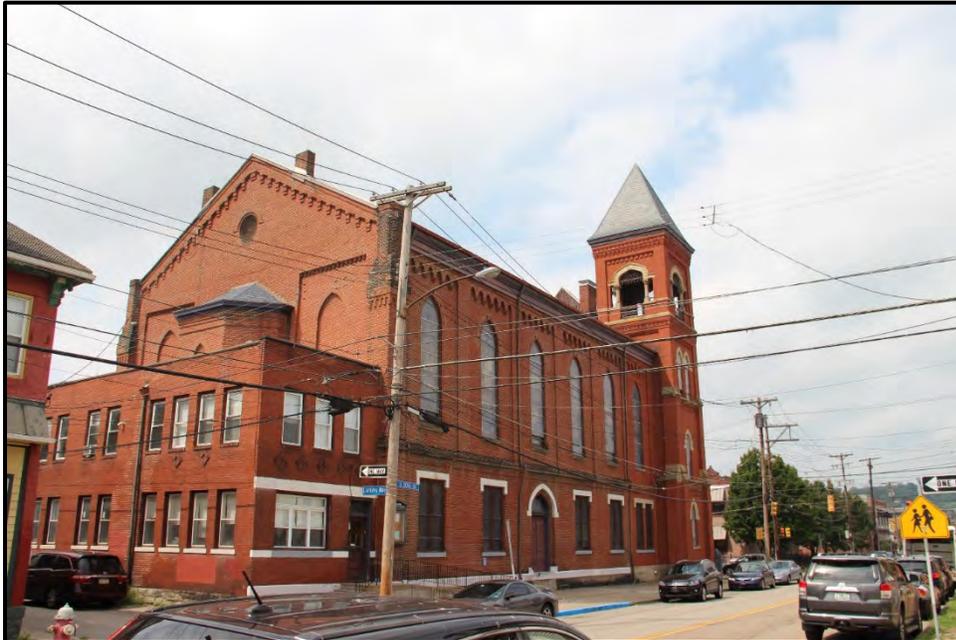
*Photo 2: South Side Presbyterian Church (August 2018). View northwest from corner of Larkins Way and S. 20<sup>th</sup> Street showing rear (south) and east (side) façades as well and the 1913/1920 community center addition.*

- Photo 2: South Side Presbyterian Church (August 2018). View northwest from corner of Larkins Way and S. 20<sup>th</sup> Street showing rear (south) and east (side) façades as well and the 1913/1920 community center addition.

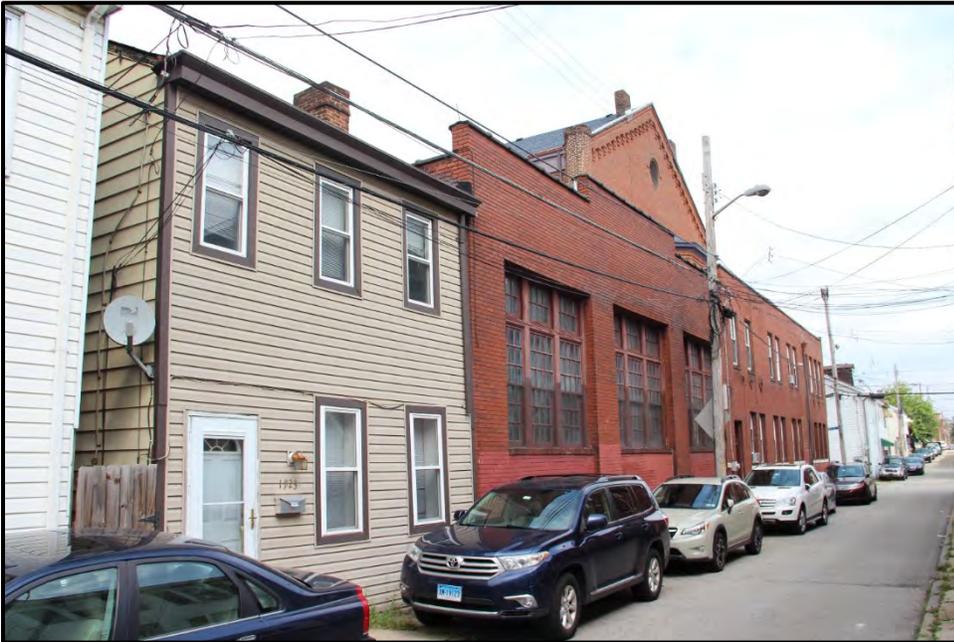
*Photo 3: South Side Presbyterian Church (August 2018). View northeast along Larkins Way showing the south façade of the community center.*

- Photo 3: South Side Presbyterian Church (August 2018). View northeast along Larkins Way showing the south façade of the community center.
- Photo 4: South Side Presbyterian Church (August 2018). View southwest from churchyard showing north façade of gym section of community center, dating to 1913.

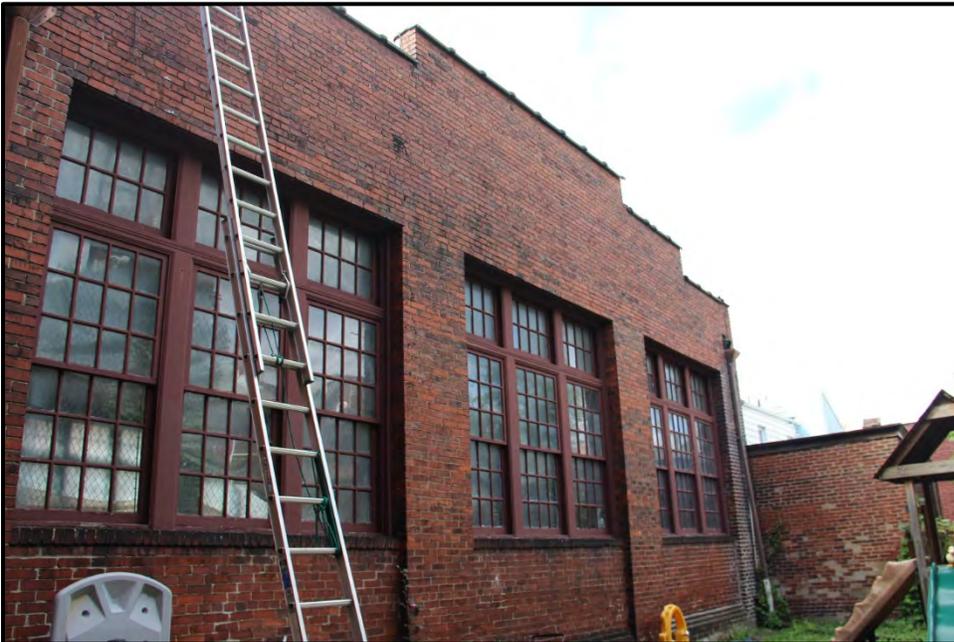
*Photo 4: South Side Presbyterian Church (August 2018). View southwest from churchyard showing north façade of gym section of community center, dating to 1913.*

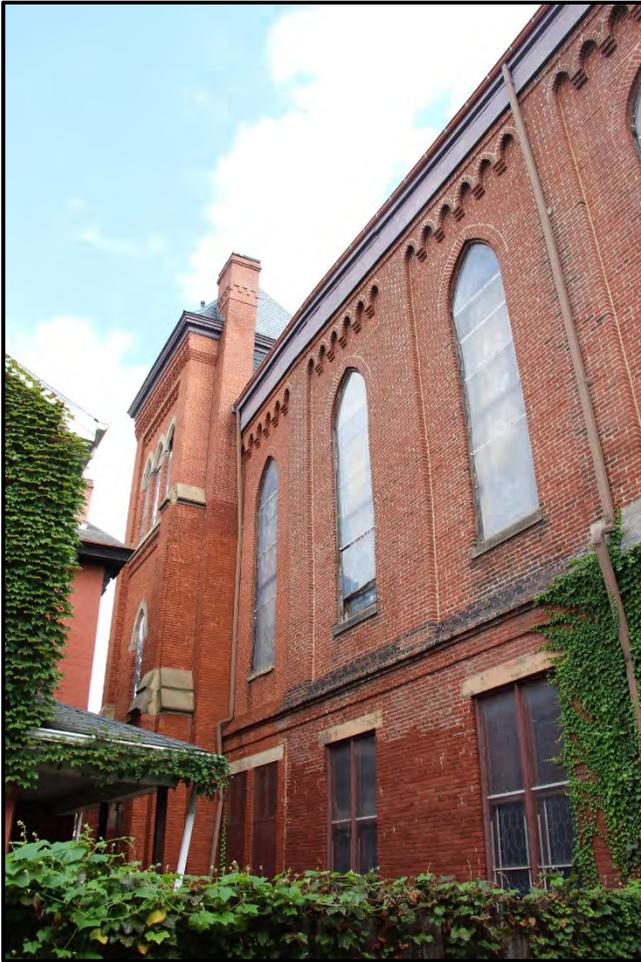
*Photo 5: South Side Presbyterian Church (August 2018). View northeast from churchyard showing west (side) façade of church.*

- Photo 5: South Side Presbyterian Church (August 2018). View northeast from churchyard showing west (side) façade of church.
- Photo 6: South Side Presbyterian Church (August 2018). View southwest along Sarah Street showing overview of north (front) façade (the first bay with towers and narthex is an 1893 addition).

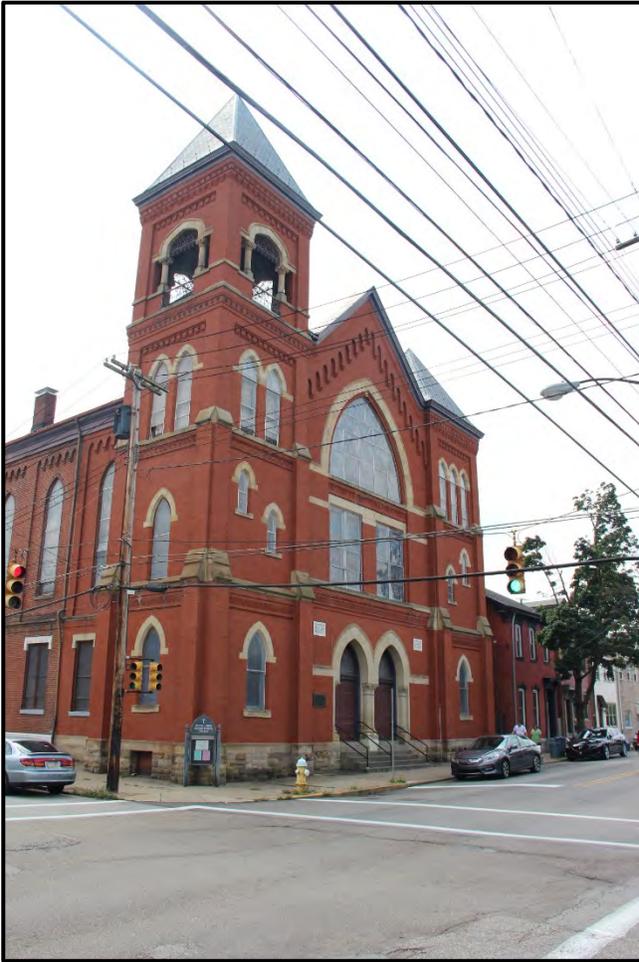
*Photo 6: South Side Presbyterian Church (August 2018). View southwest along Sarah Street showing overview of north (front) façade (the first bay with towers and narthex is an 1893 addition).*

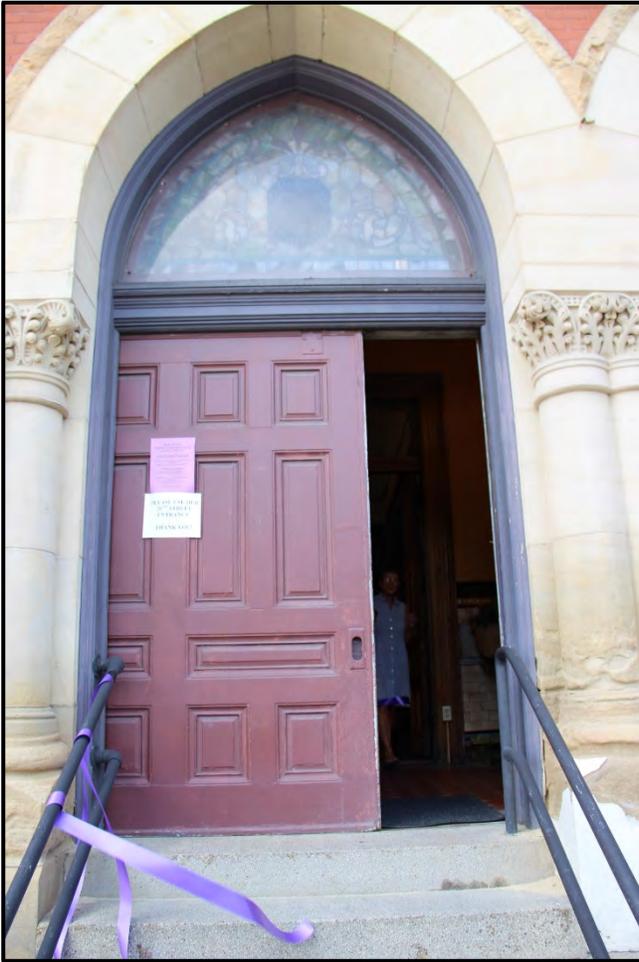
*Photo 9: South Side Presbyterian Church (September 2018). View south showing detail of left entry door. Notably, both doors are single leaf pocket doors.*

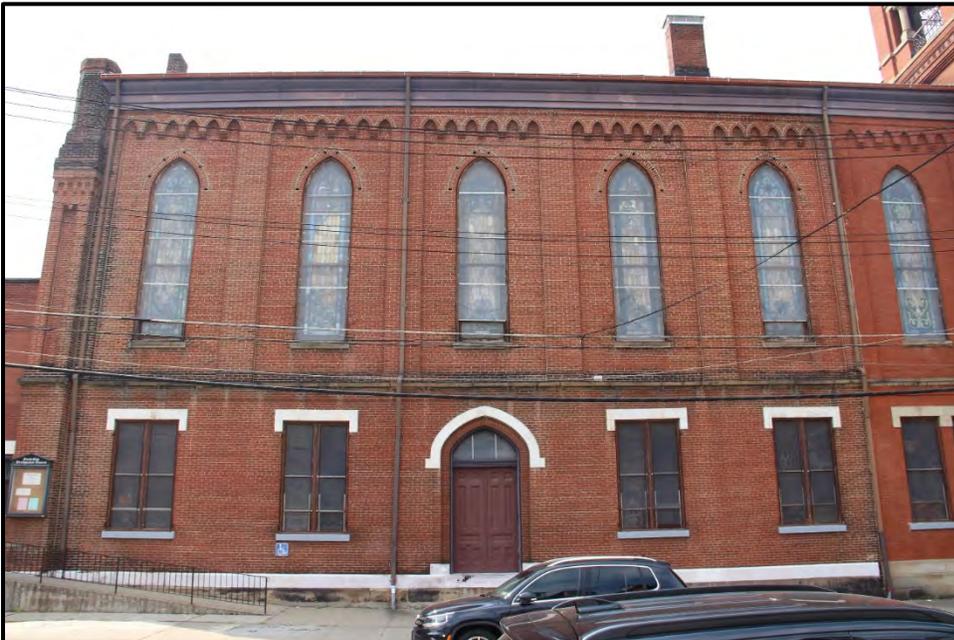
*Photo 12: South Side Presbyterian Church (August 2018). View west showing east (side) façade.*

- Photo 12: South Side Presbyterian Church (August 2018). View west showing east (side) façade.
- Photo 13: South Side Presbyterian Church (August 2018). View west showing juncture of 1869 part of building (left) and 1893 addition and alteration (right). The bay at right existed as part of the original construction, but it was rebuilt when the towers were added to the church.

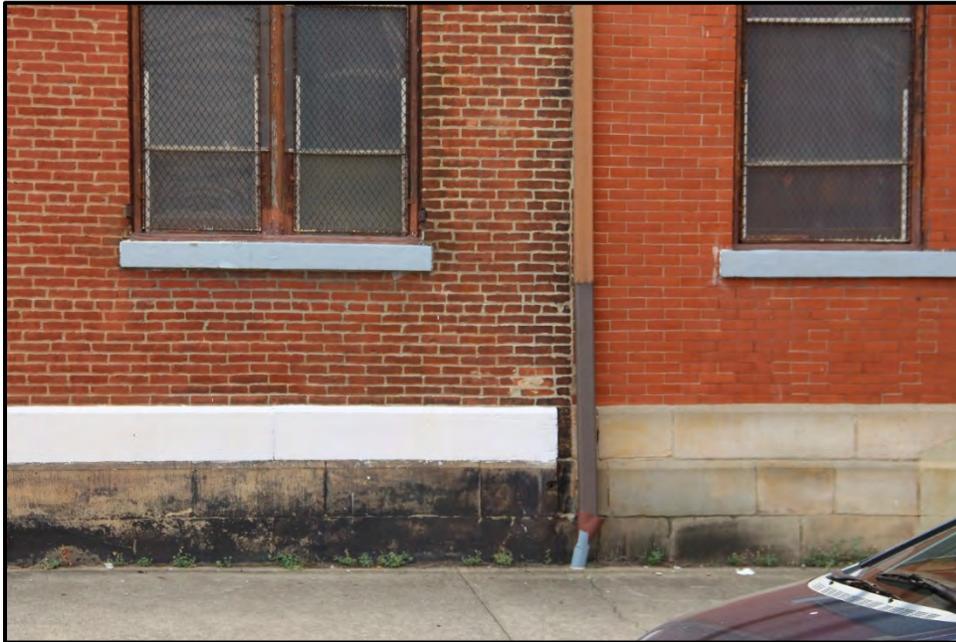
*Photo 13: South Side Presbyterian Church (August 2018). View west showing juncture of 1869 part of building (left) and 1893 addition and alteration (right). The bay at right existed as part of the original construction, but it was rebuilt when the towers were added to the church.*

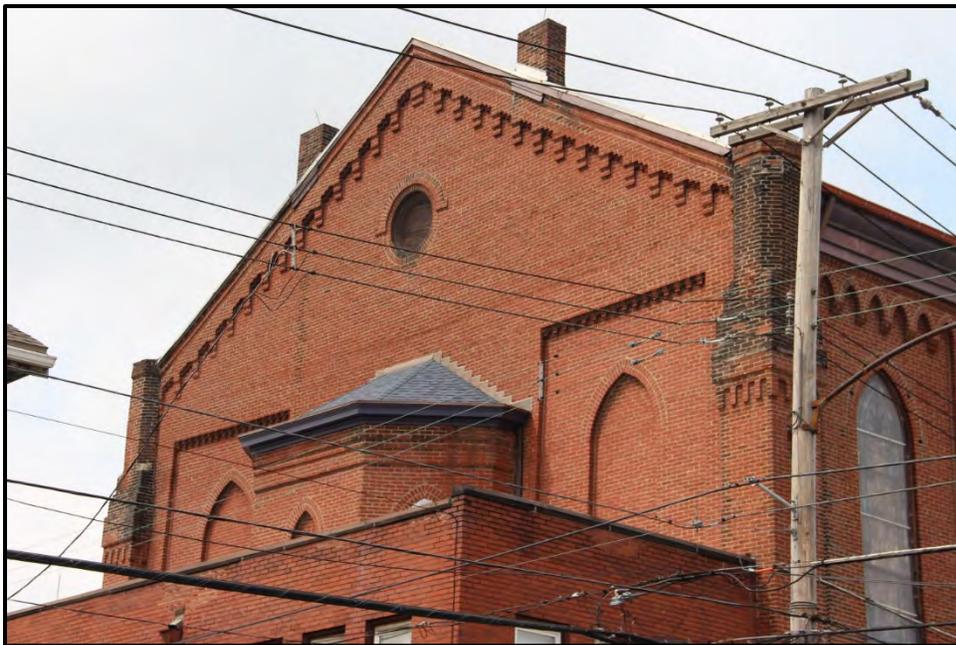
*Photo 14: South Side Presbyterian Church (August 2018). View northwest showing detail of rear (south) façade of church. The apse is now obscured by the organ, but its side windows are extant and boarded up (see Photo 62). Note the ornaments at the corners of the church; these were originally topped with pinnacles.*

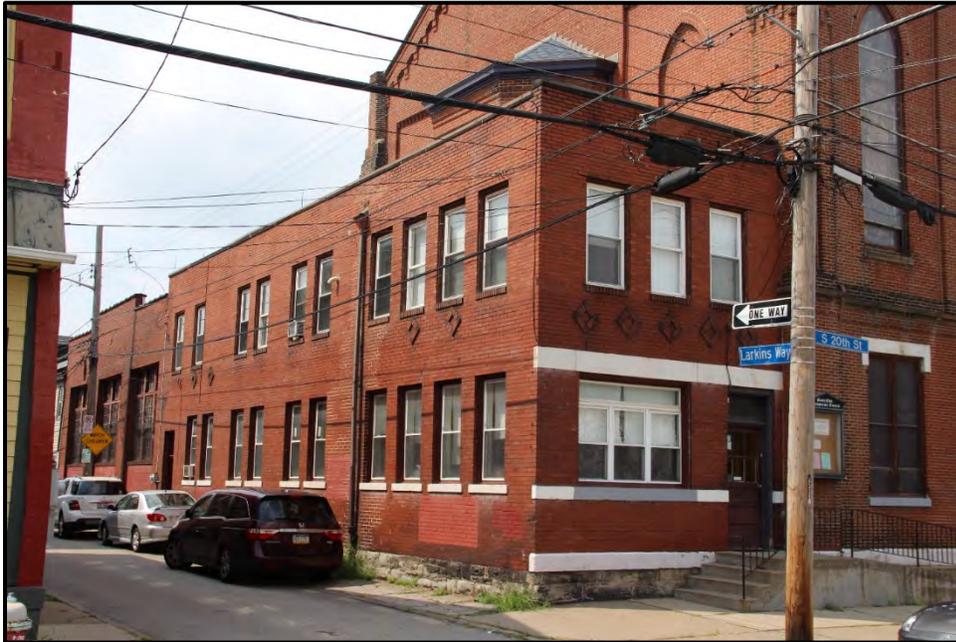
*Photo 16: South Side Presbyterian Church (August 2018). View northwest showing overview of the community center.*

- Photo 15: South Side Presbyterian Church (August 2018). View west showing the primary entrance to the community center.
- Photo 16: South Side Presbyterian Church (August 2018). View northwest showing overview of the community center.

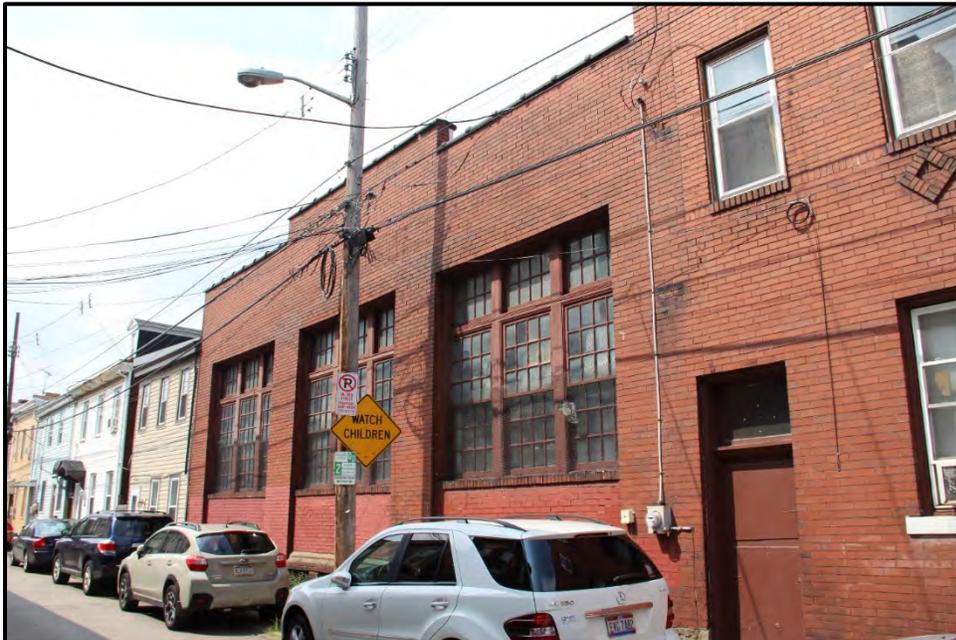
*Photo 17: South Side Presbyterian Church (August 2018). View northwest showing detail of gym section of community center and secondary entrance on Larkins Way.*

- Photo 17: South Side Presbyterian Church (August 2018). View northwest showing detail of gym section of community center and secondary entrance on Larkins Way.

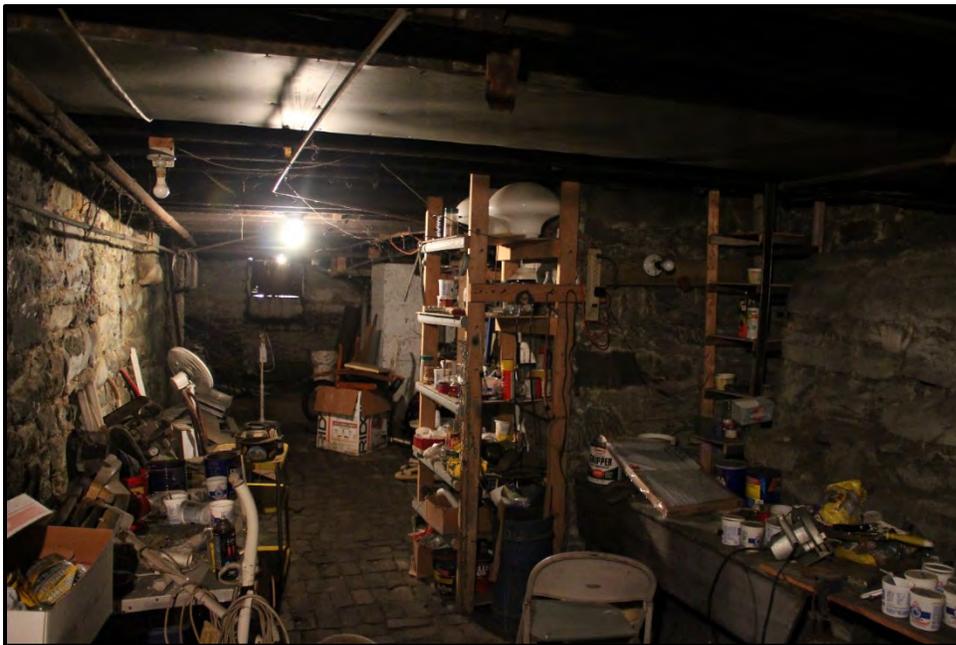
*Photo 21: South Side Presbyterian Church (September 2018). View facing east of excavated portion of basement below the narthex. This room was part of the 1893 addition, and the stone wall at right would have been the original limit of the 1869 building.*

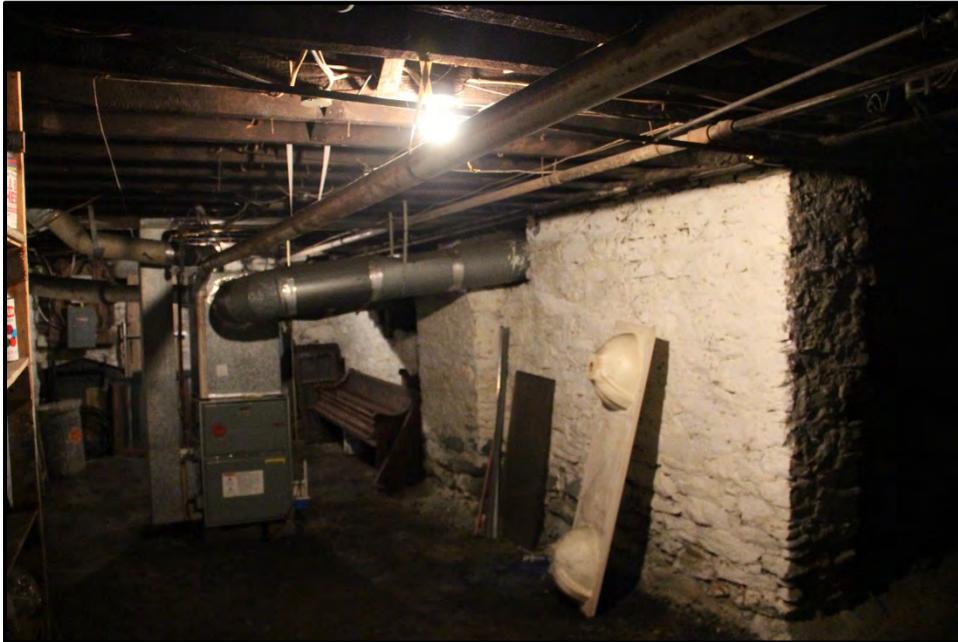
*Photo 22: South Side Presbyterian Church (September 2018). View southeast of basement section under classrooms (immediately behind the narthex). This was the only fully excavated room in the original section of the church.*

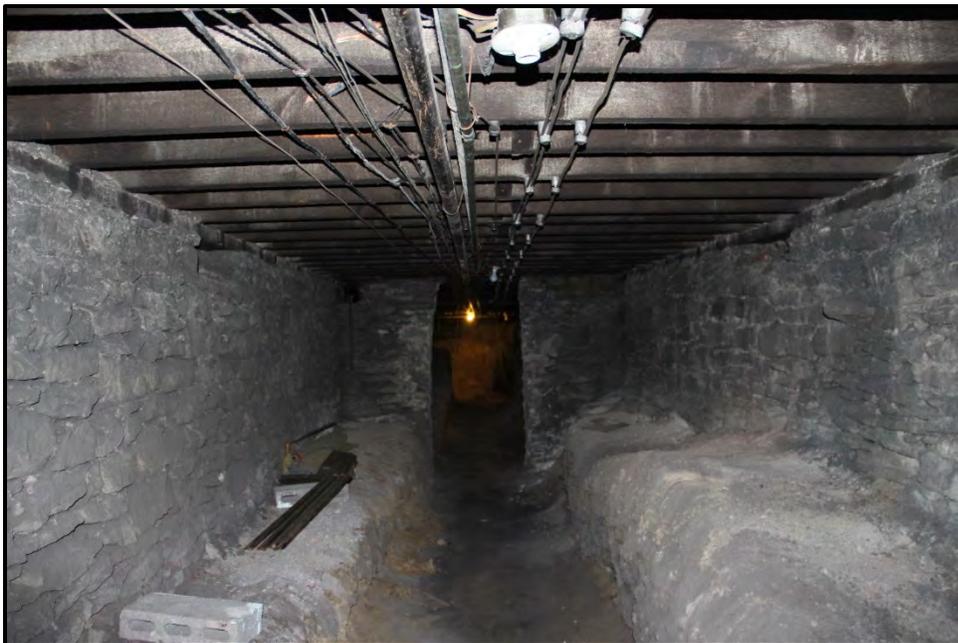
*Photo 23: South Side Presbyterian Church (September 2018). View south showing the central basement passage way. Crawl space containing heating ductwork is located behind each of the longitudinal walls.*

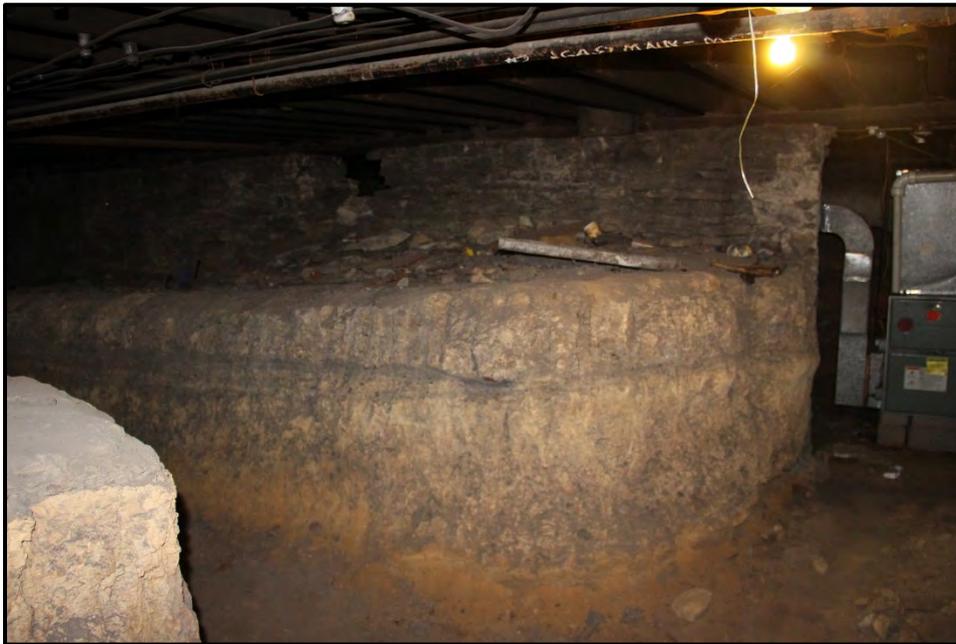
*Photo 24: South Side Presbyterian Church (September 2018). View northeast at south terminus of main basement passage showing a rear cross-passage with furnaces at either end. Note the pick marks that are still visible in the earthen wall.*

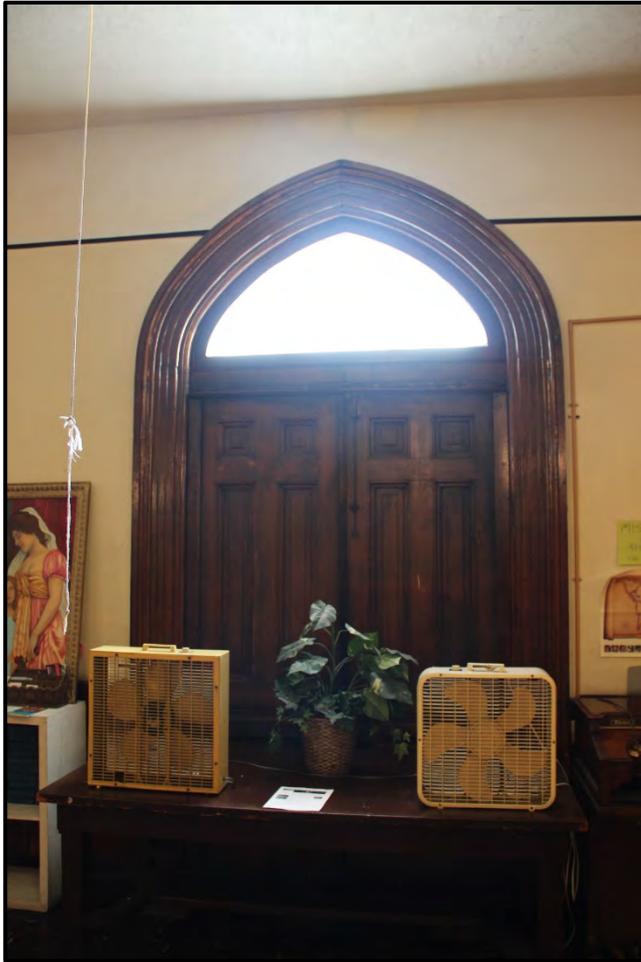
*Photo 27: South Side Presbyterian Church (September 2018). View east showing interior of S. 20<sup>th</sup> Street 1<sup>st</sup> floor entry door, which is original to the 1869 construction. The millwork was reportedly hand made by contractor John T. Natcher.*

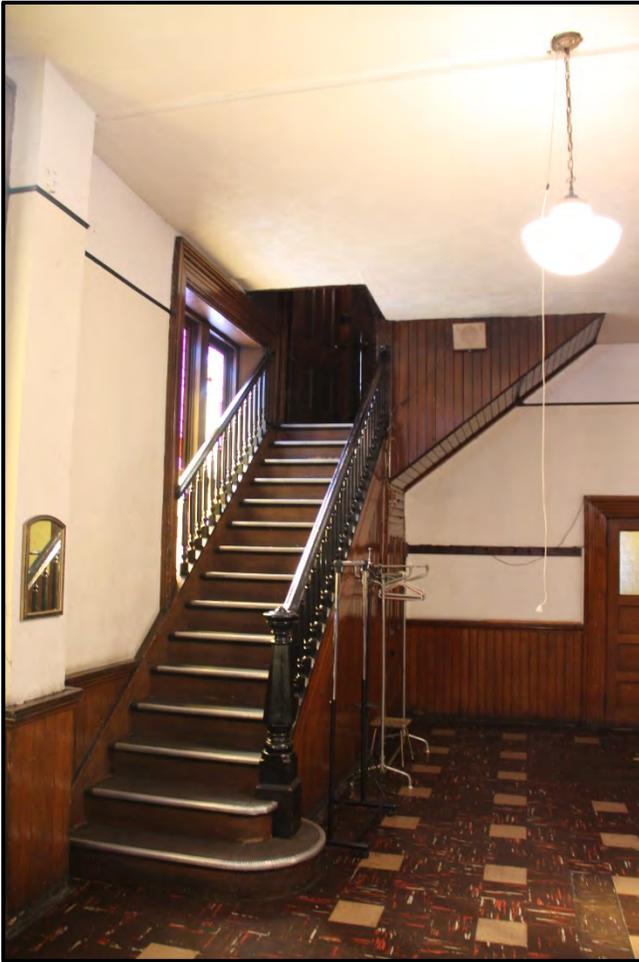
*Photo 28: South Side Presbyterian Church (September 2018). View south showing stairs (original to 1869) leading from Sunday school room to the rear of the sanctuary on the second floor.*

Photo 28: South Side Presbyterian Church (September 2018). View south showing stairs (original to 1869) leading from Sunday school room to the rear of the sanctuary on the second floor.

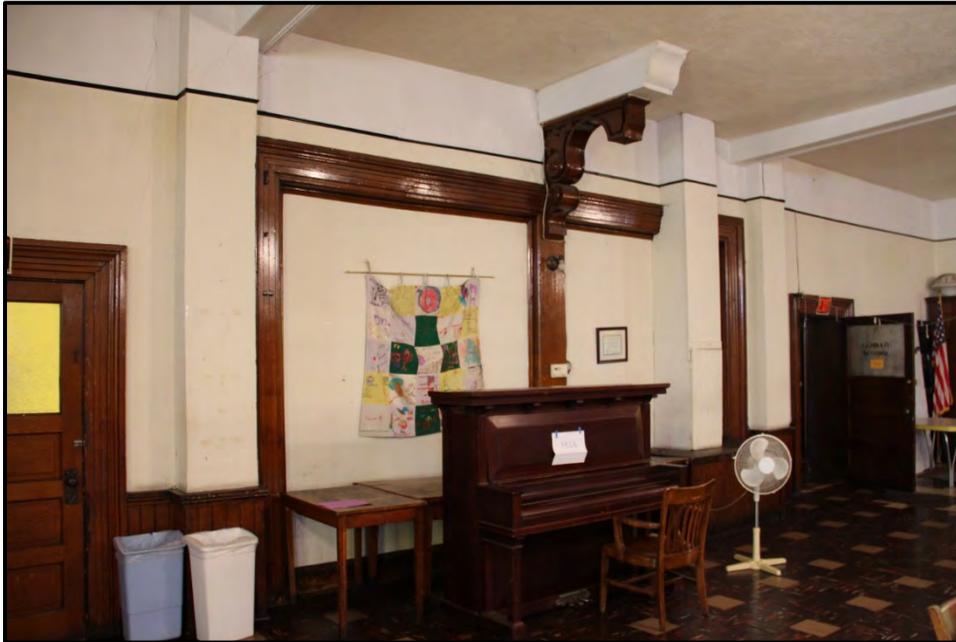
Photo 29: South Side Presbyterian Church (September 2018). View southwest showing rear wall of 1<sup>st</sup> floor Sunday school room. The central opening was infilled, and two side doors added in 1913 when the community center addition was built.

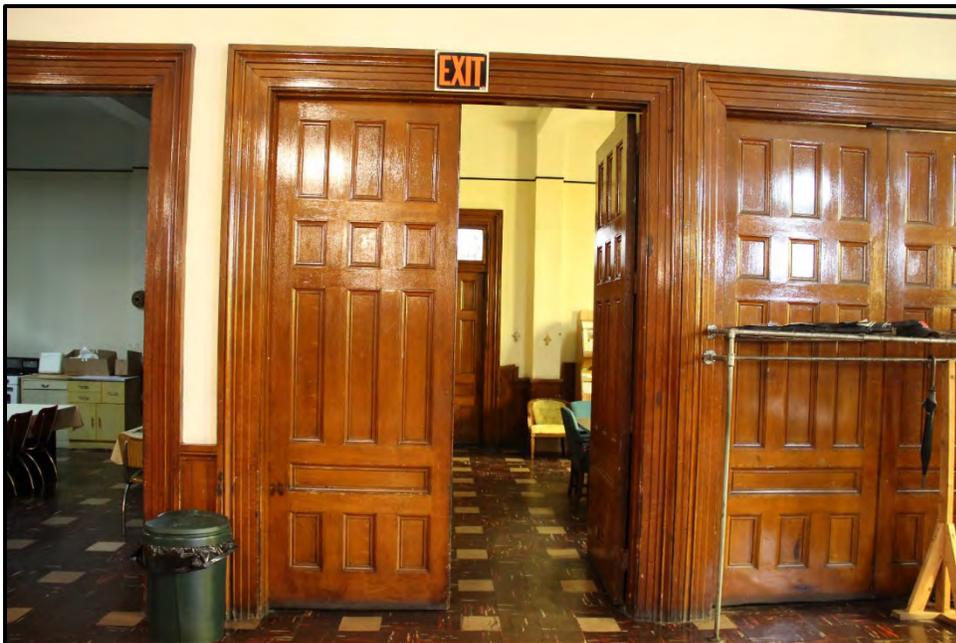
Photo 30: South Side Presbyterian Church (September 2018). View north showing three sets of doors that lead from the Sunday school room to three auxiliary rooms (the left room is a kitchen and the right room is a meeting room). Doors to the narthex are visible in the background.

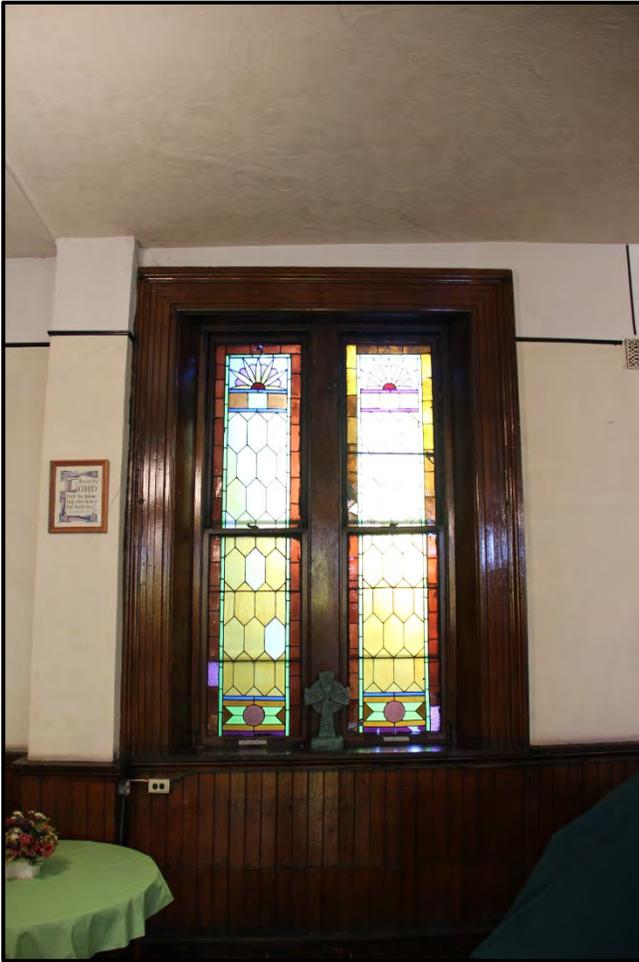
*Photo 31: South Side Presbyterian Church (September 2018). Detail of a typical stained glass window and wainscot in the 1<sup>st</sup> floor Sunday school room.*

Photo 31: South Side Presbyterian Church (September 2018). Detail of a typical stained glass window and wainscot in the 1<sup>st</sup> floor Sunday school room.

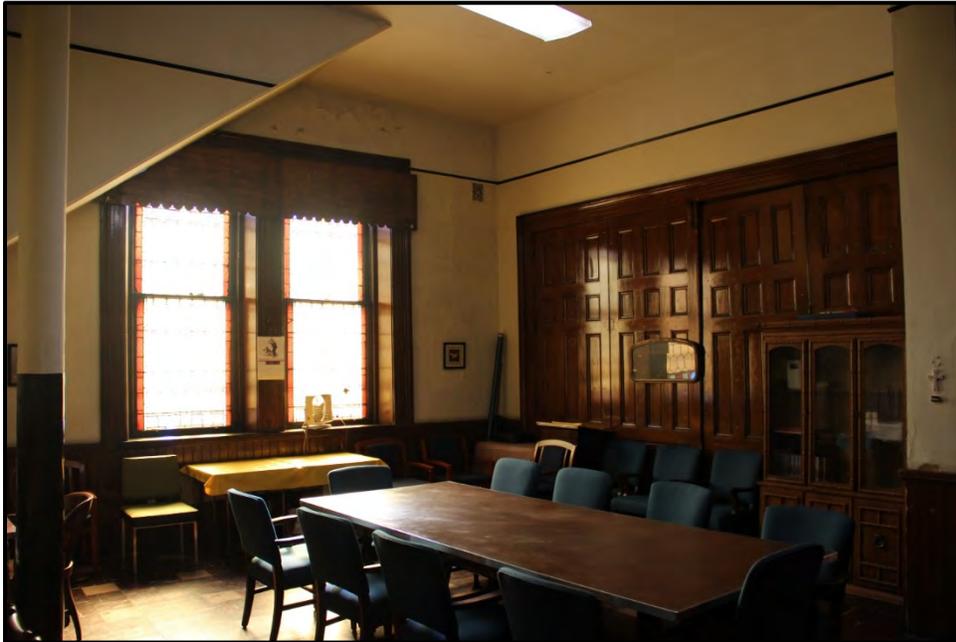
*Photo 32: South Side Presbyterian Church (September 2018). View southeast showing the 1<sup>st</sup> floor meeting room (east anteroom). The three anterooms are connected side-to-side by two pairs of folding doors.*

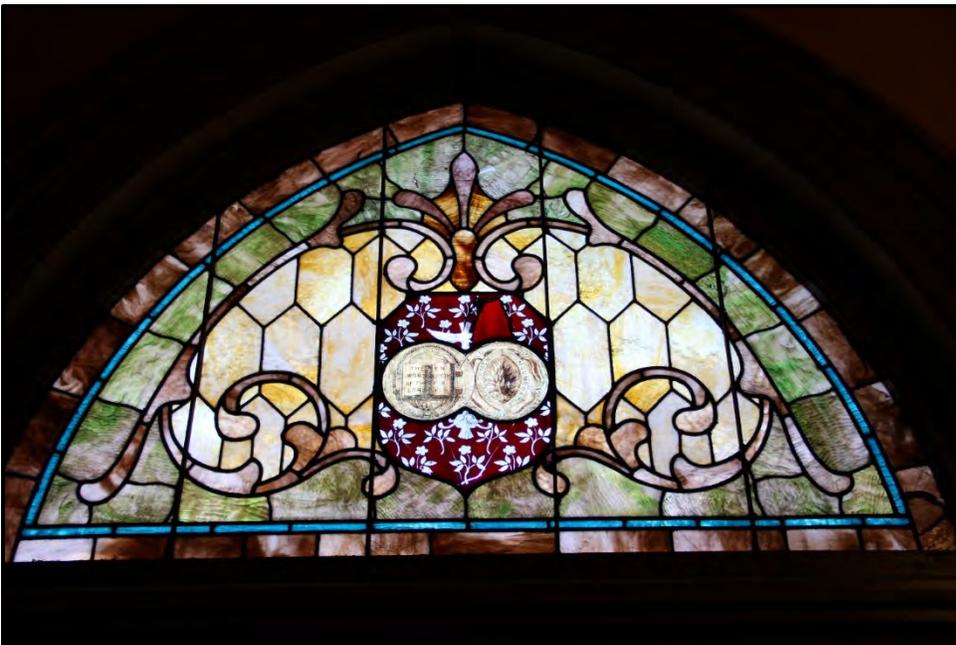
*Photo 37: South Side Presbyterian Church (September 2018). View facing north of interior of stained glass transom above west door.*

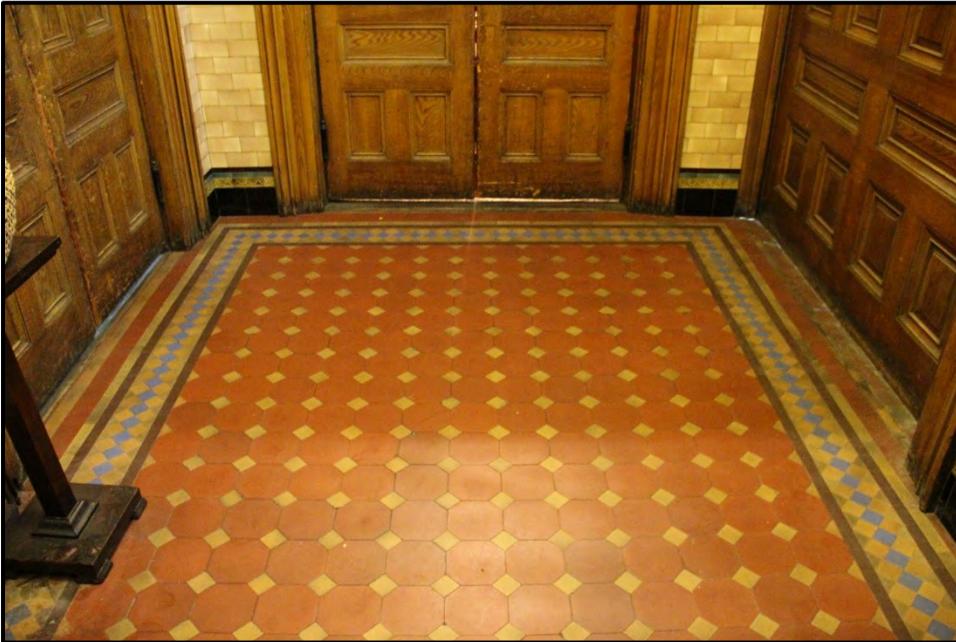
*Photo 38: South Side Presbyterian Church (September 2018). View facing west in central part of 1<sup>st</sup> floor narthex, showing detail of encaustic tile.*

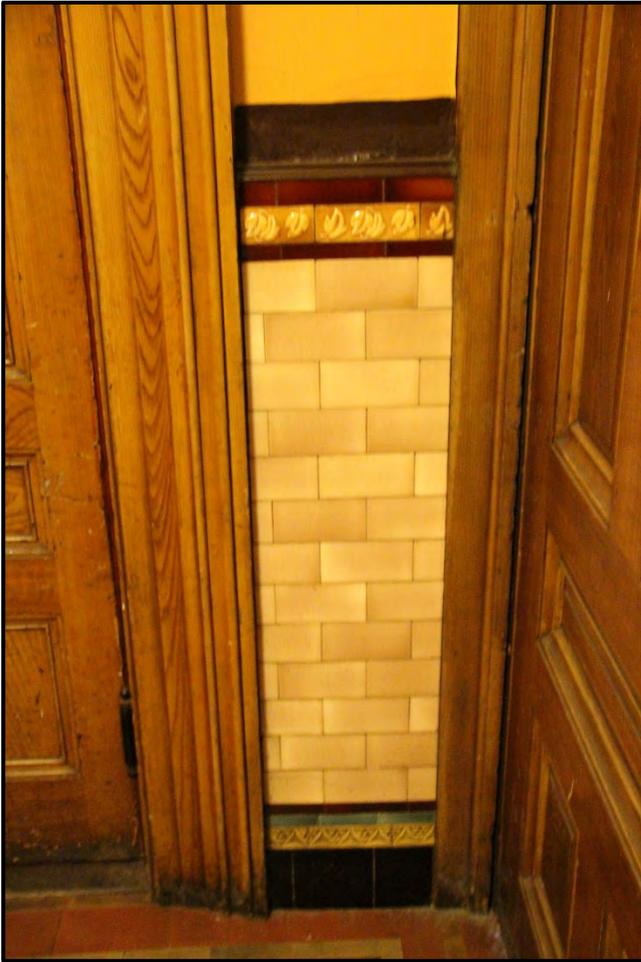
*Photo 39: South Side Presbyterian Church (September 2018). View facing south in central part of 1<sup>st</sup> floor narthex, showing detail of porcelain tile wainscot. All the woodwork in the narthex and anterooms faux finished.*

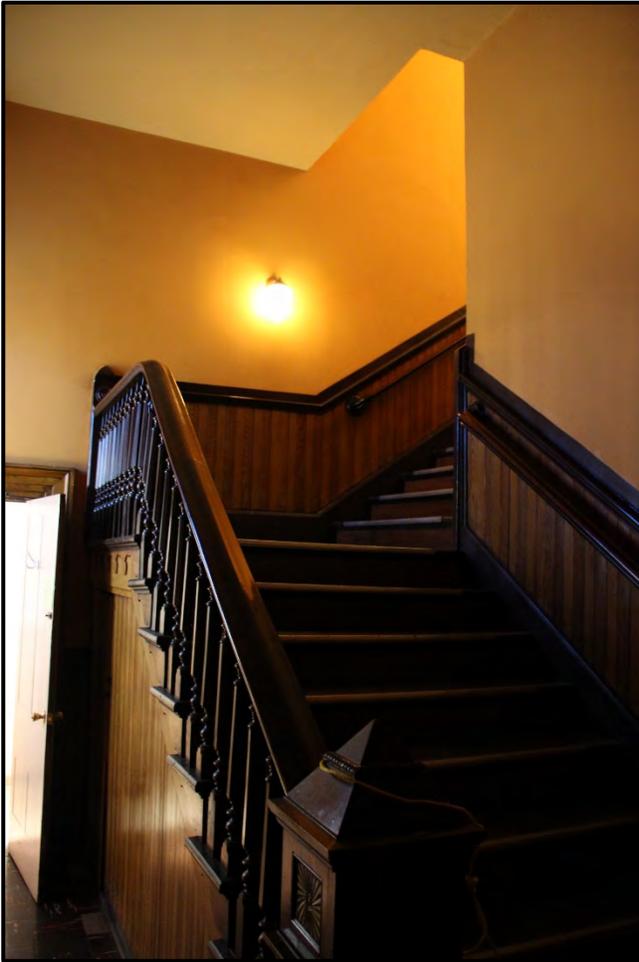
*Photo 40: South Side Presbyterian Church (September 2018). View southwest in east narthex room (1<sup>st</sup> floor) showing east stairs leading from narthex to the 2<sup>nd</sup> floor sanctuary. The door at left leads to a bathroom.*

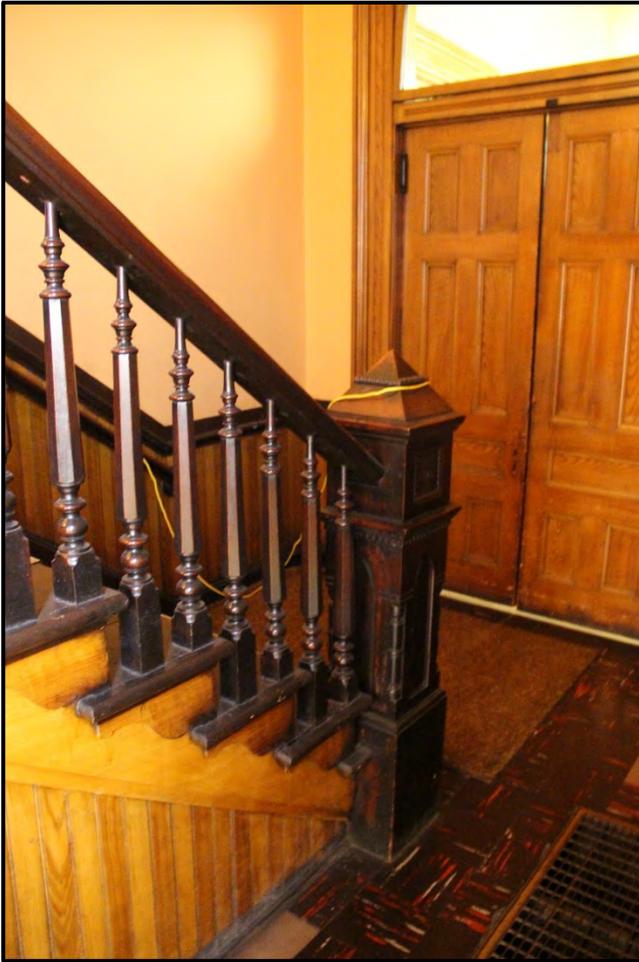
*Photo 41: South Side Presbyterian Church (September 2018). View southwest showing newel post (1893) in east room of narthex. The doors in background lead to the center narthex room. Judging from the spindle style, it is likely that, excepting the newel post, the 1869 millwork on the two narthex staircases was reused when constructing the 1893 addition.*

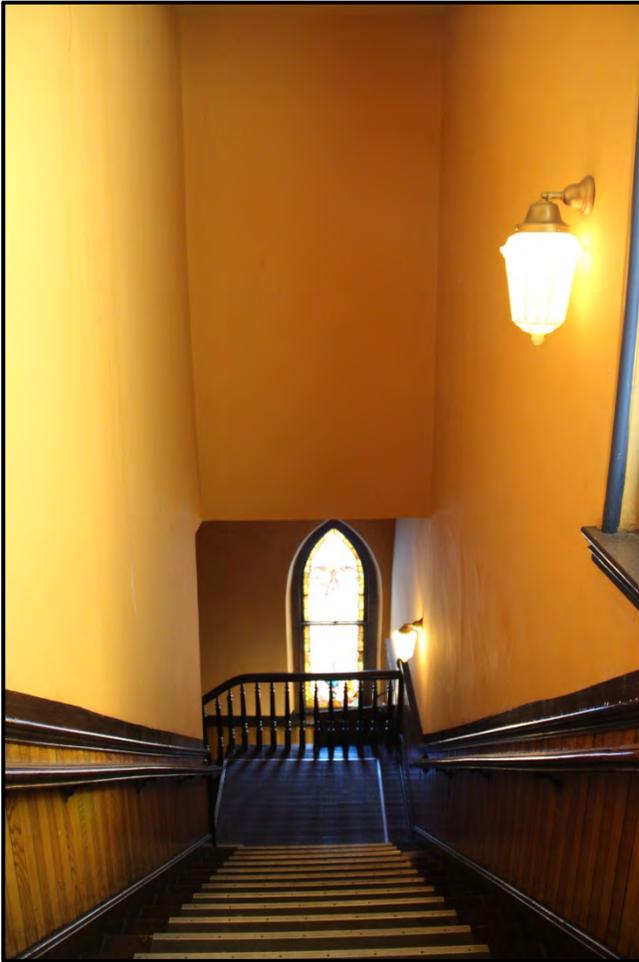
*Photo 43: South Side Presbyterian Church (September 2018). View north showing view looking down east stairs toward narthex on 1<sup>st</sup> floor. Note early electric fixtures may date to either a 1913 or a 1924 electrical renovation.*

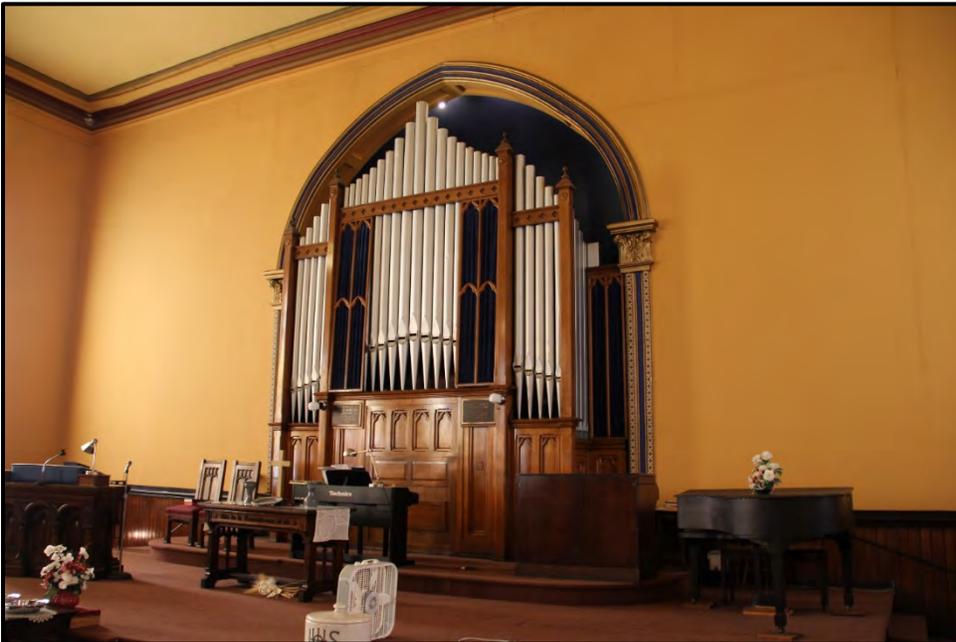
*Photo 45: South Side Presbyterian Church (September 2018). View southeast showing organ detail (with apse behind it).*

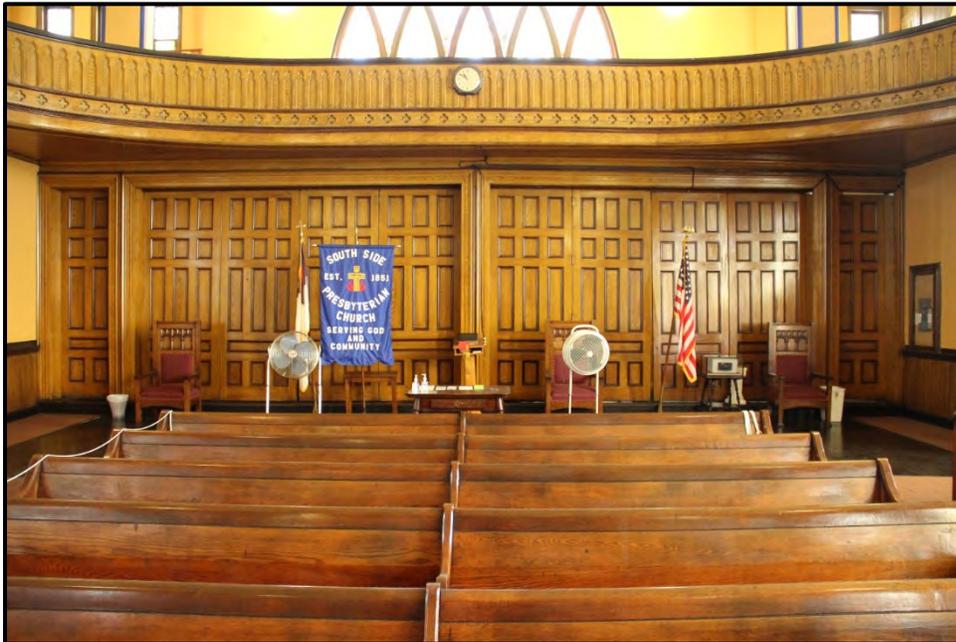
*Photo 47: South Side Presbyterian Church (September 2018). View north showing detail of two sets of folding doors between the sanctuary and 2<sup>nd</sup> floor three anterooms.*

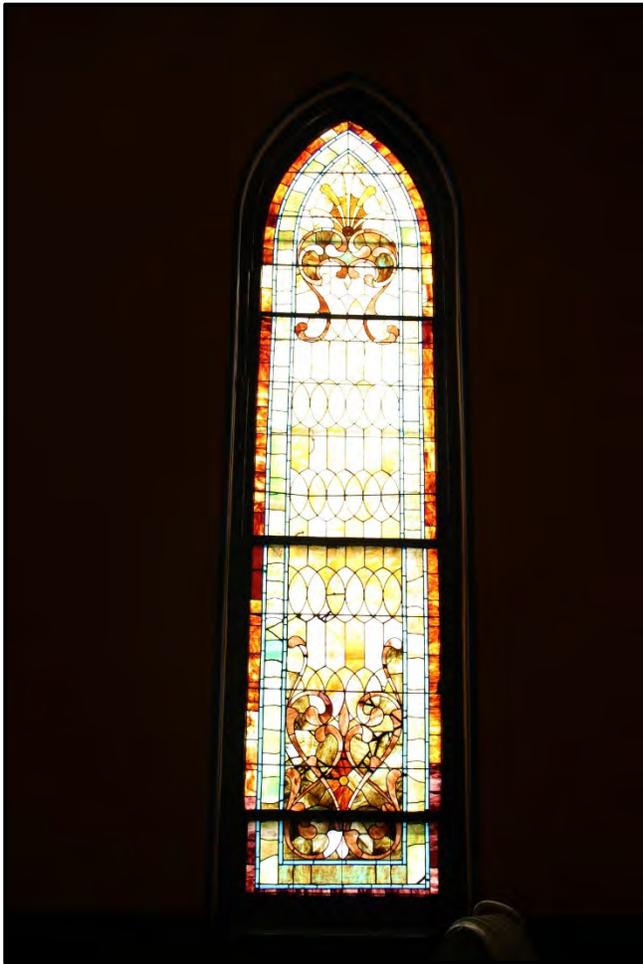
*Photo 48: South Side Presbyterian Church (September 2018). View showing detail of typical 2<sup>nd</sup> floor (sanctuary) stained glass windows. Based on style, the glass appears to have been replaced as part of the 1893 renovation. These 12 nave windows were originally has double hung sashes but were fixed in place and fitted with lower ventilators in 1940.*

- Photo 48: South Side Presbyterian Church (September 2018). View showing detail of typical 2<sup>nd</sup> floor (sanctuary) stained glass windows. Based on style, the glass appears to have been replaced as part of the 1893 renovation. These 12 nave windows were originally has double hung sashes but were fixed in place and fitted with lower ventilators in 1940.

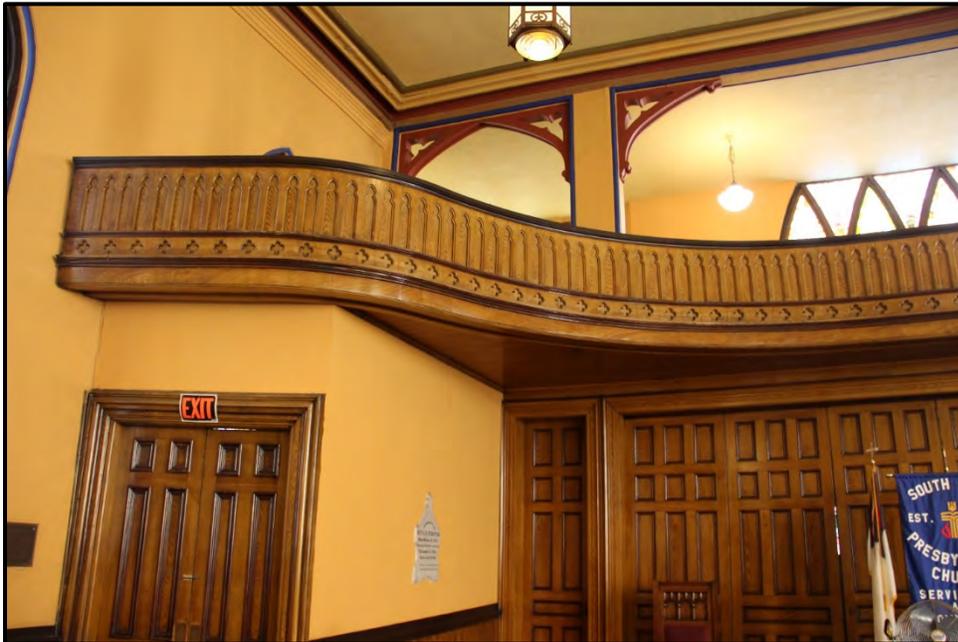
*Photo 50: South Side Presbyterian Church (September 2018). View north showing balcony details. The door at far left leads to stair accessing the narthex. The single-leaf door at center leads to the west 2<sup>nd</sup> floor anteroom.*
