## **South Side Presbyterian Church**

### **City of Pittsburgh Historic Landmark Nomination**

**Prepared by Preservation Pittsburgh for the South Side Presbyterian Church**

December, 2018.

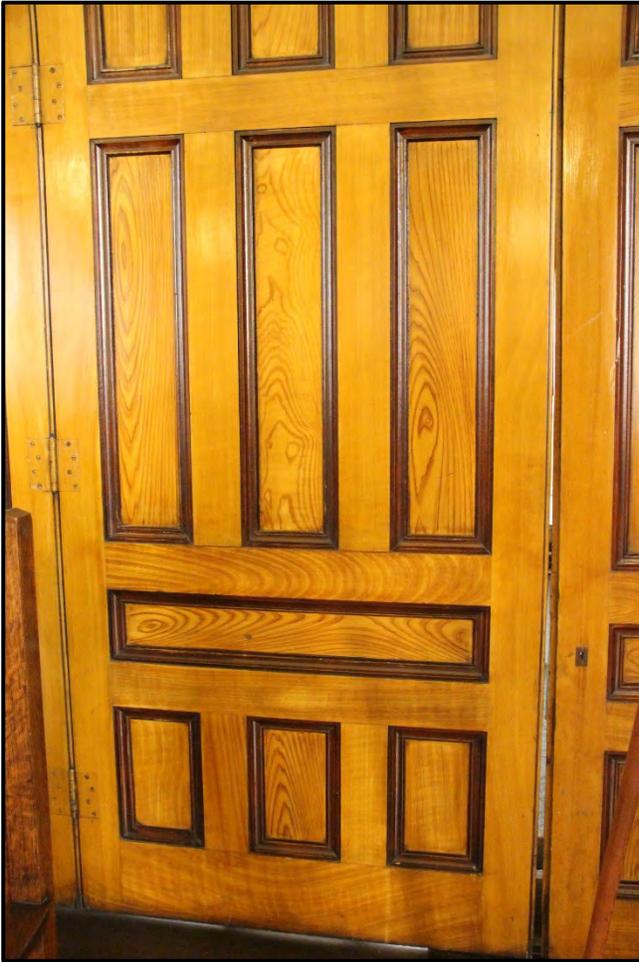
*Photo 51: South Side Presbyterian Church (September 2018). View north showing detail of sanctuary side of bi-fold doors. Note the exceptional condition of the faux graining. The dark trim outlining the panels is genuine walnut. The hardware on these doors dates to the 1893 renovation, but it is not clear if the doors were reused from the earlier part of the building. A similar scheme with walnut trim outlining a lighter field is used in the pews, which do date from the original 1869-70 construction. The opposite side of these doors (in the anteroom) lacks the walnut trim.*

- Photo 51: South Side Presbyterian Church (September 2018). View north showing detail of sanctuary side of bi-fold doors. Note the exceptional condition of the faux graining. The dark trim outlining the panels is genuine walnut. The hardware on these doors dates to the 1893 renovation, but it is not clear if the doors were reused from the earlier part of the building. A similar scheme with walnut trim outlining a lighter field is used in the pews, which do date from the original 1869-70 construction. The opposite side of these doors (in the anteroom) lacks the walnut trim.

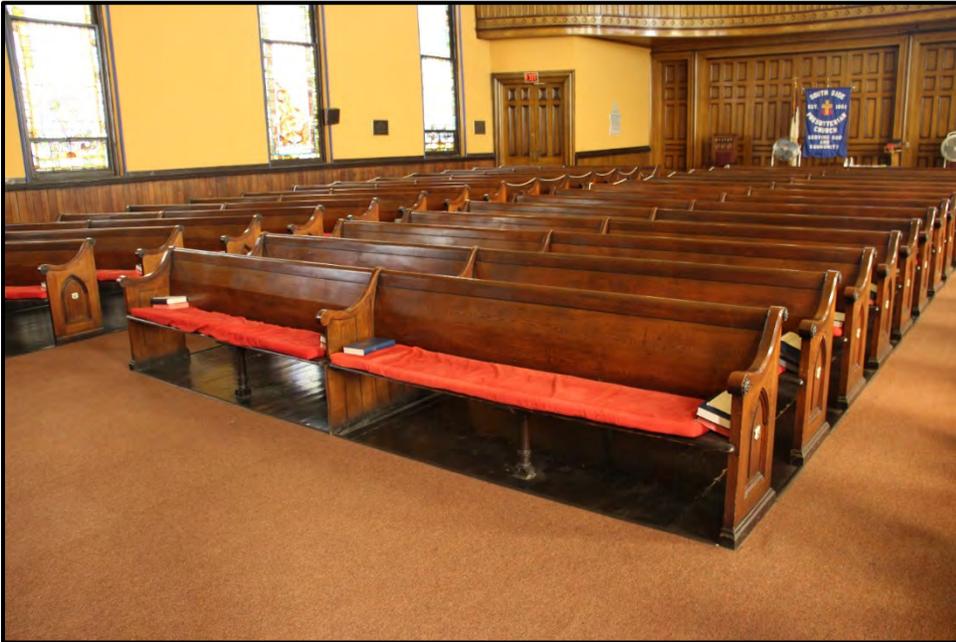
*Photo 52: South Side Presbyterian Church (September 2018). View northwest showing detail of pew arrangement. Note the skewed configuration of the side pews and the turned center supports, which are present in all pews.*

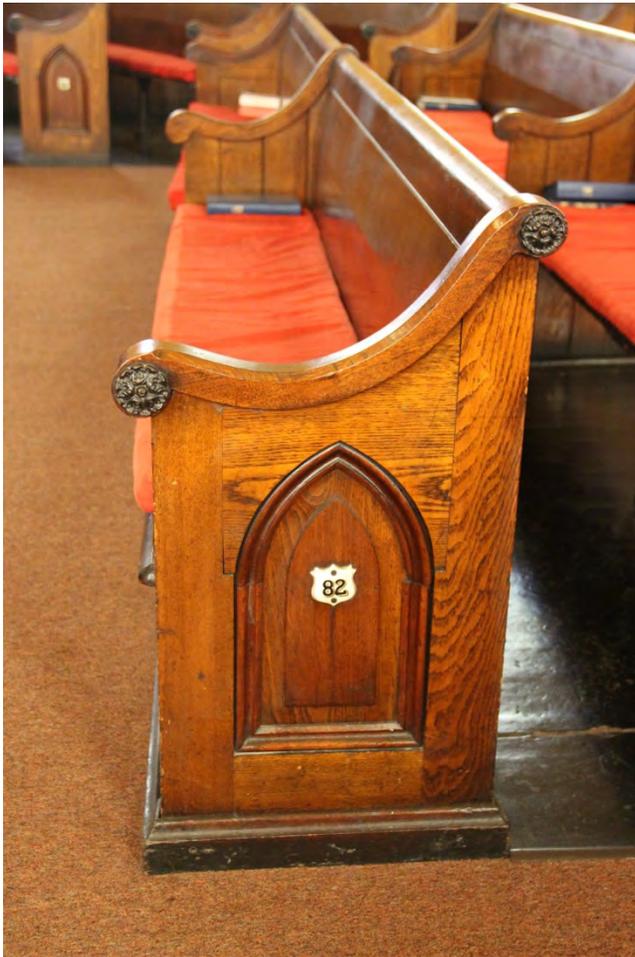
*Photo 53: South Side Presbyterian Church (September 2018). View west showing detail of pew #82. The main body of the pew is solid white ash, while the scrolls, caps, panel trim are walnut.*

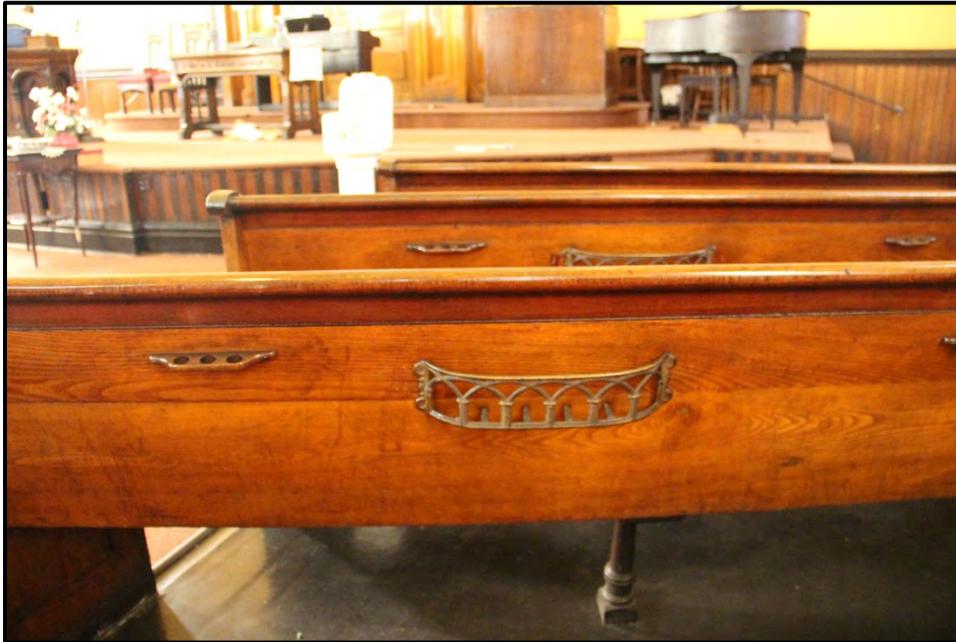
*Photo 54: South Side Presbyterian Church (September 2018). View south showing detail of decorative book rack and communion cup holders.*

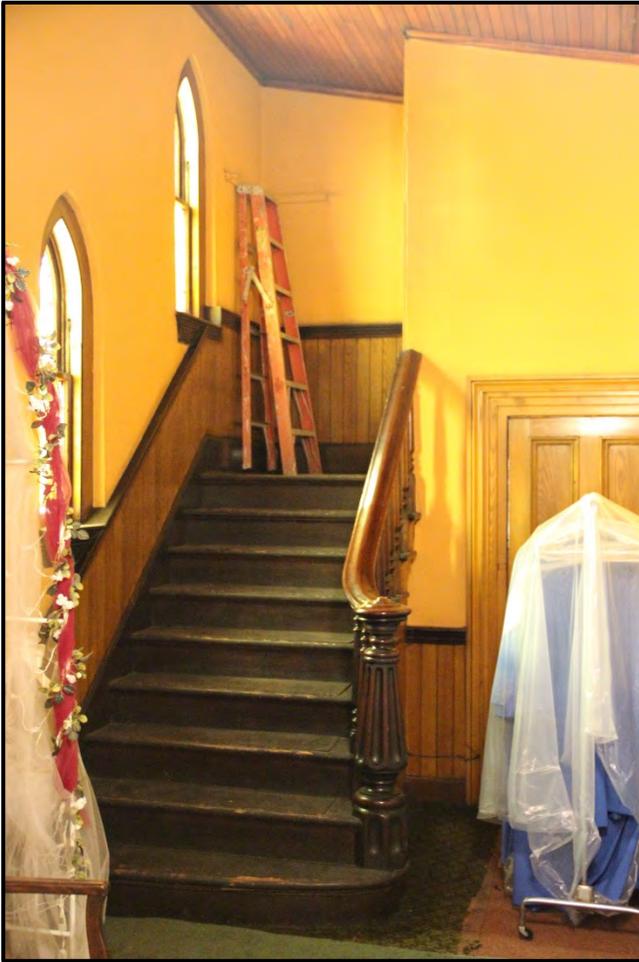
*Photo 56: South Side Presbyterian Church (September 2018). View east showing east 2<sup>nd</sup> floor anteroom and stairs to balcony. The railing and newel post appear to have been reused from the 1869 part of the building.*

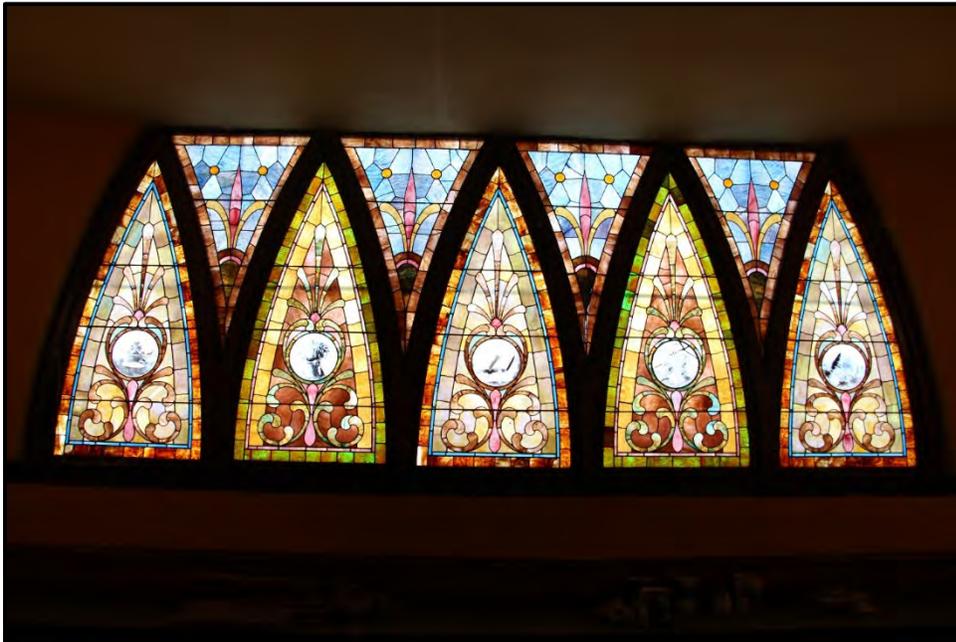
*Photo 58: South Side Presbyterian Church (September 2018). View north, showing detail of balcony stained glass window; the arched sashes are operable via a center horizontal pivot. The upper part of the window is in the attic and is covered with plywood on the inside (outer glazing is intact).*

- Photo 57: South Side Presbyterian Church (September 2018). View west showing overview of the balcony.
- Photo 58: South Side Presbyterian Church (September 2018). View north, showing detail of balcony stained glass window; the arched sashes are operable via a center horizontal pivot. The upper part of the window is in the attic and is covered with plywood on the inside (outer glazing is intact).

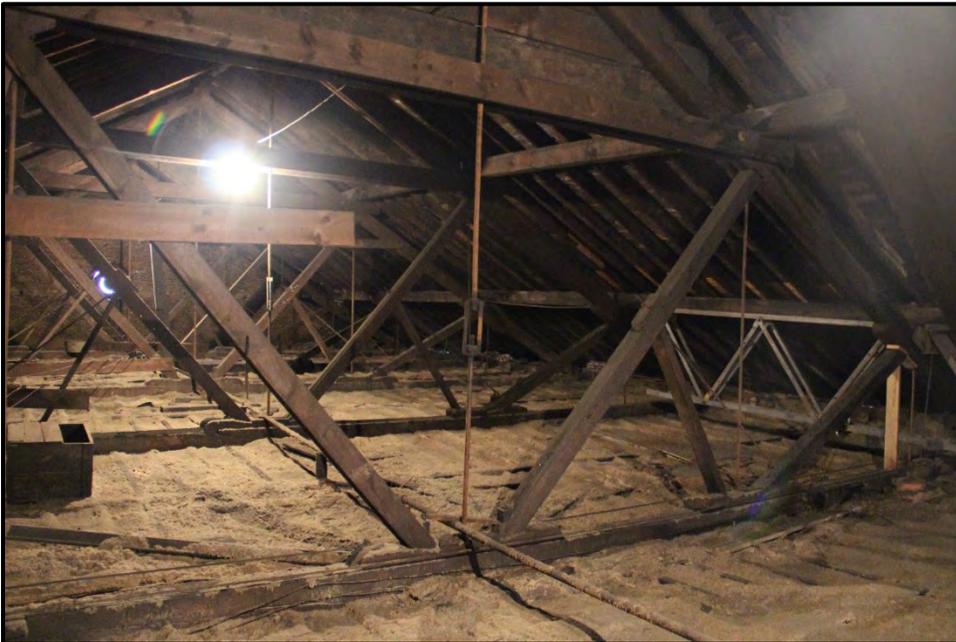
*Photo 60: South Side Presbyterian Church (September 2018). View southwest showing attic trusses above the sanctuary. The insulation dates to a mid-1980s renovation.*

- 1985, insulation installed in attic.
- Spring 1987, Ariondo Plastering repairs ceiling plaster in sanctuary for \$9,500.

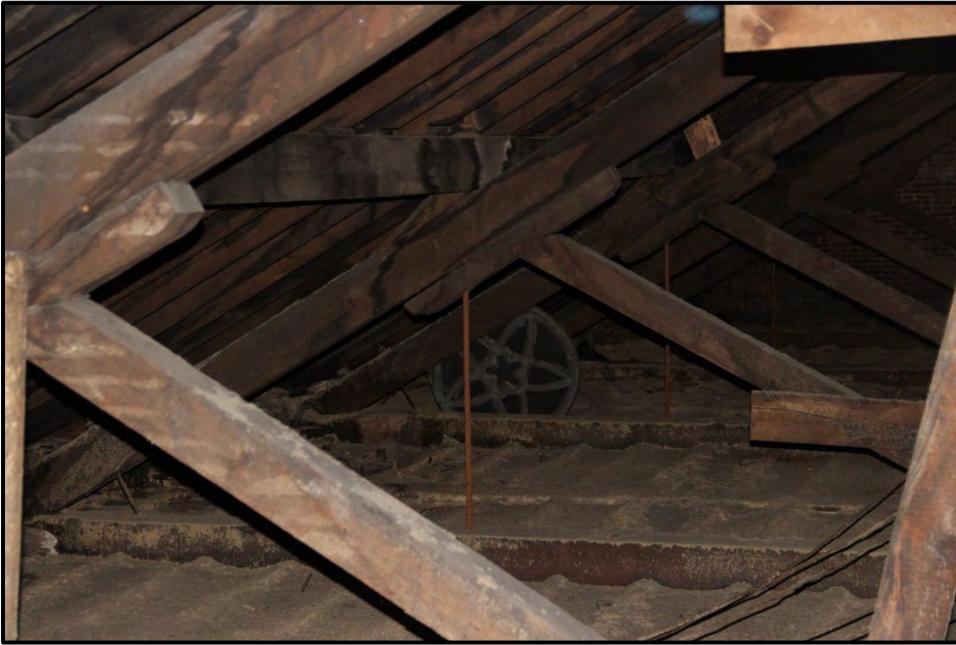
*Photo 61: South Side Presbyterian Church (September 2018). View southeast in attic show detail of original rear (south) circular gable window in storage. The window opening is presently covered with plywood with holes drilled for ventilation.*

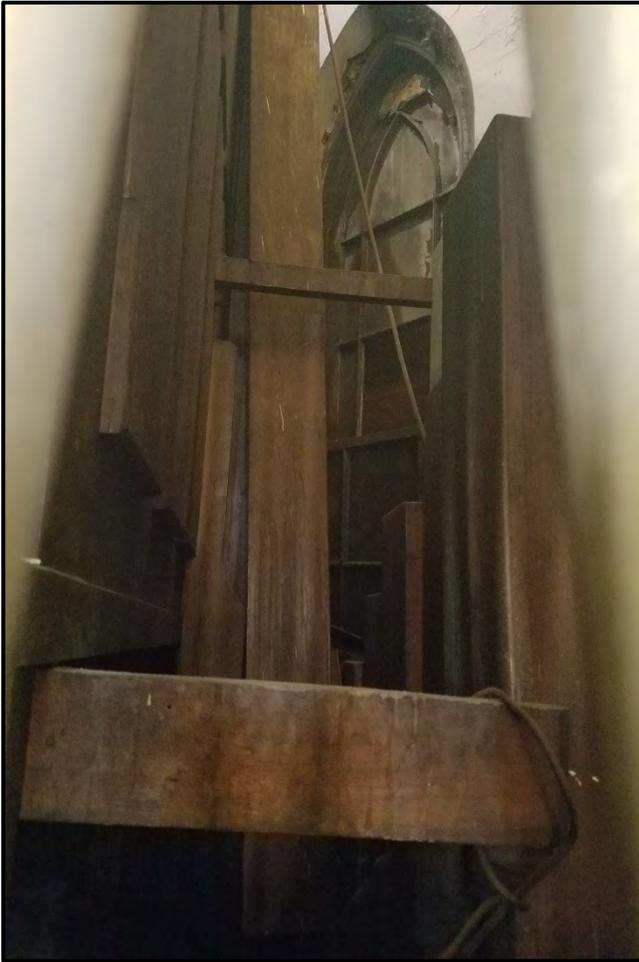
*Photo 62: South Side Presbyterian Church (September 2018). View south showing the west (side) apse window, now obscured by the organ and boarded up on the exterior. The sash lite pattern may be indicative of the original pattern used on the nave windows, which may have contained large panes of colored glass set in wood muntins rather than small pieces of leaded glass.*

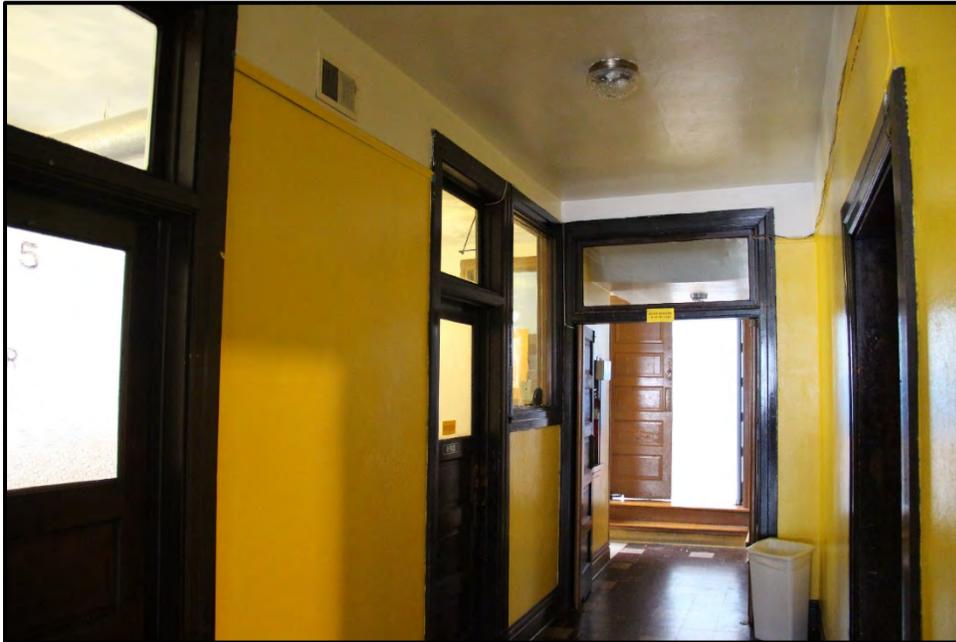
*Photo 63: South Side Presbyterian Church (September 2018). View west showing main 1<sup>st</sup> floor hallway of the 1913 community center. The two doors at left lead to offices.*

- Photo 63: South Side Presbyterian Church (September 2018). View west showing main 1<sup>st</sup> floor hallway of the 1913 community center. The two doors at left lead to offices.

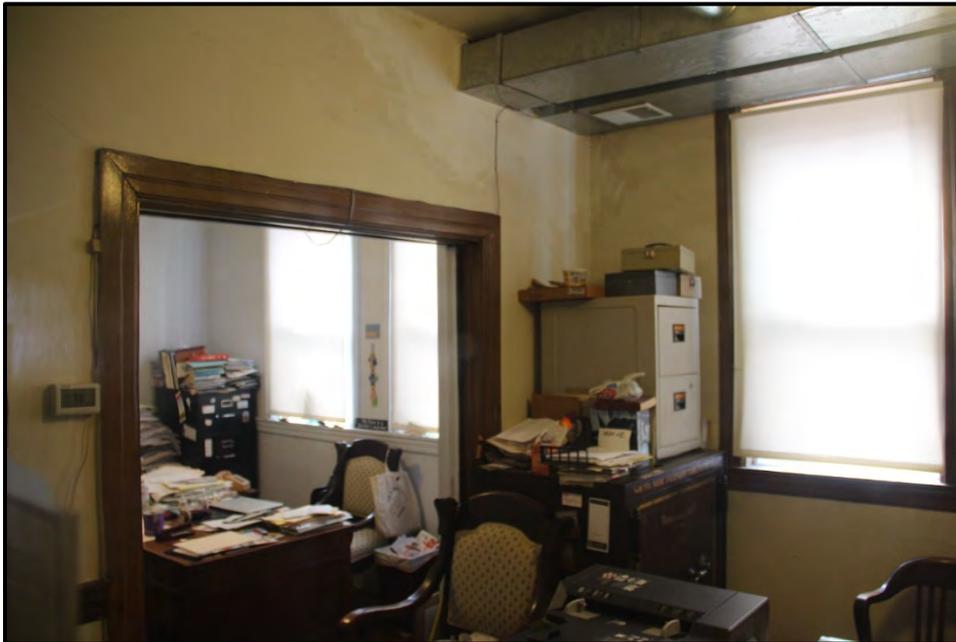
*Photo 64: South Side Presbyterian Church (September 2018). View southeast showing office room and adjacent pastor's office, which is connected by a doorway containing a pair of pocket doors.*

- Photo 64: South Side Presbyterian Church (September 2018). View southeast showing office room and adjacent pastor's office, which is connected by a doorway containing a pair of pocket doors.

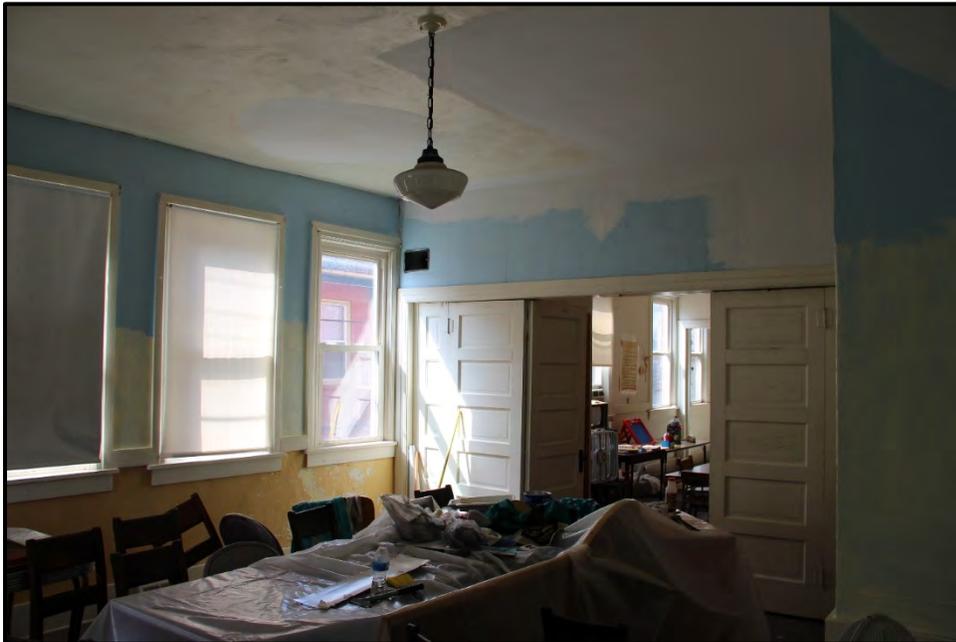
*Photo 66: South Side Presbyterian Church (September 2018). View southwest showing 2<sup>nd</sup> floor east room of the community center. The second floor is a 1920 addition.*

- Photo 66: South Side Presbyterian Church (September 2018). View southwest showing 2<sup>nd</sup> floor east room of the community center. The second floor is a 1920 addition.

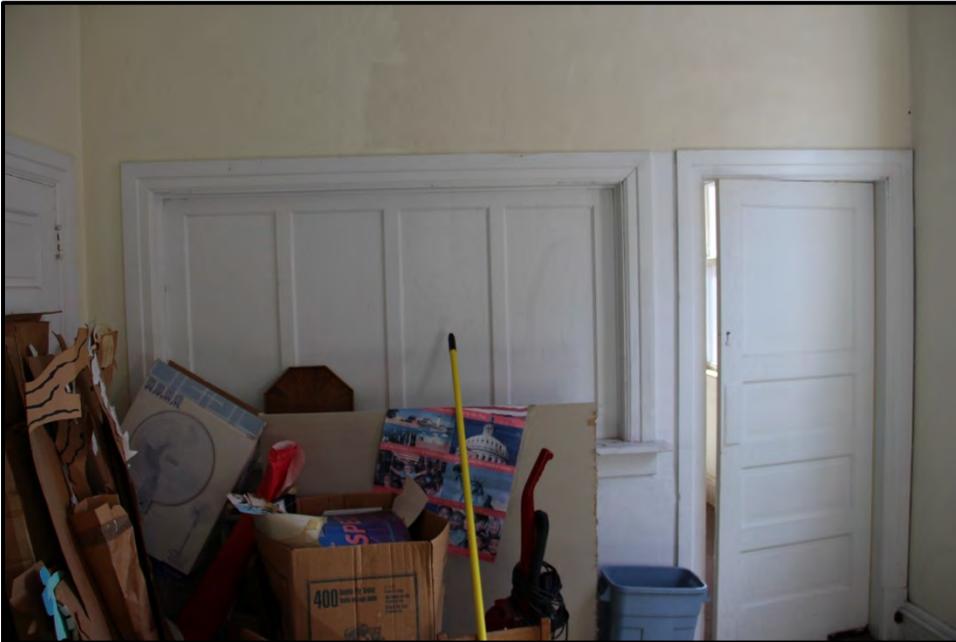
*Photo 69: South Side Presbyterian Church (September 2018). View east from community room kitchen to dining room (2<sup>nd</sup> floor). Note the sliding service window.*

- Photo 69: South Side Presbyterian Church (September 2018). View east from community room kitchen to dining room (2<sup>nd</sup> floor). Note the sliding service window.

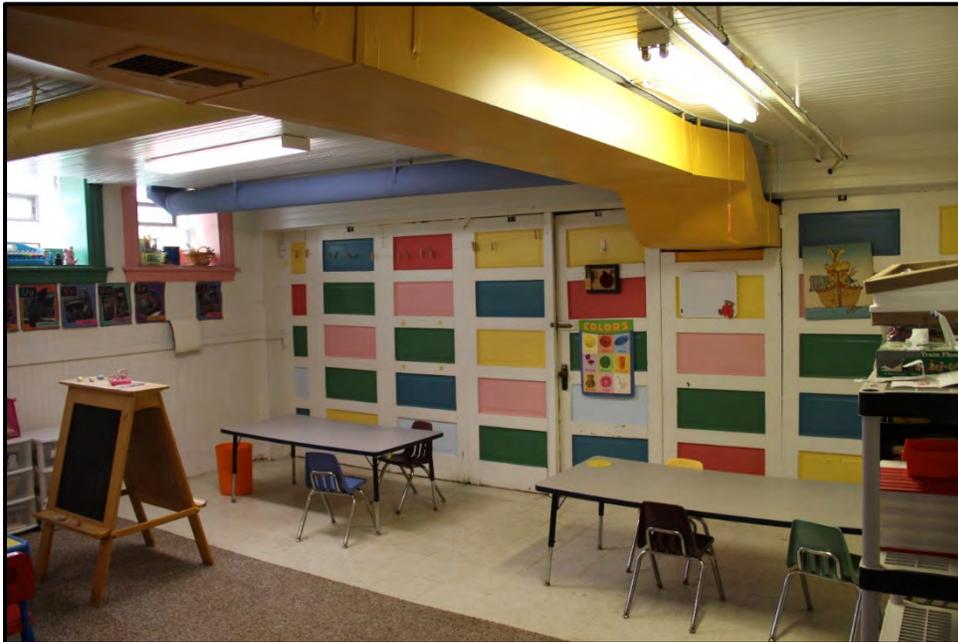
*Photo 74: South Side Presbyterian Church (September 2018). View southwest showing pre-school room in gym basement. The gym basement formerly contained shower and locker rooms.*

- Photo 73: South Side Presbyterian Church (September 2018). View northeast showing toilet room in basement of gym.
- Photo 74: South Side Presbyterian Church (September 2018). View southwest showing pre-school room in gym basement. The gym basement formerly contained shower and locker rooms.

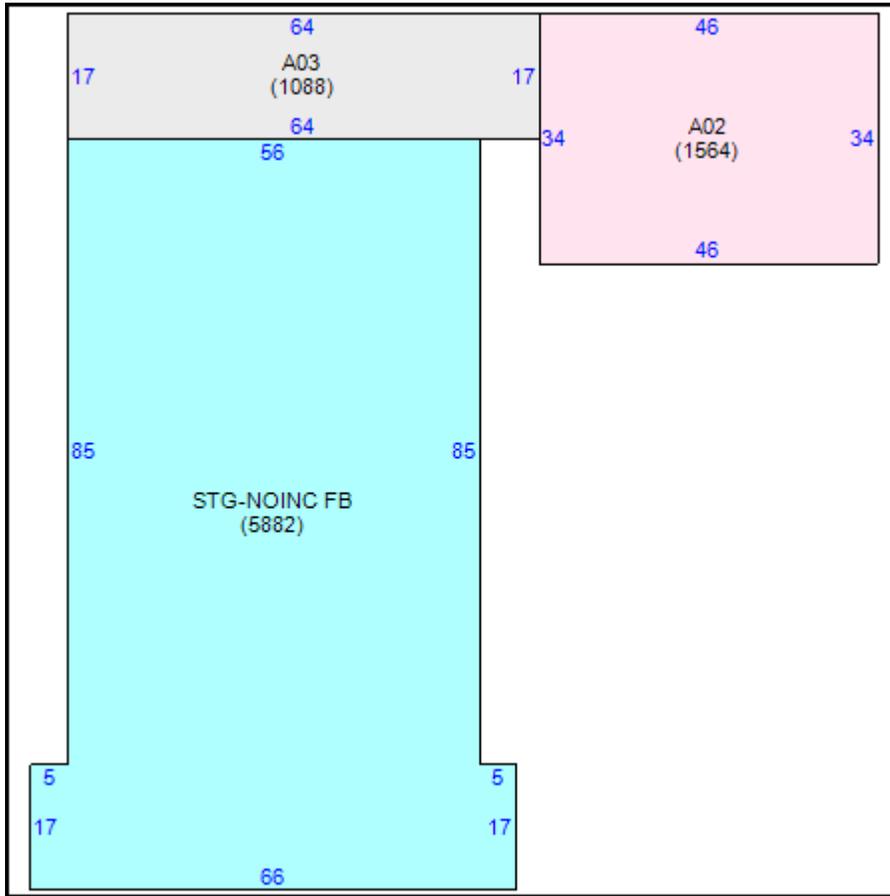
Figure 1: Building Sketch Map from Allegheny County Real Estate Portal (2018), showing exterior wall dimensions.

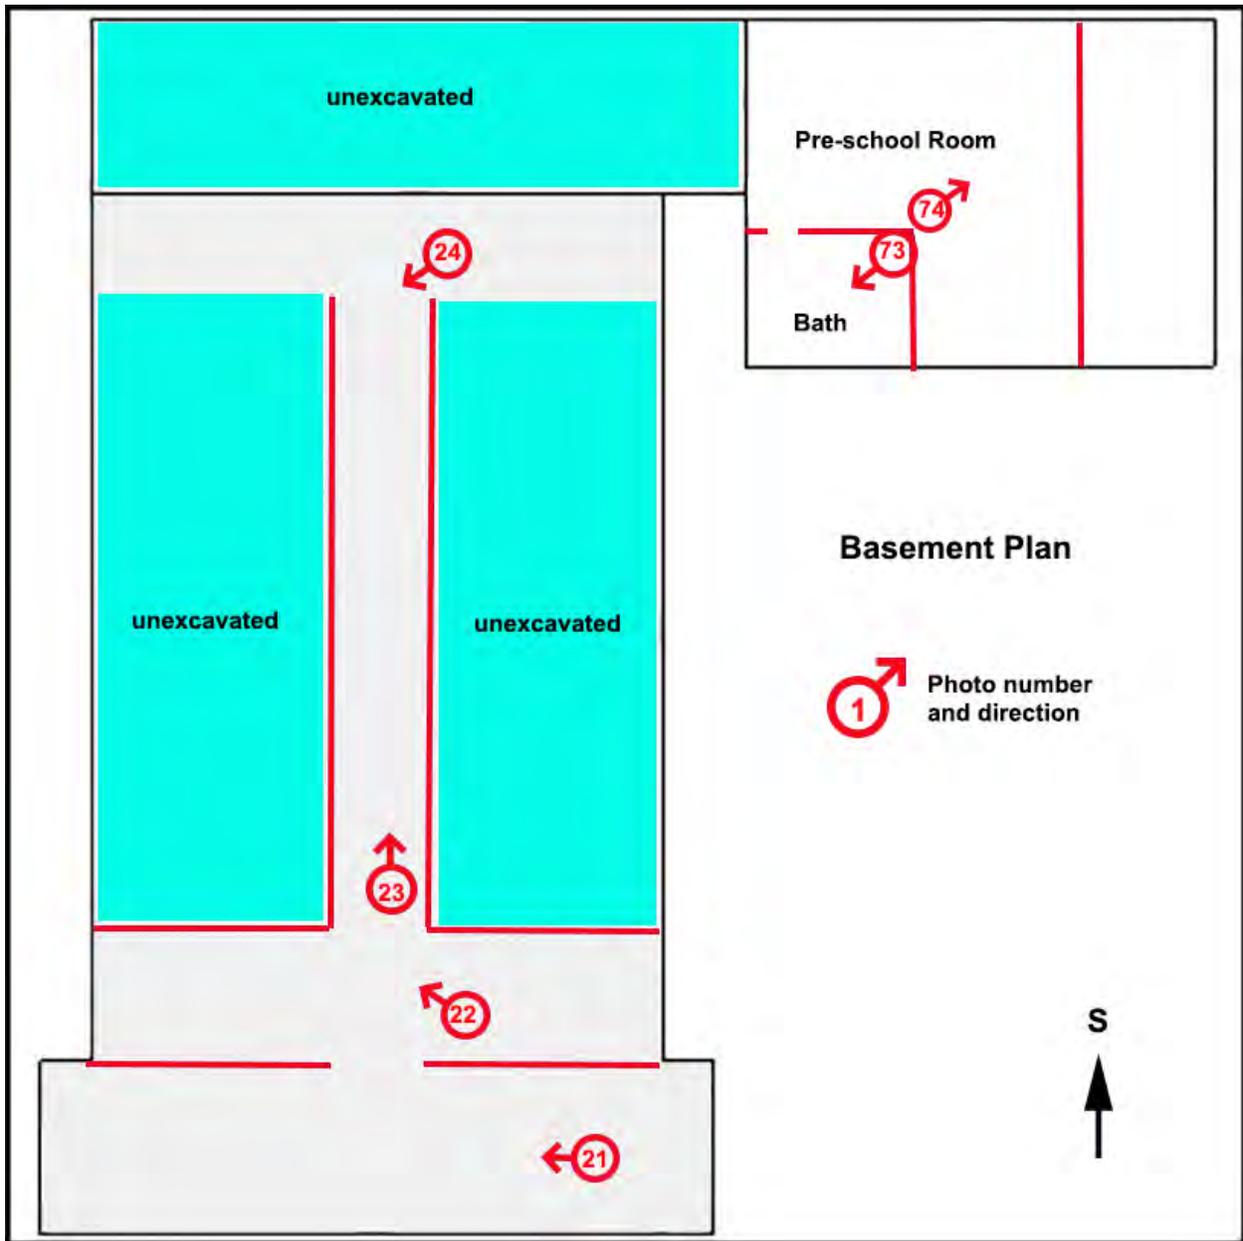
Figure 3: Basement floor plan with photo directions.

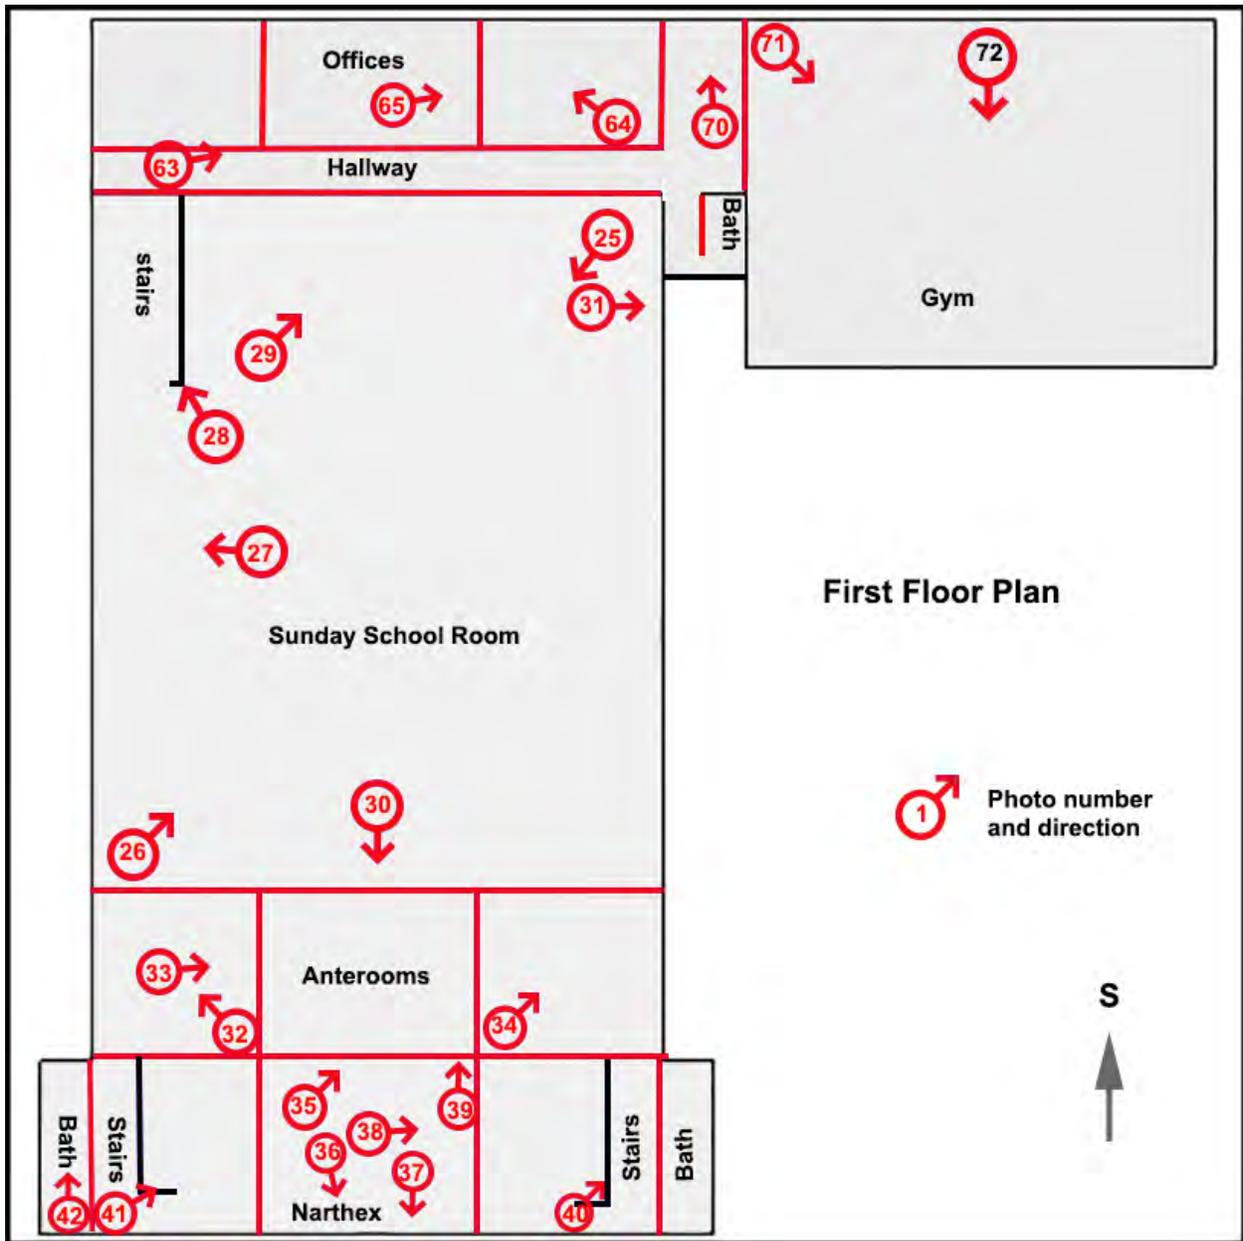
Figure 4: First floor plan with photo directions.

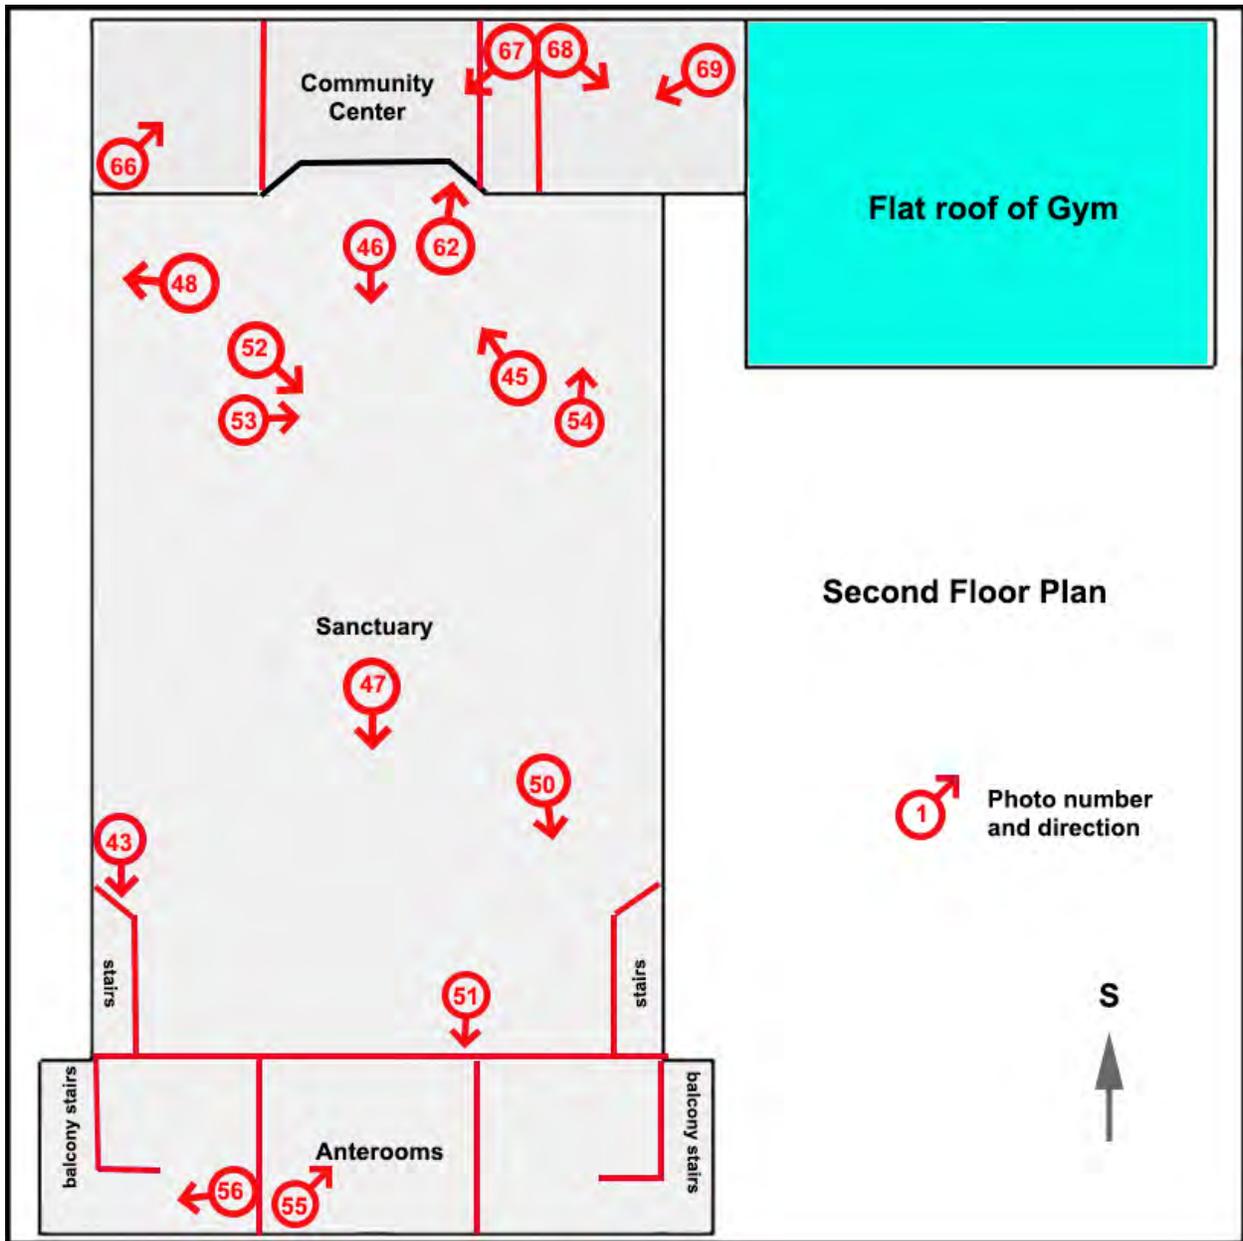
Figure 5: Second floor plan with photo directions.

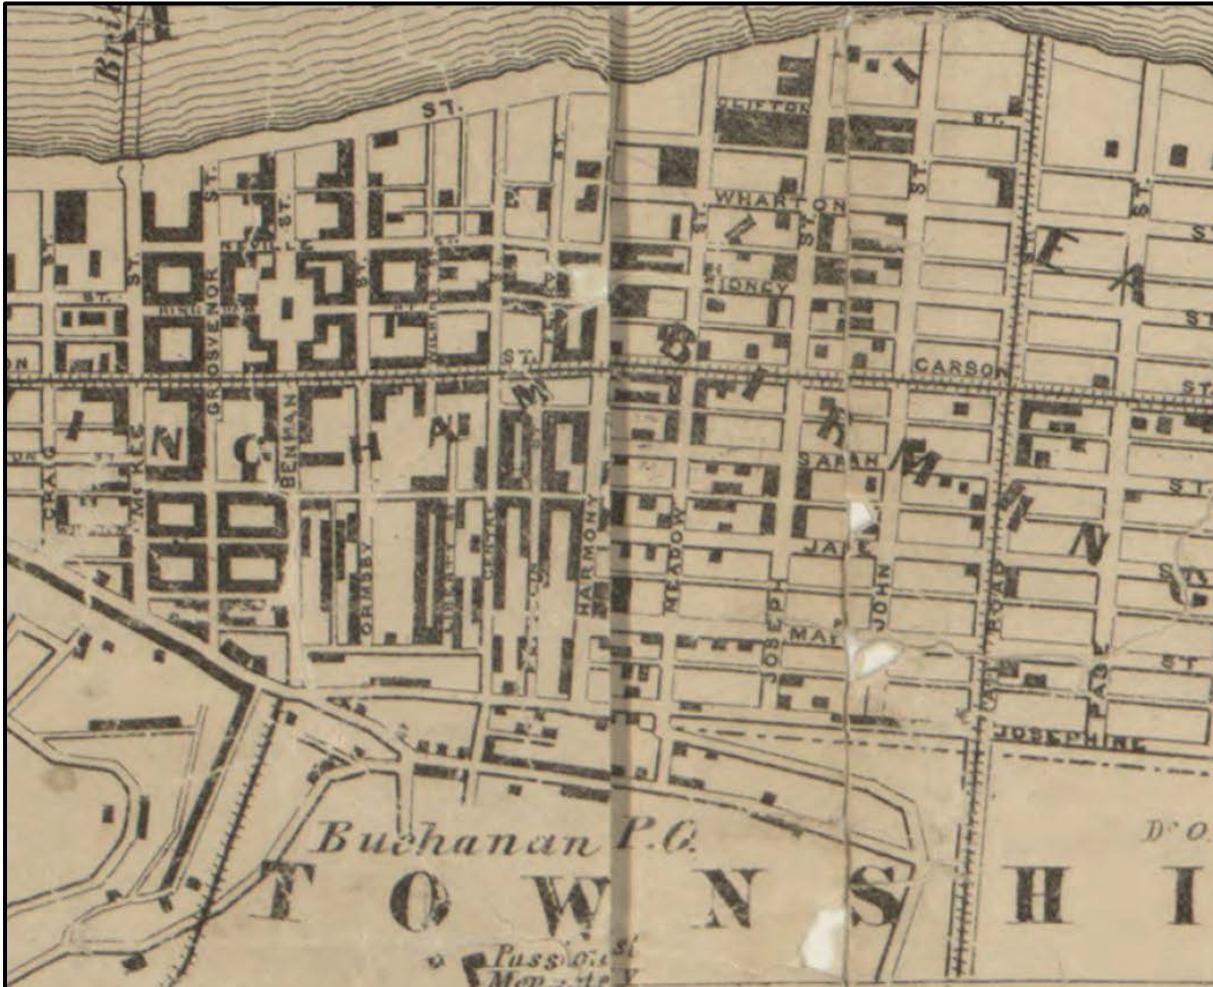
Figure 8: Site of South Side Presbyterian Church as depicted on an 1862 map (Beers, 1862).

Note that a building appears on the site of the church at the southeast corner of Sarah and John (S. 20<sup>th</sup>) streets. It is likely that this was a school or school-related building, as the property was then owned by the School District of East Birmingham.

- Figure 6: Balcony plan with photo directions.
- Figure 7: Attic plan with photo directions.
- Figure 8: Site of South Side Presbyterian Church as depicted on an 1862 map (Beers, 1862).

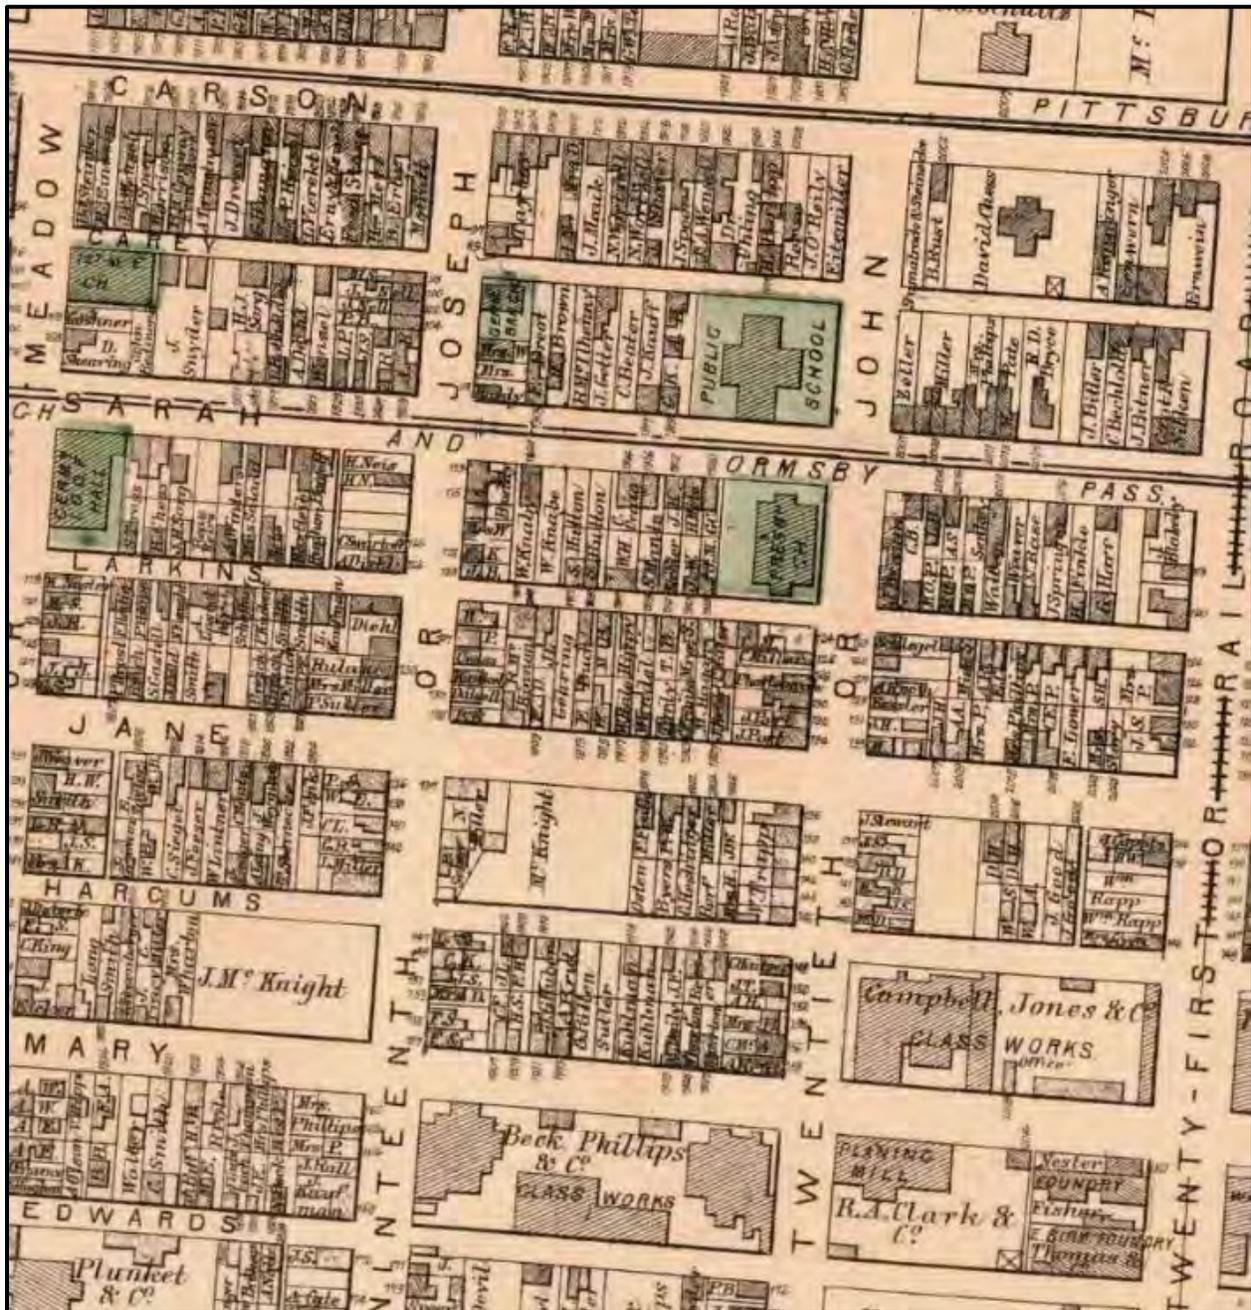
Figure 9: South Side Presbyterian Church as depicted on the 1872 Hopkins plat map (Hopkins, 1872).

This is the earliest available map depicting the church building. The shape of the building's Sarah Street façade appears to be inaccurate, as no central protrusion is noted on other maps or in an 1870 description of the building given by the *Pittsburgh Commercial Gazette*. Note the size of the church lot, which originally measured 96 feet wide by 120 feet deep. In 1878 the church sold the adjacent lot and it was developed with a rowhouse (1924 Sarah Street) and an alley house on Larkin Way. Humboldt School (built 1867) is depicted opposite the church on Sarah Street.

- Figure 9: South Side Presbyterian Church as depicted on the 1872 Hopkins plat map (Hopkins, 1872).
- Figure 10: South Side Presbyterian Church as depicted on the 1884 Sanborn Fire Insurance Map (Sanborn 1884).

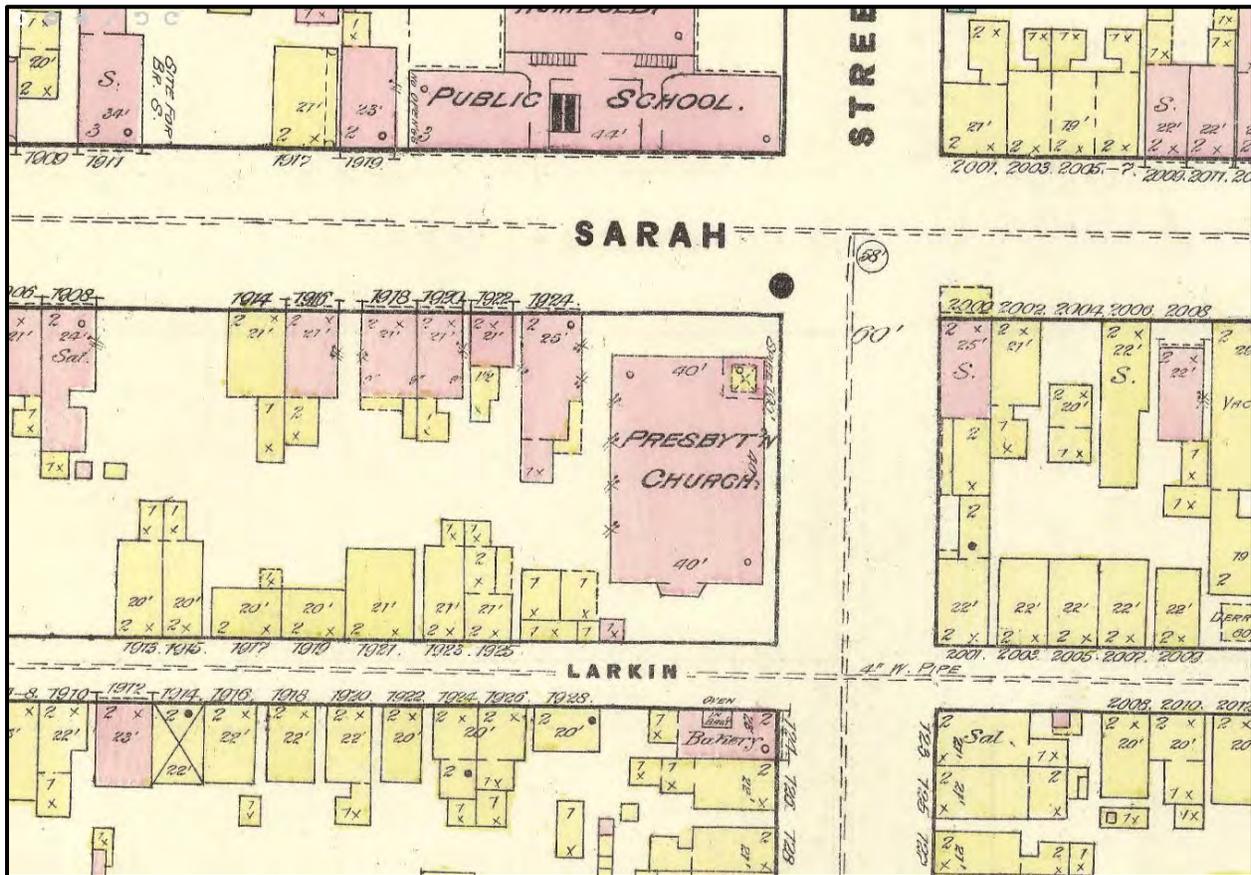
Figure 10: South Side Presbyterian Church as depicted on the 1884 Sanborn Fire Insurance Map (Sanborn 1884).

The 40-foot width of the church noted in this map is inaccurate, as the church measures 56 feet wide. The steeple height indicated on the map is not legible. The steeple height was reported to be 157 feet in an 1870 newspaper article published a couple of months prior to the church’s completion.

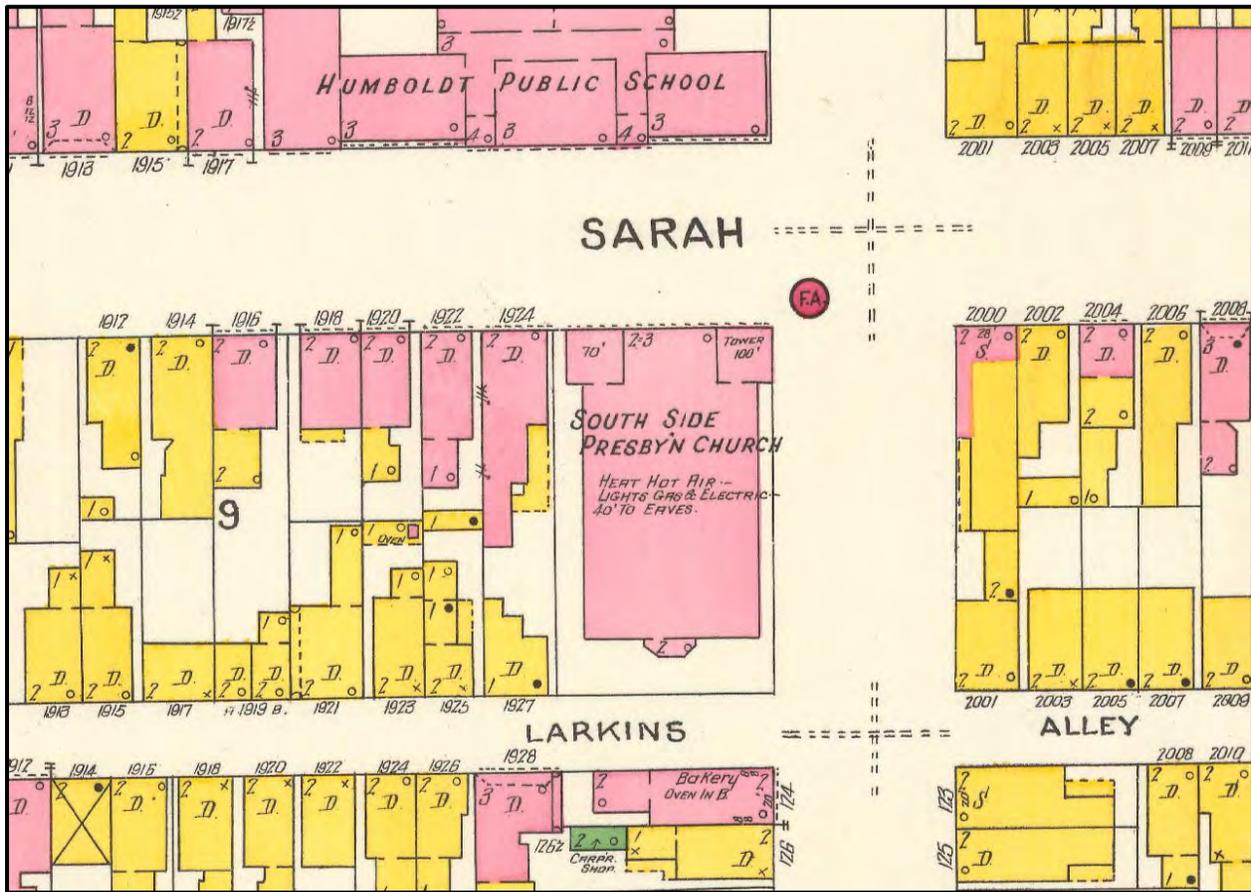
Figure 12: South Side Presbyterian Church as depicted on the 1906 Sanborn Fire Insurance Map (Sanborn 1906).

This map shows the 1893 church addition to the Sarah Street façade of the building, which extended the building to the sidewalk line and added east and west towers. The map indicates a height of 100 feet and 70 feet, respectively for the east and west tower. The map indicates a building height to eaves of 40 feet, which differs from the 37-foot height given on previous (1893) Sanborn map. In spite of this discrepancy, no change to wall height was made in 1893 or later years. The heat type is noted at hot air, and the lighting type is gas and electric.

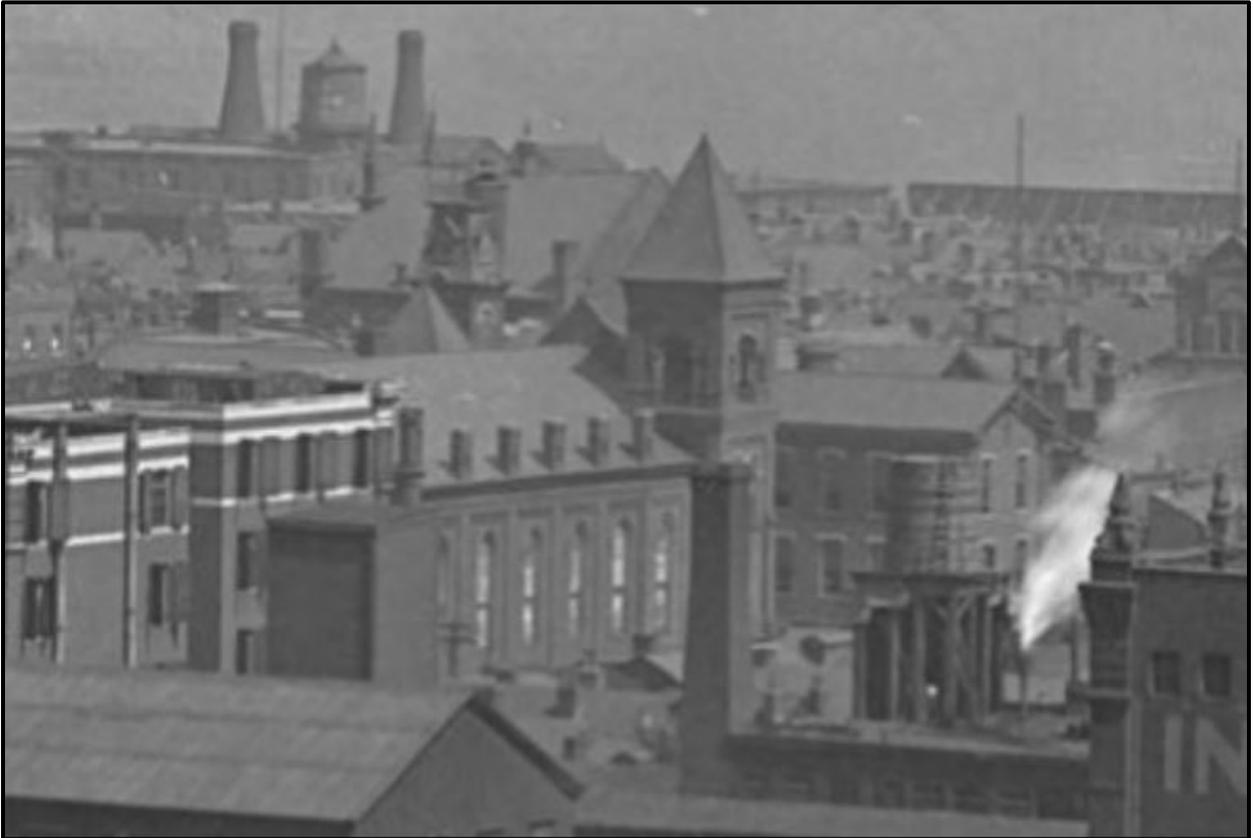
Detail of June 12, 1911 from South Side Slopes near Mission Street Pump Station, showing east façade of South Side Presbyterian Church. Note the series of chimney flues between each window on the eaves wall. Photo courtesy of the Pittsburgh City Photographer Collection, University of Pittsburgh, Archives of Industrial Society, image 715.112657.CP.
