CITY OF
PITTSBURGH
PROPERTY CONDITION REPORT

B135 – Firehouse 26
630 Brookline Blvd.
Pittsburgh, Pennsylvania 15226

June 2014

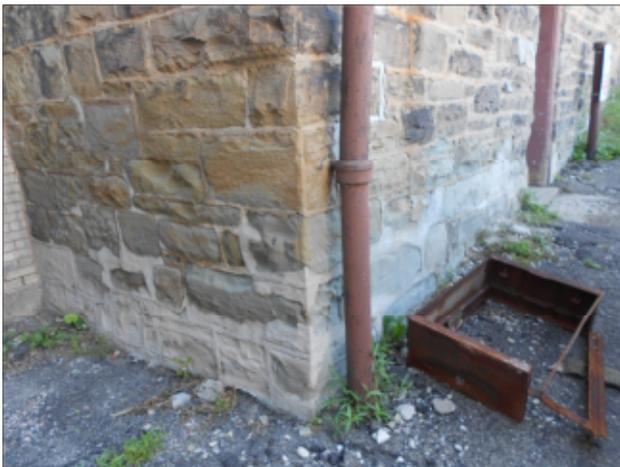
SS1 – North corner

1. Foundation
 - a. Constructed of masonry - Fair condition: the basement walls have a few light cracks and small areas of missing mortar.
 - b. Attempts at repairs / repointing are evident at the NE side.
2. Slab on grade: The basement floor is concrete and has some light cracks.

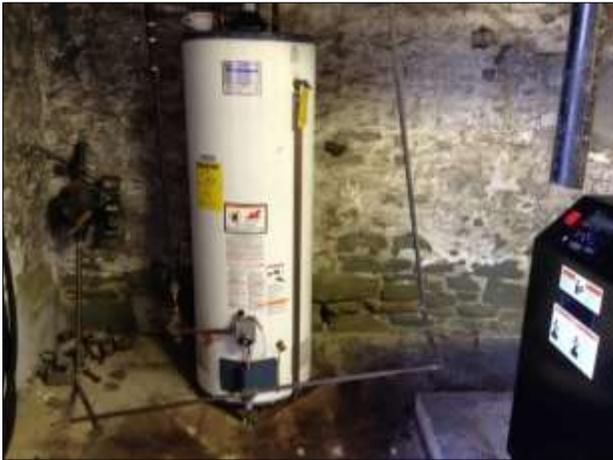
P1 – Domestic water heater - 1

2.1.1 Water Heater Condition: **Fair**

- 5.1 De minimus conditions
 - 5.1.1 Insulate supply pipes from water heaters.
- 5.2 Immediate Costs

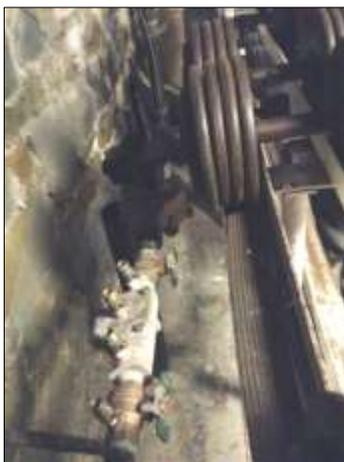
P5 – Domestic water service

- 3.1 General Description: Potable water supply
- 3.2 Construction
 - 3.2.1 Original meter, shut-off valve, and piping.
 - 3.2.2 Back-flow preventer present, older style.
- 3.3 Condition Assessment: Fair

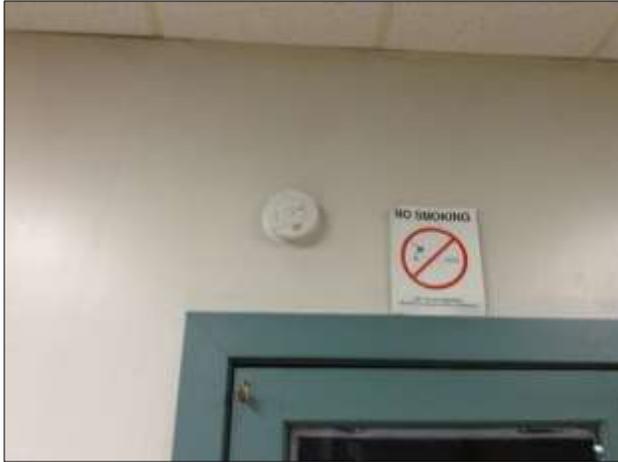
FP1 – Smoke detector dormitory

2. Fire Extinguishers
 - 2.1. No observable fire extinguishers present. **Potential Code Violation.**
3. Alarm Systems
 - 3.1. Two (2) or smoke alarms present in dormitory and stairwell.

- 3.2. Condition: **Fair**
4. Smoke Evacuation System and Stairwell Pressurization
 - 4.1. No Smoke Evacuation System or Stairwell Pressurization.
5. Sprinklers and Standpipes
