CITY OF
PITTSBURGH
PROPERTY CONDITION REPORT

B142 – Firehouse 35
1519 Orchlee St.
Pittsburgh, Pennsylvania 15212

June 2014

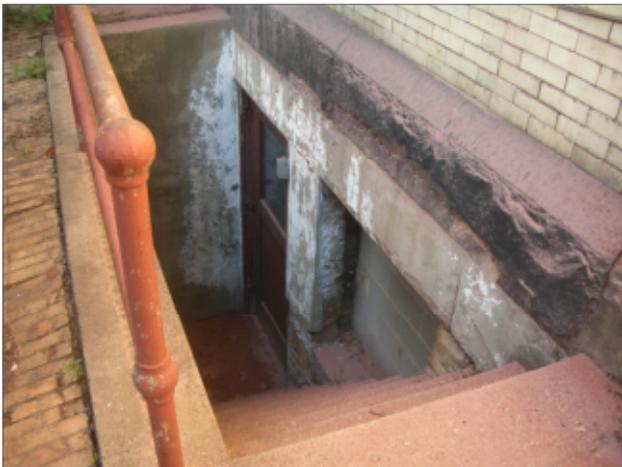
SH3 – Basement stair well

- The interior stairs are in need of replacement within 5 yrs.
- The shingle roofing system is in need of replacement
- The apparatus room floor is in need of repair
- The fire detection/notification and protection systems are inadequate.

| Section | Item | Quantity | Unit | Unit Cost | Cycle Replacement | Replacement % | Immediate Total | Short-Term Total |
|---|--|---|---|---|---|---|---|---|
| a | Repair interior stairs (5yrs) | 1 | EA | \$15,000 | | | | \$15,000 |

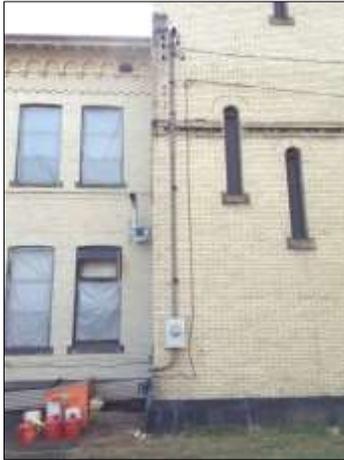
3. Utilities Service
 - 3.1. Construction
 - 3.1.1. One (1) 3-phase original electric service.
 - 3.2. Condition Assessment
 - 3.2.1. Condition Power Service: **Fair**
 - 3.2.2. Condition Electric Meter: **Good**

E18 – Electric service - 1

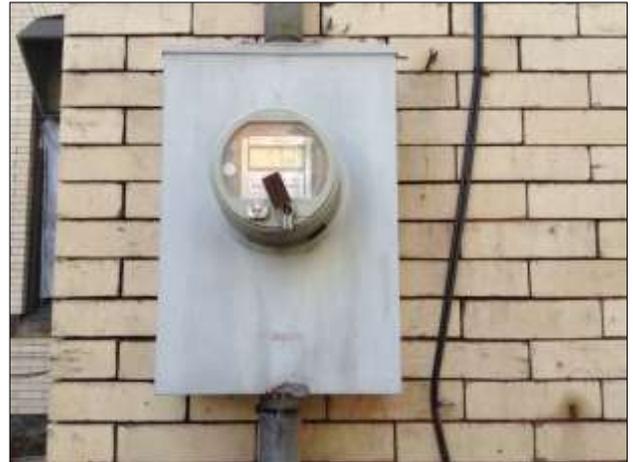
E19 – Electric meter

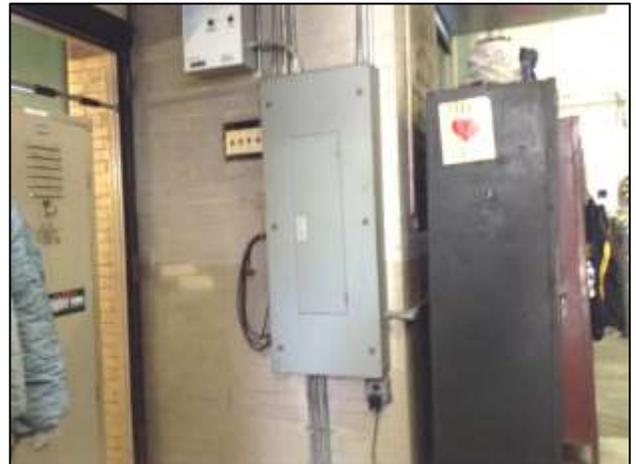
2. Power Distribution
 - 2.1. Construction and condition
 - 2.1.1. Distribution panels (original to building): Condition-**Fair**
 - 2.1.2. General Receptacles (original to building): Condition-**Fair**

E21 – Breaker panel 1st floor

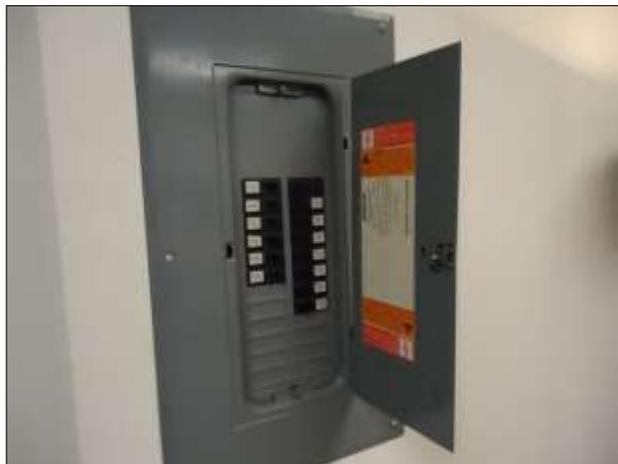
E22 – Breaker panel 2nd floor

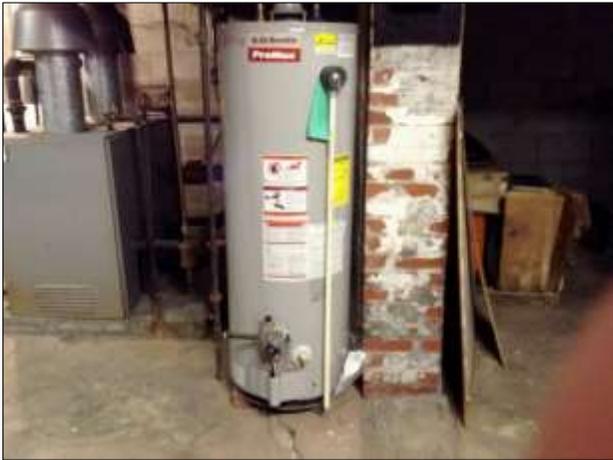
2.1.1 Water Heater Condition: **Fair**

P9 – Domestic water heater - 1

- 5.1 De minimus conditions
 - 5.1.1 Insulate supply pipes from water heaters.
- 5.2 Immediate Costs
 - 5.2.1 Install back-flow preventer: \$2,000.

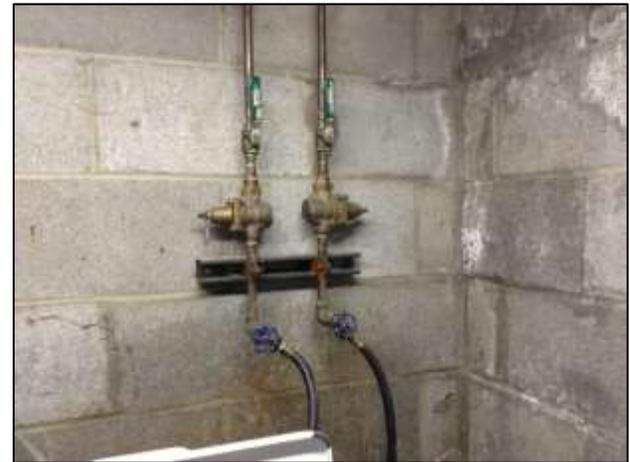
- 4.1 The plumbing systems are in fair to poor overall condition. Routine maintenance should continue to extend serviceability. Building water pressure is observed to be excessive due to the presence of secondary pressure regulation devices.

P12 – Domestic water secondary pressure regulators

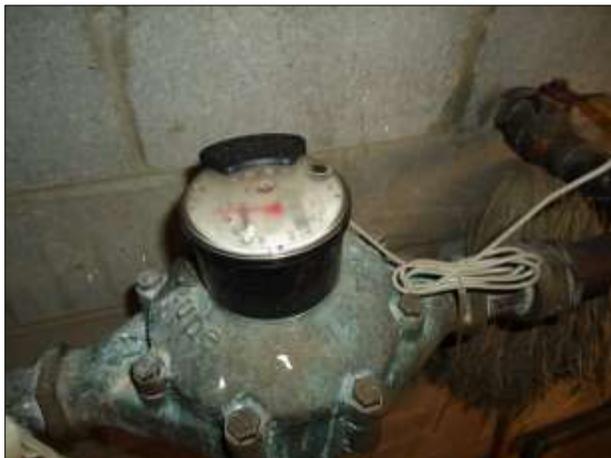
- 3.1 General Description: Potable water supply
- 3.2 Construction
 - 3.2.1 Original meter, shut-off valve, and piping.
 - 3.2.2 No back-flow prevention.**
- 3.3 Condition Assessment: **Fair**

P13 – Water meter

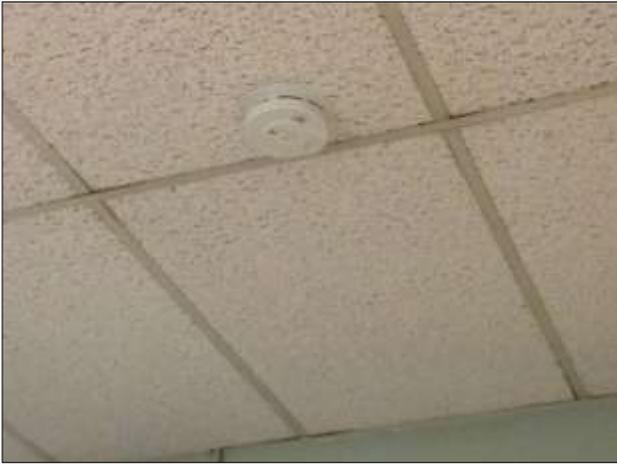
2. Fire Extinguishers
 - 2.1. No observable fire extinguishers present. **Potential code violation.**
3. Alarm Systems
 - 3.1. One smoke detector present in dormitory.

- 3.2. Condition: **Fair**
4. Smoke Evacuation System and Stairwell Pressurization
 - 4.1. No Smoke Evacuation System or Stairwell Pressurization.
5. Sprinklers and Standpipes

FP1 – Smoke detector dormitory
