CITY OF
PITTSBURGH
PROPERTY CONDITION REPORT

B124 – Firehouse 12 / Medic 7
4156 Winterburn Avenue
Pittsburgh, Pennsylvania 15207

June 2014

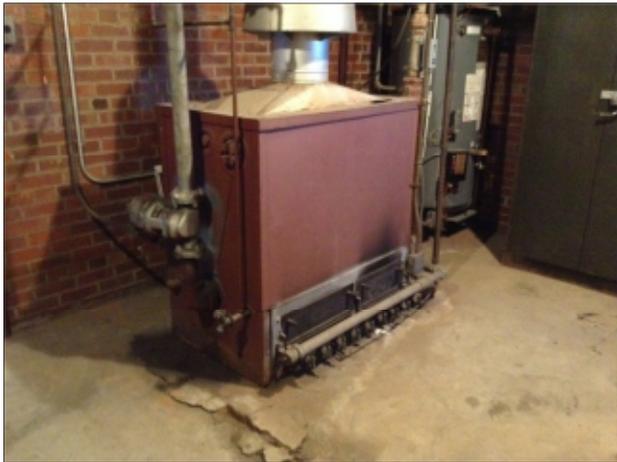
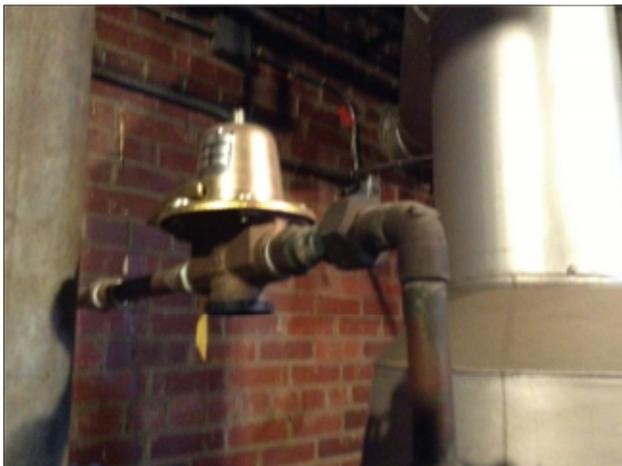
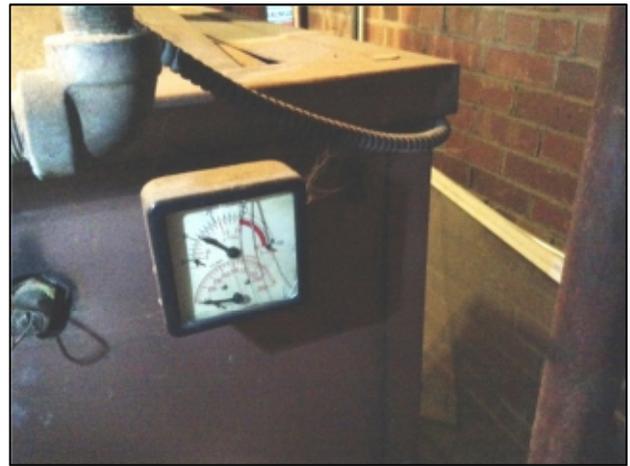
1.3.3. Condition: Central Boiler - **Poor**

- 1.3.3.1. Safety Concerns: None reported or observed
- 1.3.3.2. Physical Deficiencies: None reported or observed
- 1.3.3.3. Functional Deficiencies: None reported or observed
- 1.3.3.4. Performance Deficiencies: OA reset
- 1.3.3.5. Maintenance observations: Boiler age general condition
- 1.3.3.6. Remaining useful life observations (RUL): 1-2 years

HVAC 25 – Hot water heating boiler - 1

HVAC 27 – Hot water heating boiler - 2

HVAC 28 – Hot water heating boiler - 3

- 4.3.8. Replace existing boiler with high efficiency model (Triad 600SH): \$26,000

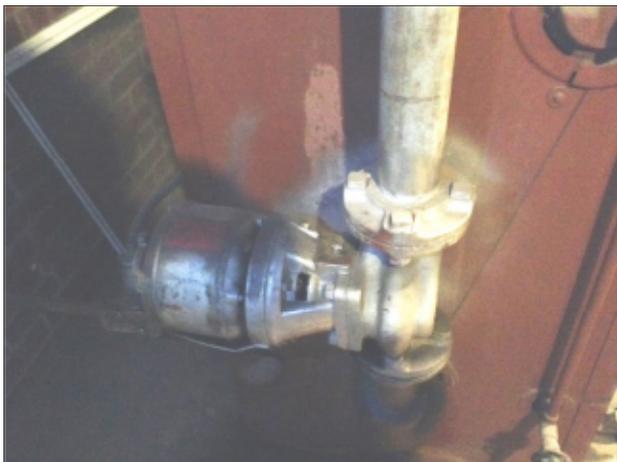
HVAC 29 – Hot water heating pump

- 1.2.1.3. One (1) Pumps: Factional HP, in-line centrifugal
- 1.2.1.4. Pump controls: Partially de-commissioned

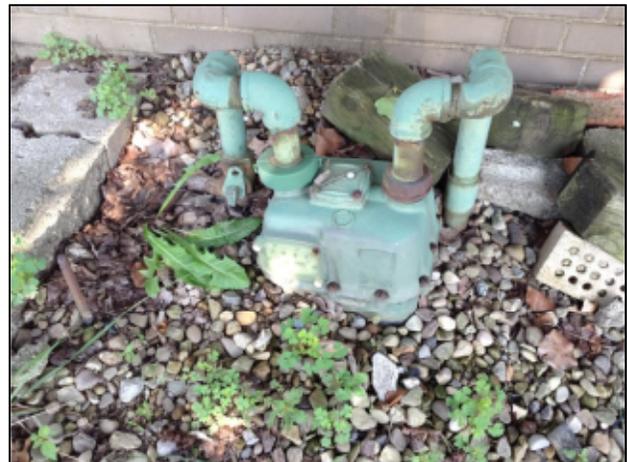
HVAC 30 – Gas meter

- 2.1. General Description: Natural gas.
- 2.2. Construction
 - 2.2.1. Low pressure natural gas meter and associated threaded, black steel piping.
- 2.3. Condition Assessment: **Fair**

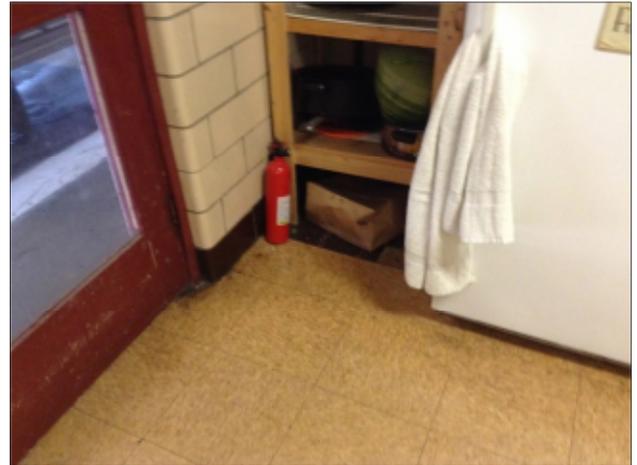
FP2 – Kitchen

7. Ground Fault Interruption
 - 7.1. Construction: GFI's are present in kitchen and laundry (not all receptacles)
 - 7.2. Condition: **Poor**
8. Conclusions:

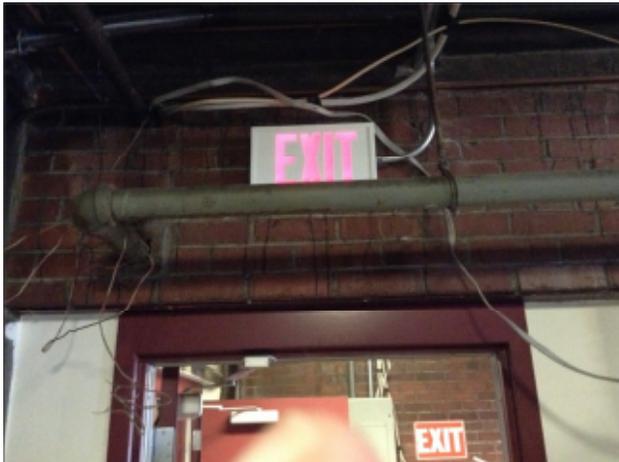
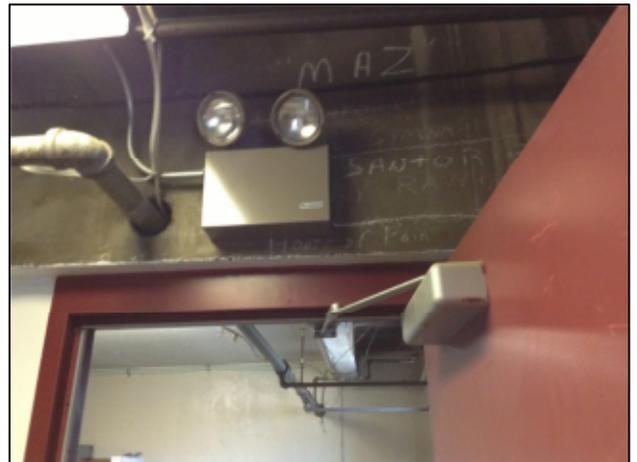
5. Sprinklers and Standpipes
 - 5.1. No sprinkler system present.
6. Emergency Lighting
 - 6.1. Construction: Two (2) emergency light fixtures present.
 - 6.2. Condition: **Fair**

LS1 – Emergency Lighting fixture/Sign

LS2 – Emergency Lighting fixture

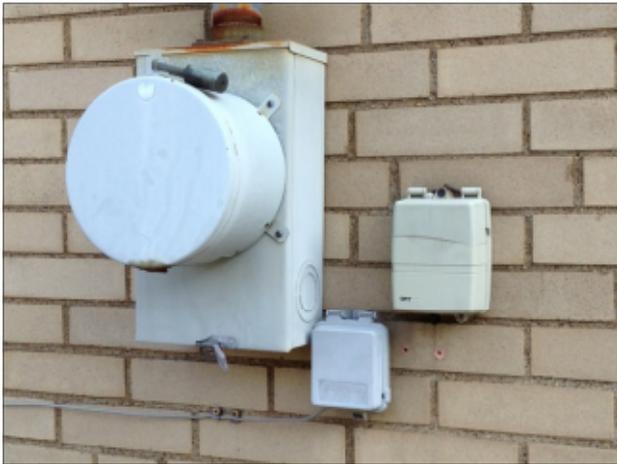
E13 – Electric meter

3. Utilities Service
 - 3.1. Construction
 - 3.1.1. One (1) 3-phase original electric service.
 - 3.2. Condition Assessment
 - 3.2.1. Condition Power Service: **Fair**
 - 3.2.2. Condition Electric Meter: **Good**

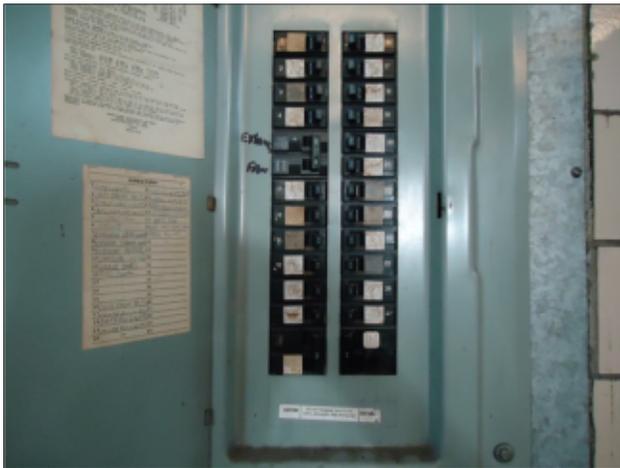
E15 – Breaker panel 1st Floor

2. Power Distribution
 - 2.1. Construction and condition
 - 2.1.1. Distribution panels (original to building): Condition-**Fair**
 - 2.1.2. General Receptacles (original to building): Condition-**Fair**
