CITY OF
PITTSBURGH
PROPERTY CONDITION REPORT

B032 – Jefferson Recreation Center
605 Redknap Street
Pittsburgh, Pennsylvania 15212

June 2014

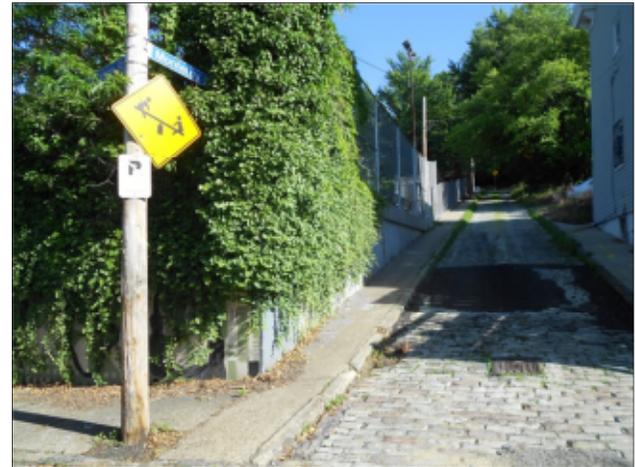
4. Landscaping and Appurtenances – Landscaping and plantings consist primarily of sloping area with wild grass and several deciduous trees. Tall trees overhang the Rec Center roof and deposit debris on the roof leading to gutter overflow when not maintained. Chain-link fencing throughout is in Fair condition. Plantings overhang and conceal much of the retaining walls along the south end of the property.
5. Site Amenities / Accessory Structures- The retaining walls at the north and south ends of the site are in Fair condition.

ST10 – Lower site retaining walls – looking north up Monterey St.

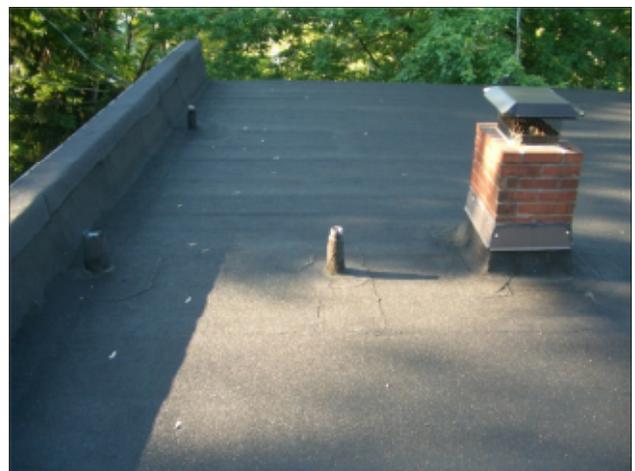
SH6 – East end of roof looking south

10 year: Maintain a pro-active maintenance program. Inspect the roof system and walls on a regular schedule – minimum twice a year (late spring and late fall). Estimated cost: none (perform in-house)

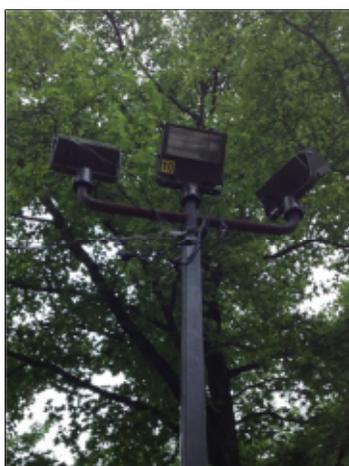
E5 – Athletic courts: typical

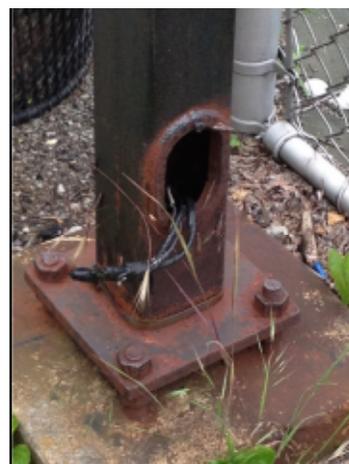
2.2.2.1. Electrical pull box cover plate missing at base of one (1) athletic court light pole. This is a serious safety issue.

E6 – Athletic courts

6. Estimates: Suggested remedies and Opinion of probable cost
 - 6.1. Immediate Costs
 - 6.1.1. Add cover plate at base of athletic court power pole
 - 6.2. Short-term Costs
 - 6.2.1. Replace exterior photo cells: \$1,500

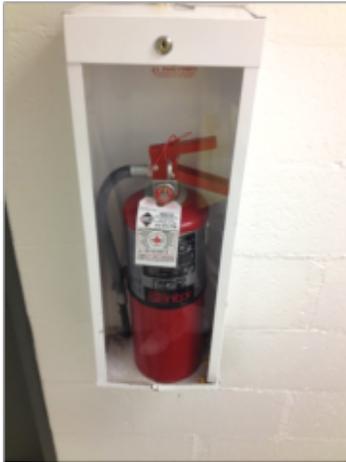
FP1 – Bottom floor hallway

1. Fire Extinguishers
 - 1.1. Construction
 - 1.1.1. Fire extinguishers are present in the bottom floor hallway only.
 - 1.2. Condition Assessment: good.
2. Alarm Systems
