CITY OF  
**PITTSBURGH**  
FACILITY ANALYSIS REPORT

**Medic 3 / Arson / Police Zone #6**  
312 South Main St.  
Pittsburgh, Pennsylvania 15220

**Medic 3 / Arson / Police Zone 6 (B112)**

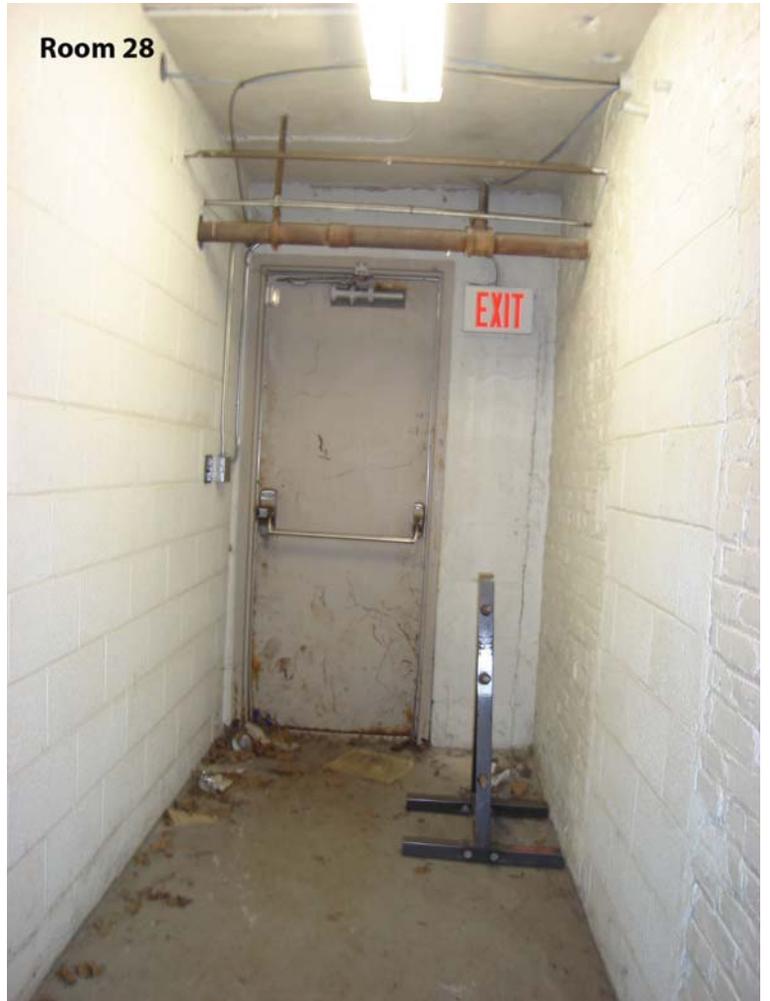
Room 28

<b>Good</b>	Ceiling - Type	Concrete	Notes:	
<b>Fair</b>	Flooring - Type	Rubber	Notes:	
<b>N/A</b>	Base - Type		Notes:	
<b>Fair</b>	Walls - Type	Masonry	Notes:	
<b>Fair</b>	Doors & Hardware	Hollow Metal	Notes:	
	General Note:		Notes:

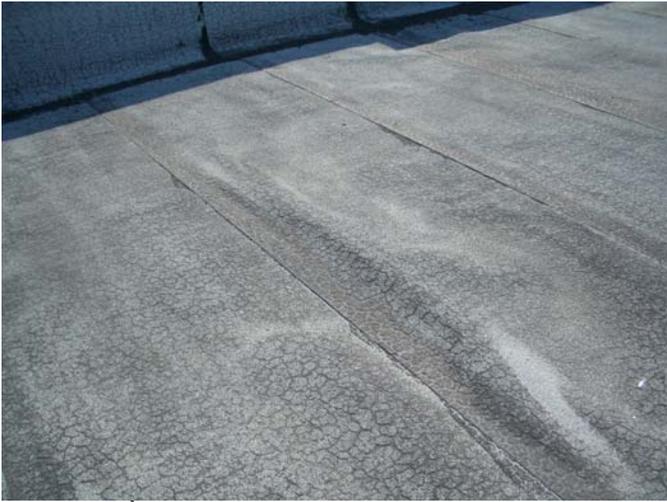
4.2 Condition: The modified roof system on both roof areas is in poor condition. Some ridges and a numerous blisters were observed. The surface is cracked and crazed. Some repairs were observed. Debris was observed at some roof drains.

R-12 2<sup>nd</sup> floor roof, blisters and crazed surface

It is our opinion the roofing systems on both areas should be replaced within the next two years.

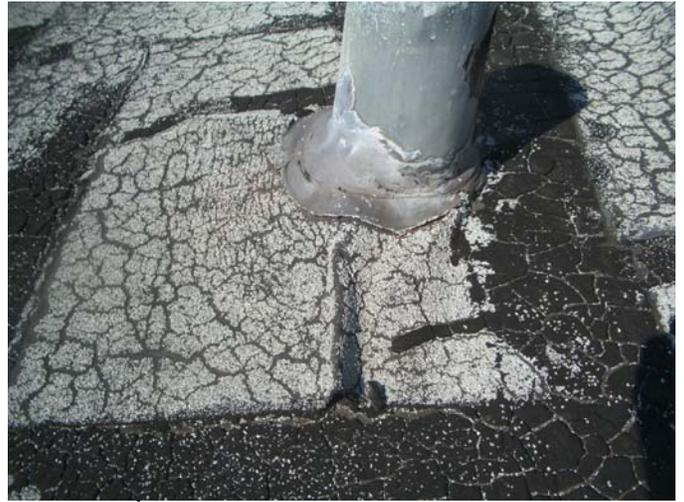
R-13 2<sup>nd</sup> floor roof, blisters

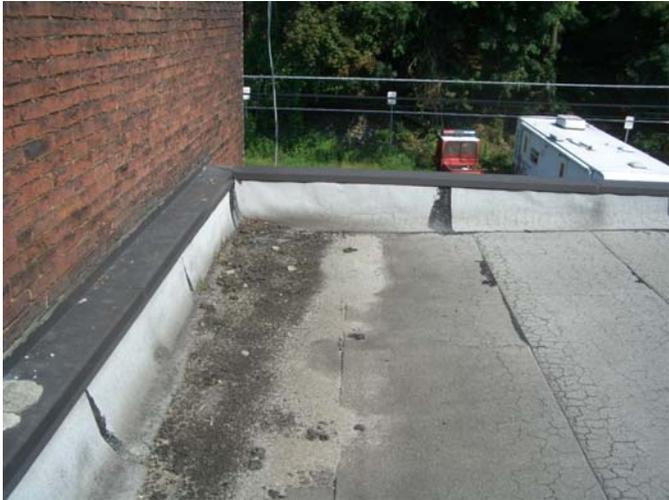
5.2 Condition: The flashing systems are in poor condition. In some areas the flashing is loose from the walls. The flashing is buckled at a few corners. Some vertical flashing joints are open. The surface is cracked and crazed.

R-35 1<sup>st</sup> floor roof, SW corner, debris and buckled flashing

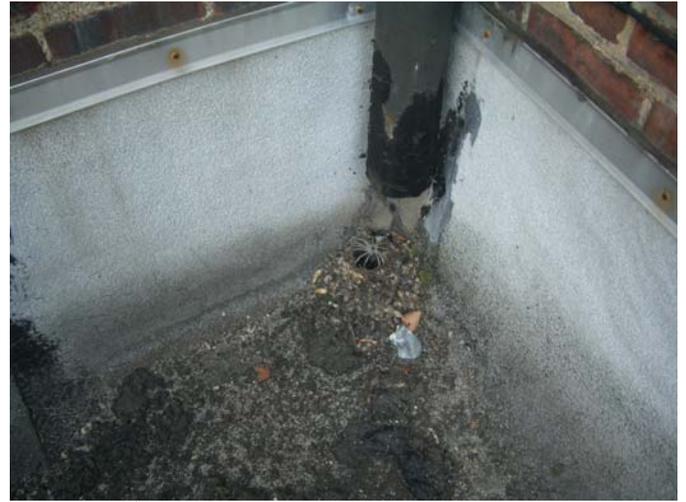
8.2 Condition: Debris observed at some drains. The drainage system appears to be operating properly although the flow is restricted.

R-40 1<sup>st</sup> floor roof, debris at drain

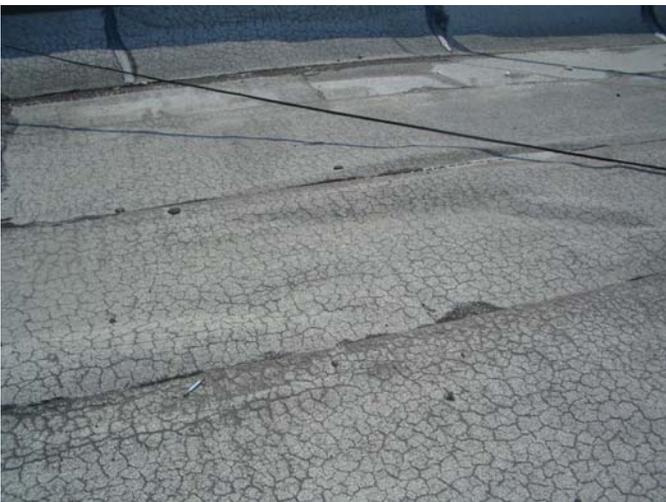
R-38 1<sup>st</sup> floor roof, blisters and crazed surface

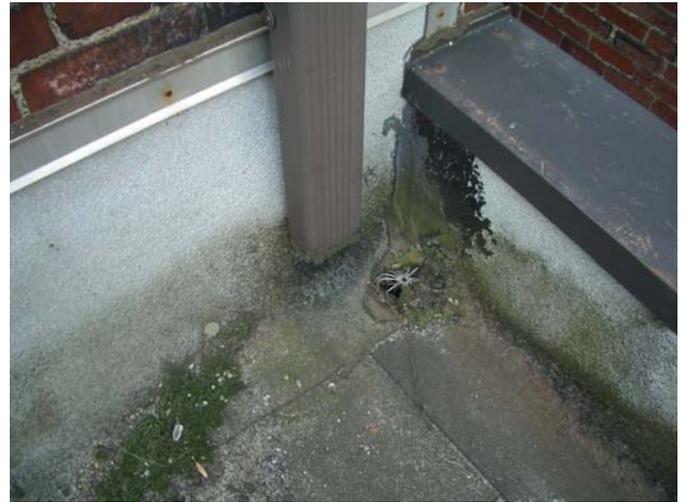
R-41 1<sup>st</sup> floor roof, debris at drain

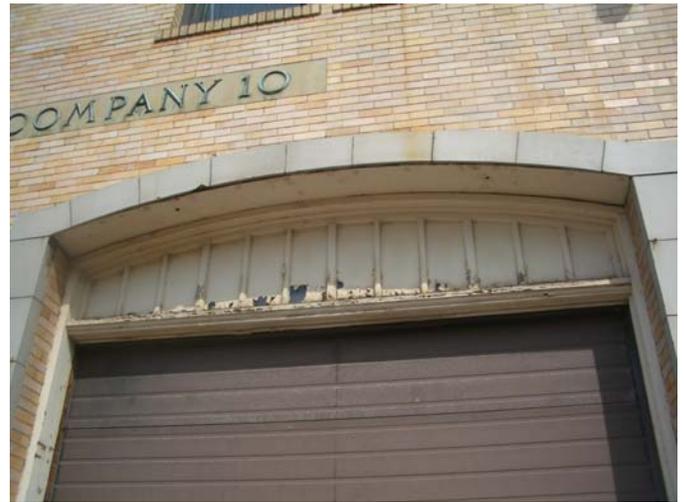
W-5 East wall (front) paint peeling above the door

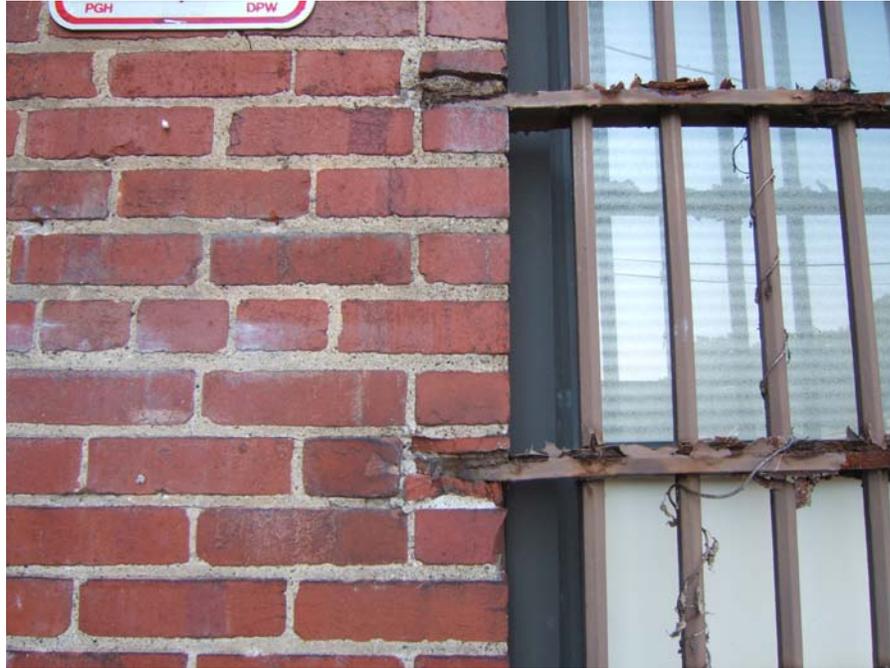
**Photo S1**

- 1) Deterioration of masonry and mortar joints was observed at the north and west façades of the single-story portion of the facility. Additionally, masonry spalling was observed at embedded areas of steel window grating. See Photo 1. Recommend cleaning and repainting of steel bars with repointing and rebuilding of masonry around steel as required. (1-5 yrs.)

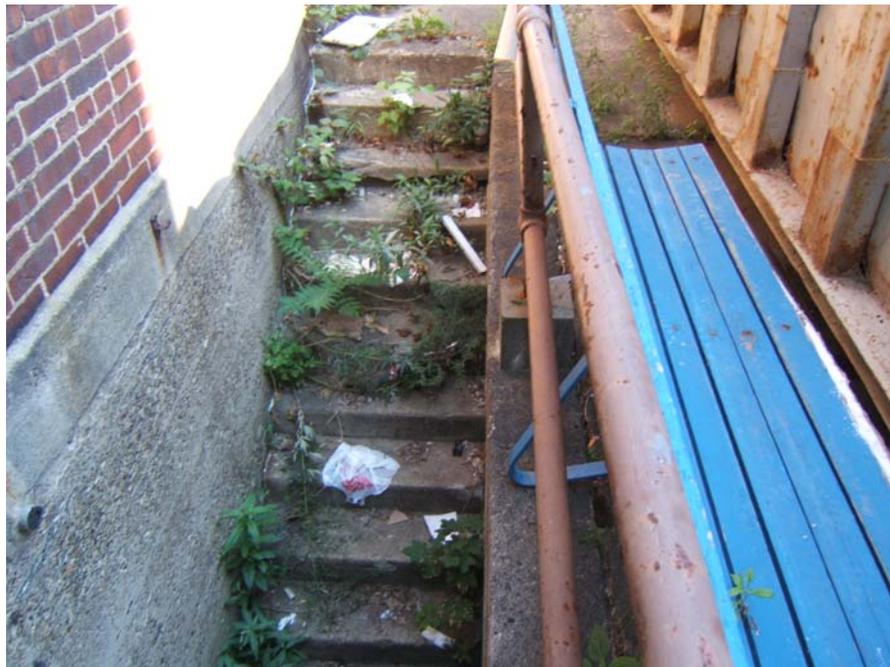
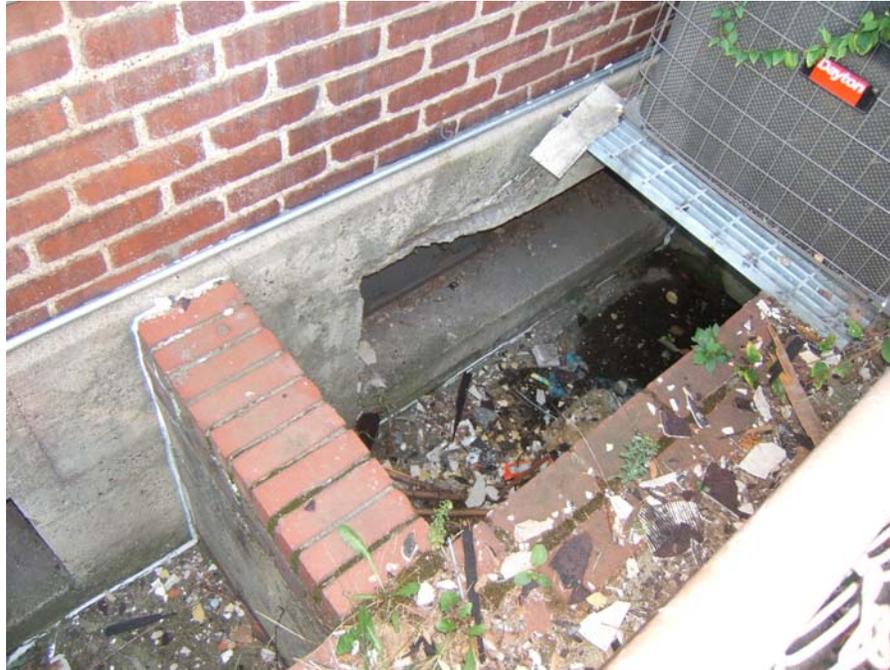
- 2) Some cracking and spalling were observed at the exterior concrete walls and basement steps along the north and west façades of the single-story portion of the facility. See Photos 2 and 3. Recommend partial depth replacement of unsound portions of the stairs and routing and sealing with epoxy at the walls. (1-5 yrs.)

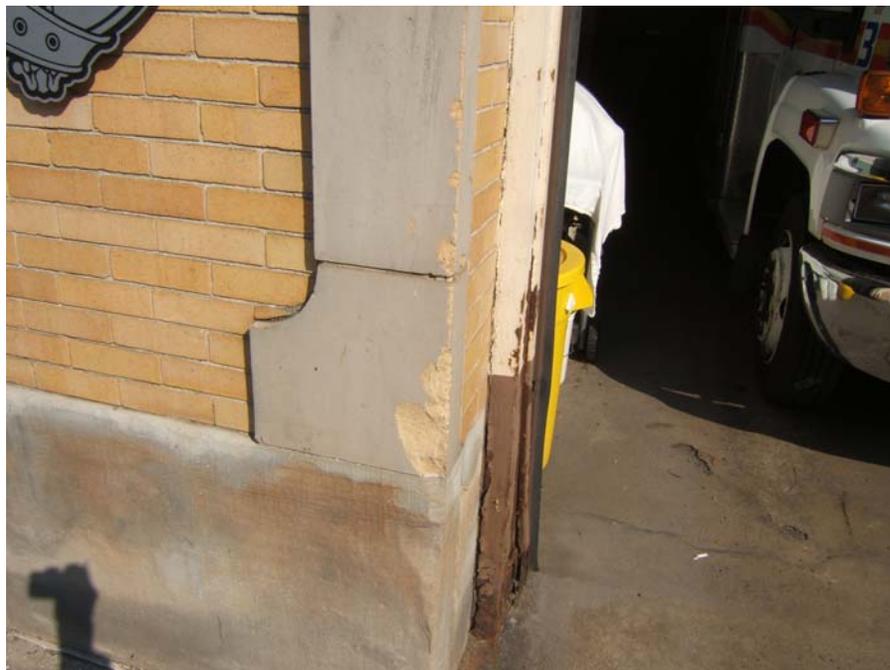
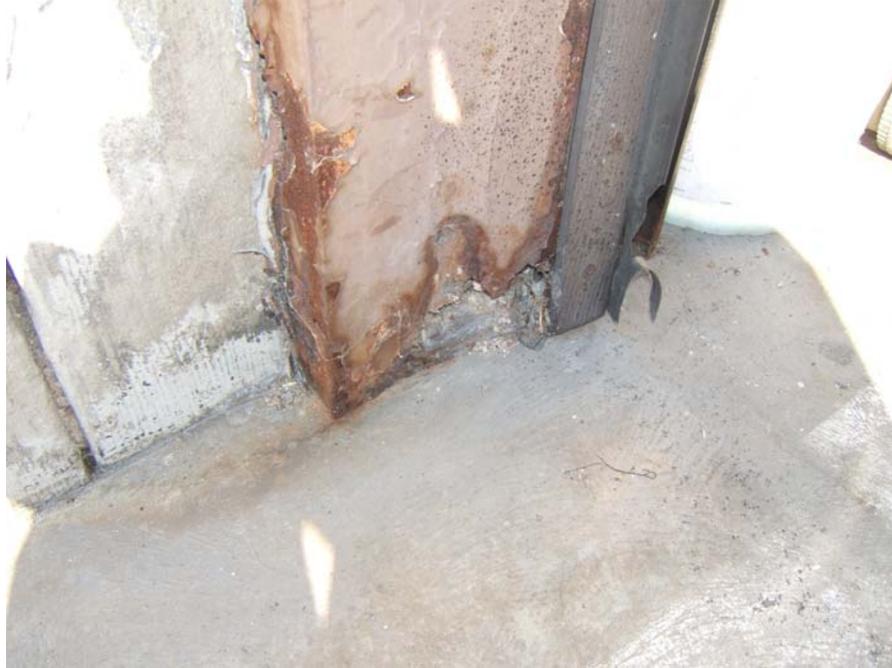
- 3) Slight vehicular damage was observed at the precast jambs of the garage doors on the east façade along with some moderate corrosion at the bottoms of the original steel jambs. See Photos 4 and 5. Recommend cleaning and painting of the steel jambs and replacement of the stone jambs as required for aesthetics only. There are no immediate structural concerns.

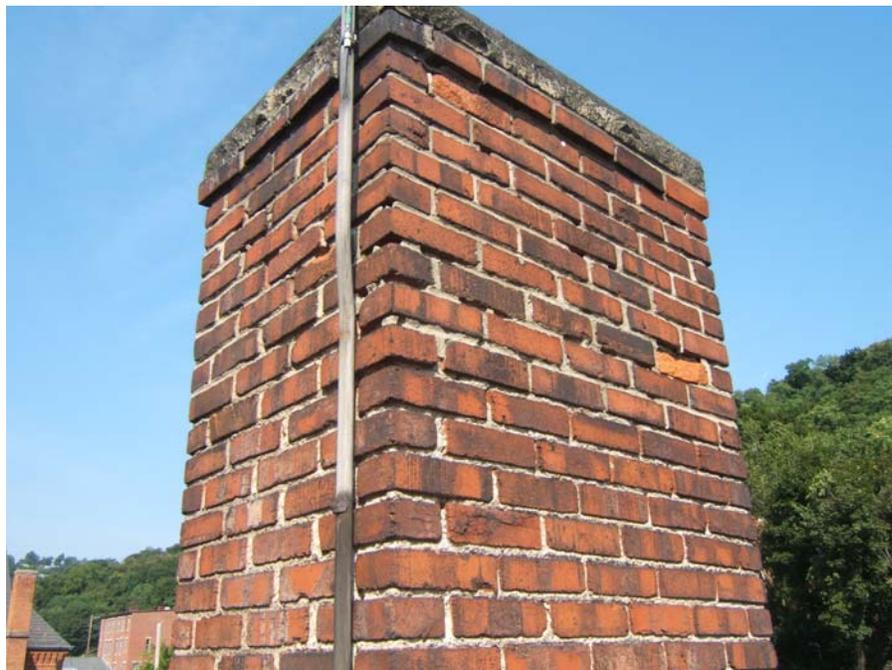
**Photo S6**

- 5) Weathering and mild deterioration of the masonry and mortar joints of the chimney was observed at the roof level. See Photo 6. Recommend re-pointing and brick replacement as required. (1-5 yrs.)

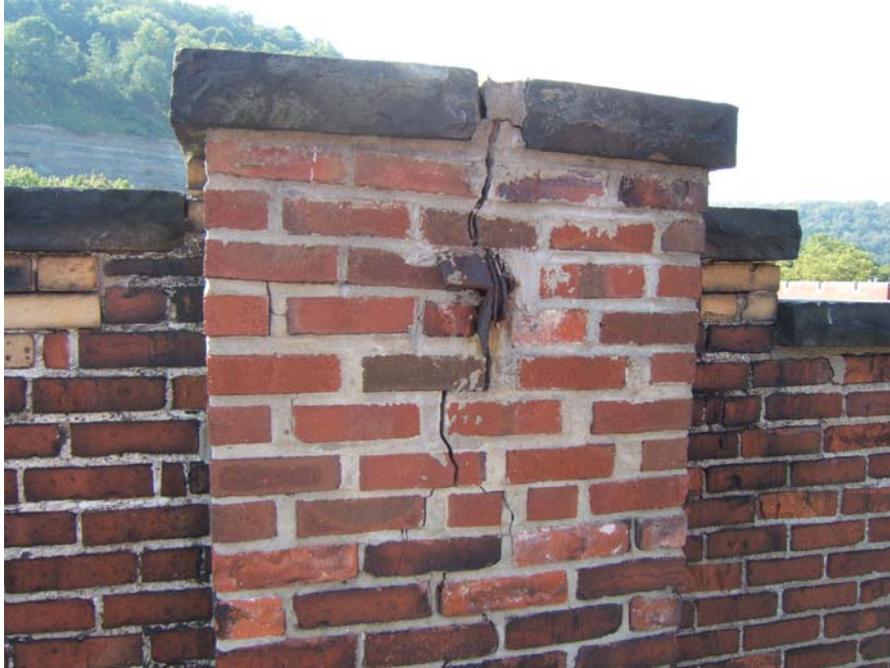
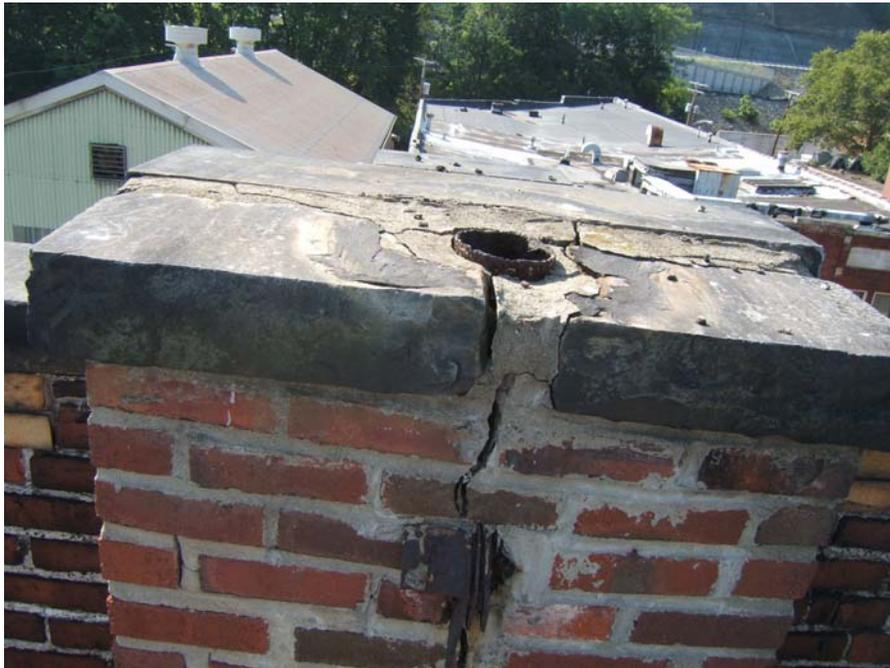
- 6) Severe masonry cracking was observed in the brick pilaster constructed around a flag pole as part of the original front parapet of the building. See Photos 7 and 8. The cracking is due to corrosion and delamination of the steel contained within the pilaster. Recommend removal of the steel from within the masonry pilaster and rebuilding of the parapet as required. (1 yr.)

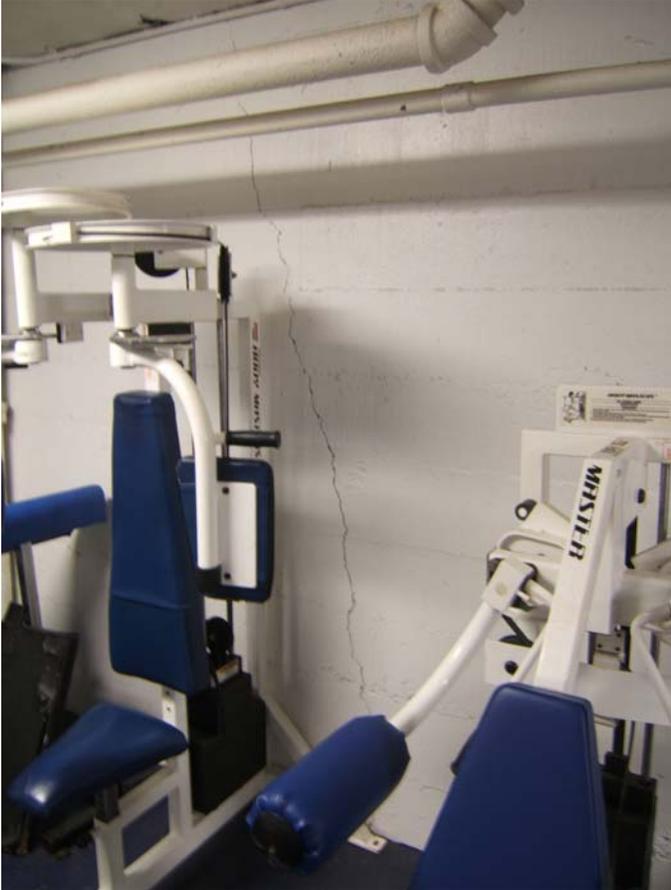
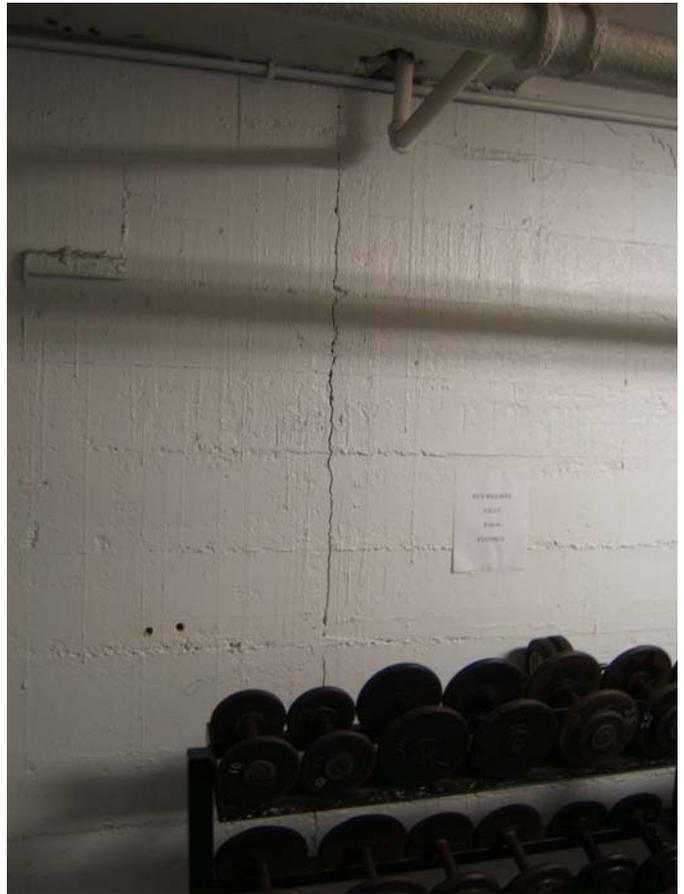
- 8) Vertical cracking was observed in the southern cast-in-place concrete wall of the weight room under the police department. See Photos 9 and 10. Recommend sealing with epoxy injection and periodic monitoring to ensure crack width is not increasing. (1 yr.)
