Planning Commission Briefing for demolition and consolidation at Boulevard, First and Market
Submitted June 9, 2020

ASSESSMENT OF BUILDING CONDITIONS

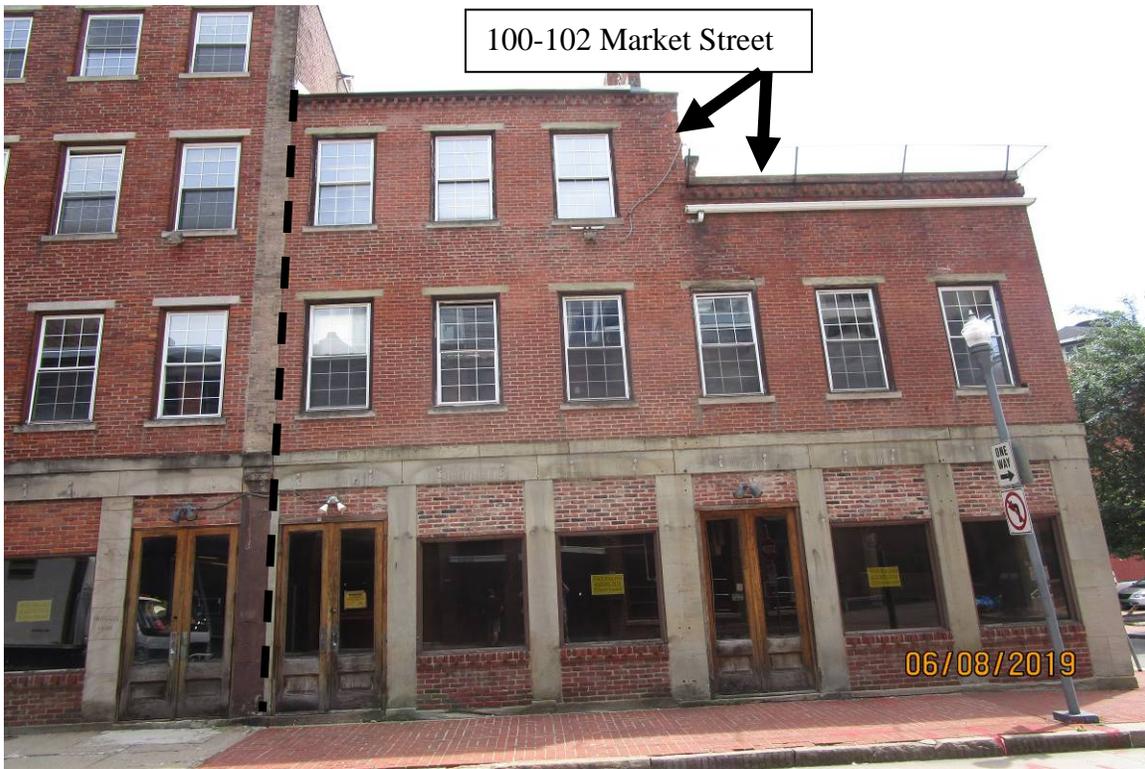
The front and rear brick walls of the building are structurally considered to be non-bearing walls. The front wall is shown in Photograph #3. No significant structural distress or structural unsoundness was observed in the front wall.

PHOTOGRAPH #3
The front wall of 100-102 Market Street.

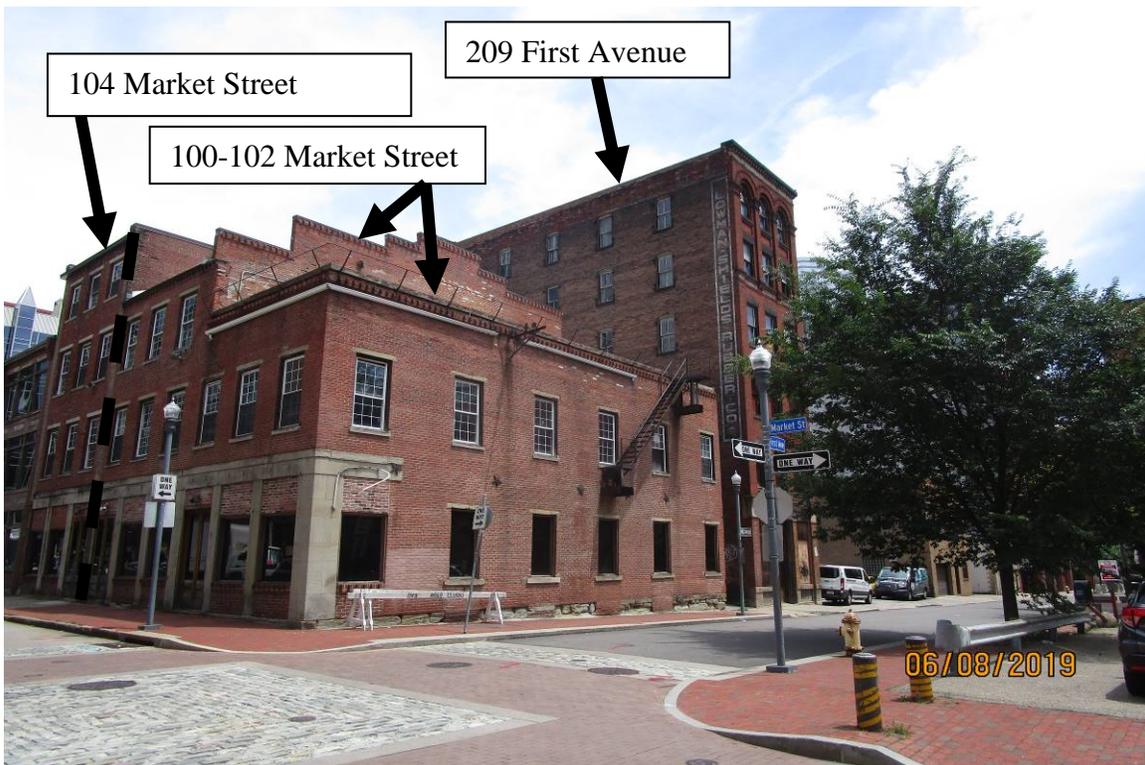
PHOTOGRAPH #6
The front and right walls of 100-102 Market Street.

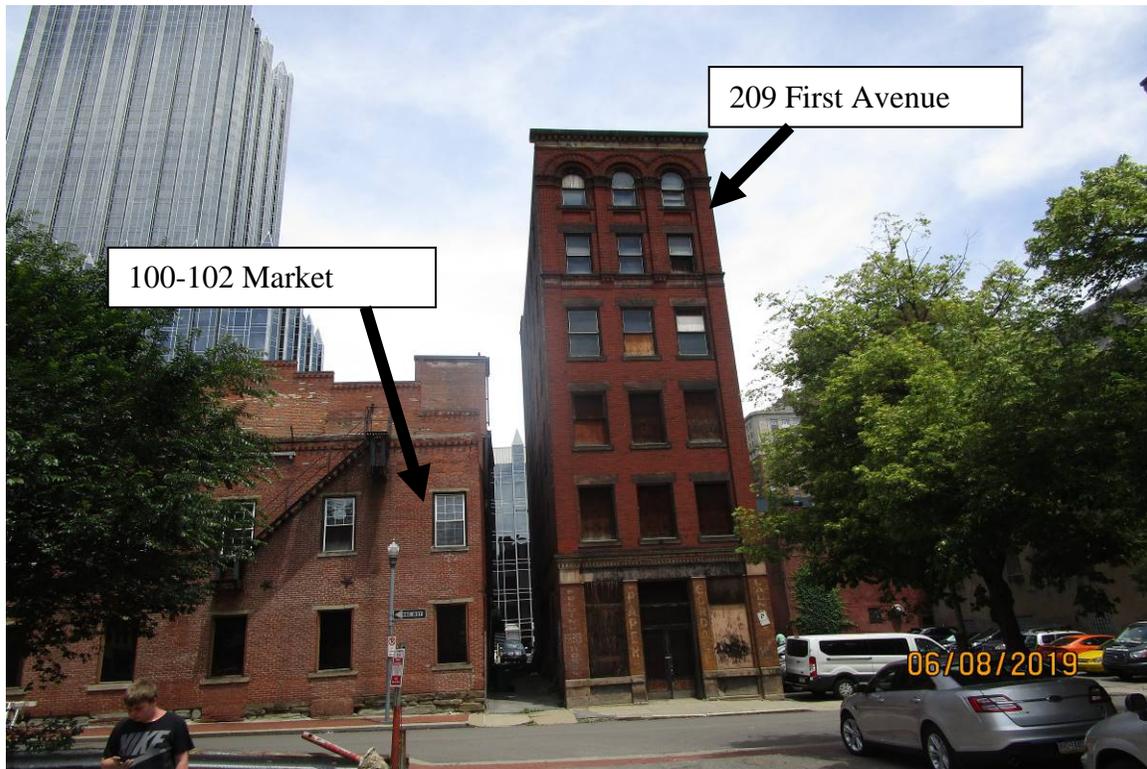
PHOTOGRAPH #7
The right wall of 100-102 Market Street.

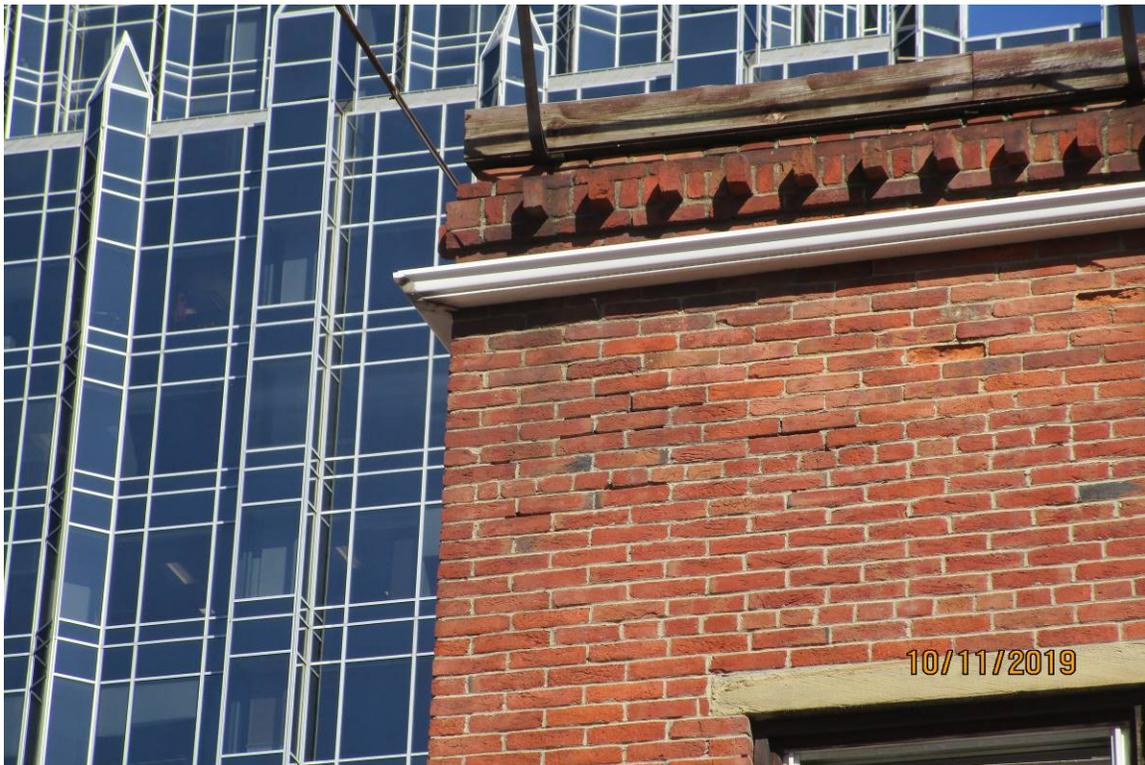
PHOTOGRAPH #16

The right exterior brick bearing wall is shown in Photographs #14, #15, & #16. There are areas of deteriorated mortar, missing mortar, and deteriorated brick in the exterior wythe of the brick work of the right bearing wall. The deterioration of the brick work is prevalent along the top of the 2-story wall.

The conditions observed on the exterior and interior faces of the right brick bearing wall lead to the conclusion that **the right brick bearing wall of the building should be considered structurally unsound and structurally unstable.**

Deteriorated mortar and deteriorated soft brick in the brick work of the right bearing wall.

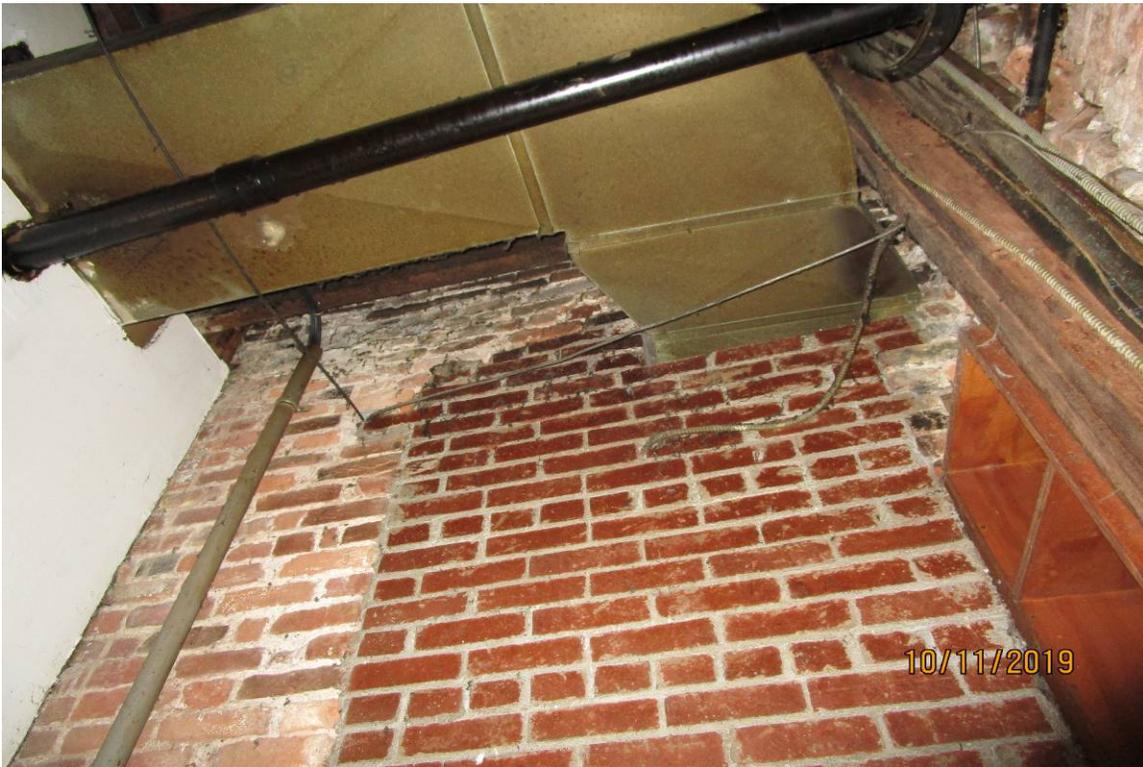
PHOTOGRAPH #17
A portion of the interior of the rear brick wall.

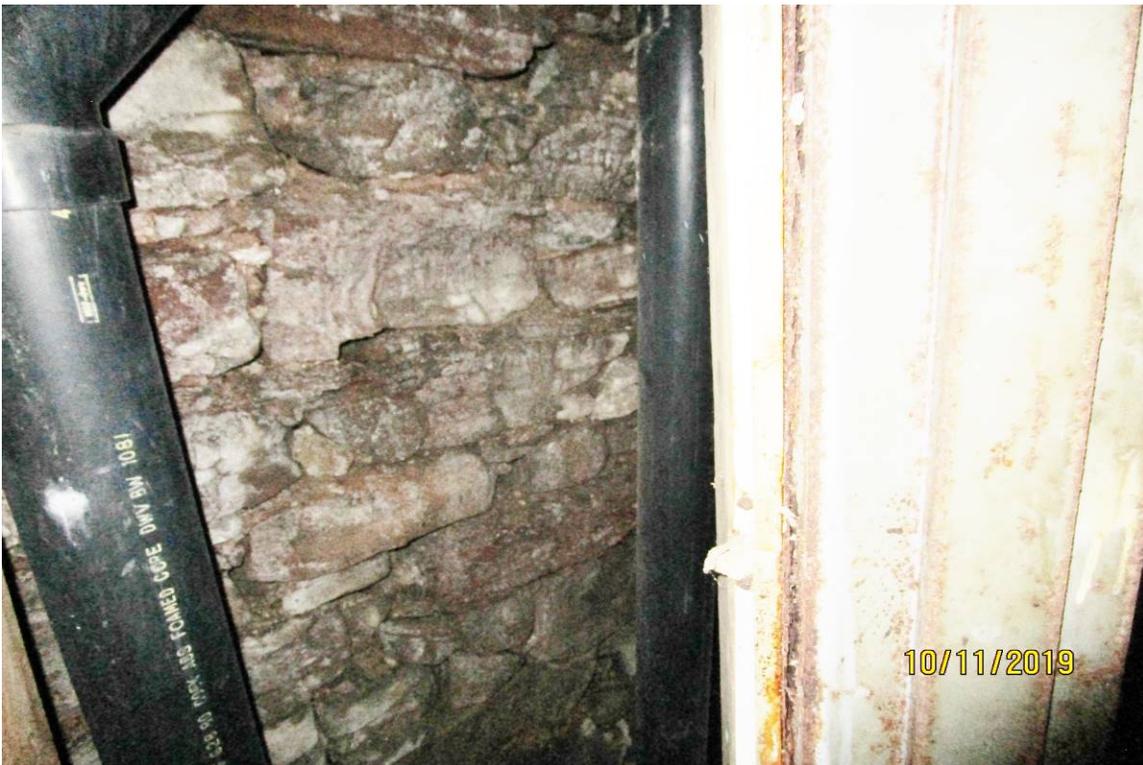
PHOTOGRAPH #18
A portion of the interior face of the rear stone basement wall.

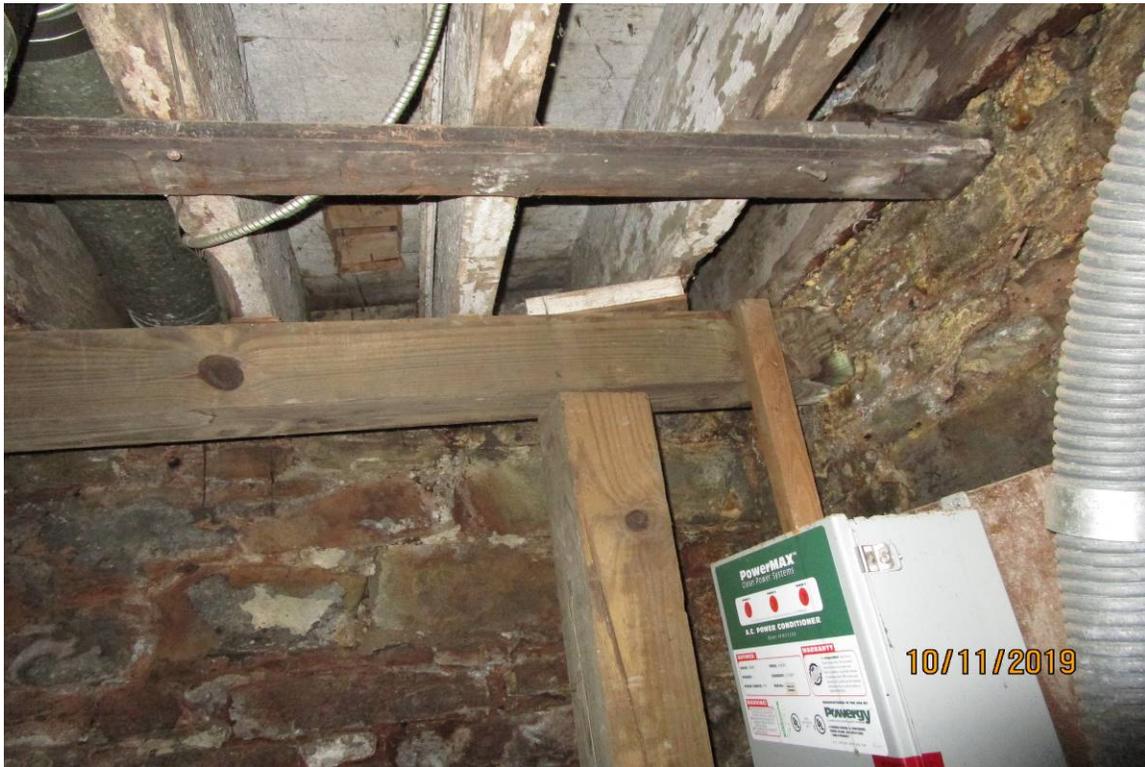
PHOTOGRAPH #19

Photographs #19 through #23 show either a 6" leftward movement of the wood joists under the 1st floor, or, a 6" rightward movement of the right foundation wall. Wood beams and posts have been installed under the floor joists to allow the joists to carry imposed loads on the floor.

Wood Beam and wood posts installed to give structural support to the end bearings of 1st floor joists along the right wall of the basement.

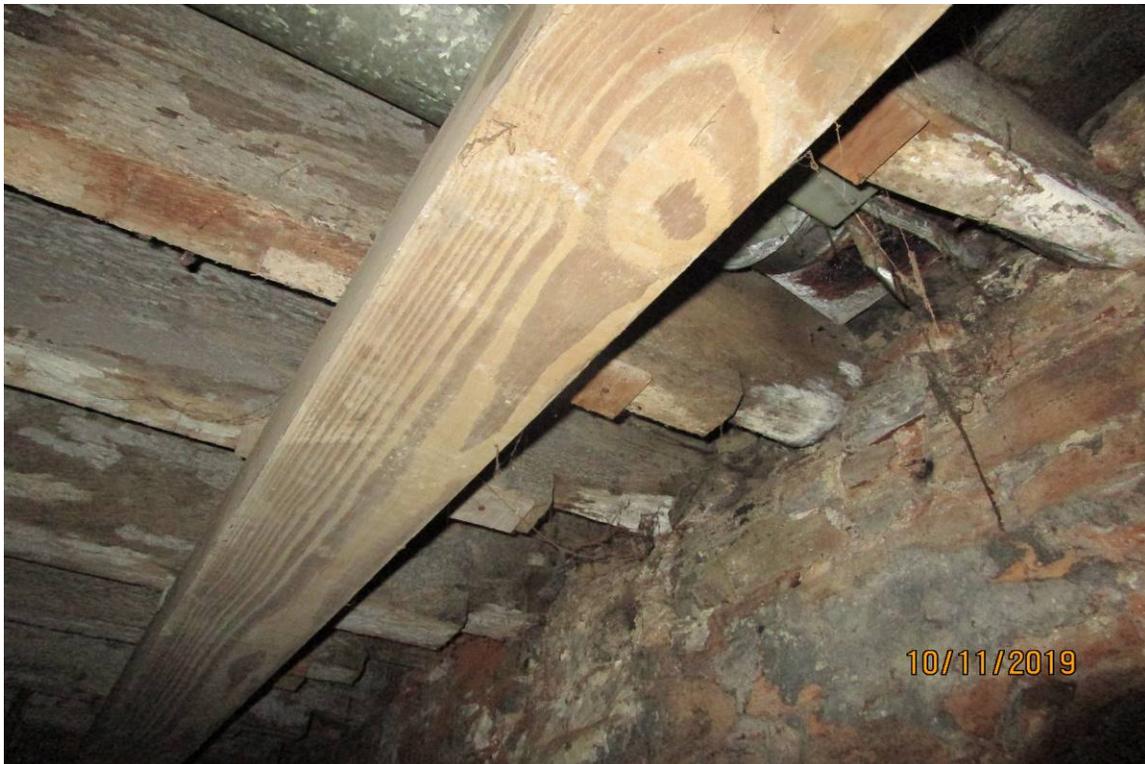
PHOTOGRAPH #20

Wood Beam and wood posts installed to give structural support to the end bearings of 1st floor joists along the right wall of the basement. Note the distance that the joist bearing areas have moved (6", or more) relative to the interior face of the stone basement wall.

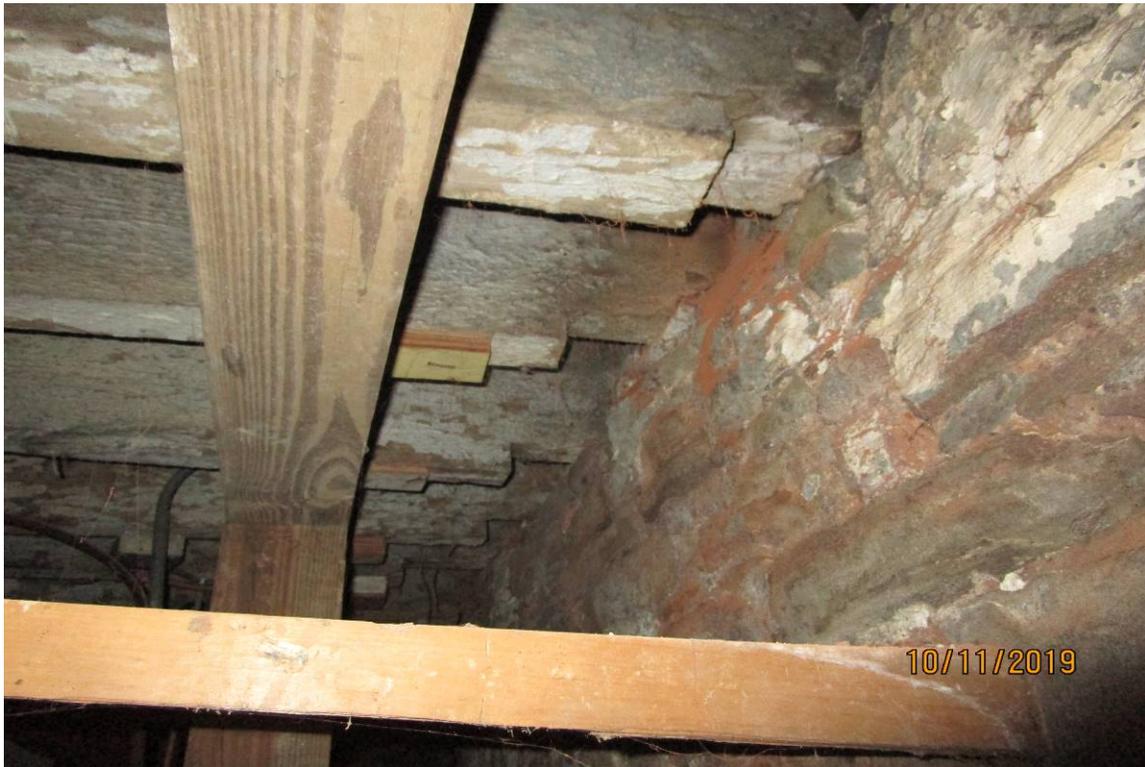
Wood Beam and wood posts installed to give structural support to the end bearings of 1st floor joists along the right wall of the basement. Note the distance that the joist bearing areas have moved (6", or more) relative to the interior face of the stone basement wall.

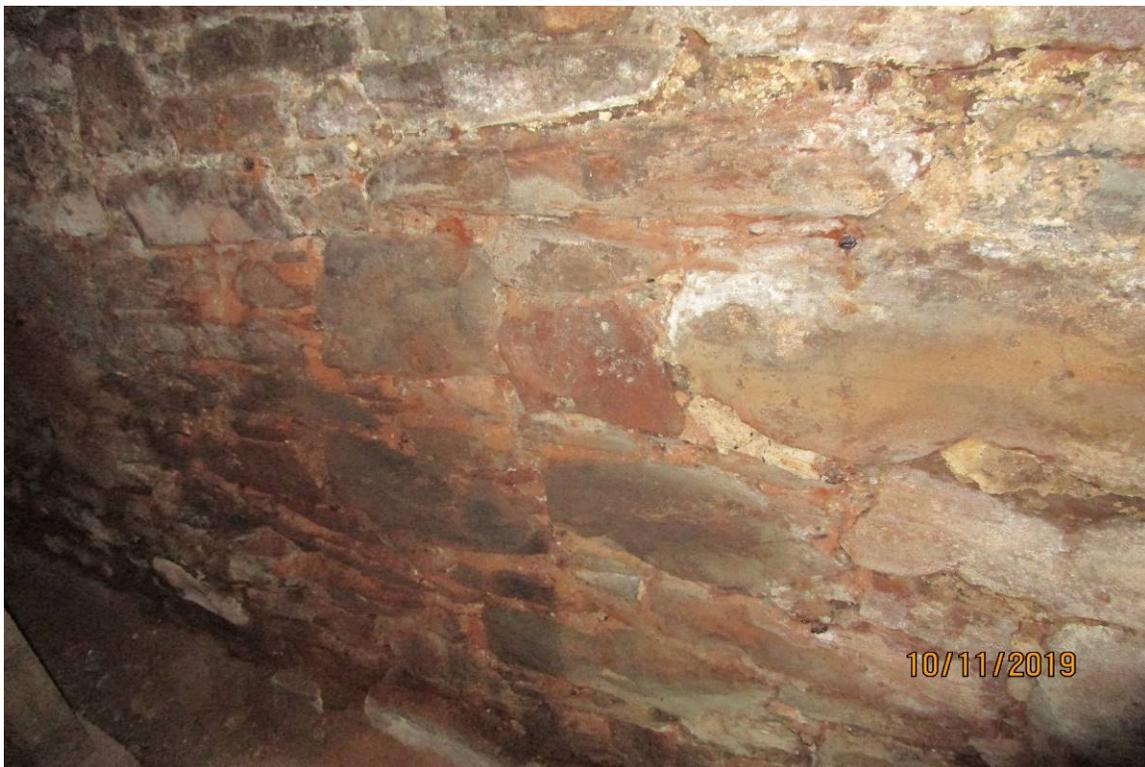
PHOTOGRAPH #22

A portion of the stone basement wall.

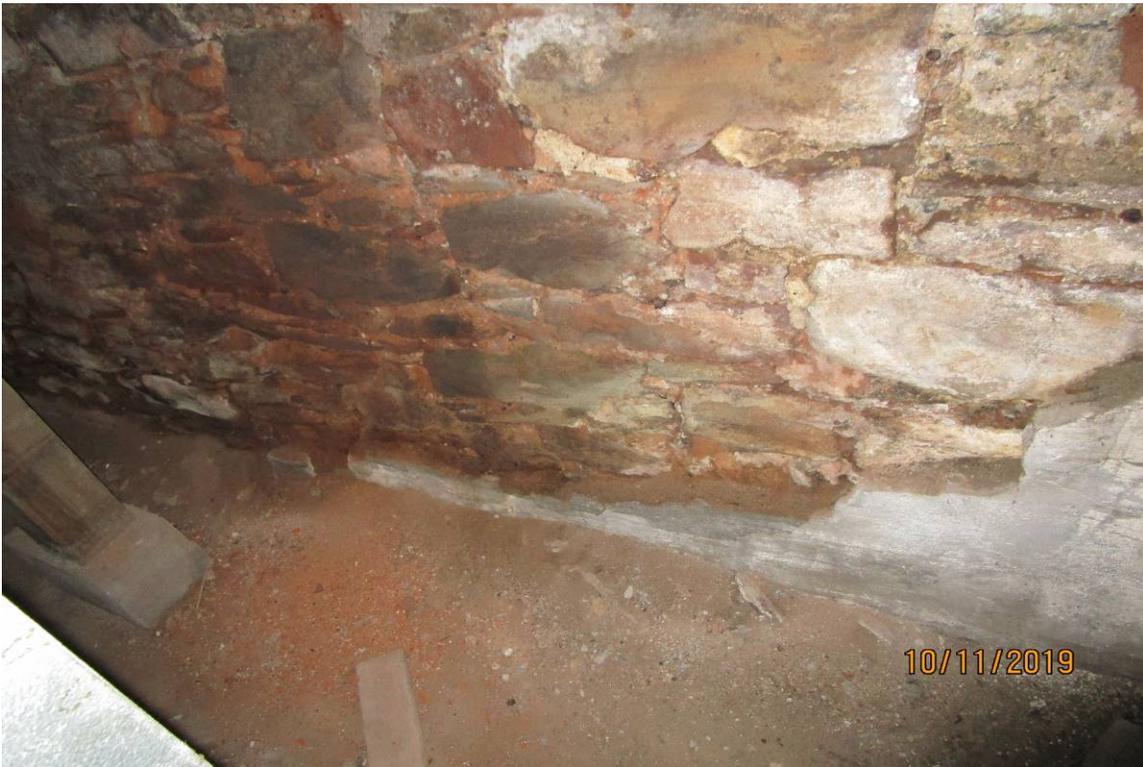
PHOTOGRAPH #23

A portion of the right stone basement wall. Note the concrete block acting as a permanent footing for the wood post under the wood beams supporting the floor joists

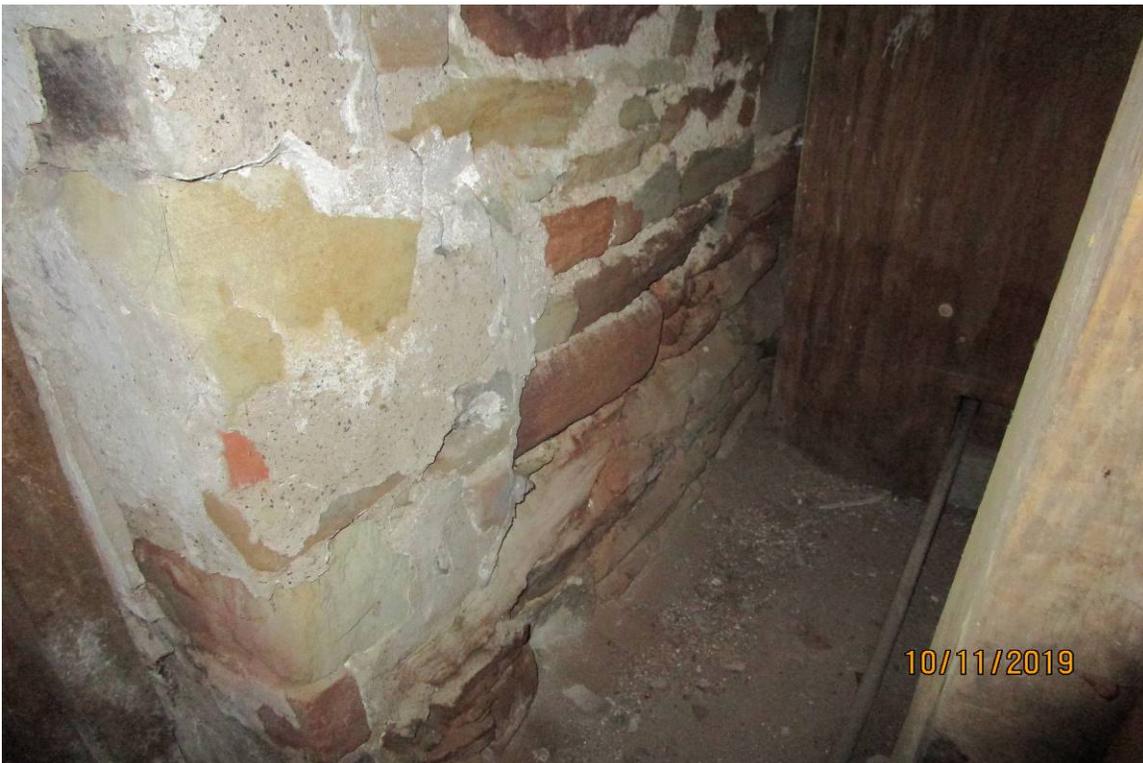
PHOTOGRAPH #24

Deteriorated mortar in a portion of the stone basement foundation walls.

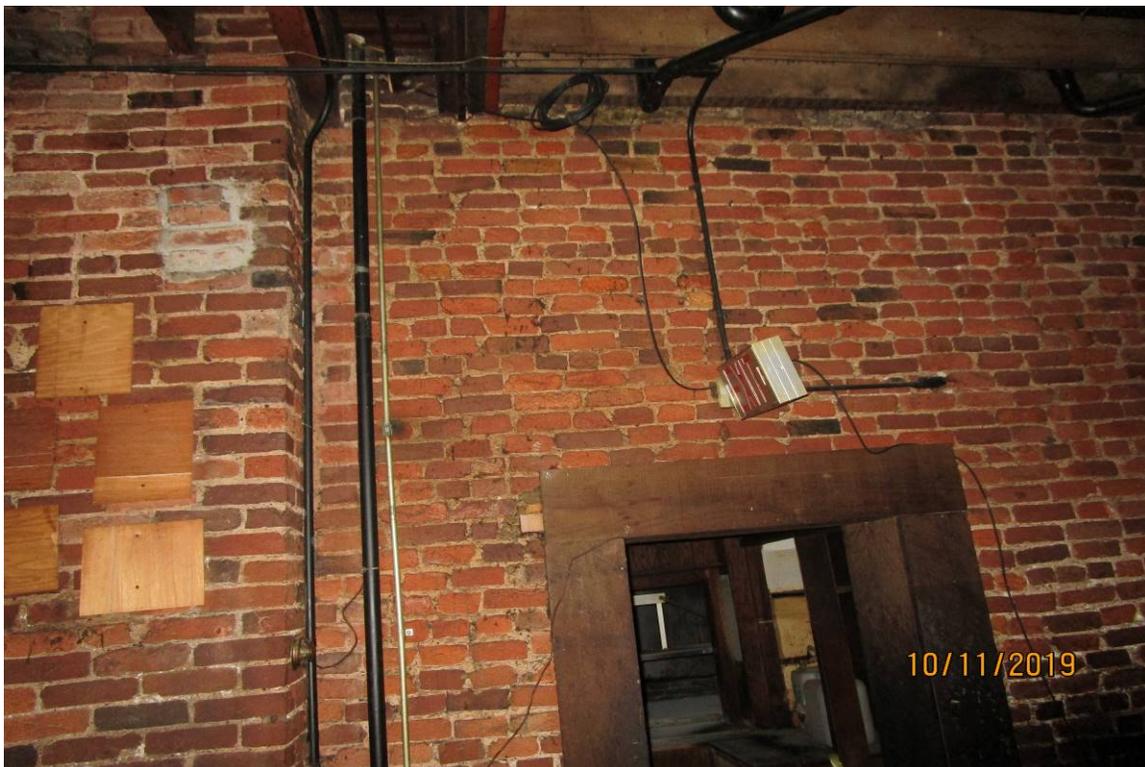
PHOTOGRAPH #26

Portions of the brick bearing wall separating the interiors of 100 Market Street and 102 Market Street are shown in Photographs #26 & #27. Note the high percentage of low strength orange-colored brick (salmon brick/pumpkin brick) in the wall.

A large section of the brick bearing wall separating the interiors of 100 Market Street and 102 Market Street. Note the high percentage of low strength orange-colored brick (salmon brick/pumpkin brick) in the bearing wall.

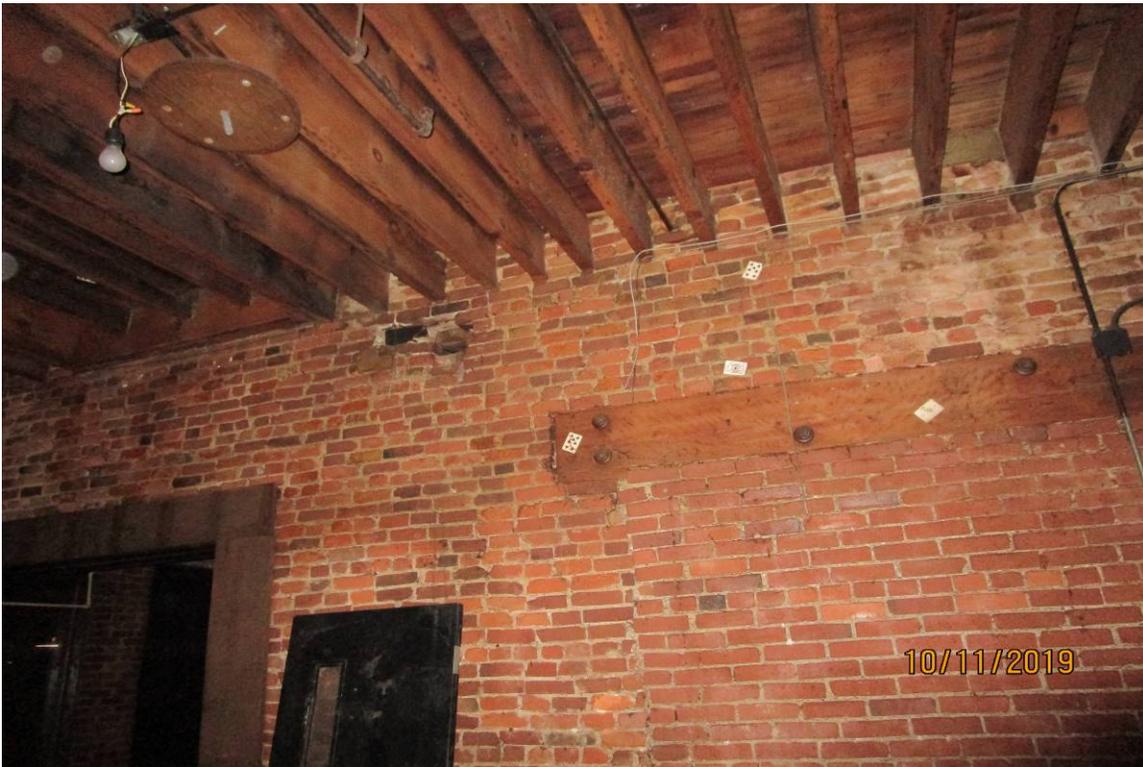
PHOTOGRAPH #27

A large section of the brick bearing wall separating the interiors of 100 Market Street and 102 Market Street. Note the high percentage of low strength orange-colored brick (salmon brick/pumpkin brick) in the wall.

Based on the deteriorated brick and mortar observed in the building walls, the existing brick wall construction-in all of the building walls-is in my opinion, structurally unsound and is not suitable for reuse. The entire building, including all of the existing brick walls, should be demolished.

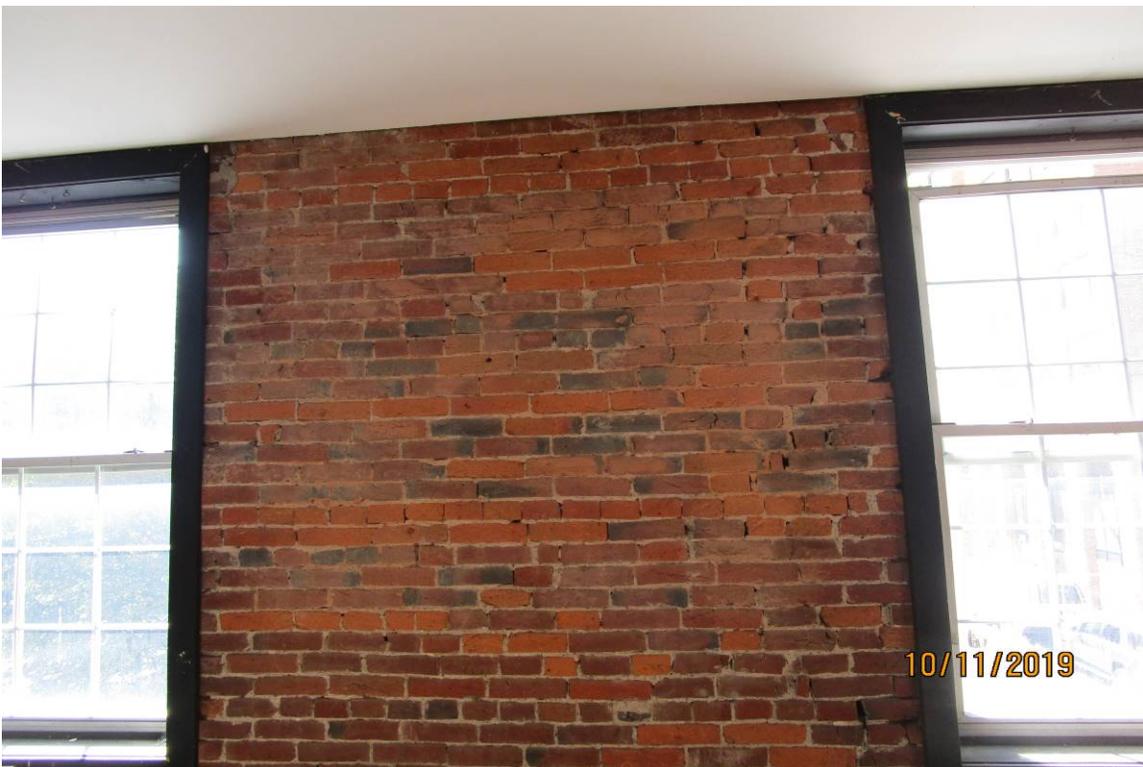
PHOTOGRAPH #28

A large section of the right brick bearing wall on the 2nd floor. Note the high percentage of low strength orange-colored brick (salmon brick/pumpkin brick) in the wall. Note the joints in the brick work without mortar.

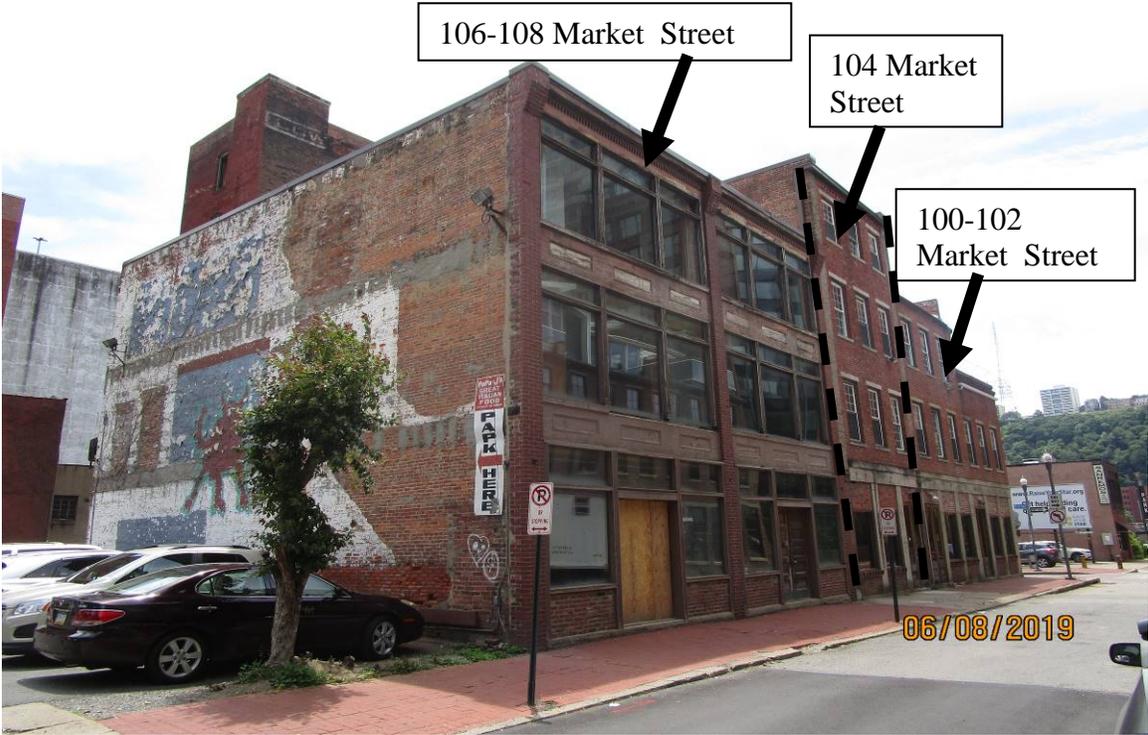
PHOTOGRAPH #1
The front of the building at 104 Market Street.

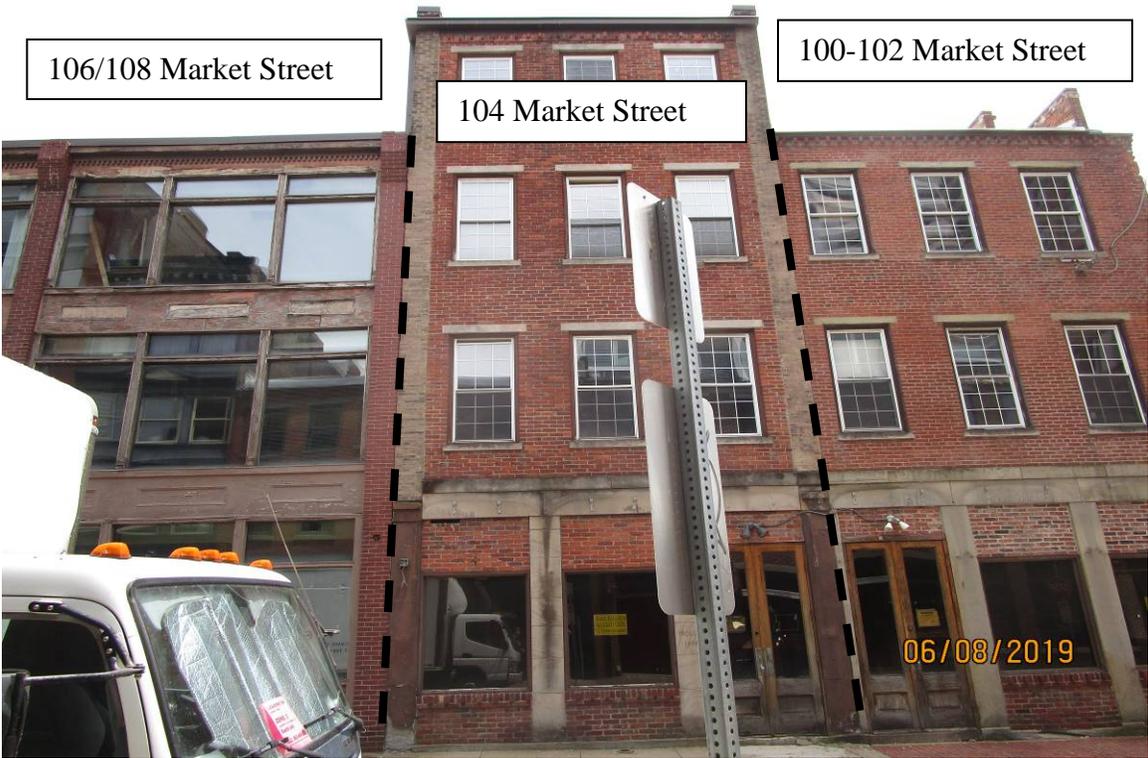
PHOTOGRAPH #2
The front of 104 Market Street. Note that the front wall of 104 Market Street and the front walls of the adjacent buildings appear to be separate walls.

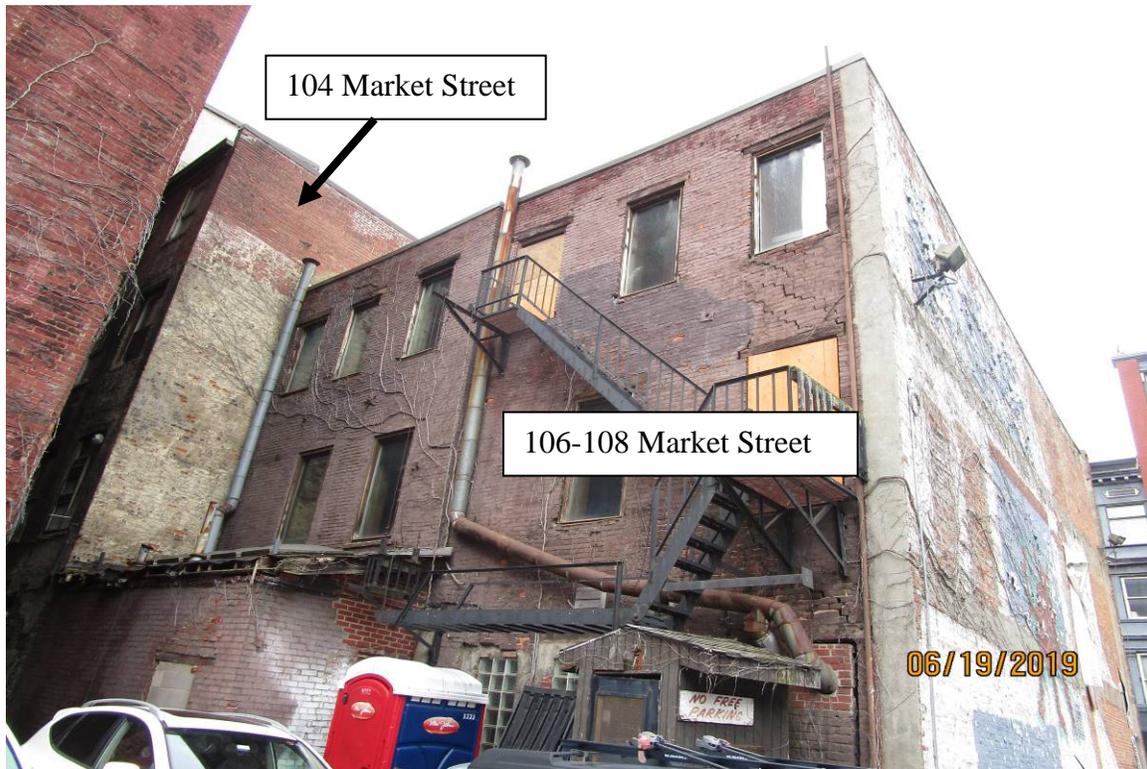
PHOTOGRAPH #3
Portions of the left and rear walls of 104 Market Street.

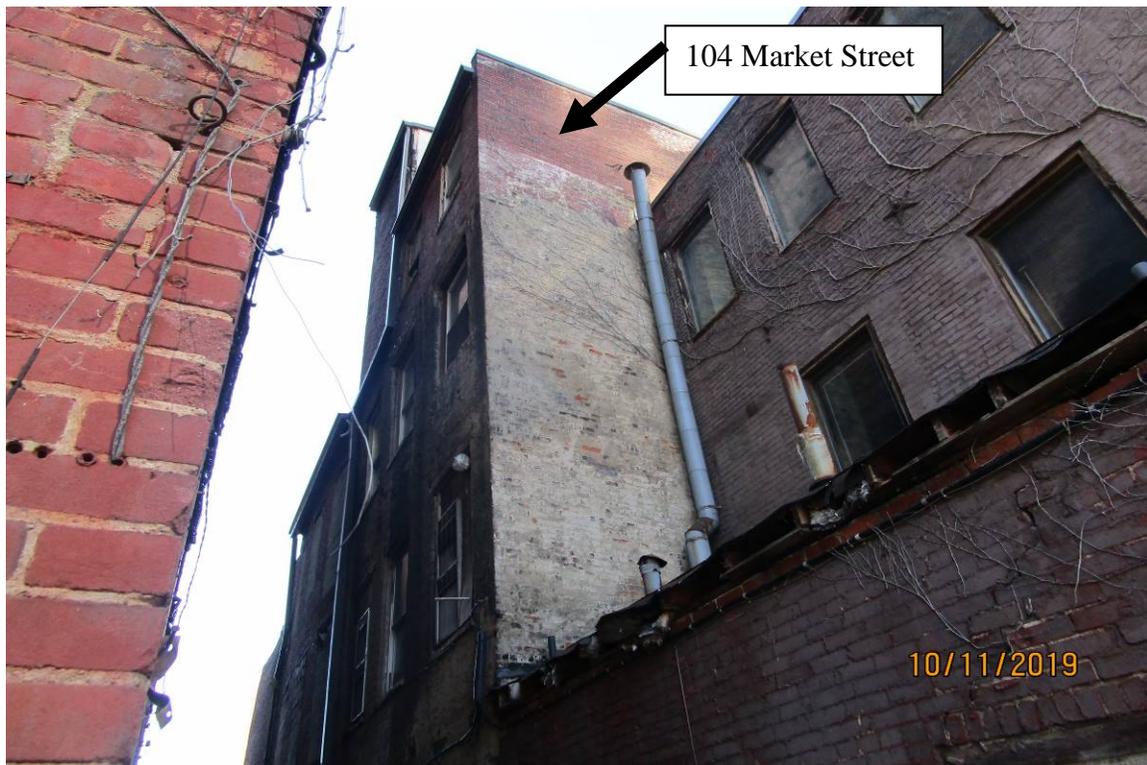
PHOTOGRAPH #4
The rear portion of the left brick wall and the upper portion of the rear brick wall of the building.

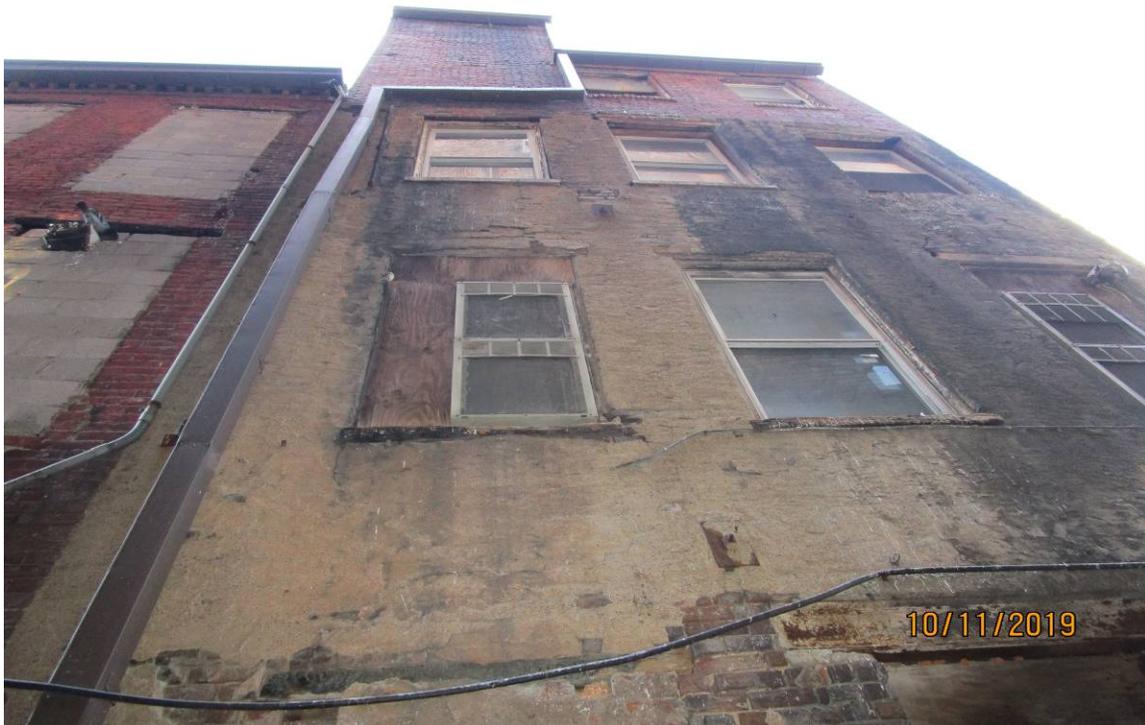
PHOTOGRAPH #6

The rear wall of the building. Note the parging covering the very deteriorated brick and mortar in some areas of the wall. See Photograph #5.

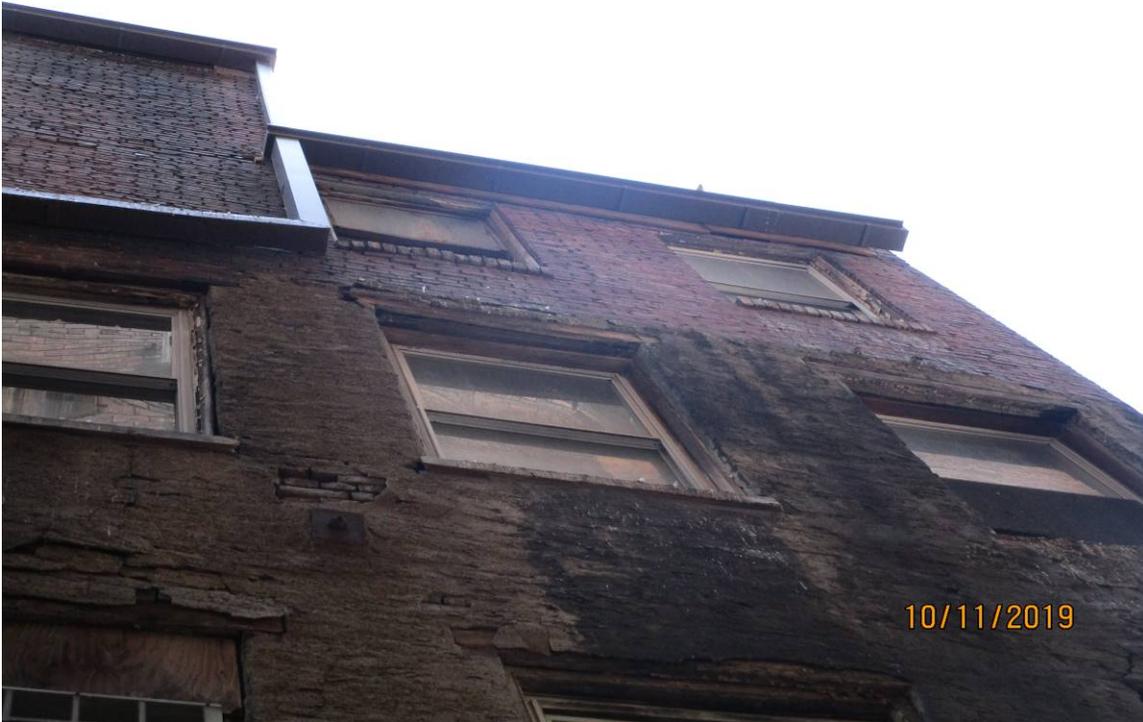
PHOTOGRAPH #7
Extremely deteriorated and missing mortar under the parging applied to the face of the wall in the past.

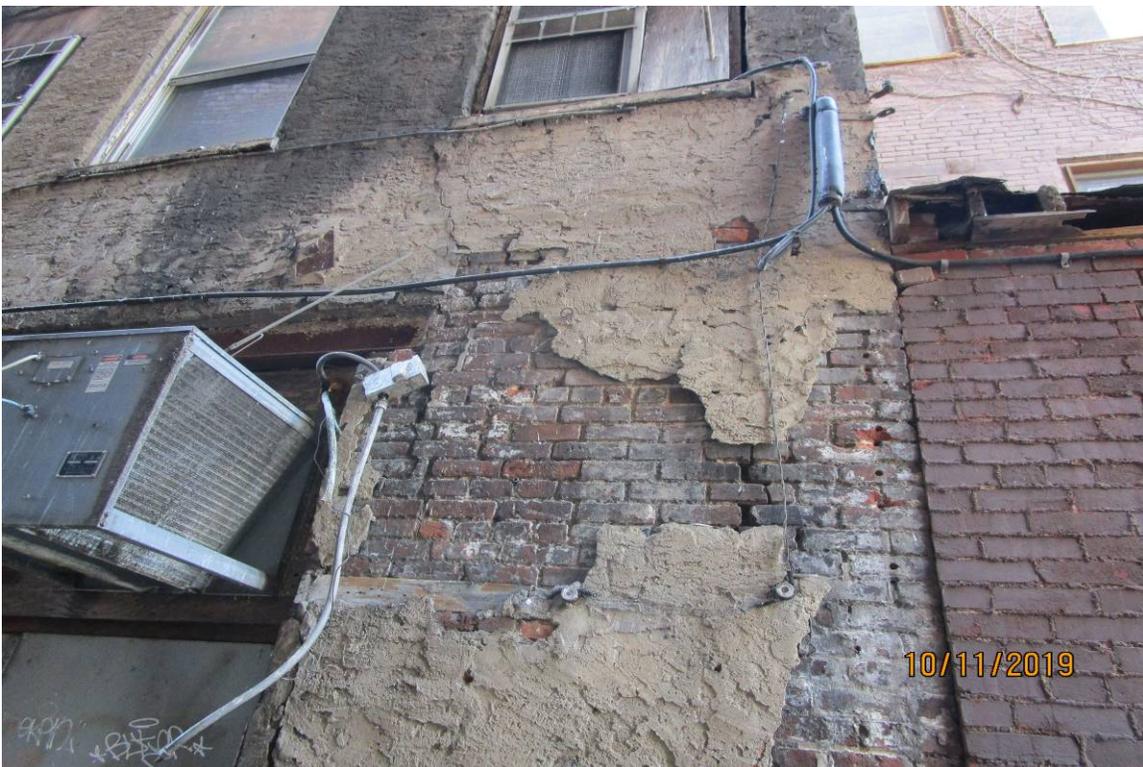
PHOTOGRAPH #8
Extremely deteriorated and missing mortar under the parging applied to the face of the wall in the past.

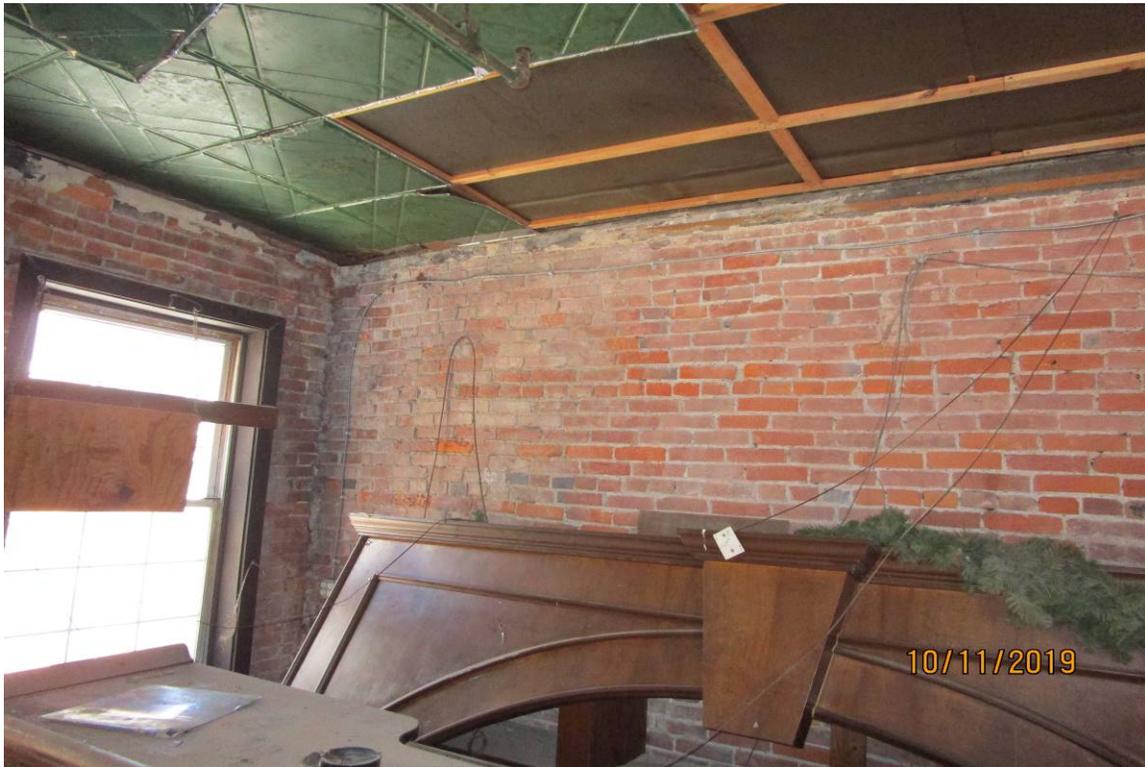
PHOTOGRAPH #11

A large section of brick bearing wall. Note the high percentage of low strength orange-colored brick (salmon brick/pumpkin brick) in the wall.

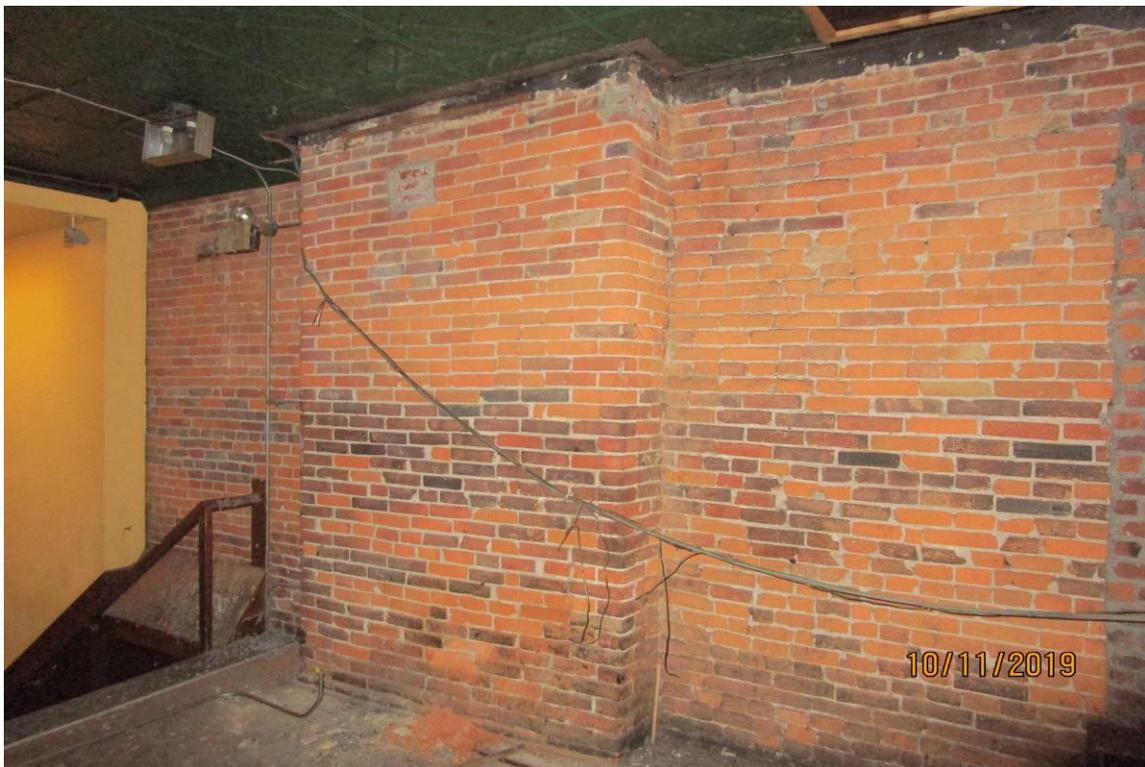
PHOTOGRAPH #12

A large section of brick bearing wall. Note the high percentage of low strength orange-colored brick (salmon brick/pumpkin brick) in the wall.

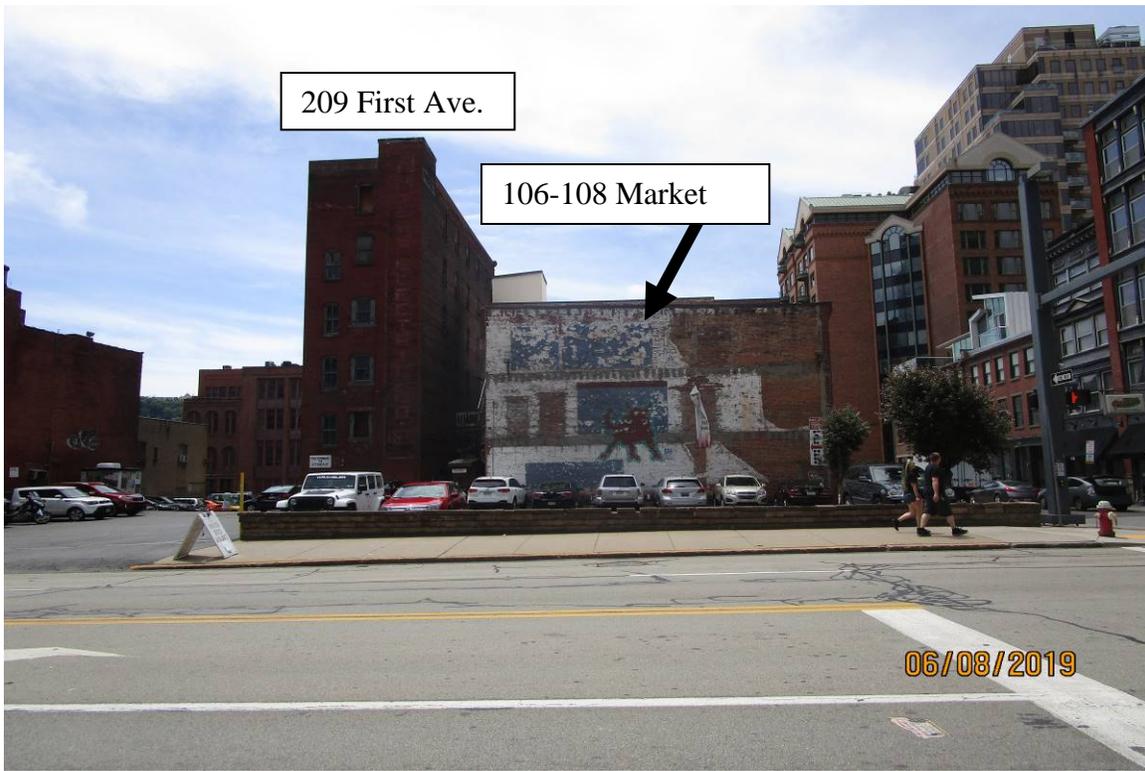
PHOTOGRAPH #1
Looking across the Boulevard of the Allies at the left wall of 106-108 Market Street.
