Planning Commission Briefing for demolition and consolidation at Boulevard, First and Market
Submitted June 9, 2020

ASSESSMENT OF BUILDING CONDITIONS

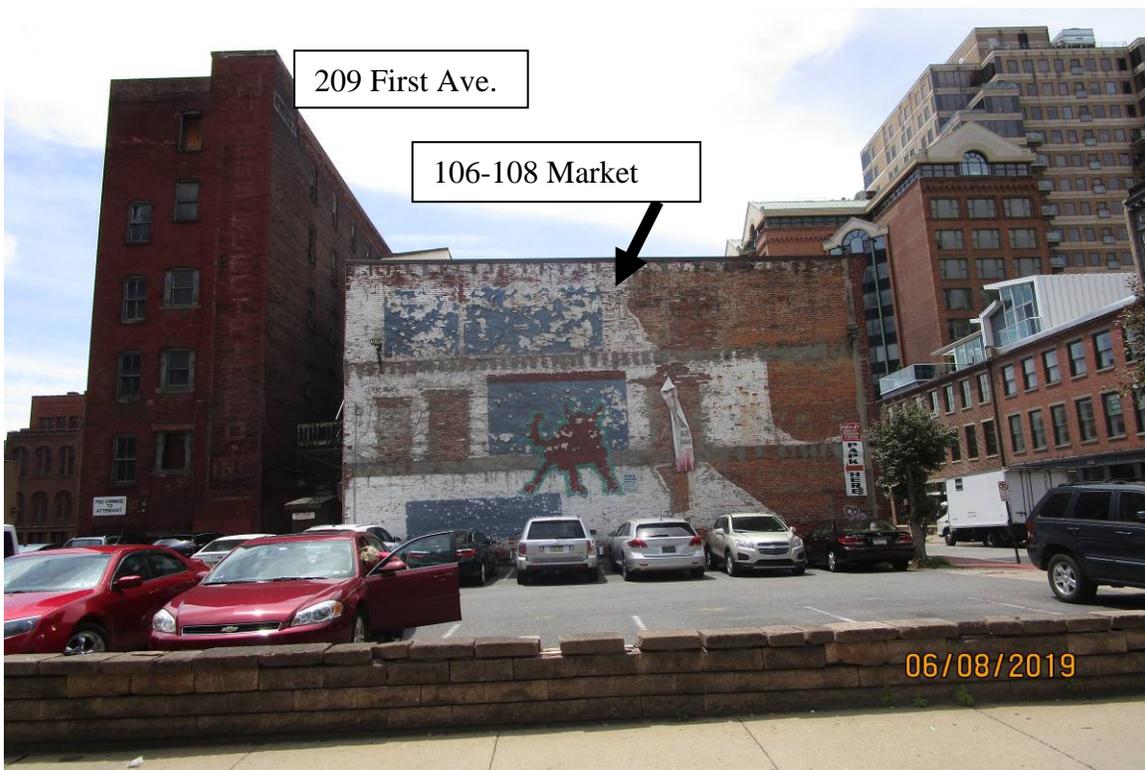
PHOTOGRAPH #2
The left wall of 106-108 Market Street.

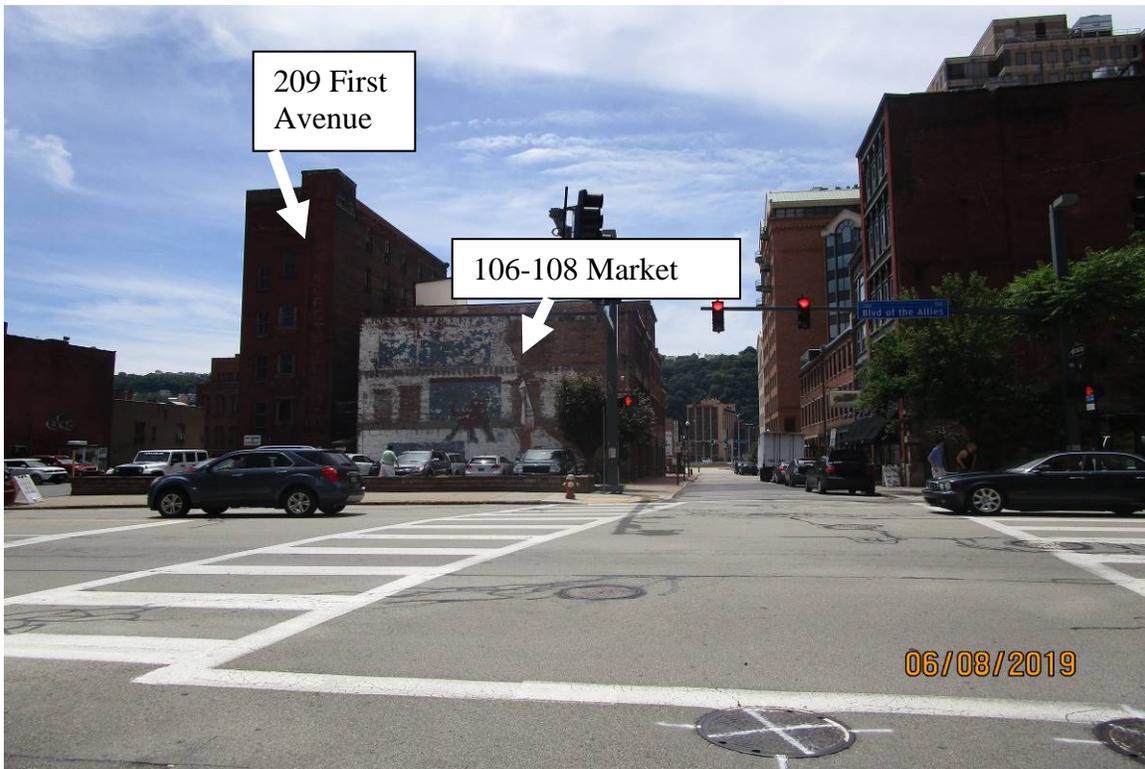
PHOTOGRAPH #3
Looking south across the Boulevard of the Allies and south on Market Street.

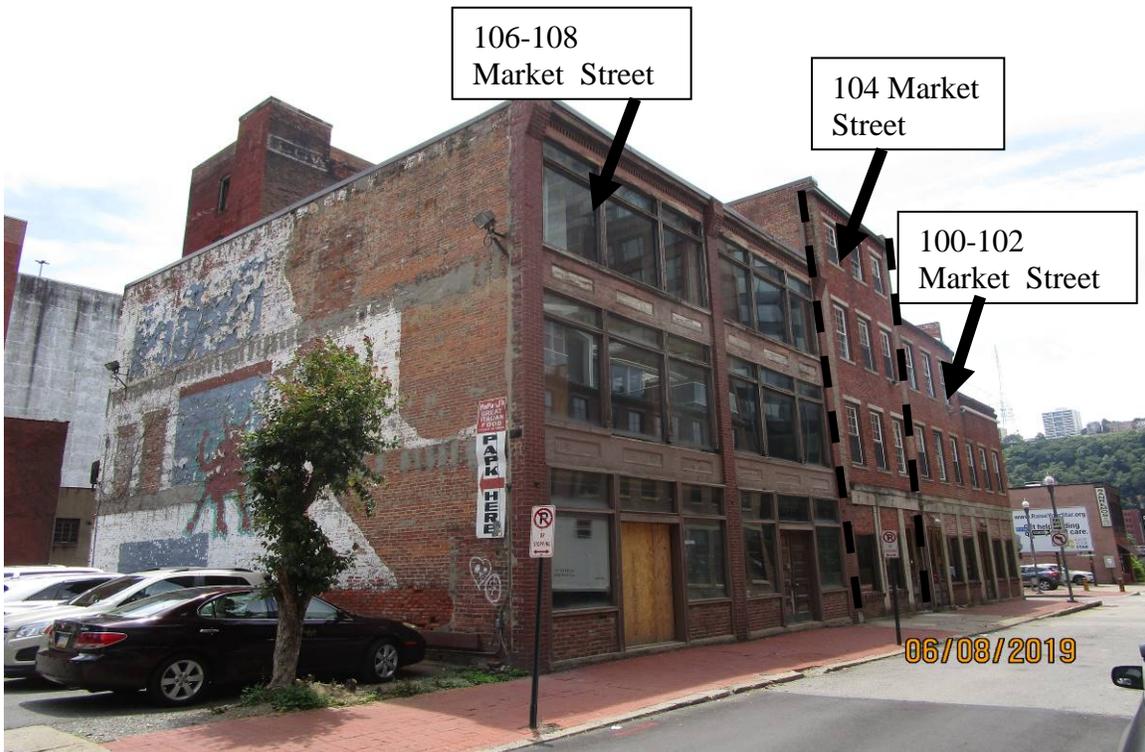
PHOTOGRAPH #4
The left front corner of 106-108 Market Street.

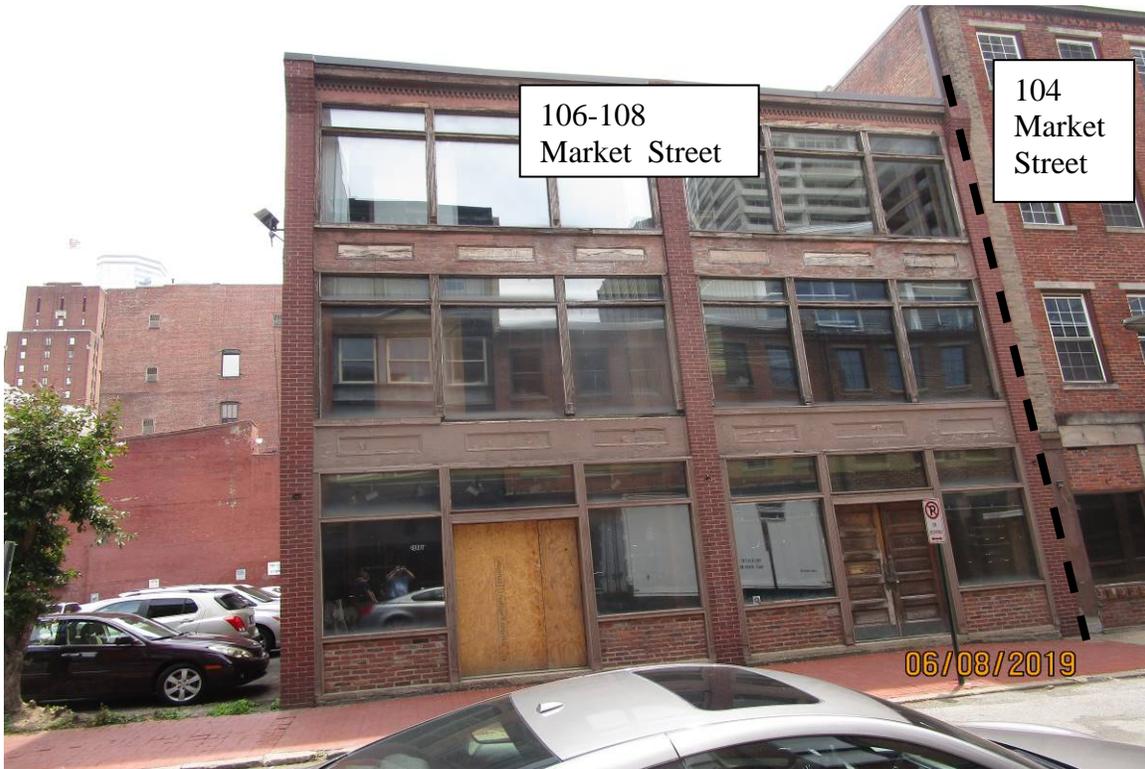
The front and rear brick walls of the building are structurally considered to be non-bearing walls. The front wall is shown in Photograph #5. No significant structural distress or structural unsoundness was observed in the front wall.

PHOTOGRAPH #5
The front of 106-108 Market Street.

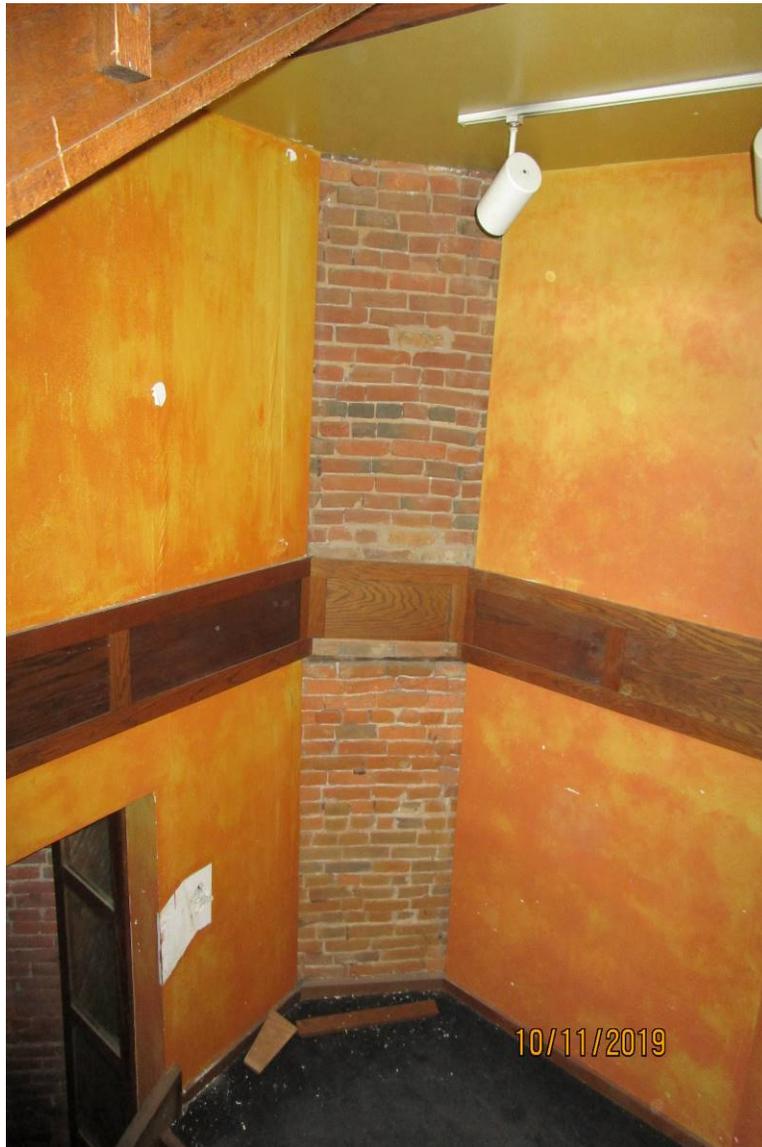
PHOTOGRAPH #8

The exterior of the left brick bearing wall of the building is shown in Photograph #6. This brick bearing wall is bowed inward an extreme amount. The condition of exposed areas on the interior of the wall can be observed in Photographs #8 & #9.

The existing conditions observed, on the exterior of the rear brick wall, on the interior of the right brick bearing wall and on the exterior and the interior of the left brick bearing wall shown in Photographs #8, #9, & #12- 1) the extreme inward bowing of the entire height, and length, of the left bearing wall and 2) the high percentage of salmon brick in the interior wythe of the left brick wall and in the isolated brick pier-presently threaten the overall stability of the entire building.

A visible portion of a 2-story brick wall. Note the high percentage of low strength orange-colored brick (salmon brick/pumpkin brick) in the exposed portion of the wall.

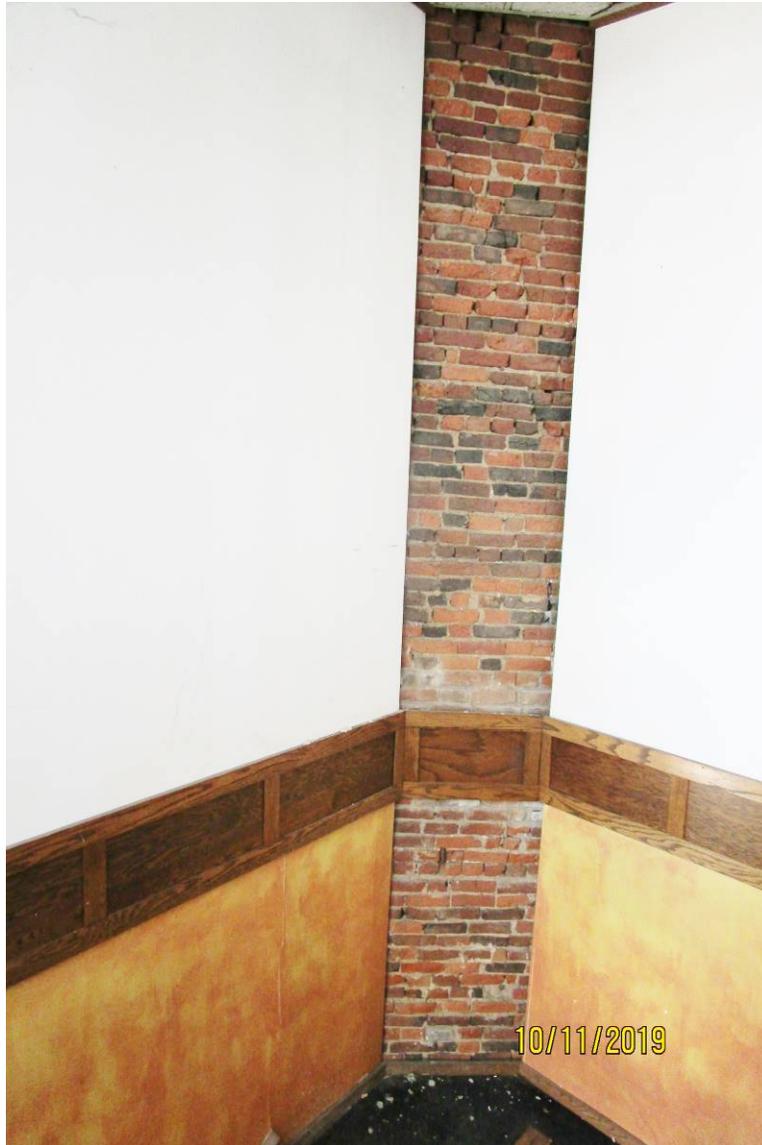
PHOTOGRAPH #9

A visible portion of a 2-story brick wall. Note the high percentage of low strength orange-colored brick (salmon brick/pumpkin brick) in the exposed portion of the wall.

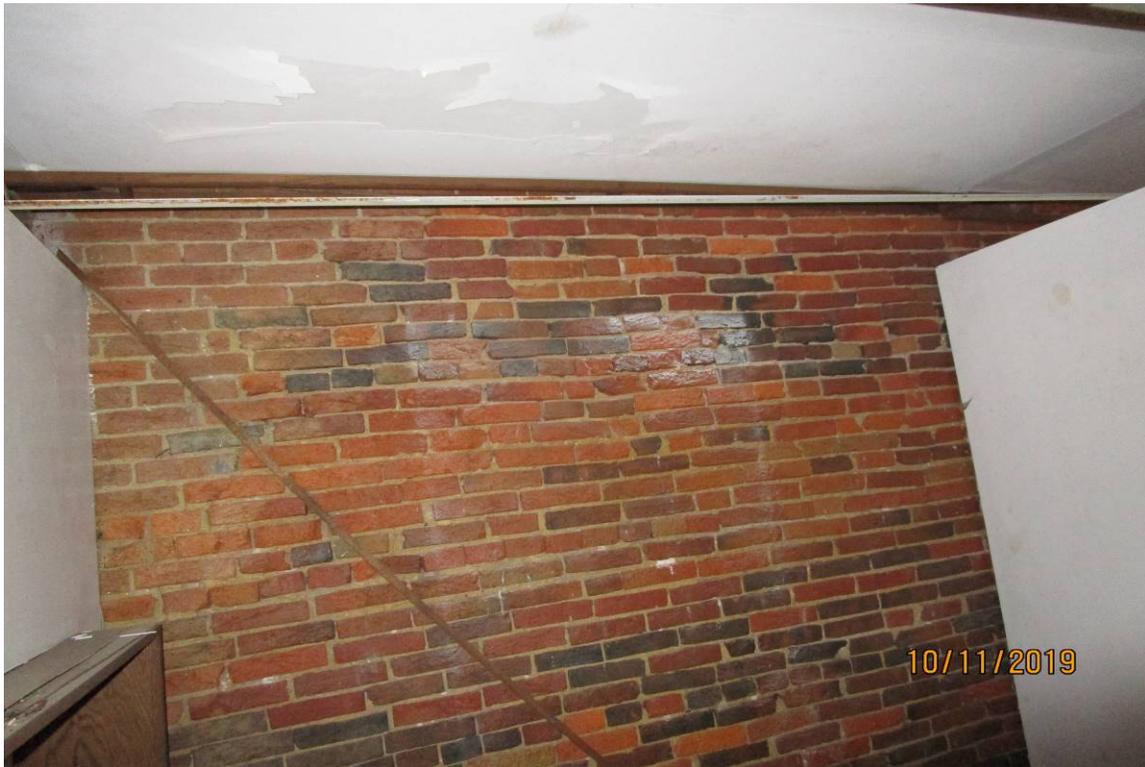
PHOTOGRAPH #10

The right brick bearing wall of the building of 106-108 Market abuts the left wall of 104 Market Street. See Photograph #5. Visible portions of the interior wythe of the right brick bearing wall are shown in Photographs #10 & #11. There is a high percentage of low strength orange-colored brick (salmon brick/pumpkin brick) in the exposed portions of the wall.

The conditions observed on the interior face of the right brick bearing wall (Photographs #10 & #11) lead to the conclusion that **the right brick bearing wall of the building should be considered structurally unsound and structurally unstable.**

A visible section of a brick bearing wall. Note the high percentage of low strength orange-colored brick (salmon brick/pumpkin brick) in the exposed portion of the wall.

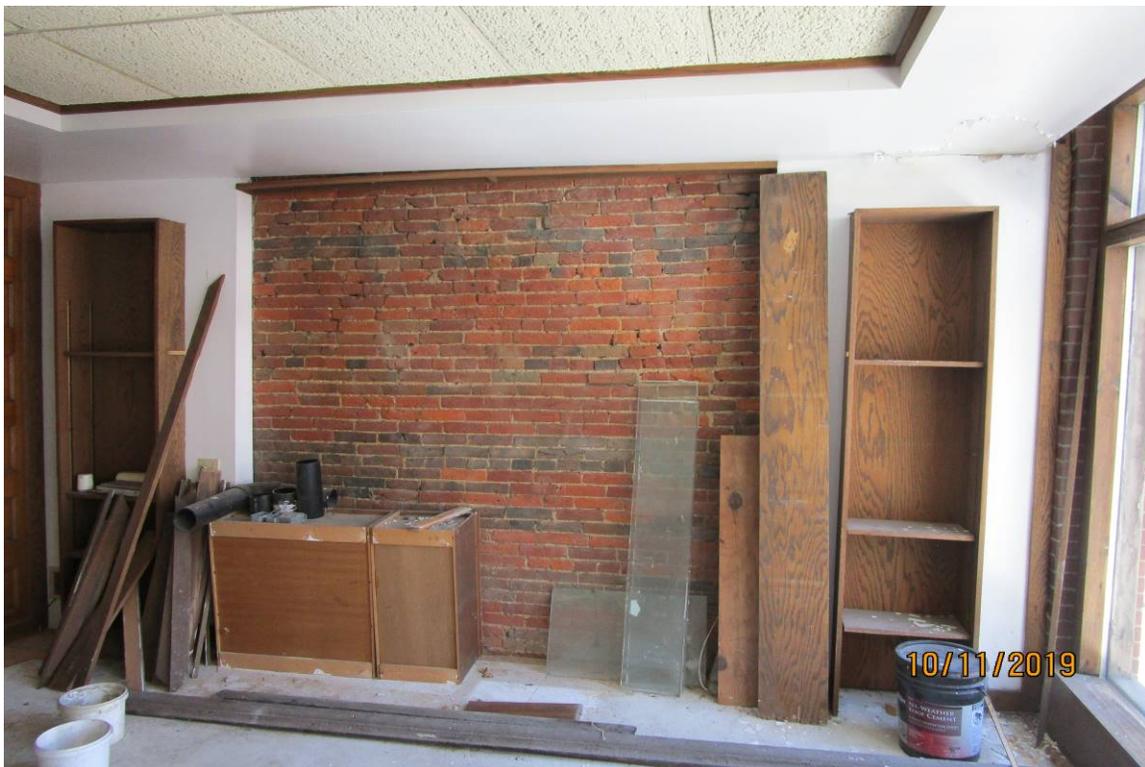
PHOTOGRAPH #11

A visible section of a brick bearing wall. Note the high percentage of low strength orange-colored brick (salmon brick/pumpkin brick) in the exposed portion of the wall.

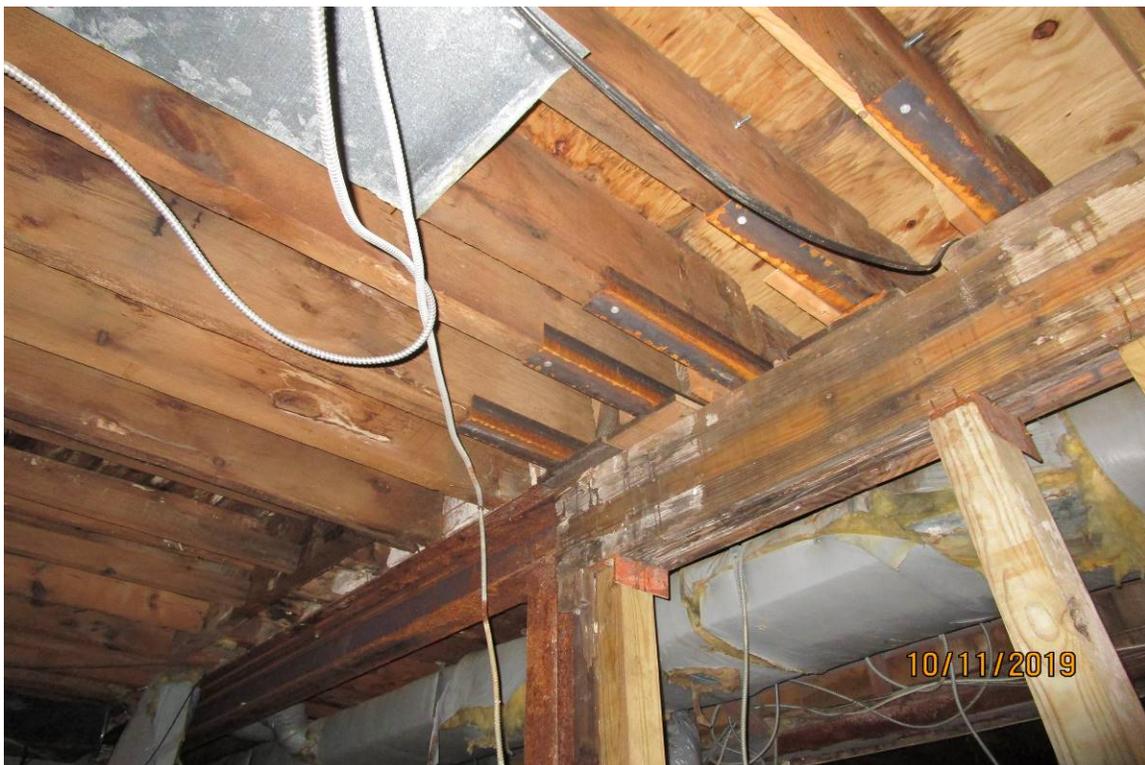
PHOTOGRAPH #13

Strengthened wood roof joists, strengthened wood beams and added wood columns.

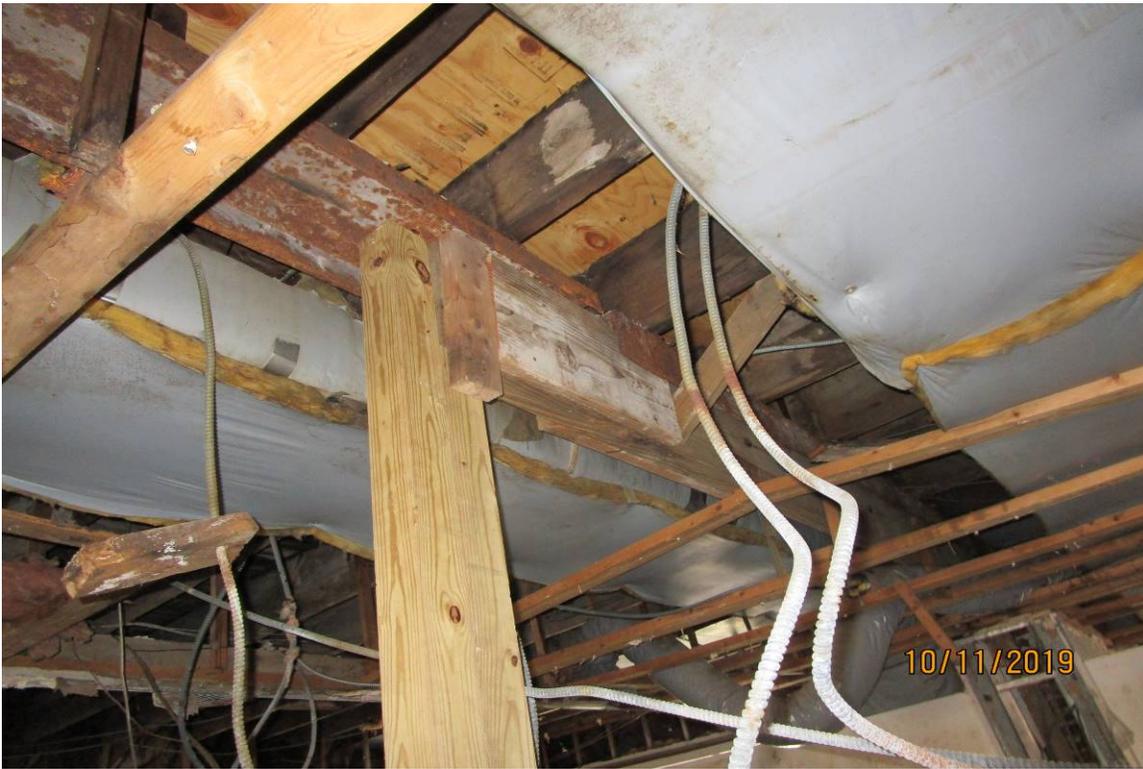
PHOTOGRAPH #14
An additional wood post installed to strengthen steel/wood beam members which support wood roof joists.

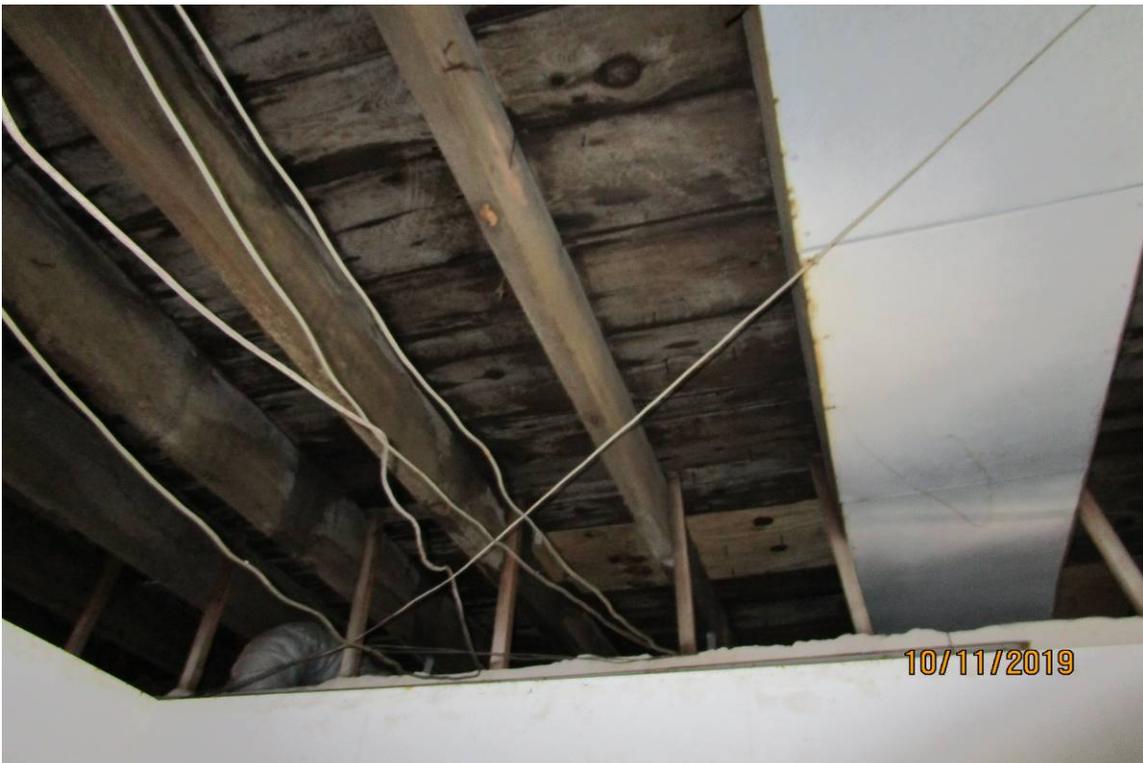
PHOTOGRAPH #15
Wood roof joists and wood board sheathing with watermarking.

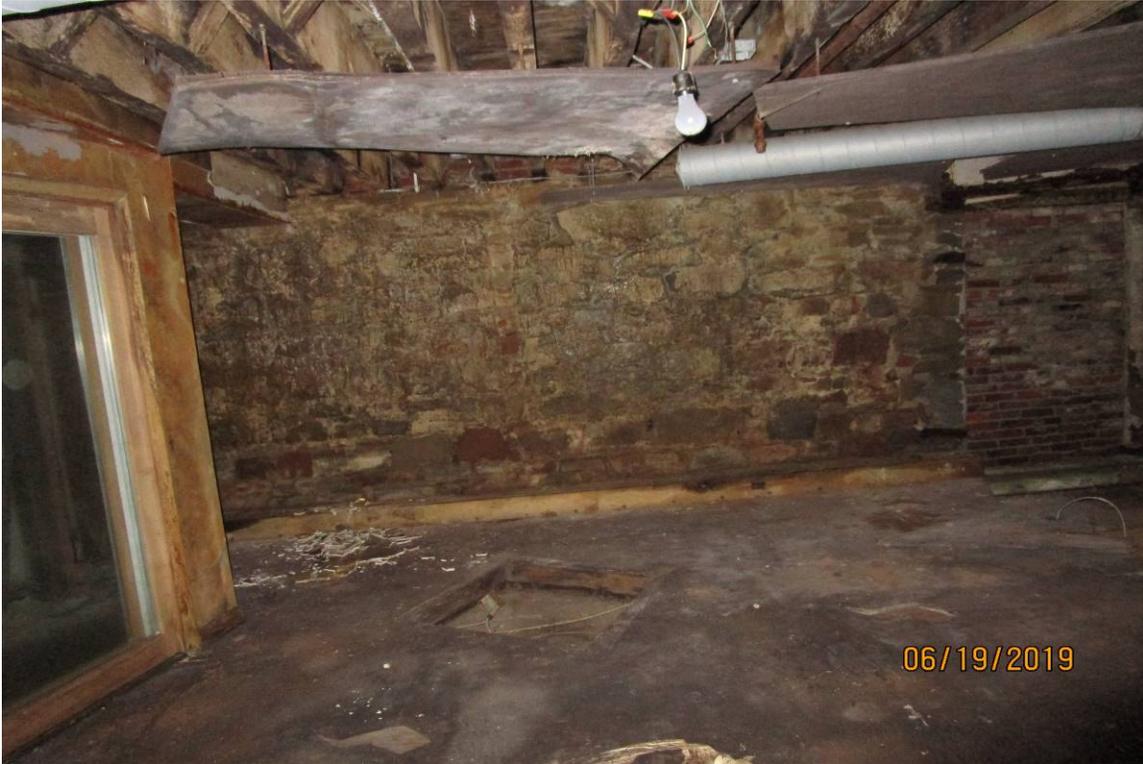
PHOTOGRAPH #16

A portion of the right foundation wall of 106-108 Market Street. This foundation wall is likely a common foundation wall with 104 Market Street.

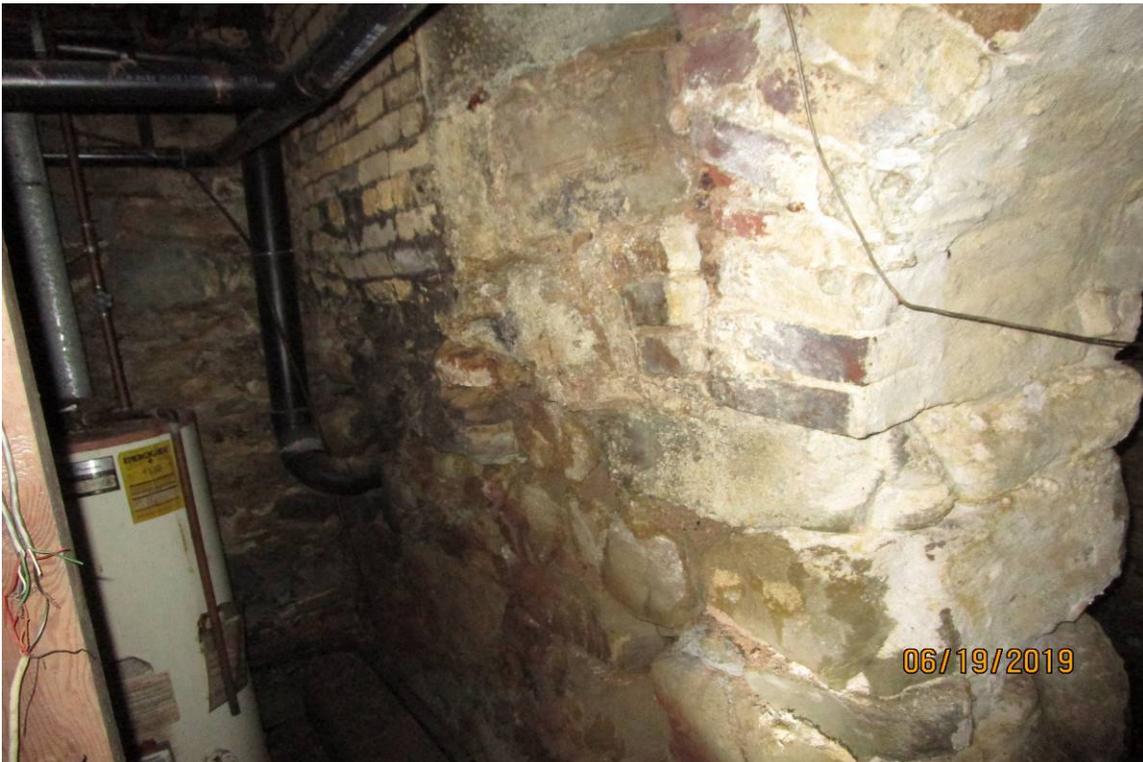
PHOTOGRAPH #17

A portion of the front foundation wall of 106-108 Market Street.

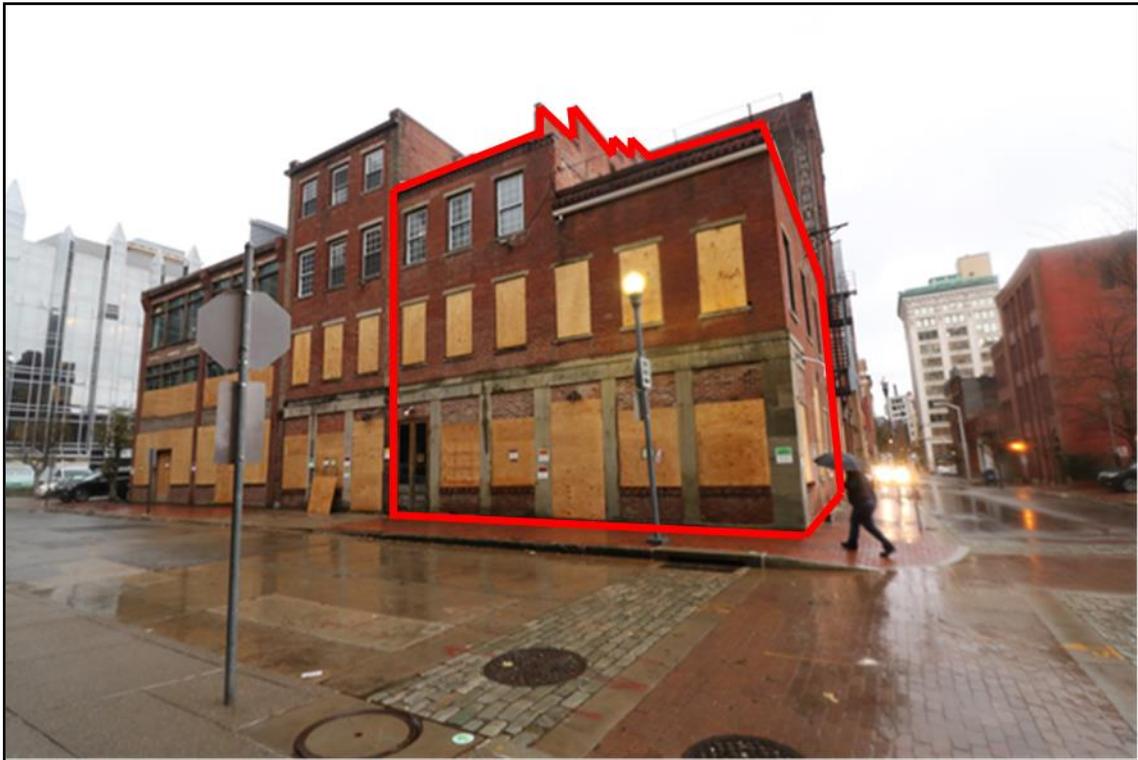
View of 100 Market at the corner of Market Street and First Avenue, looking northeast.

The building has been vacant since at least the early 2000s and remains in very poor condition. After more than a decade of vacancy, with no maintenance, the building has deteriorated to the extent that it is no longer structurally sound. A 2019 structural viability inspection conducted by AE&C Engineering Consultants determined that a majority of exterior walls and interior joists are structurally unsound, and in some instances posed a risk of total building collapse.¹

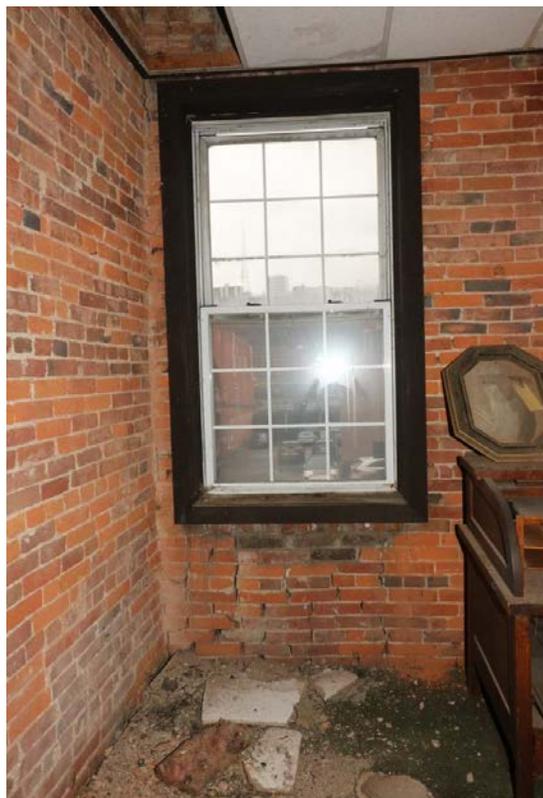
The building is in very poor condition. There is evidence of water damage, material loss, and structural damage. There is step-cracking visible at the exterior, along with other evidence of failing masonry (see image below), and the hardwood floors are uneven and buckling in areas. A 2019 structural viability inspection conducted by AE&C Engineering Consultants determined that a majority of exterior walls and interior joists are structurally unsound, and in some instances posed a risk of total building collapse.³

Interior photograph of 104 Market Street, looking northwest. Note the visibly buckling brick.

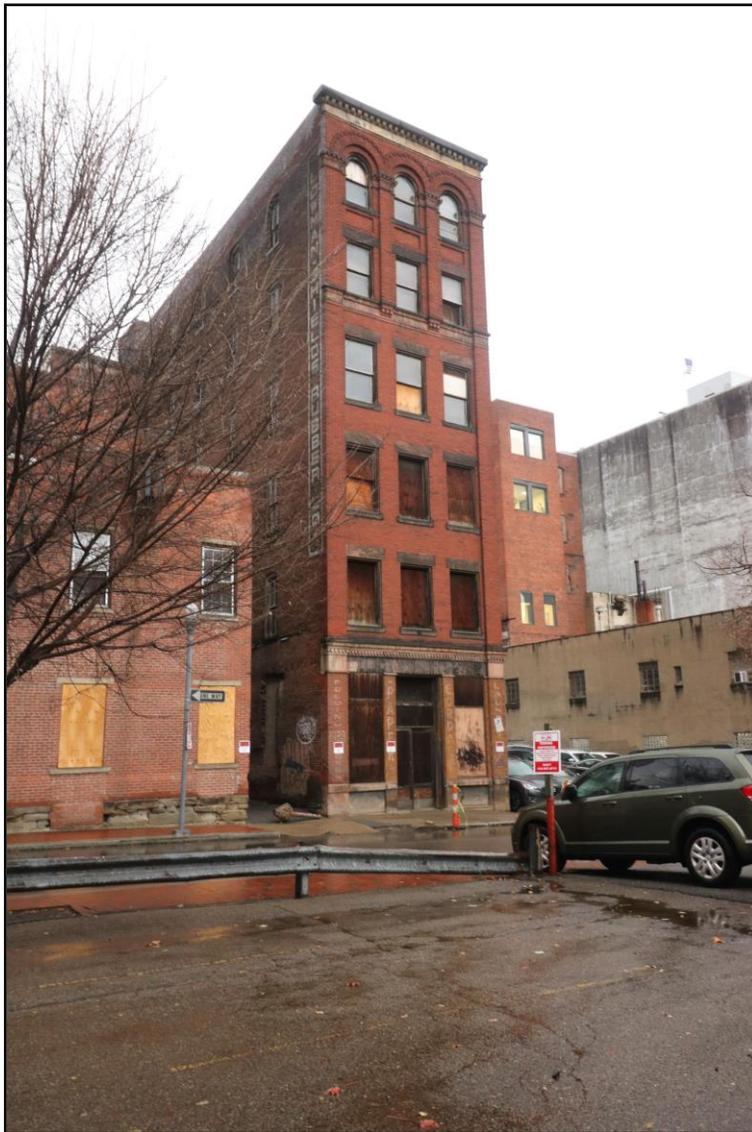
Looking northeast towards the subject building at 209 First Avenue (center).

The building has been vacant for decades, and has not been maintained or heated in that time. Consequently, the building is in very poor condition and in danger of collapse. There is evidence of water damage, material loss, and structural damage throughout the building. During Heritage's site visit it was observed that there are gaps in the floors and significant water damage to load-bearing masonry walls and ceiling/floor joists. At the secondary elevations many of the exterior face bricks have fallen away leaving the underlying layers of masonry exposed to the elements. In addition, there are large step cracks throughout, which are particularly evident at the rear elevation. A structural viability inspection conducted by AE&C Engineering Consultants determined that, "The present conditions of the front portion of the left brick bearing wall, as observed and photographed, lead to the conclusion that a sudden collapse of the left front portion of the brick bearing wall of the building would cause the drastic and complete collapse of the entire structure." Many of the ceiling joists have rotted at joist pockets so severely that they have been displaced from the masonry pocket. The limited wood flooring that remains is in extremely poor condition and severely water-damaged as evidenced by their uneven and buckled appearance. Overall, the steel windows at the side elevation are in poor condition with broken glazing, corrosion, and sash displacement. All windows at the first, second, and third floors of the primary south elevation have since been boarded up. Many of the arched windows at the upper floor of the primary elevation are completely missing or missing sashes.

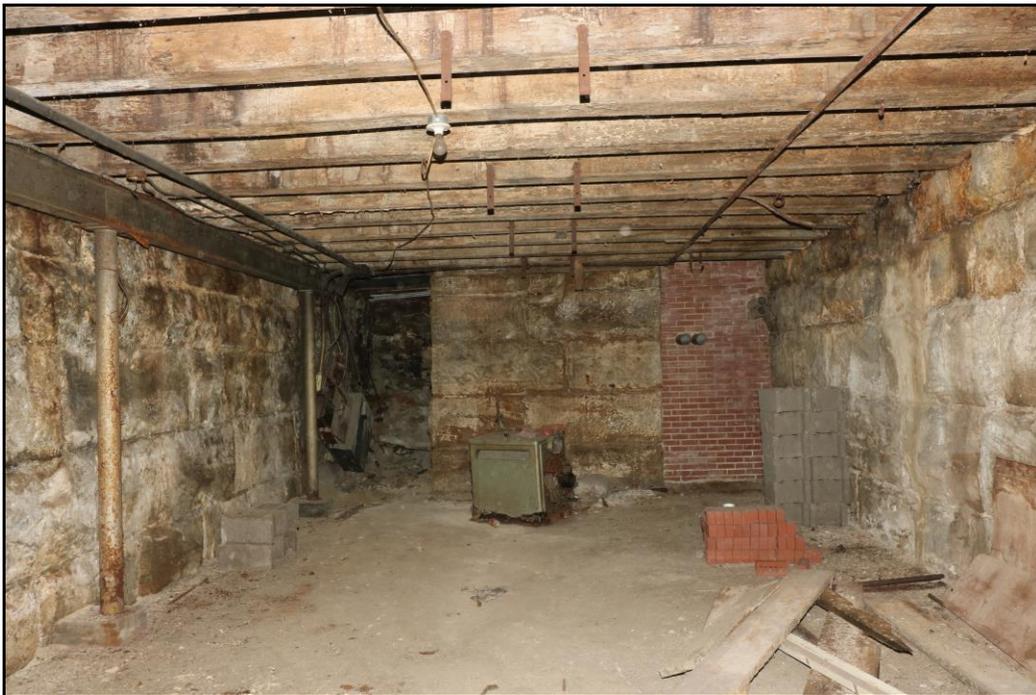
Interior photograph of basement of 209 First Avenue. Note the steel beam supporting the displaced floor joists at left.

cracked and missing brick, total reconstruction of the masonry walls would be necessary. Particularly in 209 First Street, the interior joists are heavily water-damaged and displaced from the wall pockets. Wholesale window replacement would likely be necessary.

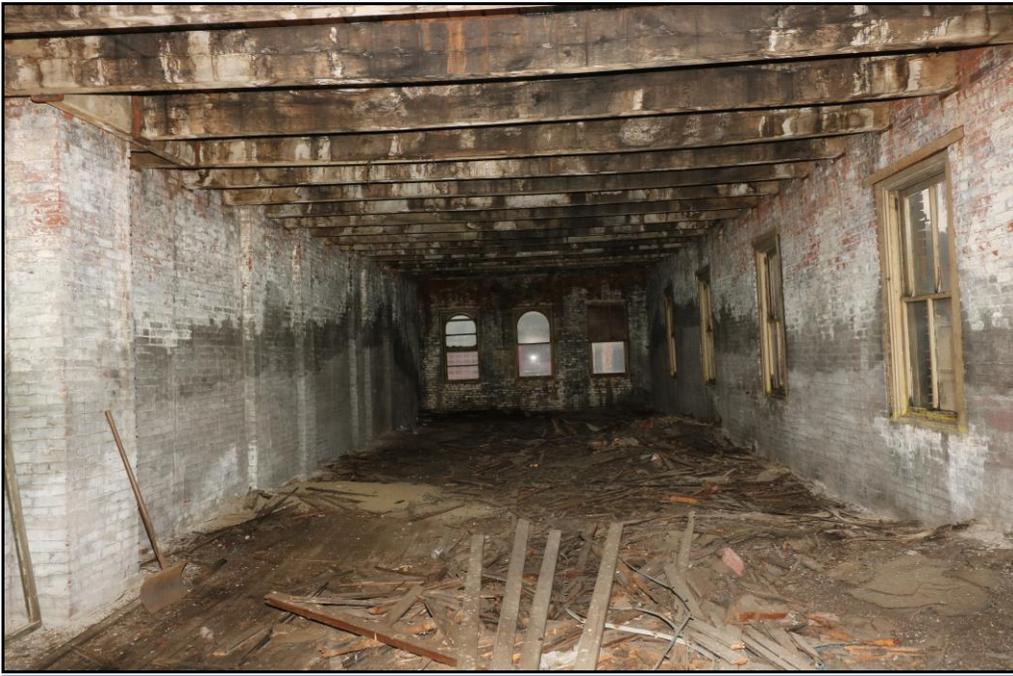
Interior photograph of upper floor of 209 First Avenue, looking southwest. Visible evidence of water intrusion and structural deterioration.

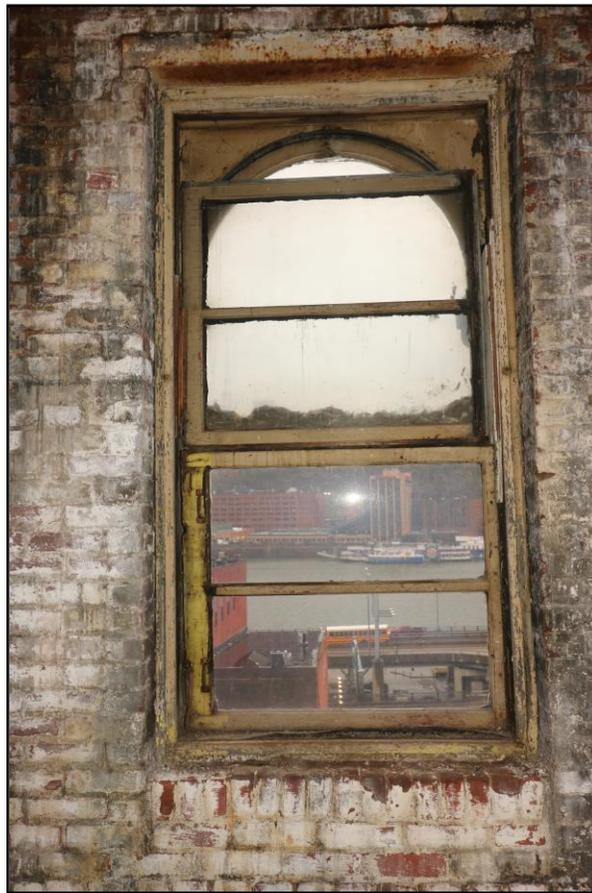
Interior photograph of upper floor window of 209 First Avenue. Note the overall conditions of deterioration.

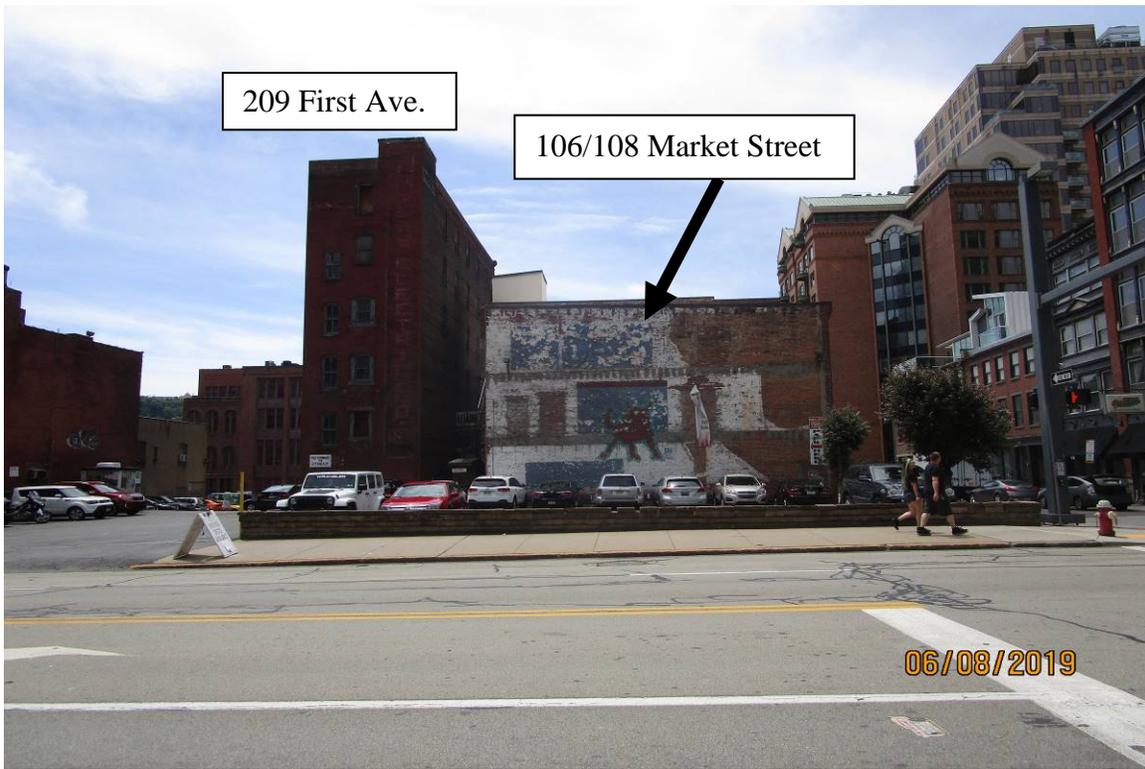
PHOTOGRAPH #1
Looking across the Boulevard of the Allies at the north side of the building at 106/108 Market Street and the north side of 209 First Avenue.

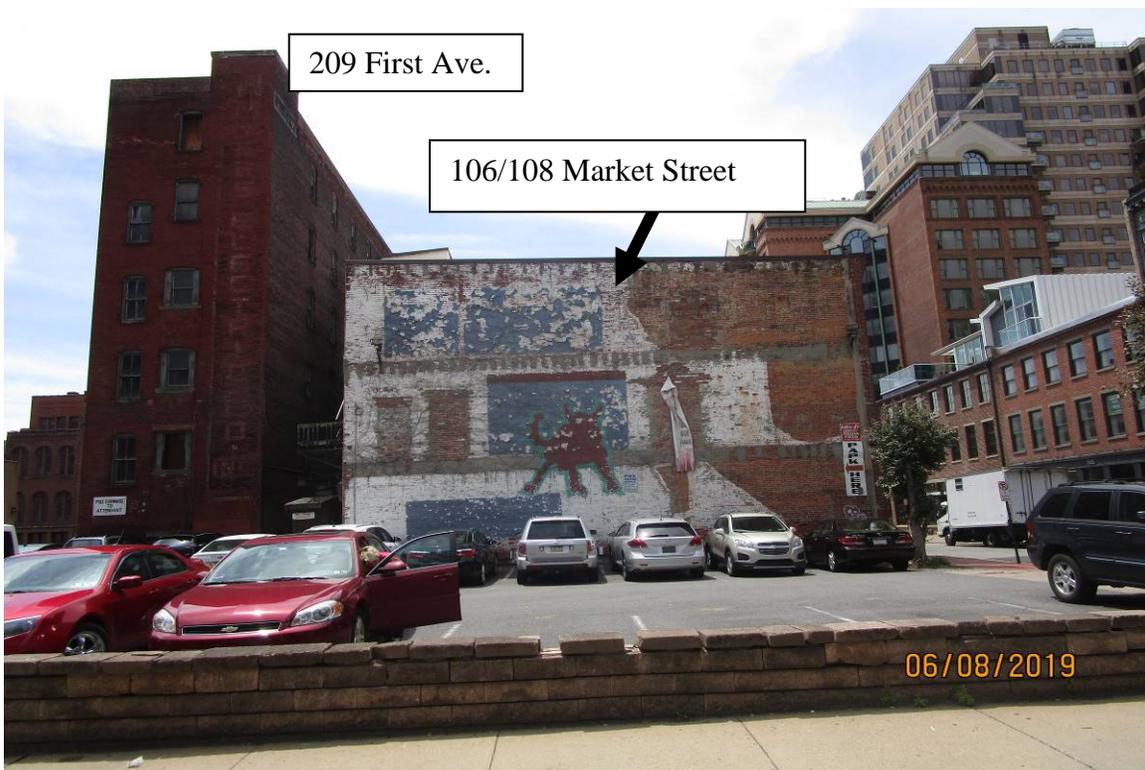
PHOTOGRAPH #2
The open paved space adjacent to 106/108 Market Street and 209 First Avenue.

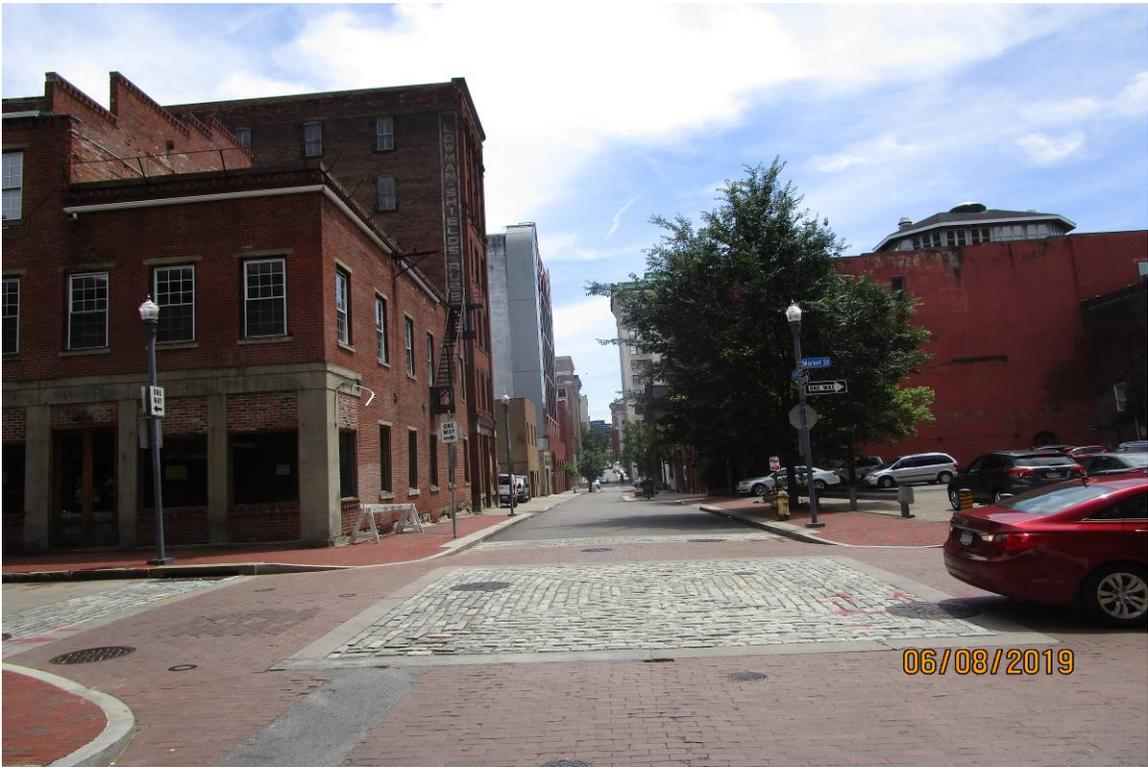
PHOTOGRAPH #3
Looking east on First Avenue across the intersection of First Avenue and Market Street.

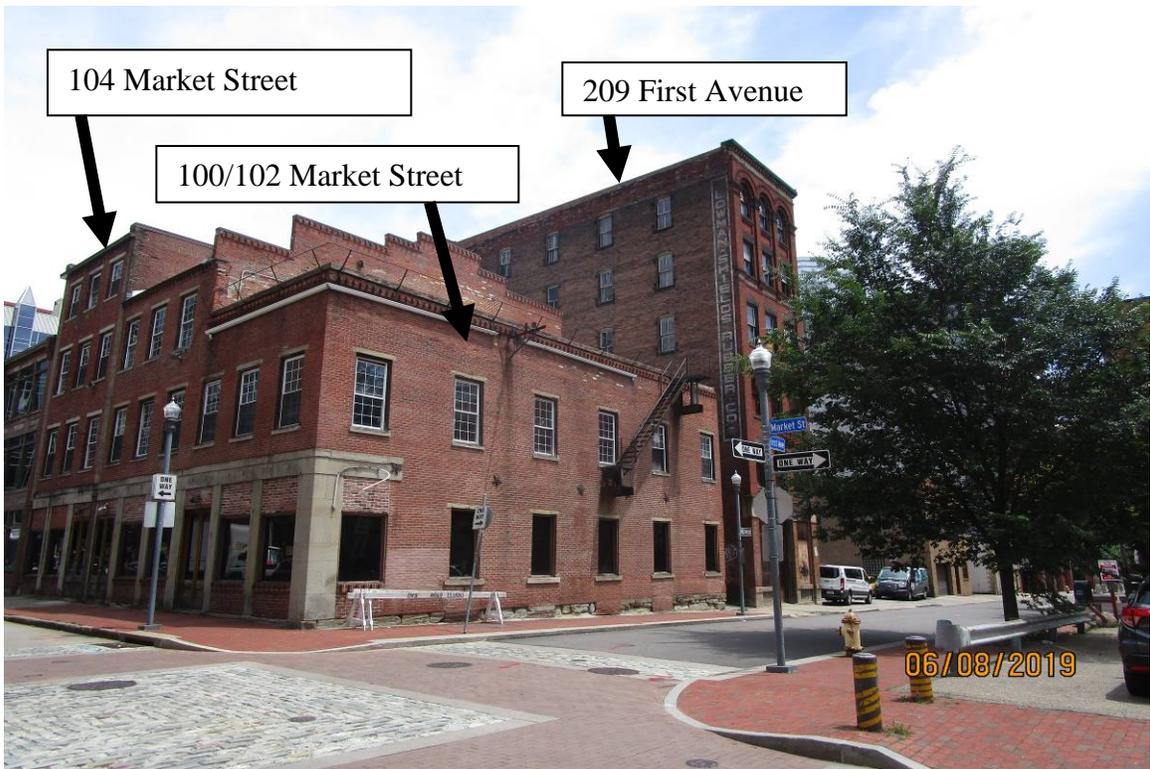
PHOTOGRAPH #4
The intersection of Market Street and First Avenue.

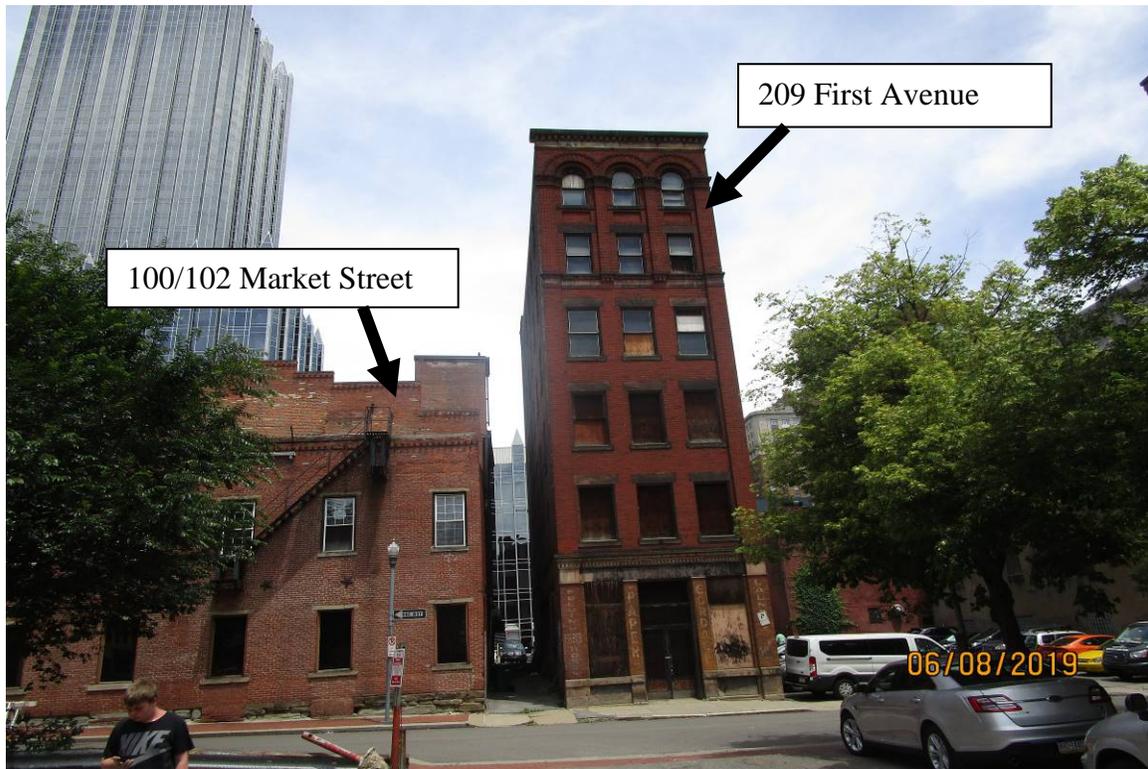
The front and rear brick walls of the building are structurally considered non-bearing walls. The front wall is shown in Photograph #5. No significant structural distress or structural unsoundness was observed in the front wall.

**PHOTOGRAPH #5
The front of 209 First Avenue.**

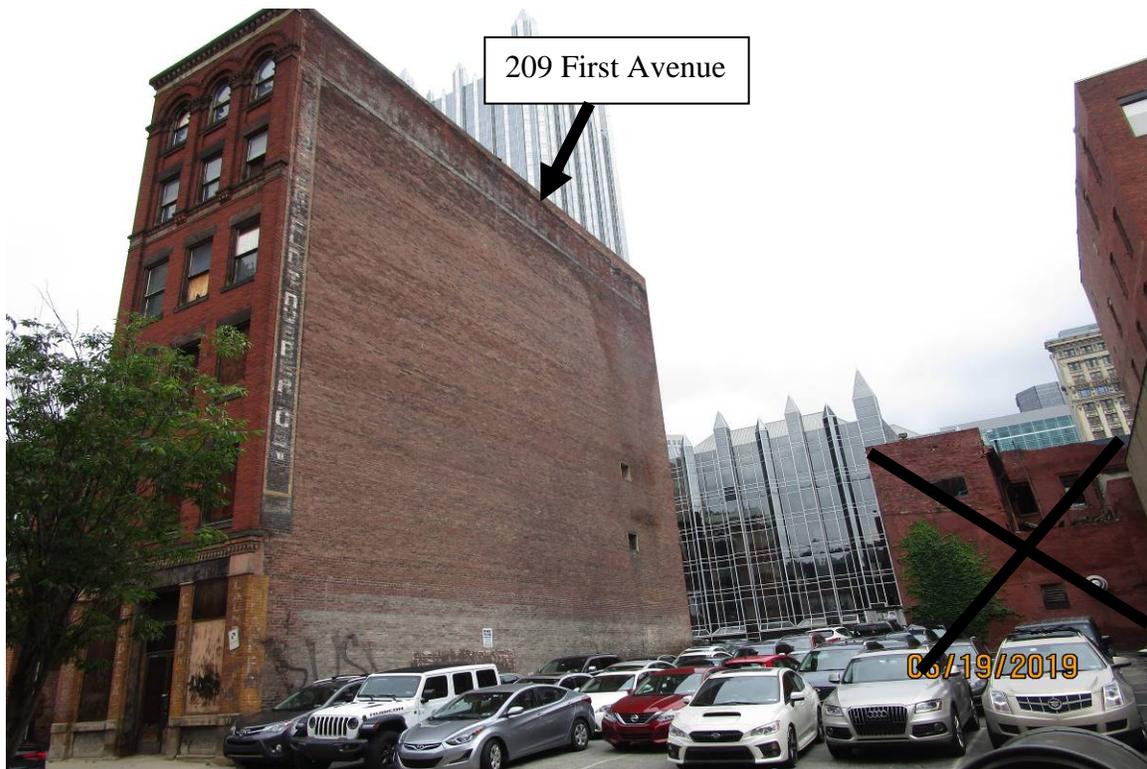
The right brick bearing wall of the building is shown in Photograph #6. The exterior wythe of the brick in this wall is intact and appears to generally be weather-tight. The present condition of the brick and mortar of the interior wythes of the right bearing wall could not be determined. No significant areas of brick and/or mortar deterioration were observed in this wall,

**PHOTOGRAPH #6
The front and right walls of 209 First Avenue.**
