Planning Commission Briefing for demolition and consolidation at Boulevard, First and Market
Submitted June 9, 2020

ASSESSMENT OF BUILDING CONDITIONS

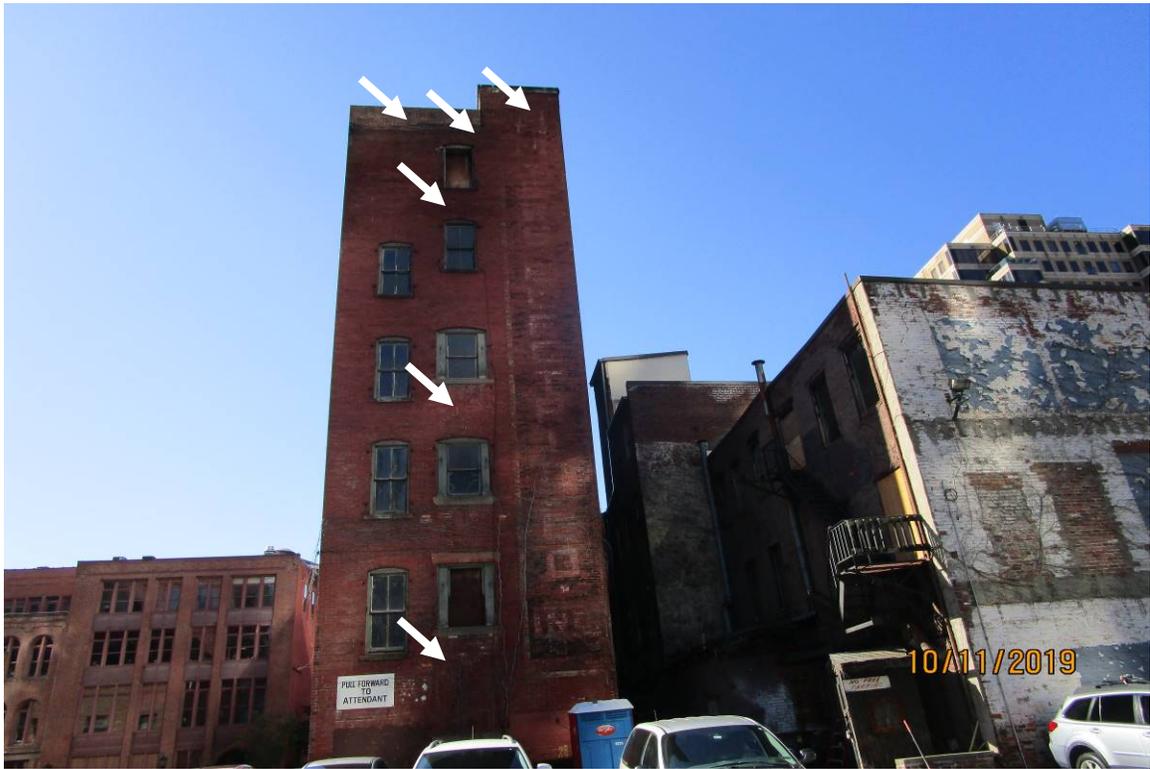
PHOTOGRAPH #7

The rear wall is shown in Photographs #7, #8, #9, & #10. Four (4) areas of severely deteriorated mortar are shown in the exterior wythe of brick near the top of the wall. Three (3) locations of cracks in the brick work were also observed. There are numerous small areas where the exterior wythe has been pointed in the past to fill deteriorated mortar joints and cracks in the brick work, which were allowing water and moisture to get into the interior wythes of the brick wall.

The rear of 209 First Avenue. Note the locations of areas with mortar deterioration and cracking in the exterior wythes of the multi-wythe wall.

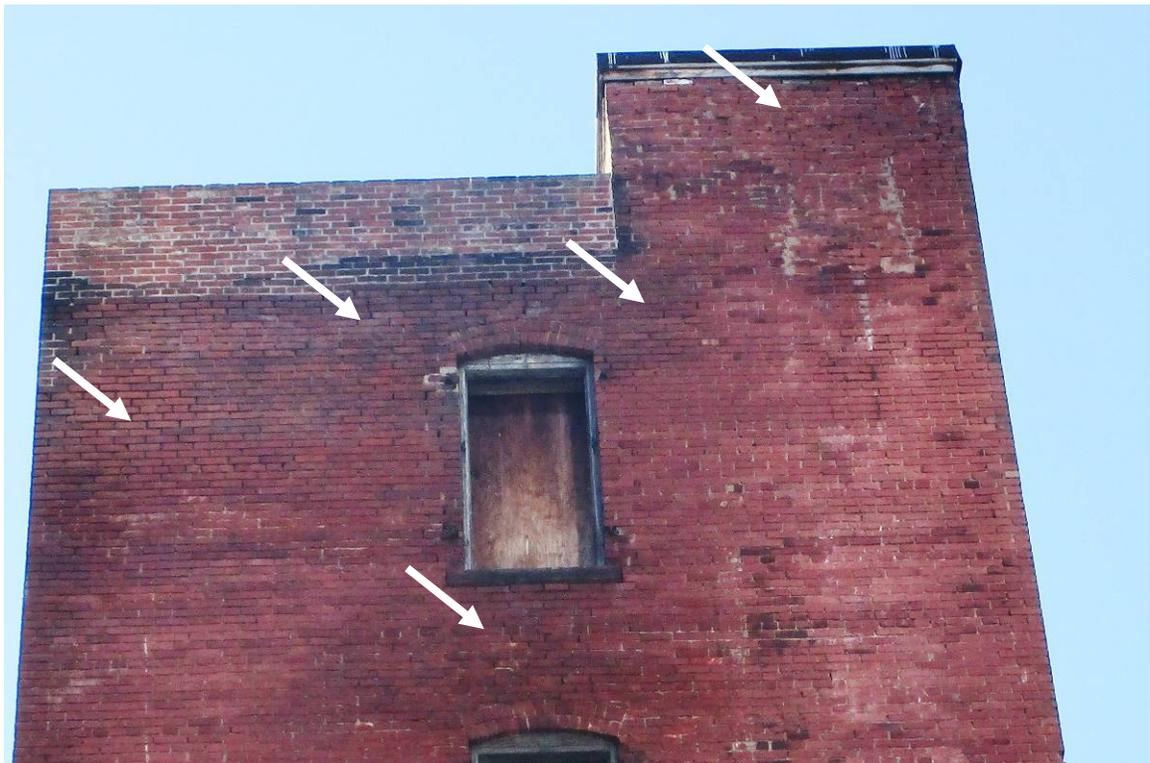
PHOTOGRAPH #8

Areas of mortar deterioration near the top of the rear wall of the building.

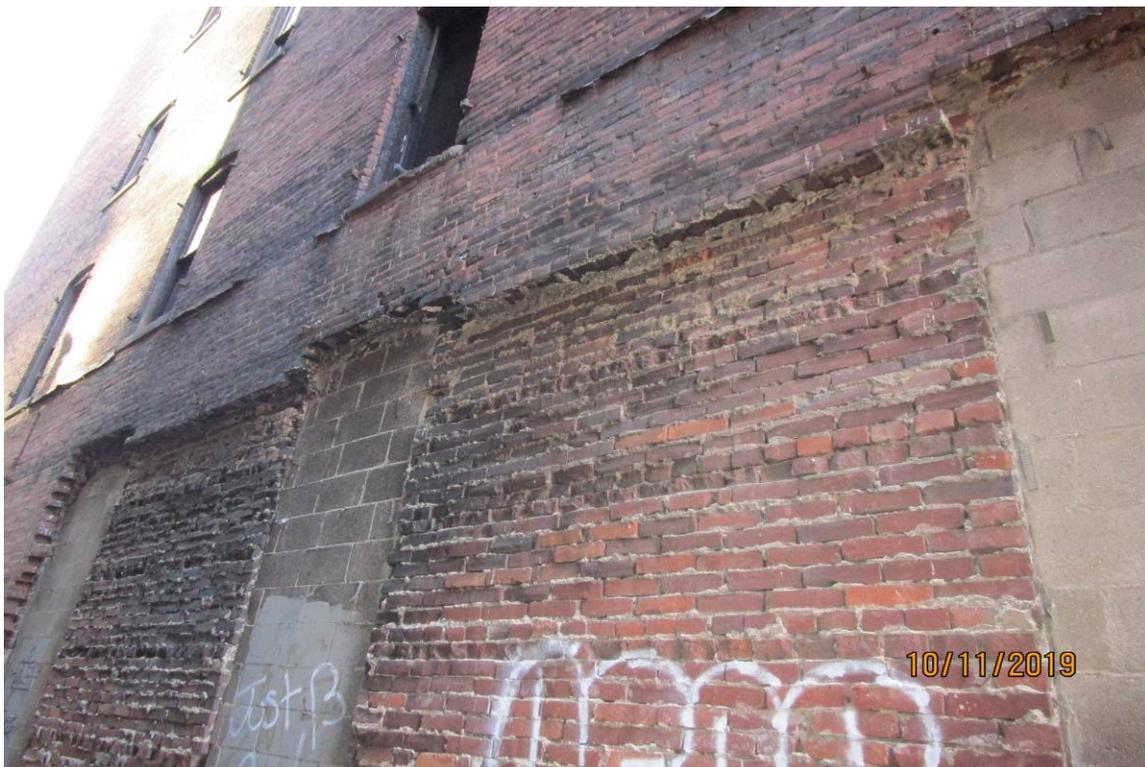
PHOTOGRAPH #12

An area of exposure of the interior wythes of the left brick bearing-wall. Note the complete deterioration of the mortar in large areas of the interior wythe.

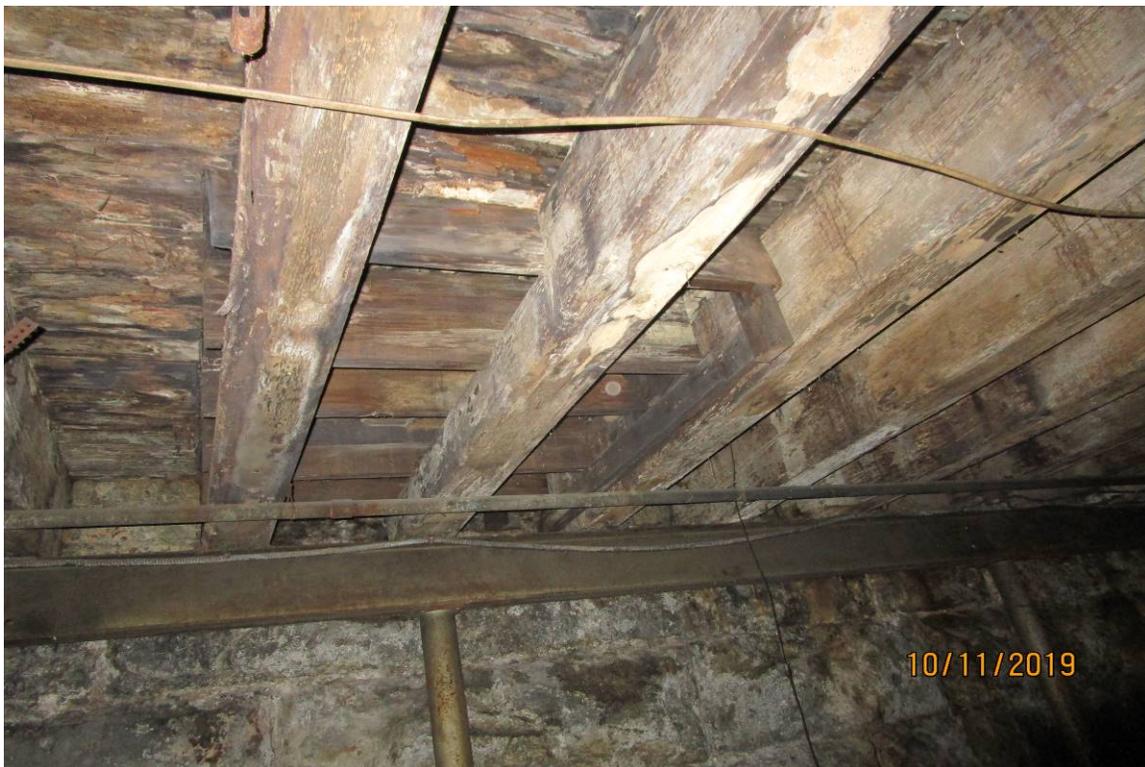
PHOTOGRAPH #14

The steel beam and steel posts, along the right foundation wall, which provide support for the deteriorated end bearings of the water damaged, wood beams under the 1st floor.

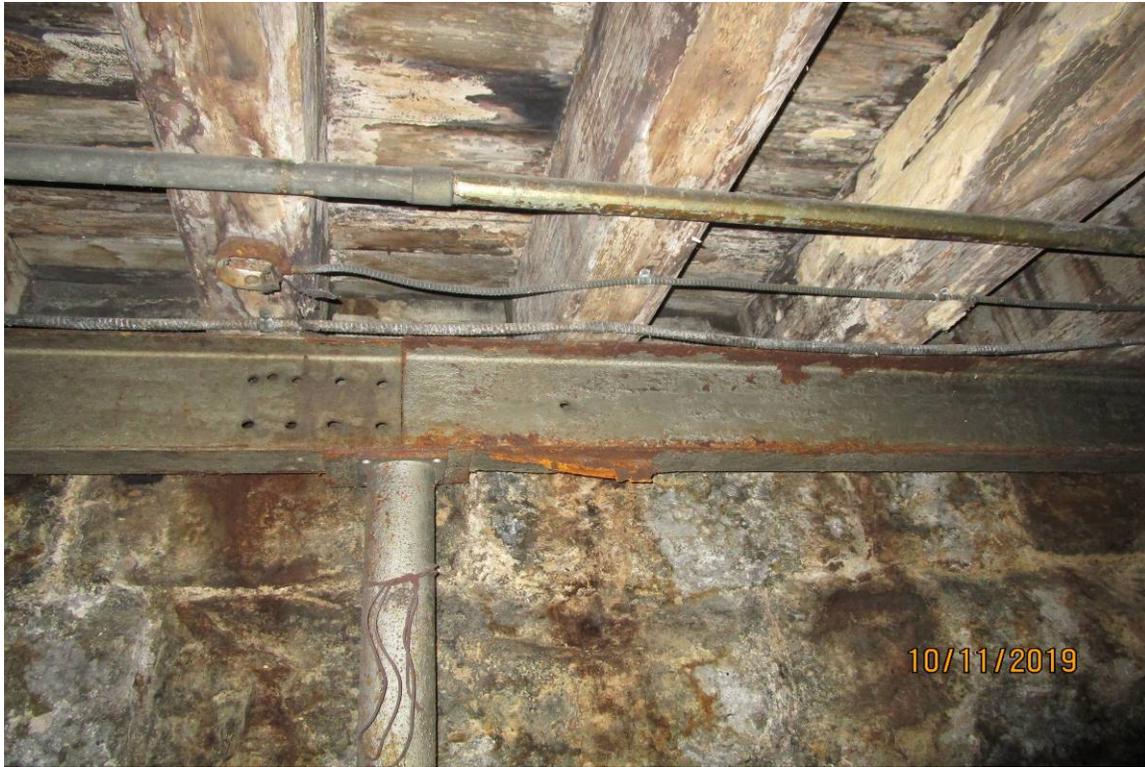
PHOTOGRAPH #15

The steel beam and steel posts, along the right foundation wall, which provide support for the deteriorated end bearings of the water damaged, wood beams under the 1st floor.

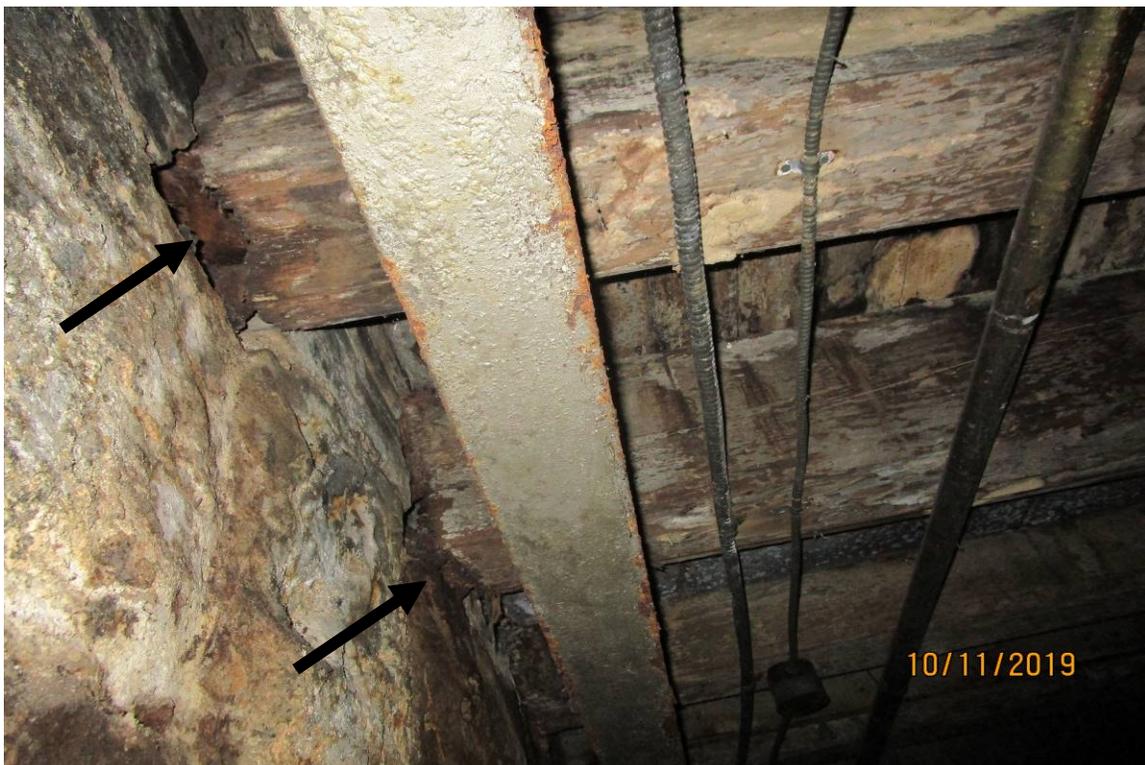
PHOTOGRAPH #16

Typical deteriorated ends of the wood floor beams supported by the steel beam and posts shown in Photographs #14 & #15.

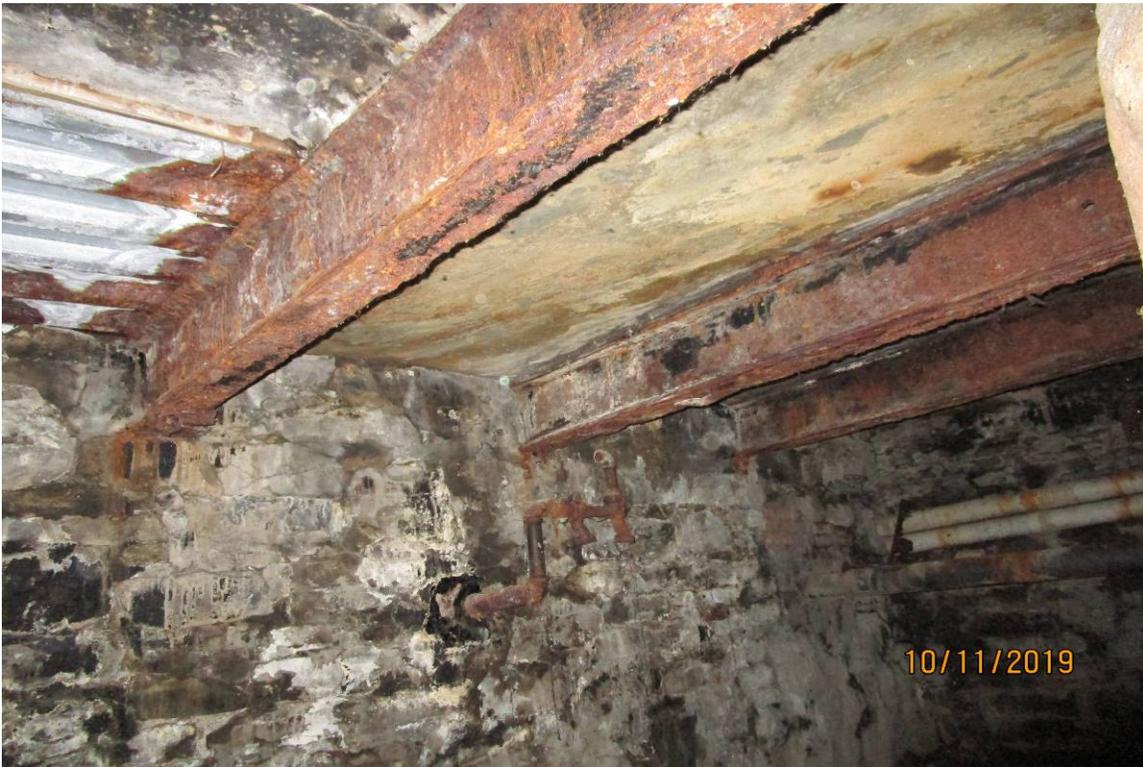
PHOTOGRAPH #17
Severely rusted steel beams under a portion of the 1st floor.

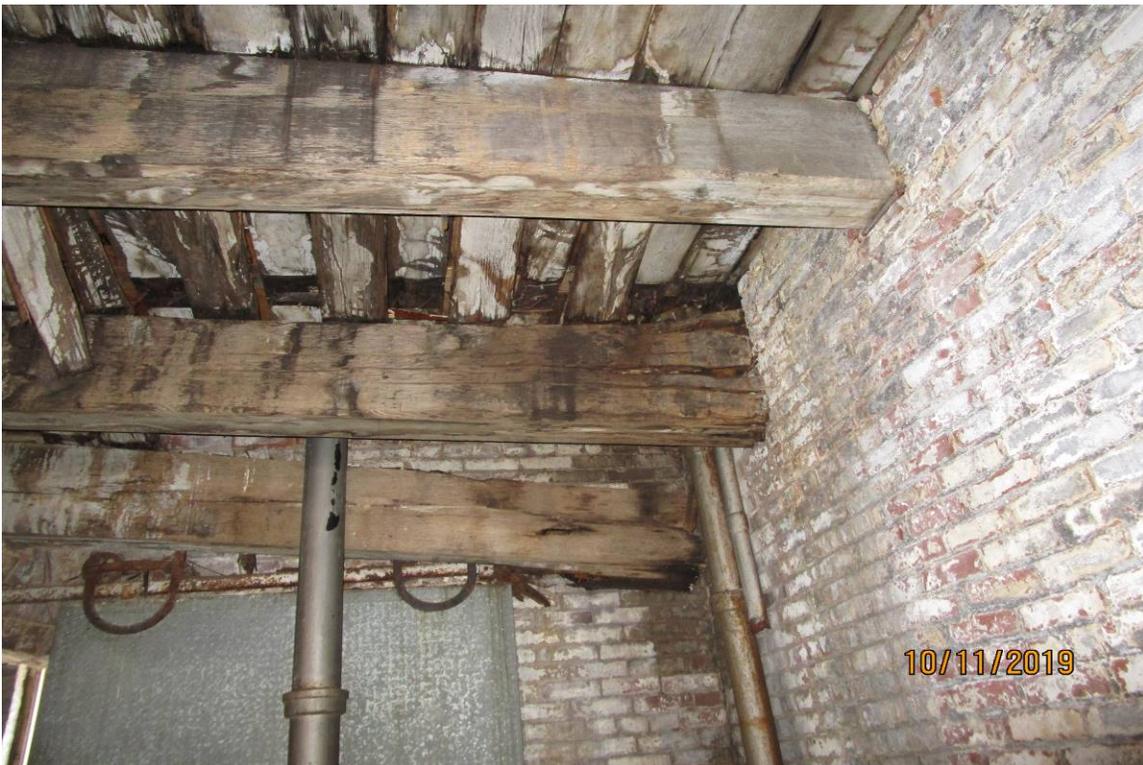
PHOTOGRAPH #18
**Cracked, structurally unsound, and water damaged floor beams
along the right bearing wall.**

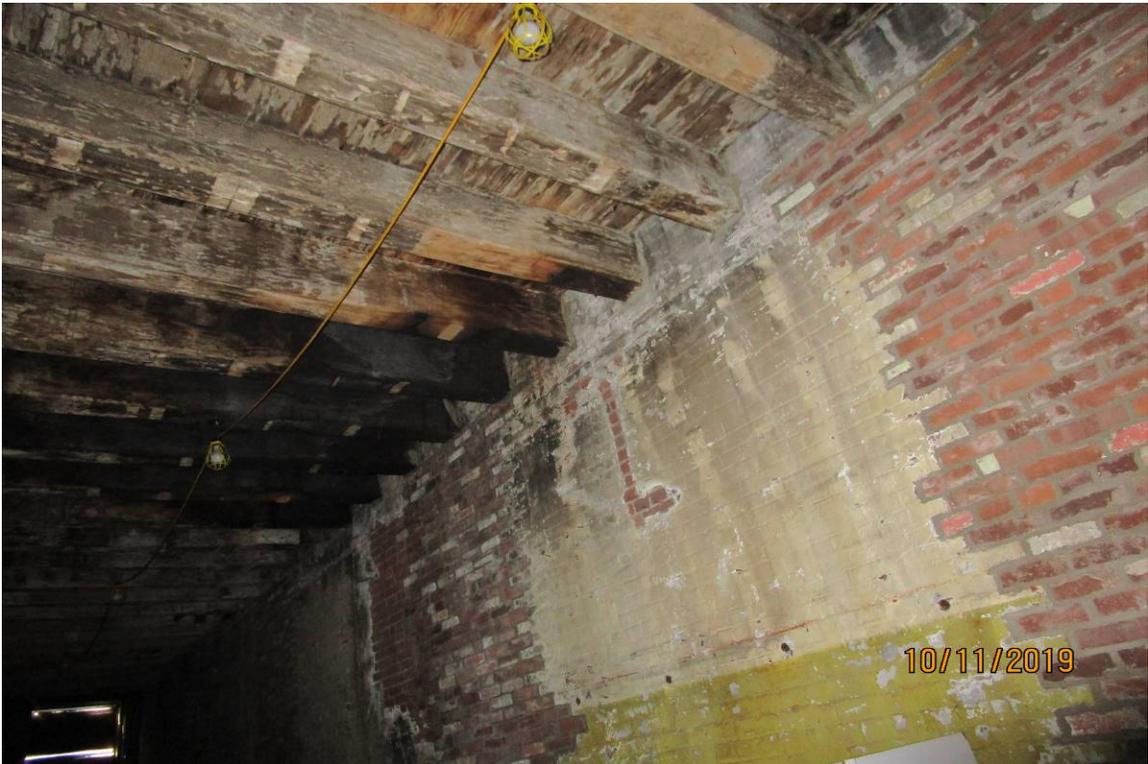
PHOTOGRAPH #26
An area of fire damaged wood floor beams.

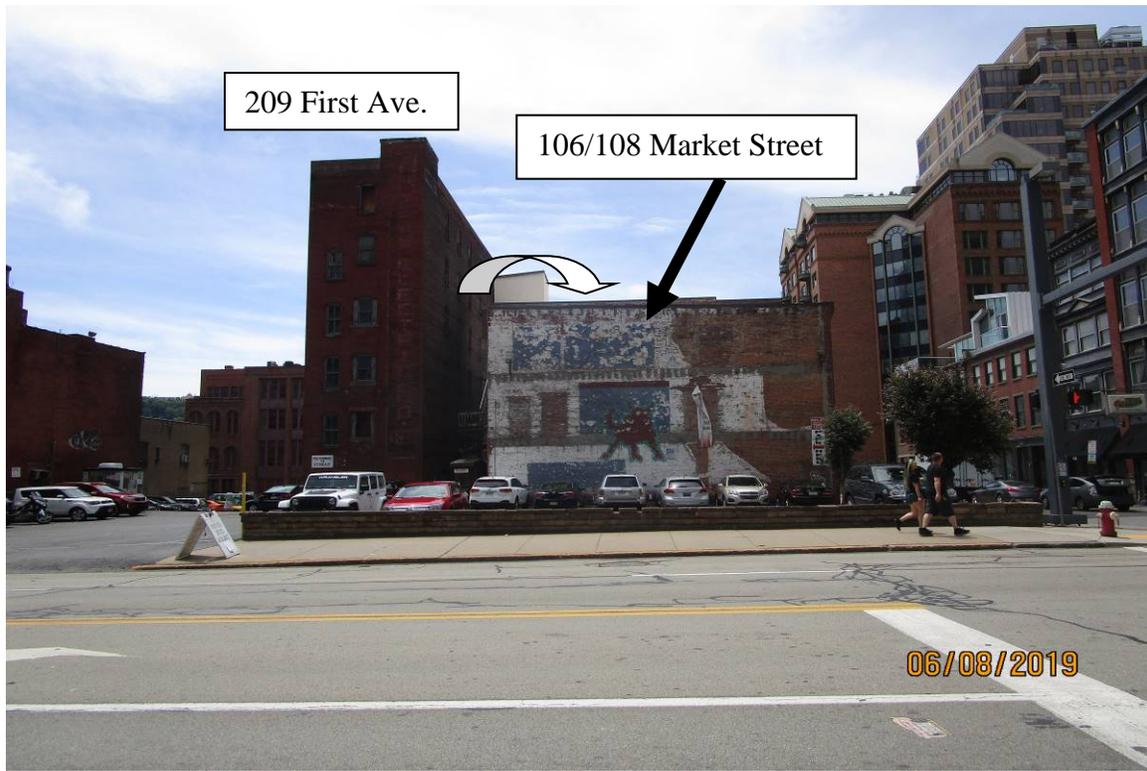
PHOTOGRAPH #1

Looking across the Boulevard of the Allies at the north side of the building at 106/108 Market Street and the north side of 209 First Avenue. Note that the collapse of the severely weakened 1st floor section of the west brick bearing wall of the 6-story building at 209 First Avenue would cause that 6-story building to collapse westward and fall onto (and against) the buildings at 106/108 Market Street. See Photographs #11, #12, & #13.

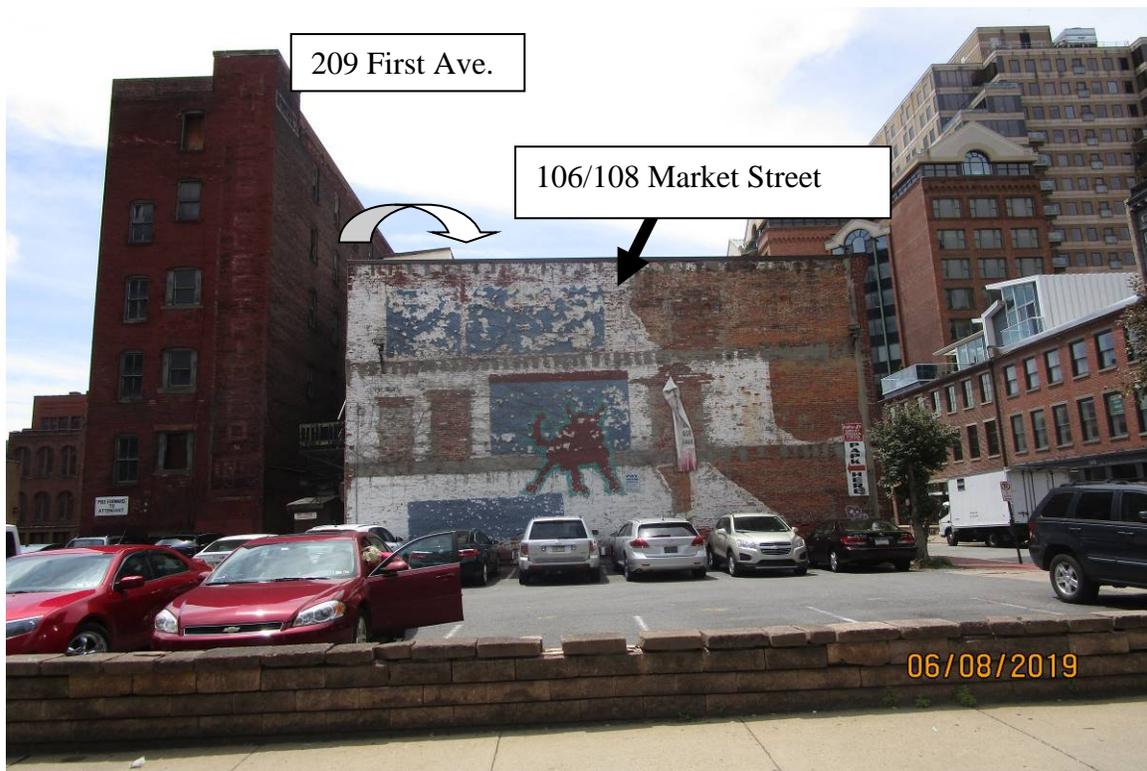
PHOTOGRAPH #2

The open paved space adjacent to 106/108 Market Street and 209 First Avenue. Note that the collapse of the severely weakened 1st floor section of the west brick bearing wall of the 6-story building at 209 First Avenue would cause that 6-story building to collapse westward and fall onto (and against) the buildings at 106/108 Market Street. See Photographs #11, #12, & #13.

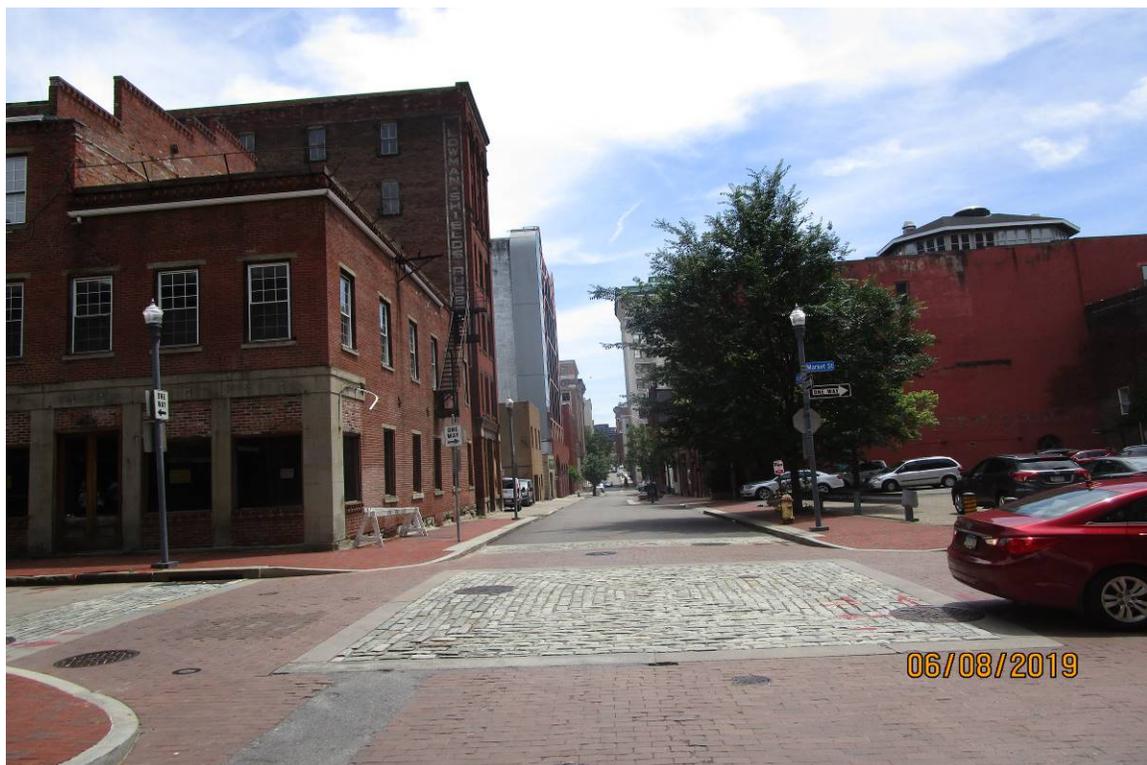
PHOTOGRAPH #3

Looking east on First Avenue across the intersection of First Avenue and Market Street.

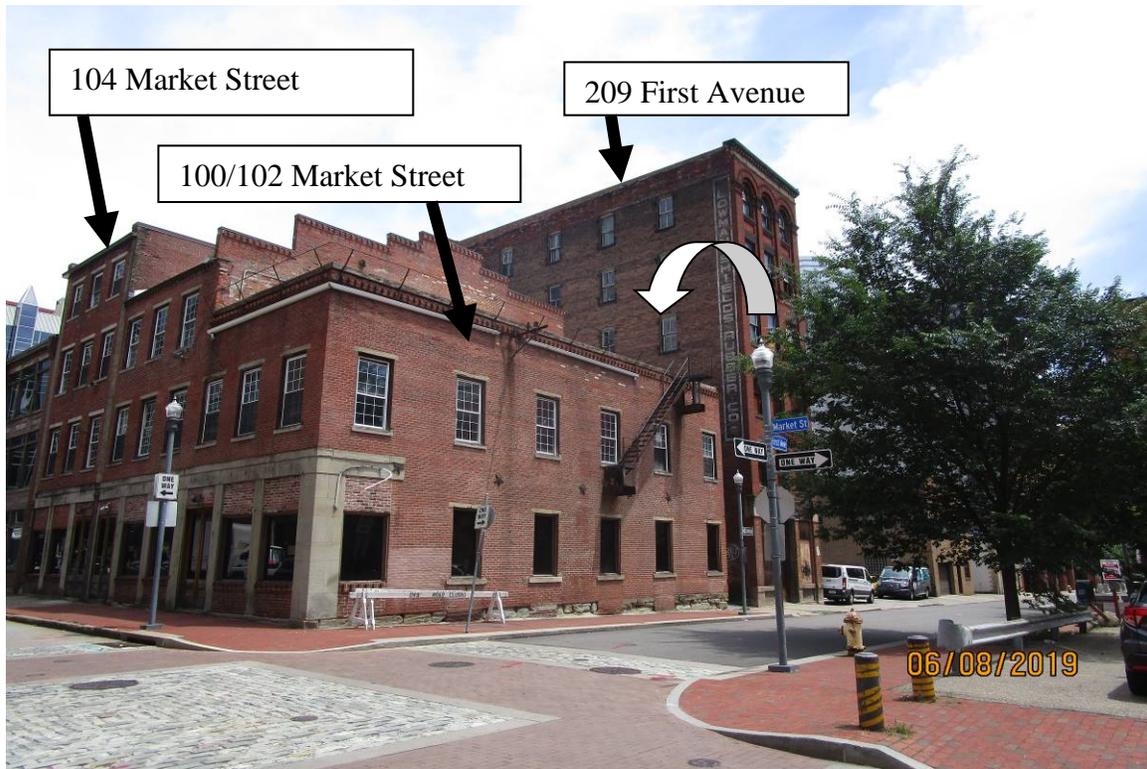
PHOTOGRAPH #4

The intersection of Market Street and First Avenue. Note that the collapse of the severely weakened 1st floor section of the west brick bearing wall of the 6-story building at 209 First Avenue would cause that 6-story building to collapse westward and fall onto (and against) the buildings at 104 Market Street and 100/102 Market Street.

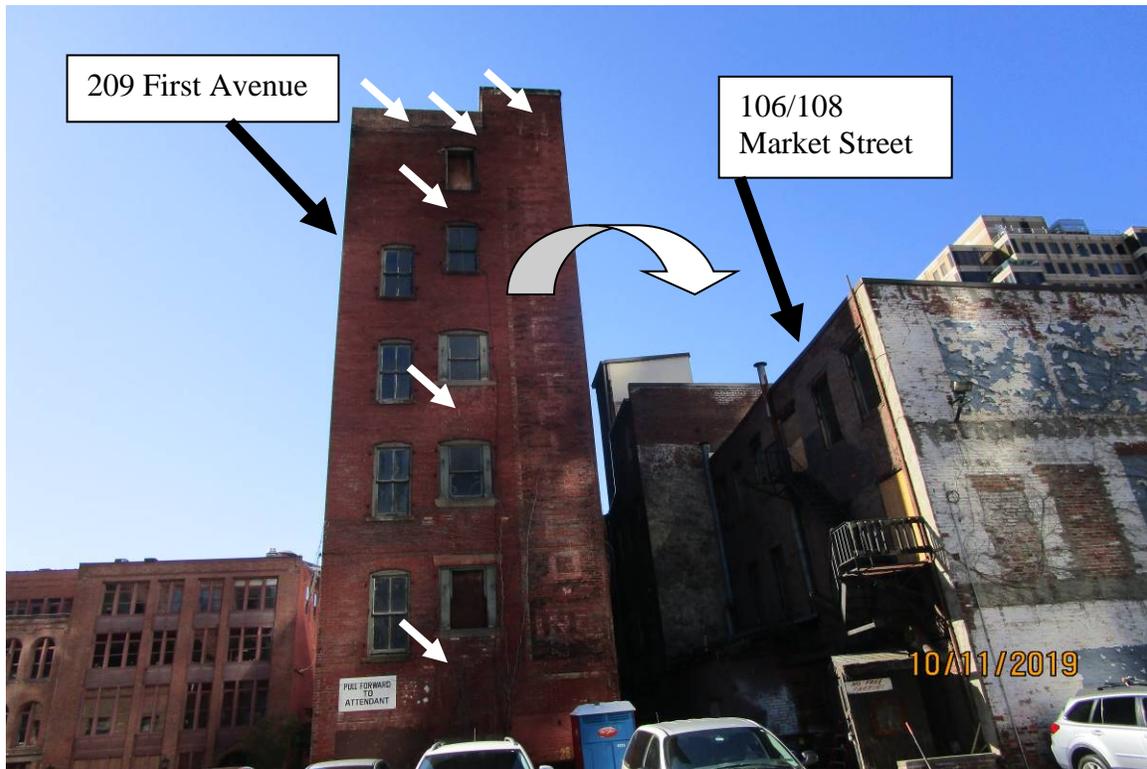
PHOTOGRAPH #7

The six (6) story rear wall is shown in Photographs #7, #8, #9, & #10. Four (4) areas of severely deteriorated mortar are shown in the exterior wythe of brick near the top of the wall. Three (3) locations of cracks in the brick work were also observed. There are numerous small areas where the exterior wythe has been pointed in the past to fill deteriorated mortar joints and cracks in the brick work, conditions which were allowing water and moisture to get into the interior wythes of the brick wall.

The rear of the 6-story building at 209 First Avenue. Note the locations of areas with mortar deterioration and cracking in the exterior wythes of the multi-wythe wall. Note that the collapse of the severely weakened 1st floor section of the west brick bearing wall of the 6-story building at 209 First Avenue would cause that 6-story building to collapse westward and fall onto (and against) the buildings at 106/108 Market Street. See Photographs #11, #12, & #13.

In light of the conditions observed and the likelihood of rather large areas of structurally unsound and deteriorated brick/mortar on the interior of the rear wall, **the rear non-bearing brick wall of this six (6) story building should be considered structurally unsound. No areas of visible structural instability were observed in the rear wall at the time of this inspection.** However, this condition could change due to continuing deterioration of the brick and mortar from water entering the wall, and from seasonal freeze/thaw cycles. Additionally, vibrations and shifting of vertical loads on the rear wall could occur during the top-down demolition of the building or the drilling of soil test borings for the foundation investigation of future construction-thereby causing the wall to become structurally unstable and collapse.

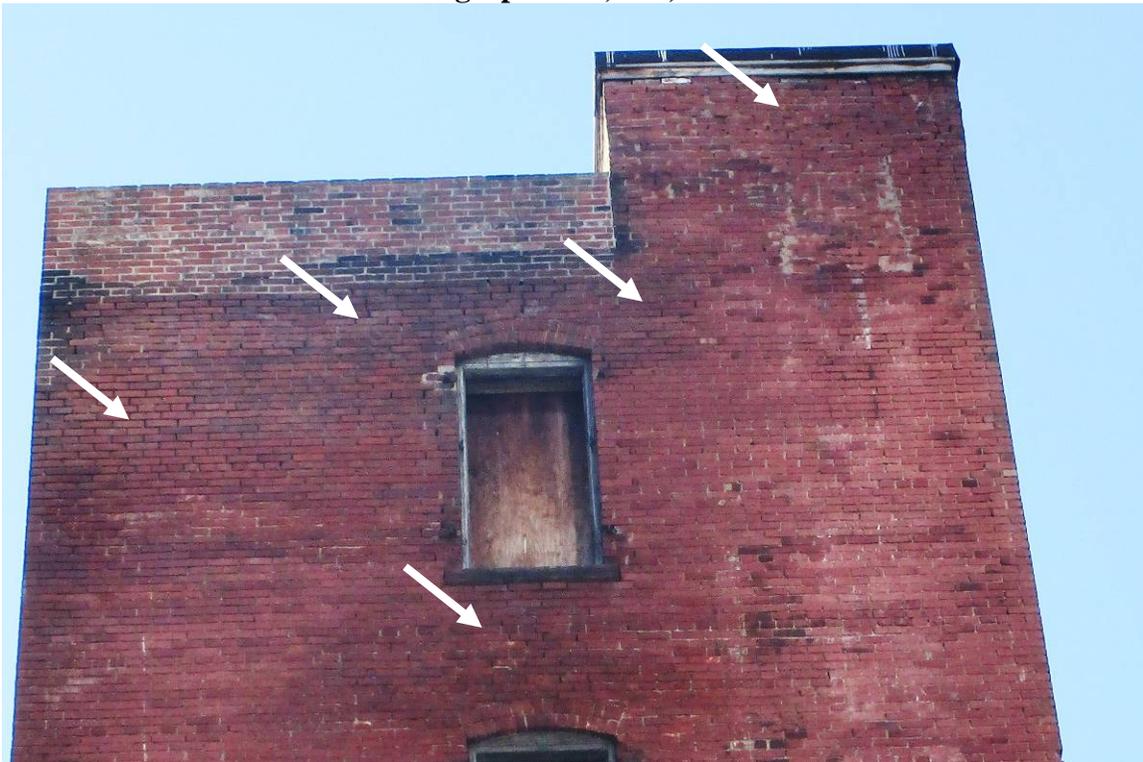
PHOTOGRAPH #8

Areas of mortar deterioration near the top of the rear wall of the building.

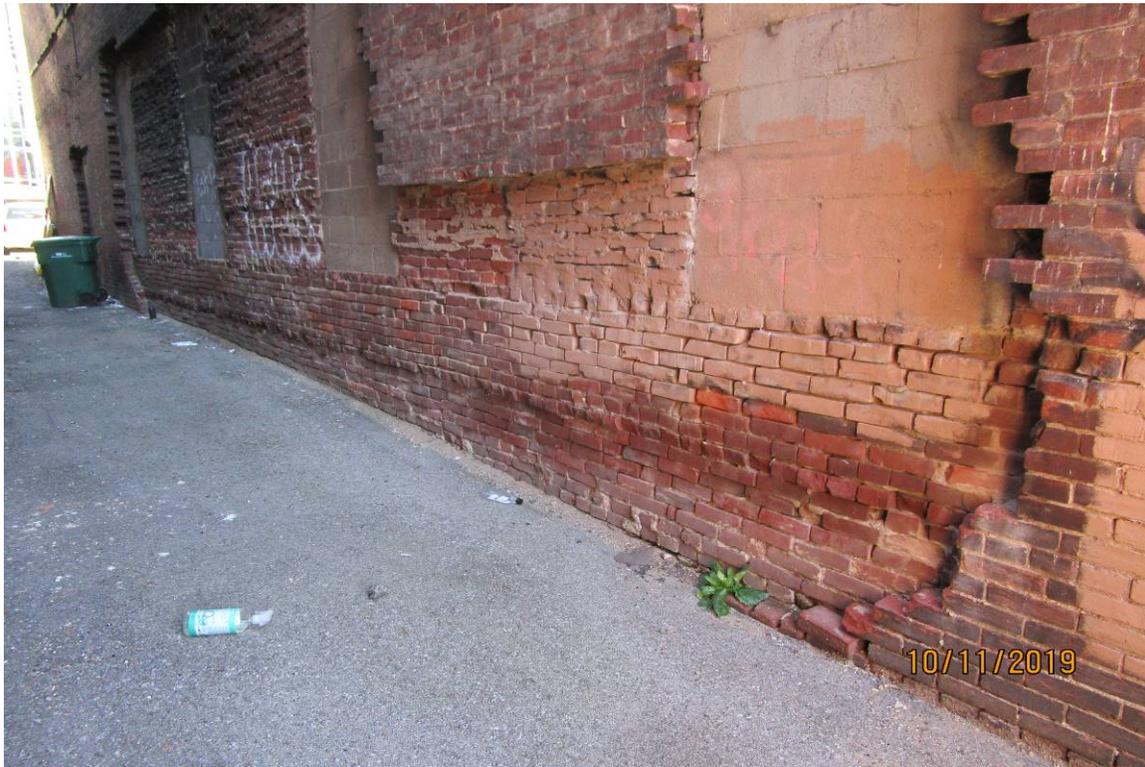
PHOTOGRAPH #11

Photograph #11 was taken looking to the rear along a significant length of the west brick bearing wall of the building at 209 First Avenue. The exterior wythe (4" width) of the brick bearing-wall has completely fallen off the wall in this area; exposing the 1st interior wythe of the wall. Note the deterioration of the soft bricks and the absence of mortar in the exposed area of the 1st interior wythe of the bearing wall. Note the concrete block in-fills of the 1st floor windows.

This bearing wall appears to be 5-wythes thick (5-widths/horizontal layers x 4" per wythe = 20" thick). The exterior 2-wythes (an 8" thickness of wall) are missing or are structurally unsound; this condition leads to the conclusion that the structural strength of the wall has been reduced by as much as 40% from its load-carrying capacity when the wall was originally built. The structural ability of the interior wythes of brick to act in compression to safely carry the present dead loads of the wall, and the floor & roof structures above, has been reduced to an indeterminate value.

Note that the collapse of the severely weakened 1st floor section of the west brick bearing wall of the 6-story building at 209 First Avenue would cause that 6-story building to collapse to the left (westward) and fall onto (and against) the buildings at 100/102 Market Street, 104 Market Street, & 106/108 Market Street. See Photographs #1, #2, #4, #5, & #7.

The present conditions of the front portion of the left brick bearing wall, as observed and photographed, lead to the conclusion that the front portion of the left

1st floor brick bearing wall of the building is very unsafe structurally and is in danger of, a possibly imminent, collapse. The collapse of this section of the left brick bearing wall would more likely, than not, cause the drastic and complete collapse of the entire structure.

Looking to the rear along a significant length of the west brick bearing wall of the building at 209 First Avenue. The exterior wythe (4" width) of the brick bearing-wall has completely fallen off the wall in this area; exposing the 1st interior wythe of the wall. Note the deterioration of the soft bricks and the absence of mortar in the exposed area of the 1st interior wythe of the bearing wall. Note the concrete block in-fills of the 1st floor windows.

Note that the collapse of the severely weakened 1st floor section of the west brick bearing wall of the 6-story building at 209 First Avenue would cause that 6-story building to collapse westward and fall onto (and against) the buildings at 100/102 Market Street, 104 Market Street, & 106/108 Market Street. See Photographs #1, #2, #4, #5, & #7.

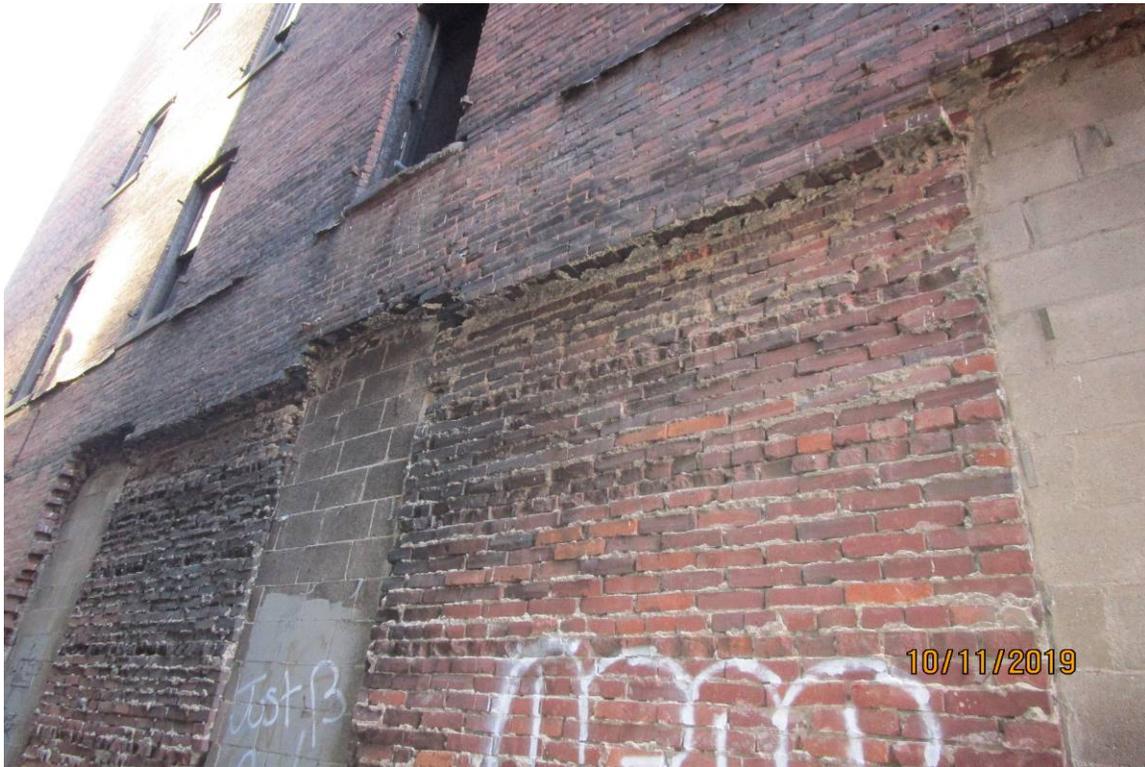
PHOTOGRAPH #12

An area of exposure of the 1st interior wythe of the left brick bearing-wall. Note that the exterior wythe of brick is completely missing and note the extensive deterioration of the mortar in large areas of the 1st interior wythe of the brick bearing wall. Note the concrete block in-fills of the 1st floor windows.

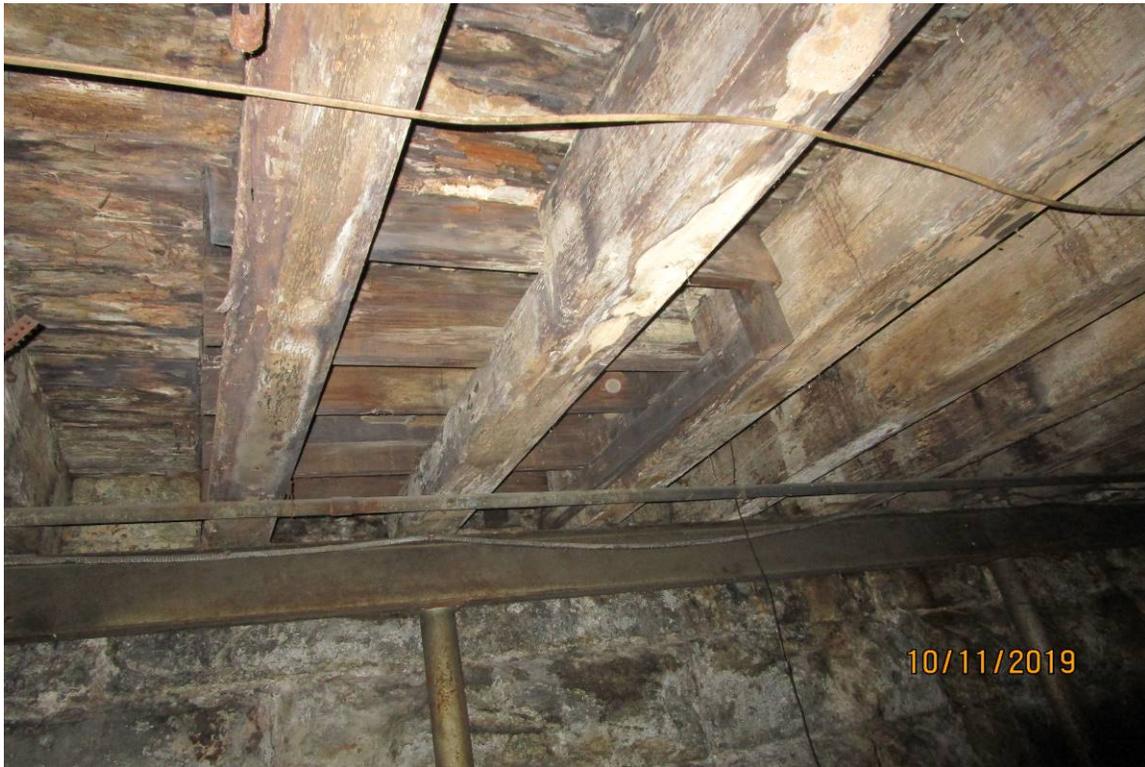
PHOTOGRAPH #14

The steel beam and steel posts, along the right foundation wall, which provide support for the deteriorated end bearings of the water damaged, wood beams under the 1st floor.

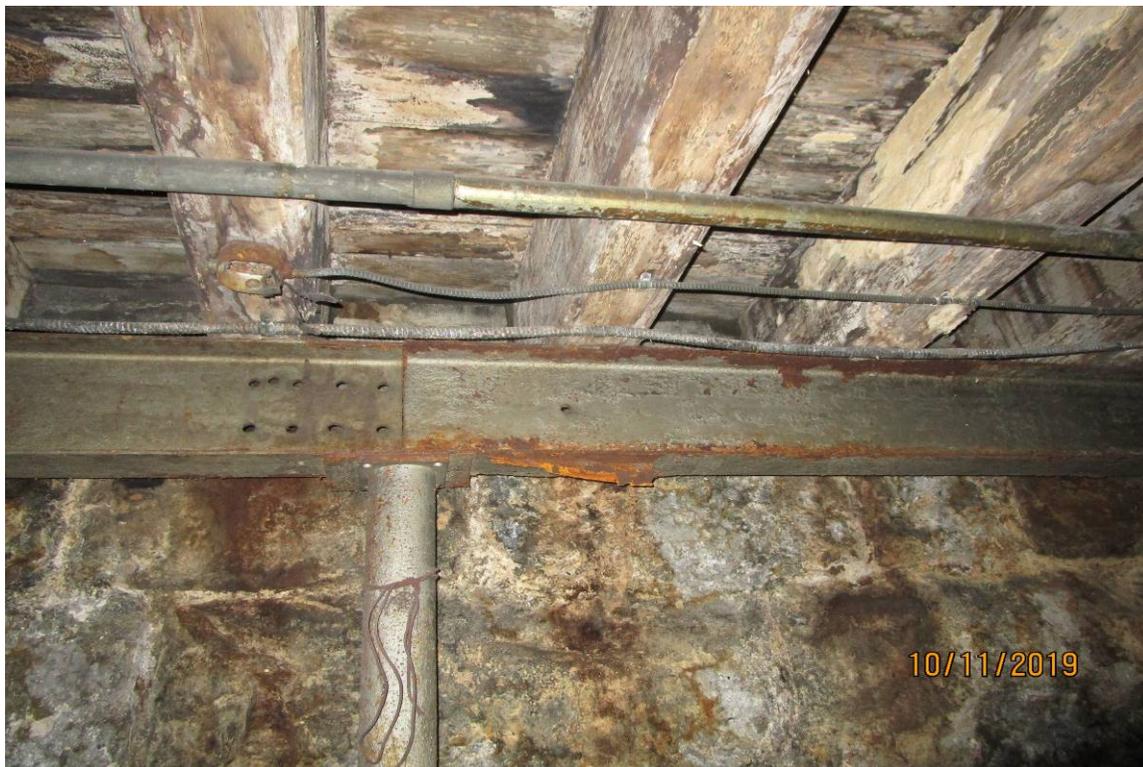
PHOTOGRAPH #15

The steel beam and steel posts, along the right foundation wall, which provide support for the deteriorated end bearings of the water damaged, wood beams under the 1st floor.

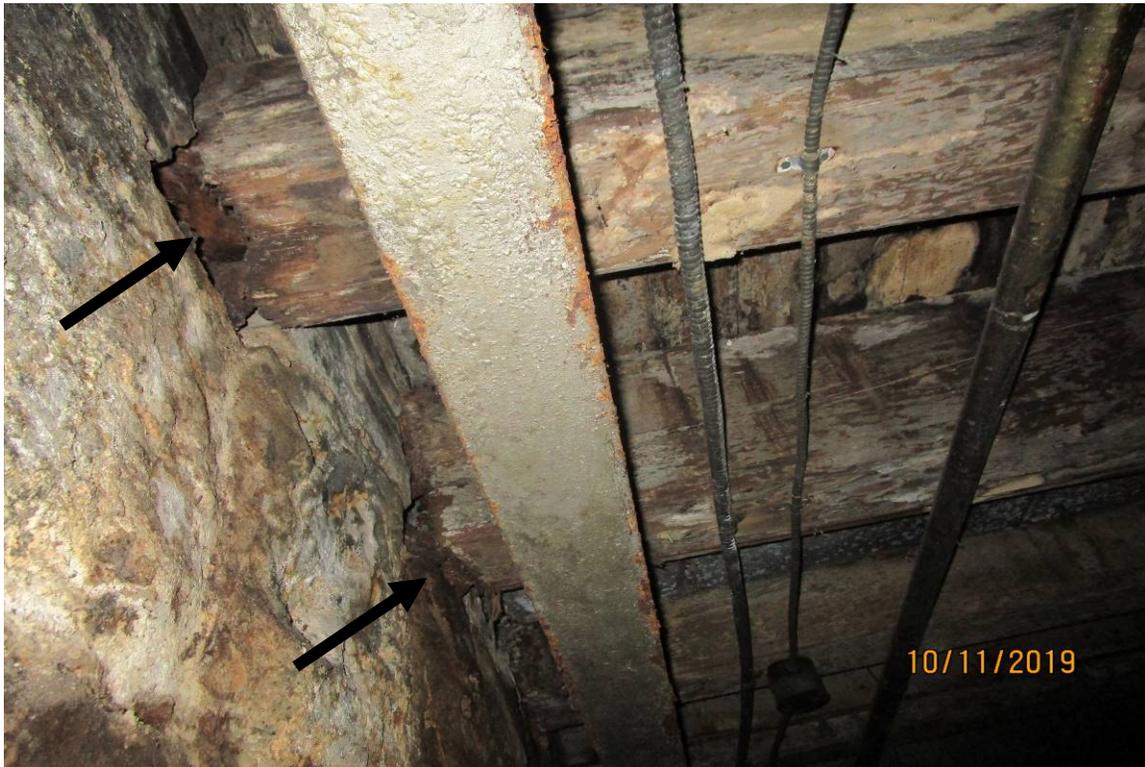
PHOTOGRAPH #16

Typical deteriorated ends of the wood floor beams supported by the steel beam and posts shown in Photographs #14 & #15.

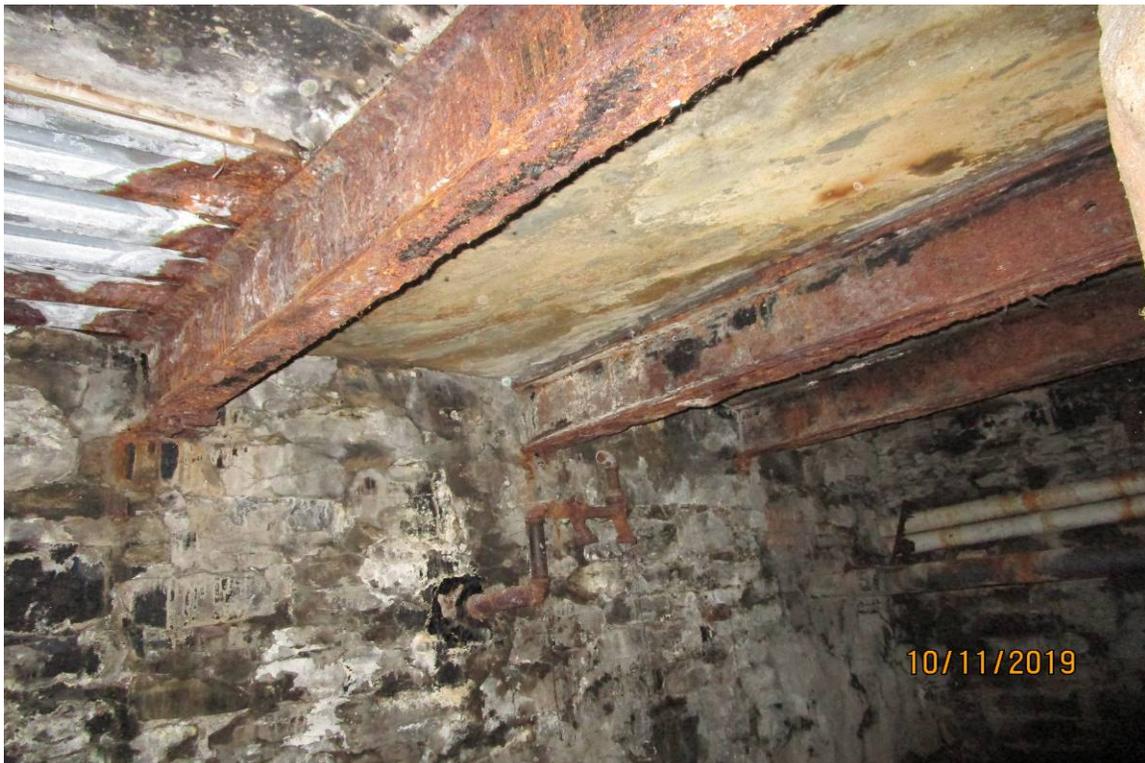
PHOTOGRAPH #17

Severely rusted steel beams under a portion of the 1st floor.

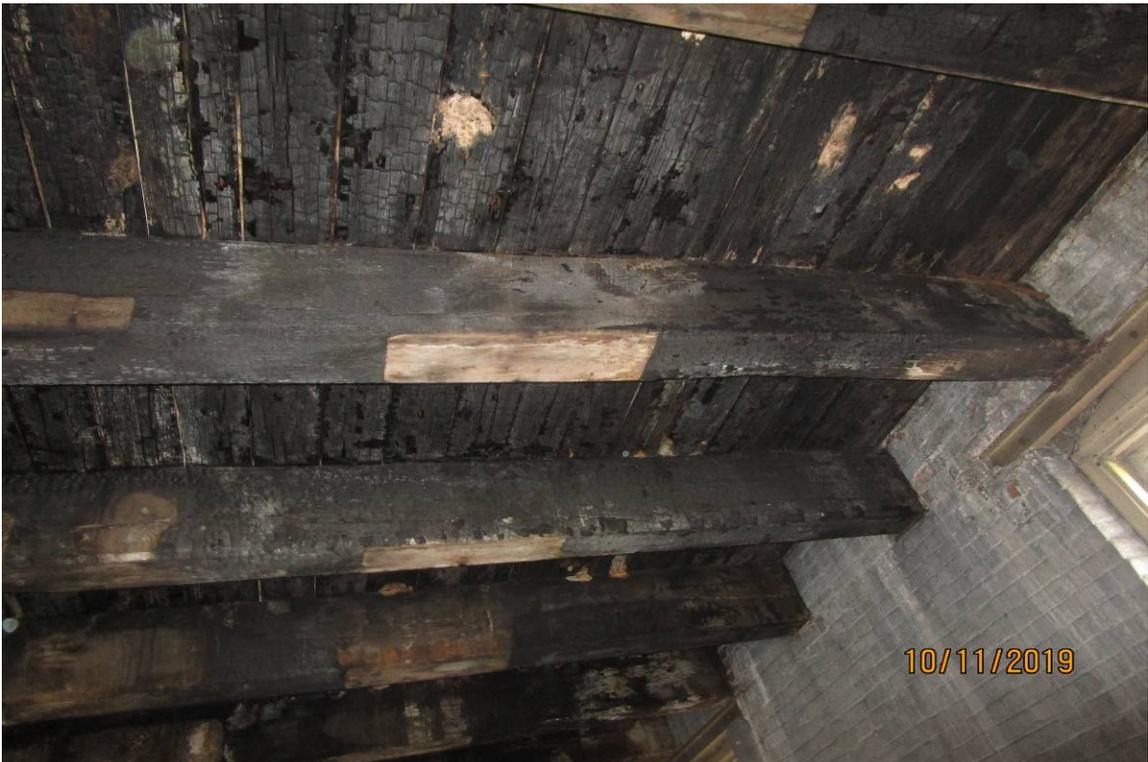
PHOTOGRAPH #19
An area of fire damaged wood floor beams.

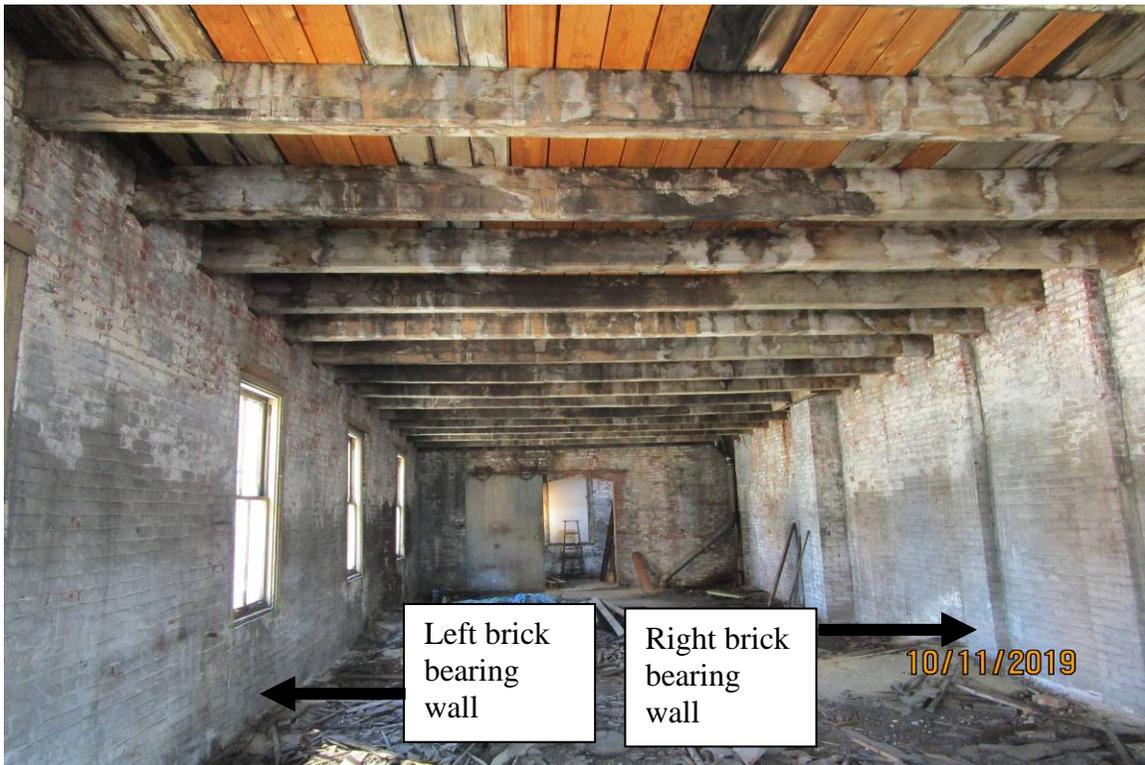
The right multi-wythe brick bearing wall of the six (6) story building is shown in Photographs #6, #21, & #22. The exterior wythe of the brick in this wall is intact and appears to generally be weather-tight. The brick wythe on the inside face of the wall shown in Photographs #21 & #22 is sound and stable. The present condition of the brick and mortar of the wythes on the interior of the right bearing wall could not be determined. No significant areas of brick and/or mortar deterioration were observed in this wall.

PHOTOGRAPH #21
Looking to the rear at typical water damaged roof beams.
