Planning Commission Briefing for demolition and consolidation at Boulevard, First and Market
Submitted June 9, 2020

ASSESSMENT OF BUILDING CONDITIONS

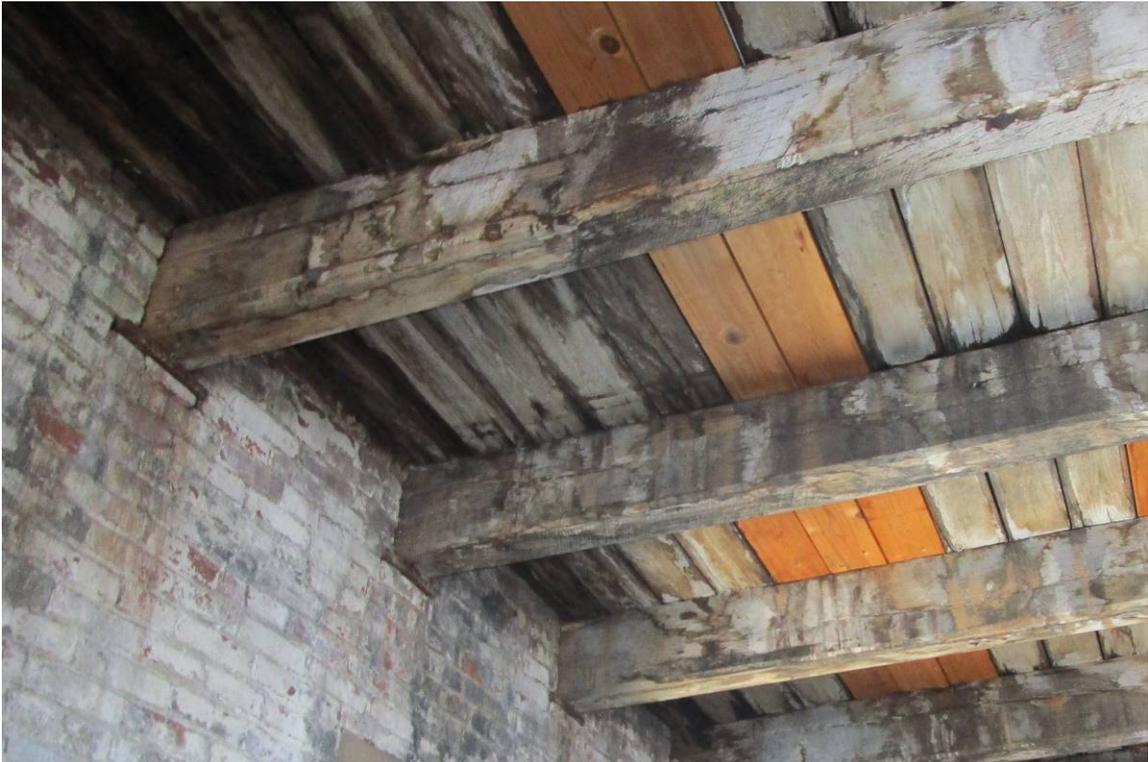
PHOTOGRAPH #25
Cracked and structurally unsound floor beams.
