Southwestern Pennsylvania Commission Shady Avenue from Penn Avenue to Monitor Street Road Safety Audit

Shady Avenue from Penn Avenue to Monitor Street
Allegheny County
City of Pittsburgh

Road Safety Audit Conducted October 2019

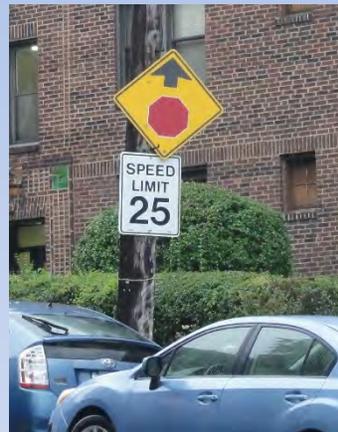
OBSERVATIONS: Some signs in the corridor have been damaged, defaced, or are faded. Some stop signs are undersized. Many use the obsolete Type I retroreflective sheeting. Many signs are blocked by vegetation or other obstructions.

Incorrectly
mounted

- Replace damaged, defaced and faded signs with new retroreflective signs.
- Replace undersized 24" by 24" STOP signs with 30" by 30" signs.
- Trim vegetation near signs.
- Utilize a separate support for each sign, ensure that nothing is blocking line of sight to signs.

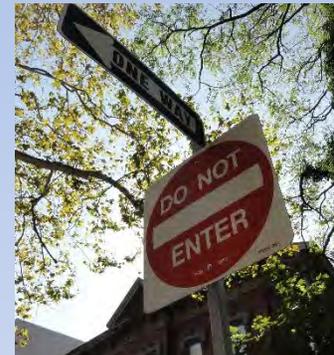
Type I Sheeting

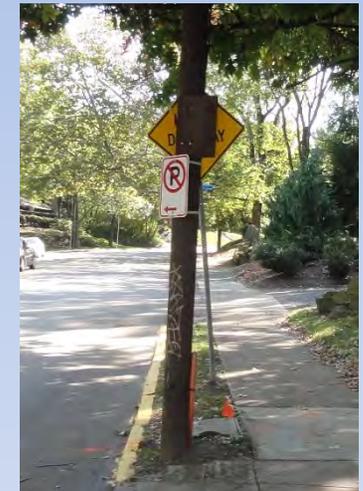
Obstructed Hidden
Driveway Signing

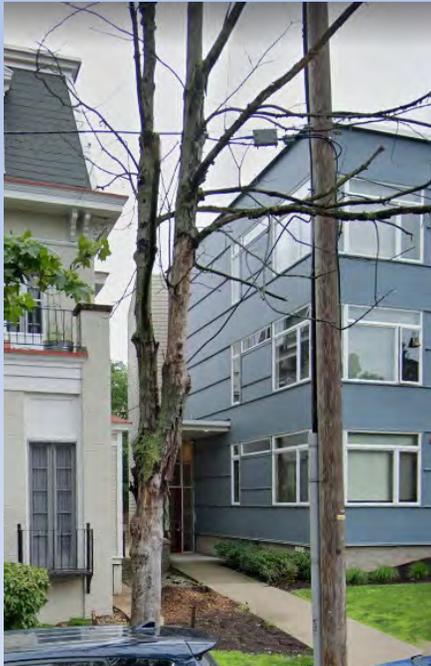
EXPECTED FREQUENCY	EXPECTED SEVERITY	RISK RATING	F
Frequent	Medium	High	
OBSERVATION: There are numerous fixed objects in close proximity to the roadway, including utility poles, trees, old poles, and posts.

Dead tree near Howe

- Review corridor to identify potential hazards and have them removed or vegetation trimmed.
- Remove unnecessary roadside fixed objects.
- Use a 4" yellow flexible, high-intensity grade tape to wrap poles and trees.
- Use tubular delineators for other fixed objects.

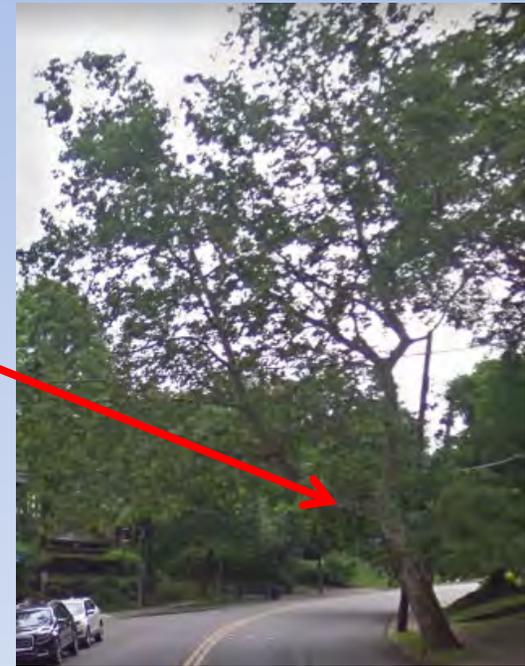
Leaning tree near Mellon Park

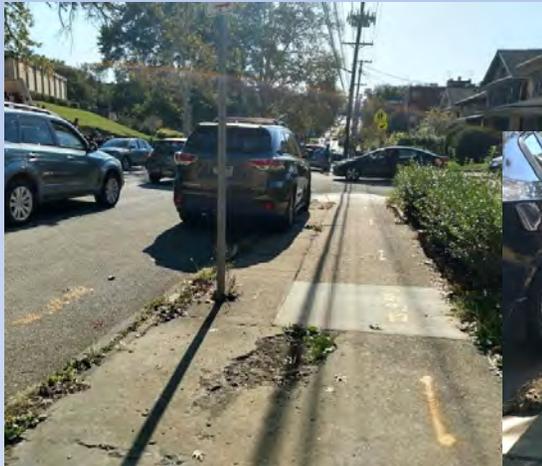
Approaching Pittock Street

EXPECTED FREQUENCY	EXPECTED SEVERITY	RISK RATING	B
Occasional	Low	Moderate-Low	
<p>OBSERVATIONS: The sidewalk network is complete, but many sections of sidewalk along the corridor are in poor condition. Distress includes fractured concrete, surface wear, tree root upheaval, and other uneven surfaces. In addition to the examples shown below, poor sidewalk conditions were also noted at Aurelia Street, Wilkins Avenue and several other locations along the corridor.</p>

- Repair or replace damaged sections of sidewalks and bring sidewalks up to ADA compliance.

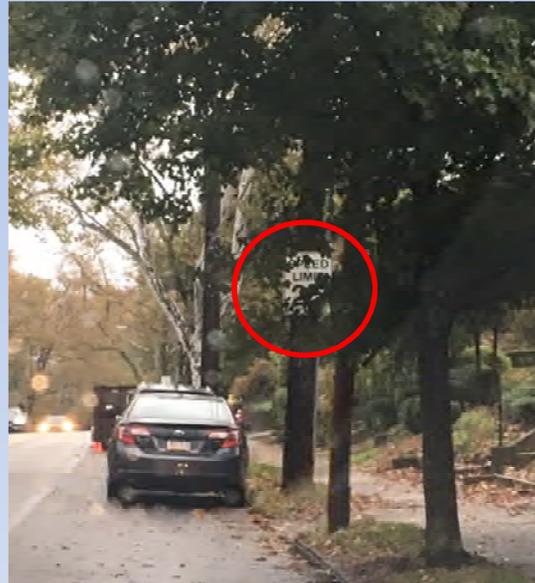
NB at Hastings Street

EXPECTED FREQUENCY	EXPECTED SEVERITY	RISK RATING	D
Occasional	Medium	Moderate-High	
<p>OBSERVATIONS: There are 17 speed limit signs southbound and 11 northbound and all are posted at 25 mph. The majority of the signs are in good condition with sufficient retro reflectivity. However, several signs are obstructed by overgrown vegetation. Speeding was observed and was mentioned in the stakeholder interviews.</p>

- Trim vegetation around regulatory signs.
- Relocate speed limit signs if trimming vegetation is not an option.
- Add speed limit pavement markings.
- Increase speed enforcement throughout the corridor.

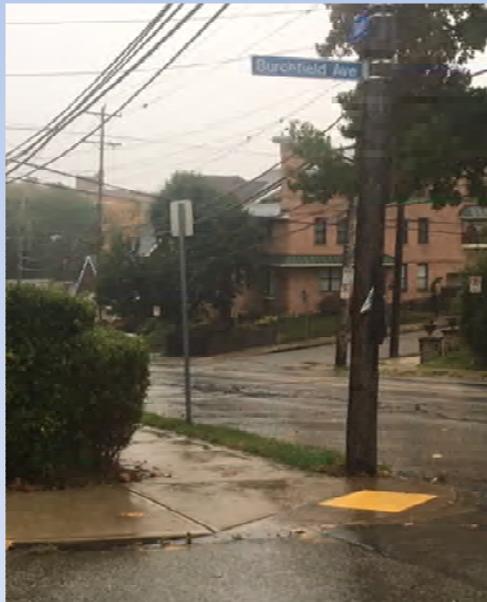
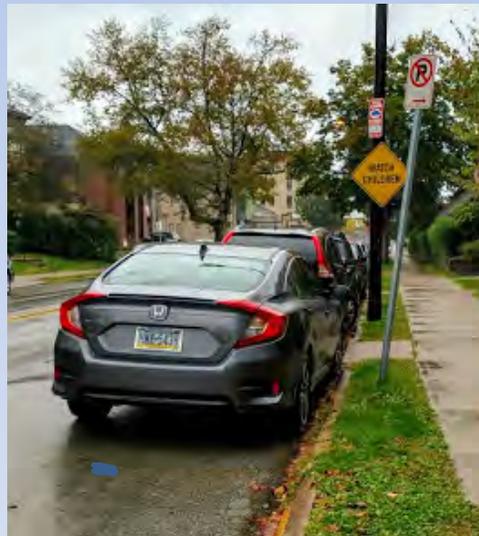
Figure 12: Corridorwide: Intersection Sight Distance

OBSERVATIONS: Parking, trees, landscaping, and signs infringe upon the driver's sight cone at the following unsignalized intersections: Marchand Street, Alder Street, Sellers Street, Howe Street, Kentucky Avenue, Mellon Park Road, Parkton Place, Highmont Road, Braeburn Place, Devereaux Lane, Hastings Street, Marlborough Road, Darlington Road, Bartlett Street, Hobart Road, Douglas Street, Nicholson Street, Pittock Street, Sherbrook Street, Alderson Street, Burchfield Avenue. These parked vehicles also block bus stops.

- SUGGESTIONS:
- Remove or relocate trees, landscaping, and signs out of the drivers sight cone.
 - Restrict parking inside the drivers sight cone and enforce parking restrictions.

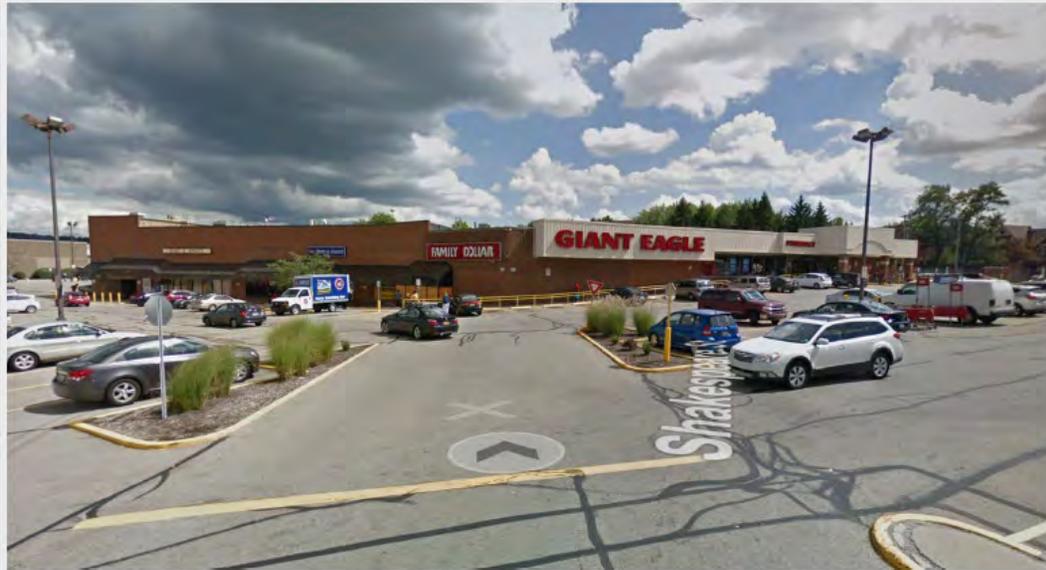
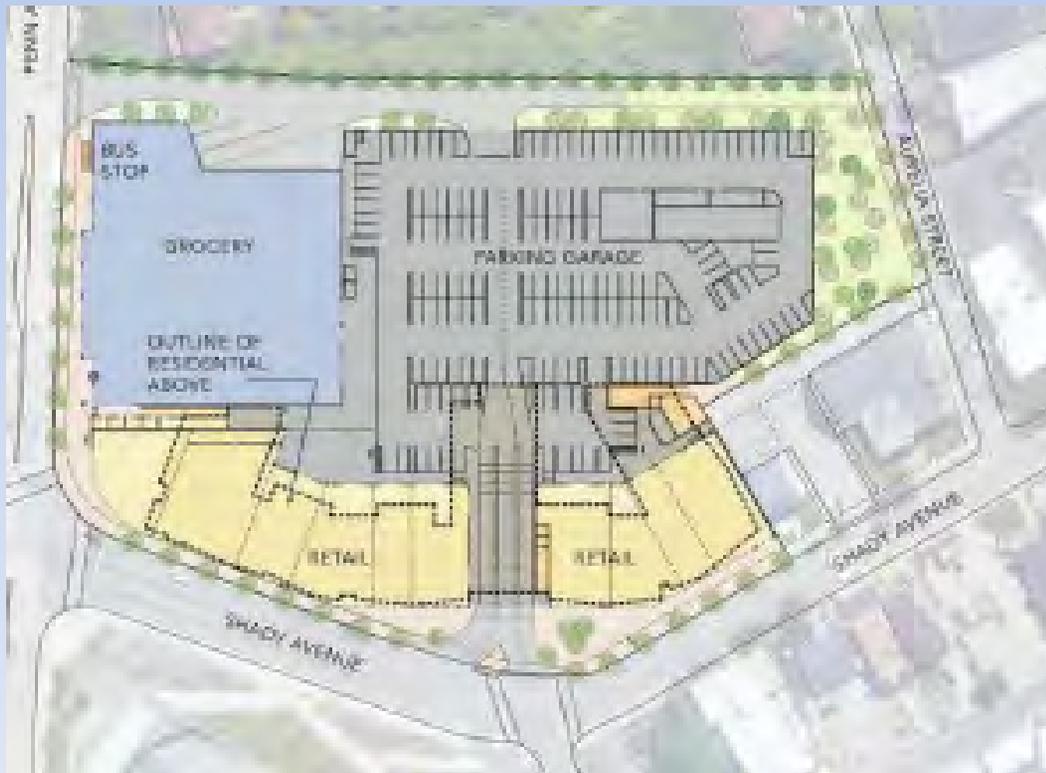
Figure 19: Location Specific: Shady Avenue and Ellsworth Avenue (Continued)

EXPECTED FREQUENCY	EXPECTED SEVERITY	RISK RATING	D
Occasional	Medium	Moderate-High	
OBSERVATIONS: Giant Eagle driveway is wide and not pedestrian friendly. There are no pedestrian signals. Crosswalk markings are outdated. Drivers may have difficulty seeing the northbound signals.

- Redesign development driveway for a more traditional pedestrian crossing.
- Install pedestrian countdown signals and high visibility crosswalks.
- For the northbound approach, install a SIGNAL AHEAD sign, install 12 inch supplemental signal head and backplates on all signals.
- Consider NO TURN ON RED restriction for all approaches.

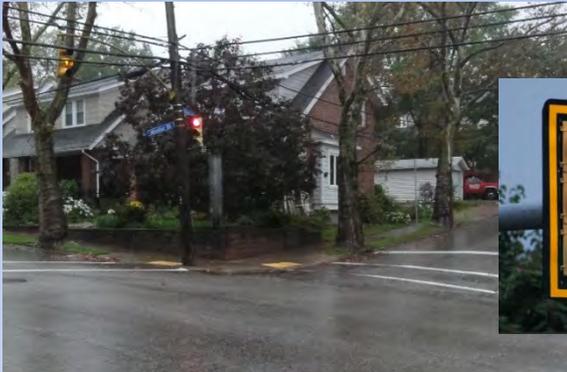
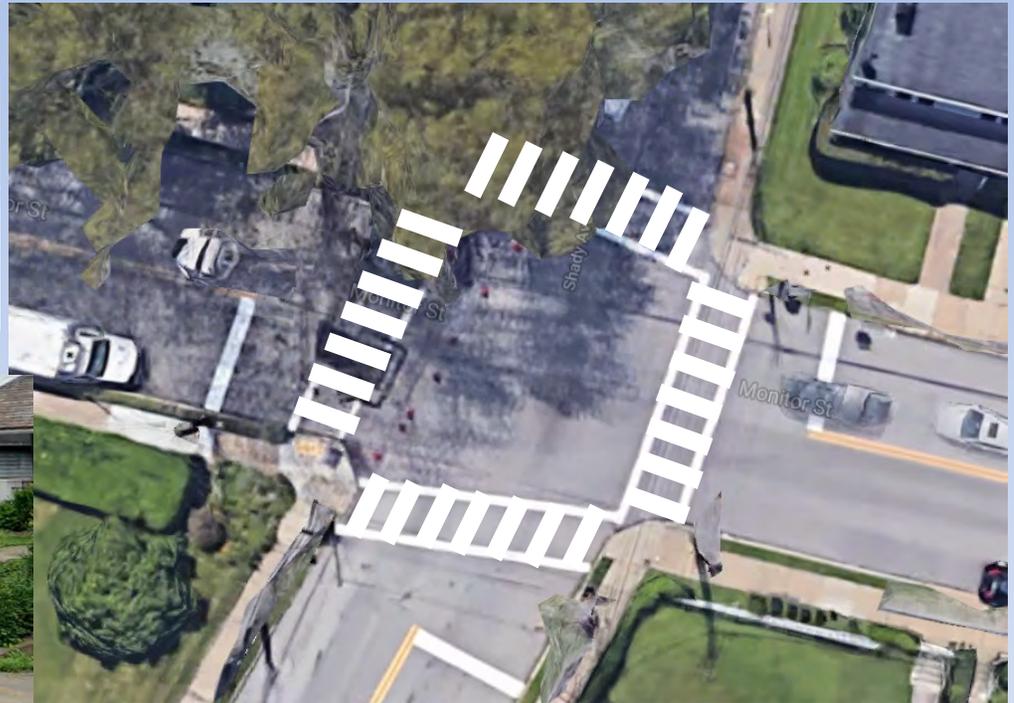
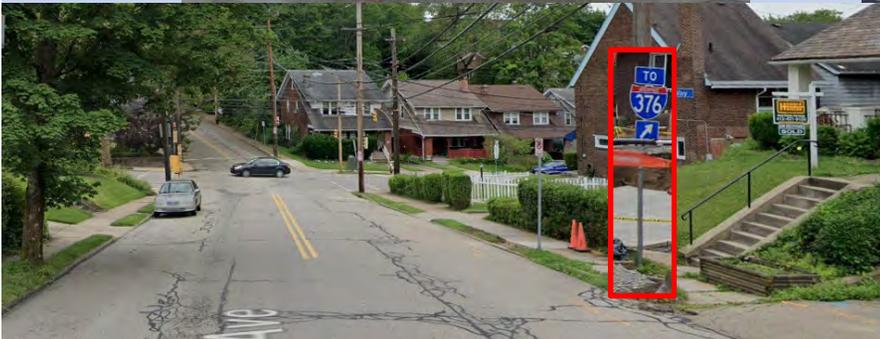
EXPECTED FREQUENCY	EXPECTED SEVERITY	RISK RATING	D
Occasional	Medium	Moderate-High	
OBSERVATIONS: The signal is old and lacks detection. Not all quadrants have ADA compliant ramps, crosswalks are the style with two lines defining the crossing. No guide signing is present for the Parkway East.

- Upgrade signal, add detection and pedestrian accommodations.
- Upgrade crosswalks with piano-key style markings.
- Upgrade curb ramps with detectable warning surfaces.
- Provide route shield signing to the Parkway East.
