CITY OF
PITTSBURGH
FACILITY ANALYSIS REPORT

Bloomfield Pool and Recreation Center (B086)
408 Ella Street
Pittsburgh, Pennsylvania 15224

June 16, 2010

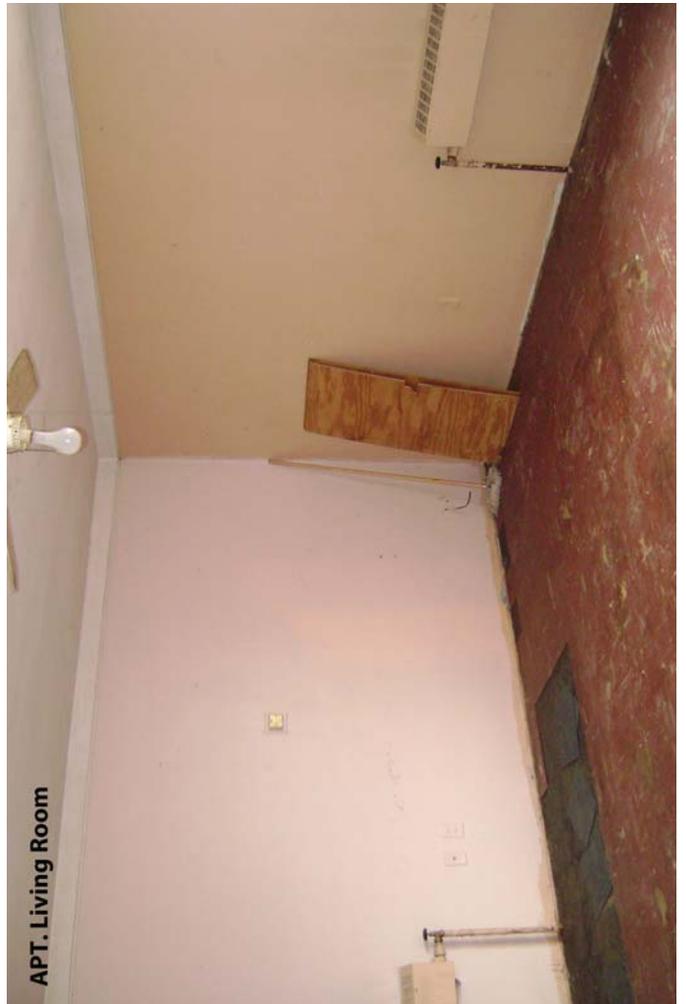
APT. Living Room

Water that has leaked from roof into the apartment ceiling may have created air quality issues and or mold

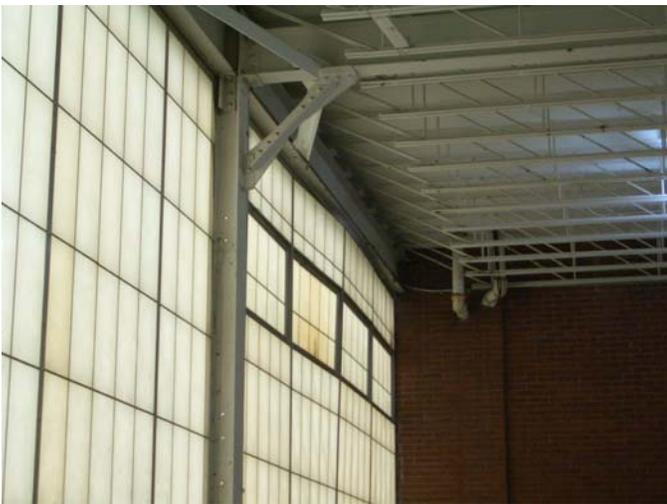
R-2 Underside of roof in the gym of the main roof area. Showing the bar joist.

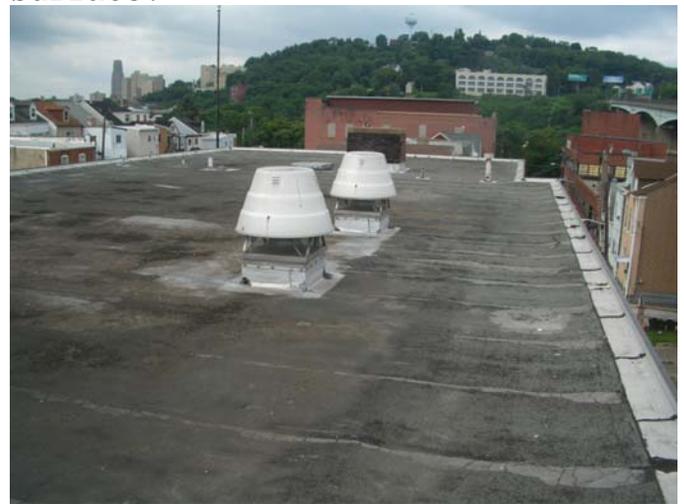
R-5 Main roof looking south along the west wall

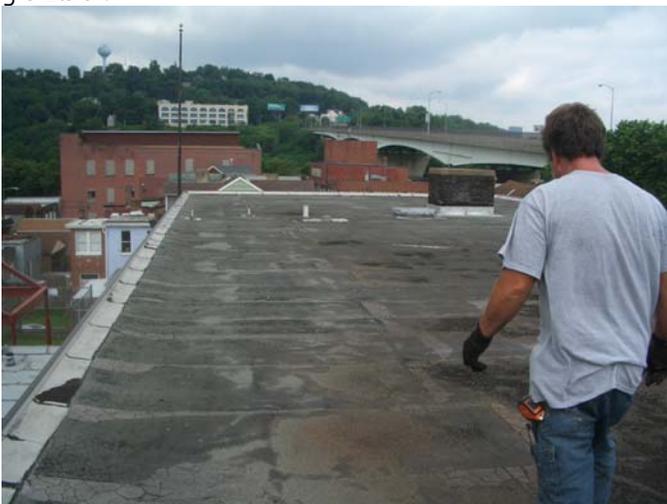
R-3 Main looking south along the east wall

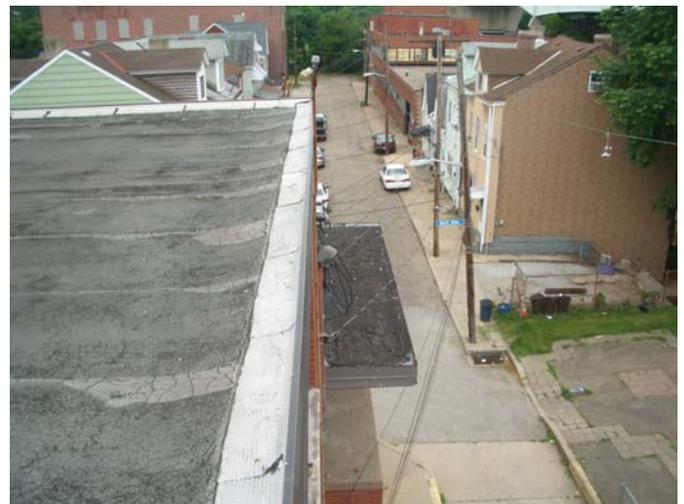
R-6 Main roof and porch roof in the SW corner

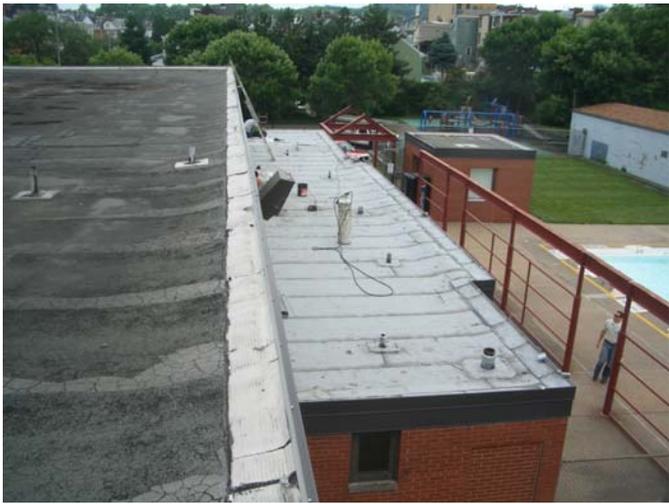
R-10 Restroom roof area looking north, crazed roof surface on the main roof

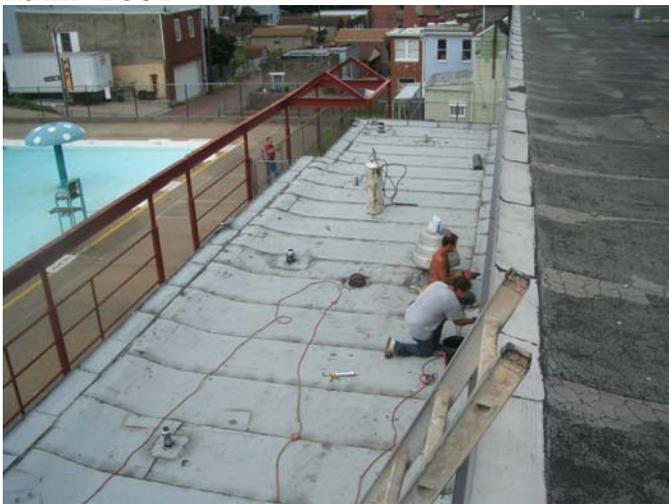
R-11 Restroom roof area looking south, new flashing being installed

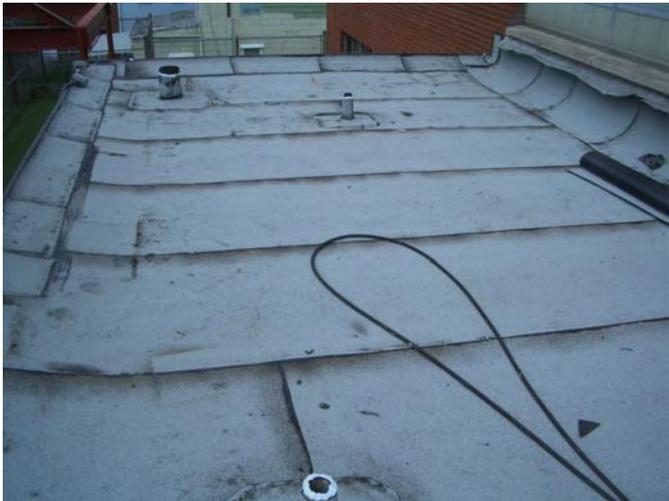
R-12 New roof on south end of restroom area

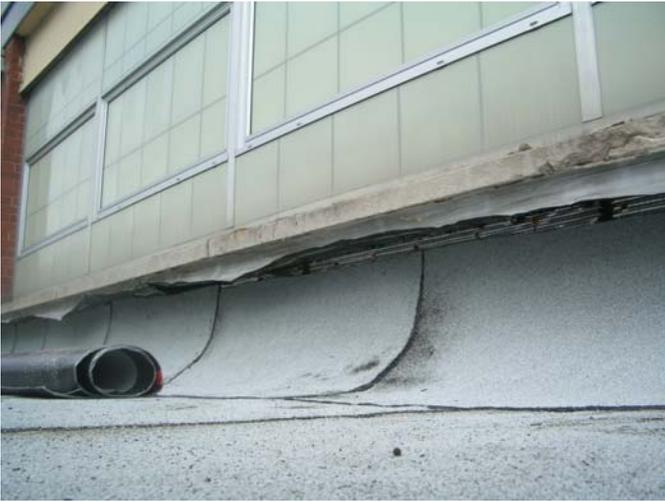
R-13 Flashing, term bar and counter flashing on restroom roof area

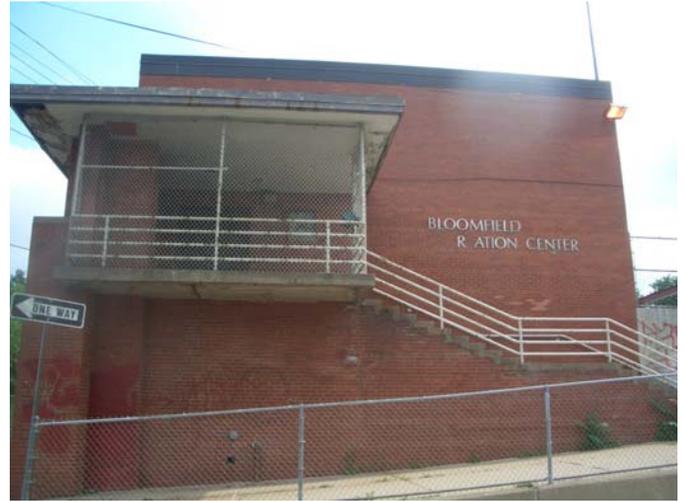
R-16 Porch area on south end of building

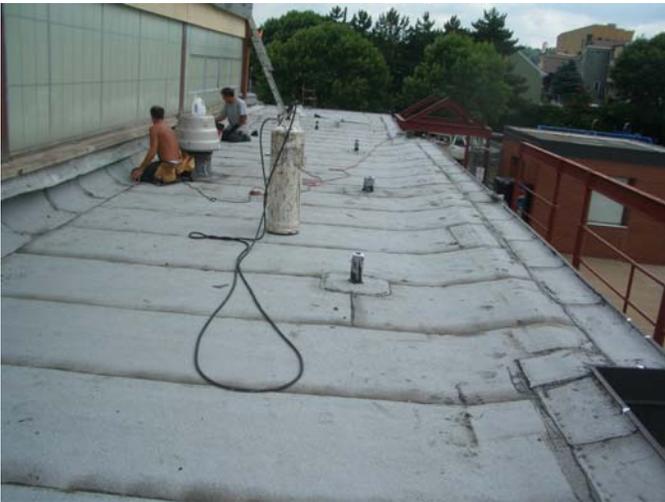
R-14 New roof installation on the restroom area, looking north
