CITY OF
PITTSBURGH
FACILITY ANALYSIS REPORT

Cowley – Goettman Recreation Center (B034)
1200 Goettman Street
Pittsburgh, Pennsylvania 15212

June 11, 2010

Executive Summary

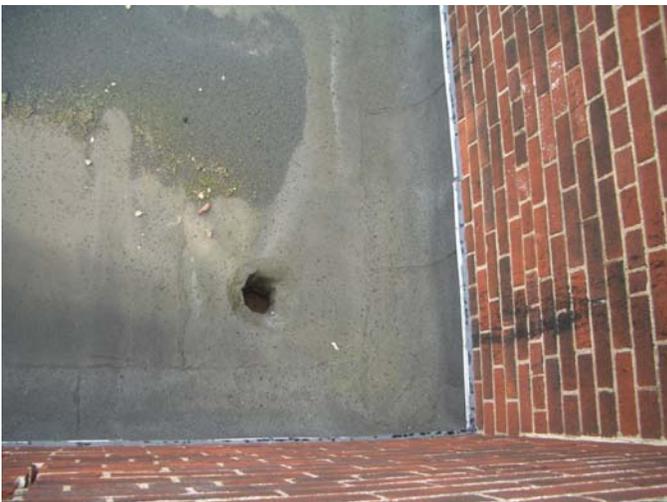
8.2 Condition: The drainage system appears to be operating properly. The drain in the NW Corner is clogged, backing up water and creating a pond on the roof. Some drains were not roofed properly (no clamping ring or strainer installed).

R-2 Roof drain in NE corner, no clamping ring or strainer

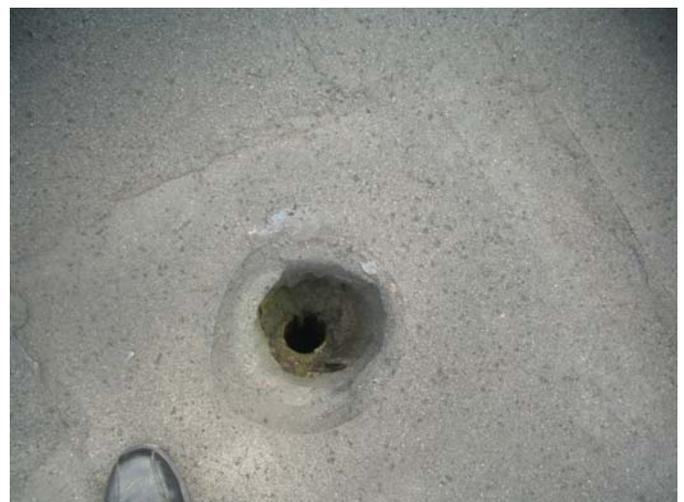
R-6 Roof drain on east side, no clamping ring or strainer

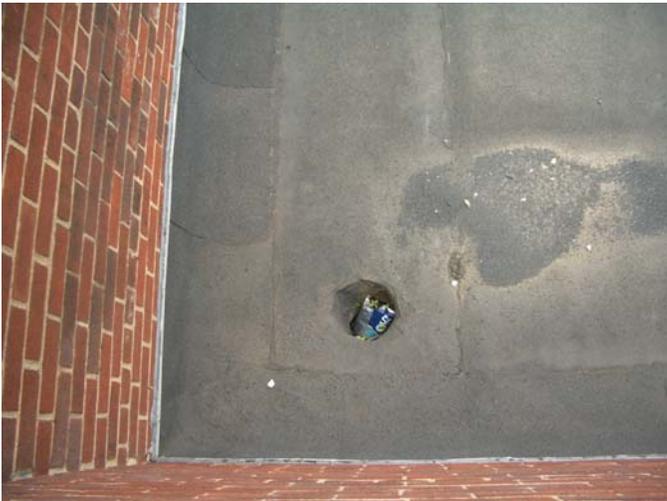
R-9 Drain on SE corner, no clamping ring or strainer, debris

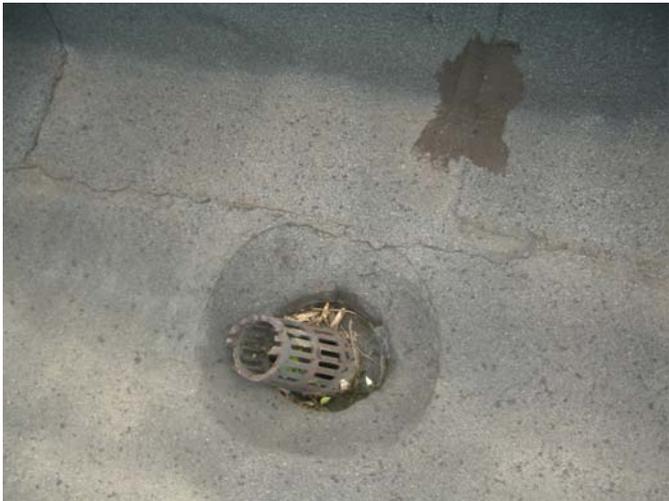
4.2 Condition: The roof membrane appeared in fair condition. No repairs or patches were observed. Debris was observed at some roof drains. Ponding water was observed on the roof area over the apartment on the NW corner.

R-12 Roof drain on main roof, debris

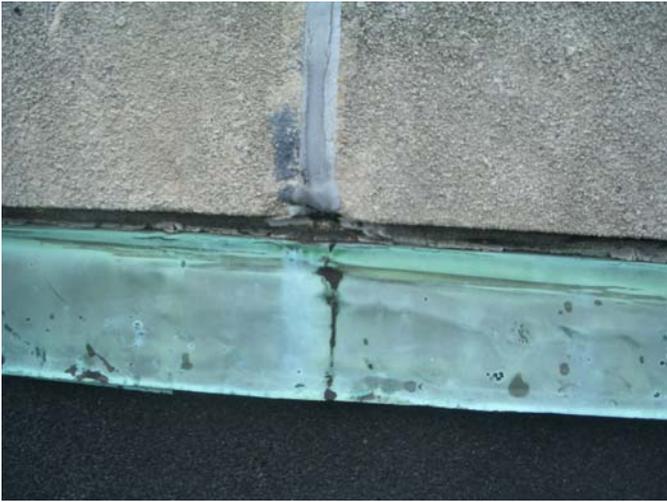
R-13 Existing copper counter flashing on main roof

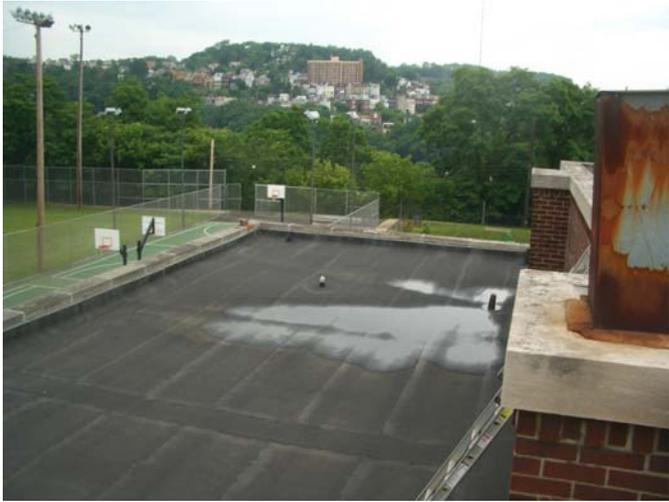
R-18 North end of west roof, pond area

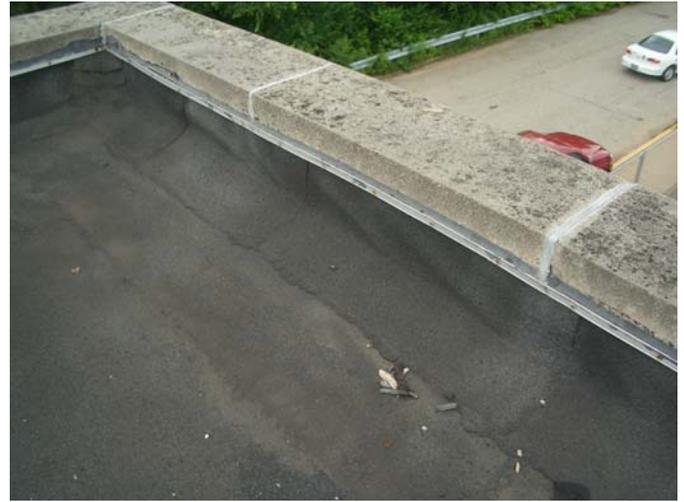
5.2 Condition: The membrane flashing system is in fair condition. The flashing is loose from the wall and buckled (wrinkles) along the west wall. No repairs or patches were observed.

R-22 Buckled flashing on west wall

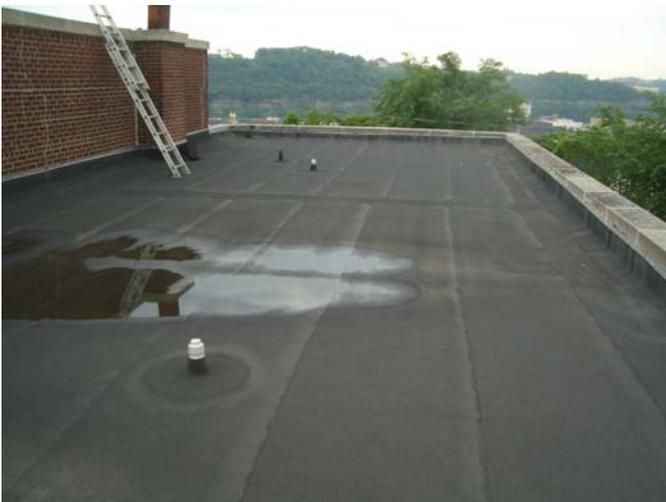
R-20 West roof looking south, pond area

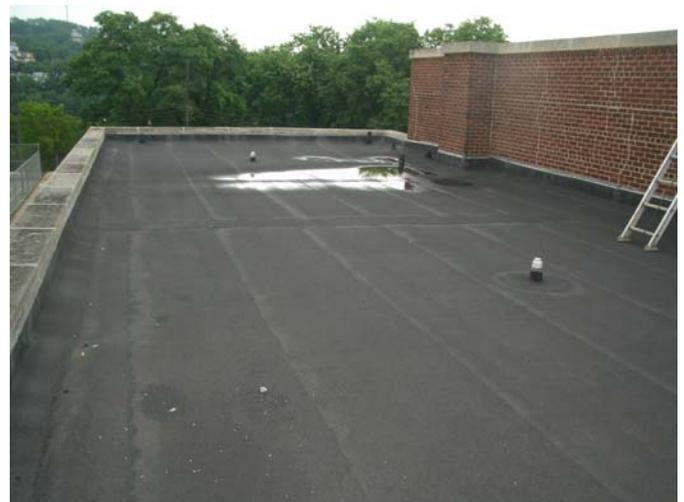
R-23 West roof looking north, pond area

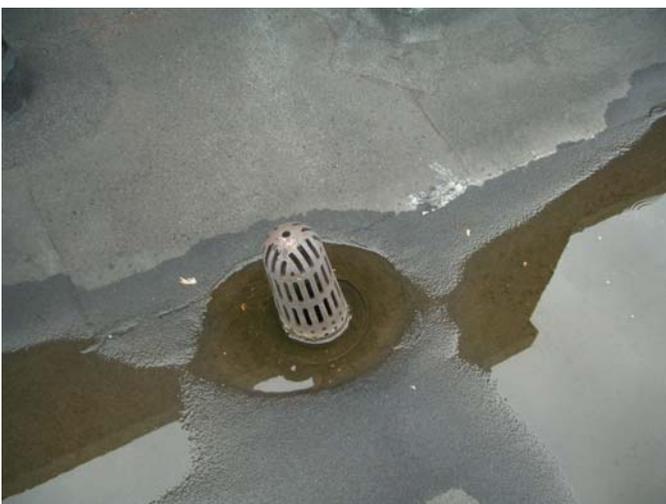
R-21 West roof, clogged drain with ponding water

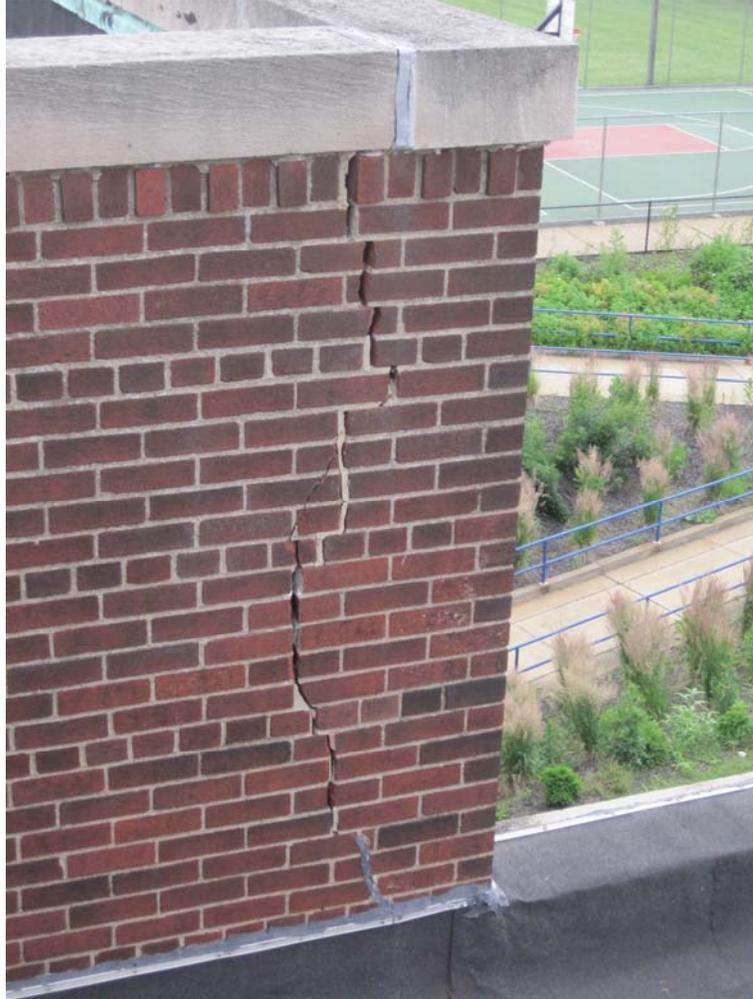
Photo S1

- 1) Rout and seal vertical masonry cracks with an elastomeric expansion filler. Cracks observed are the result of thermal expansion and contraction of the wall. (1yr) **(Photo S1)**
- 2) Clean and paint exposed portions of exterior steel lintels at windows and doors. Patch and re-caulk masonry where associated deterioration has occurred. (1yr) **(Photo S2)**
- 3) Replace deteriorated base stone at perimeter. - 10 SF (1yr) **(Photo S3)**
- 4) Remove and replace masonry and steel lintel at northeast window head and parapet. Corrosion to window lintel likely cause for masonry pushing away from building. (1yr) **(Photo S4)**
- 5) Repoint stone capstones at top of parapet. (1yr) **(Photo S5)**
