CITY OF
PITTSBURGH
PROPERTY CONDITION REPORT

B017 – DPW 5th Division
1330 Hassler Street
Pittsburgh, Pennsylvania 15212

June 2014

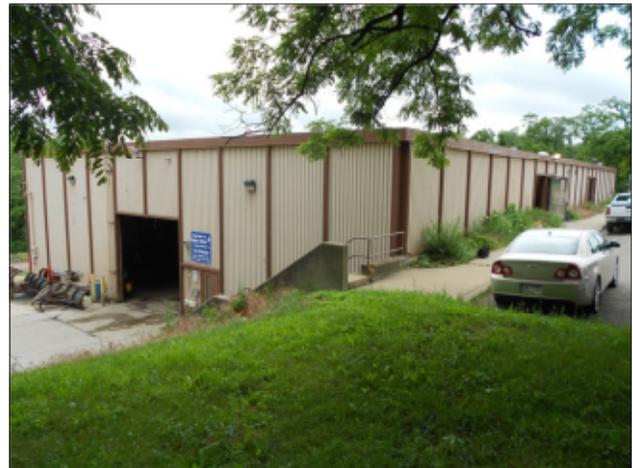
ST4 - Upper site - looking east

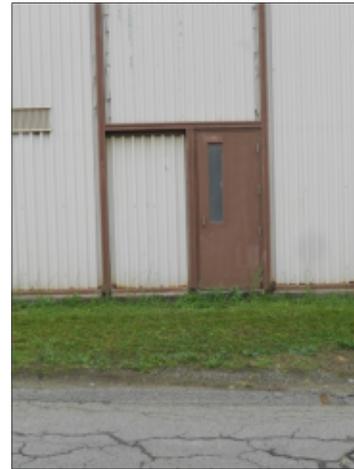
ST8 - Egress door – no landing

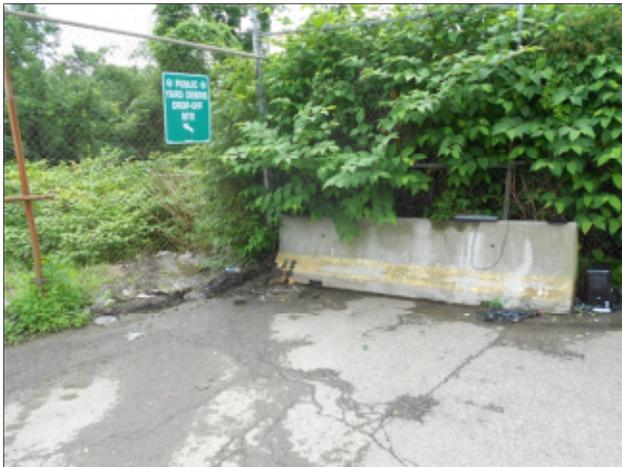
ST9 - Uncontrolled storm water flow along south side of Hassler St.

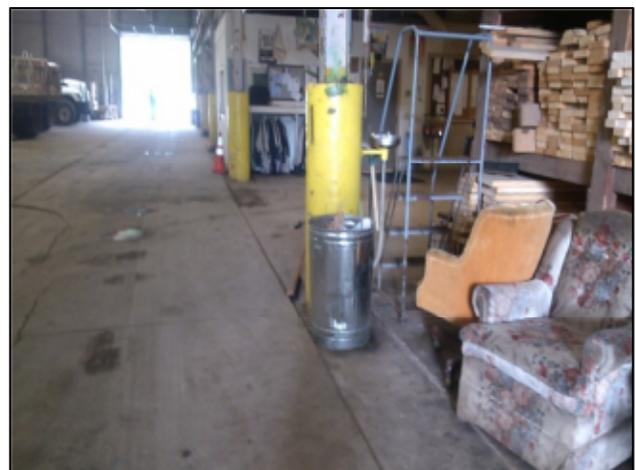
SS10 – Typical column base protection – concrete guard

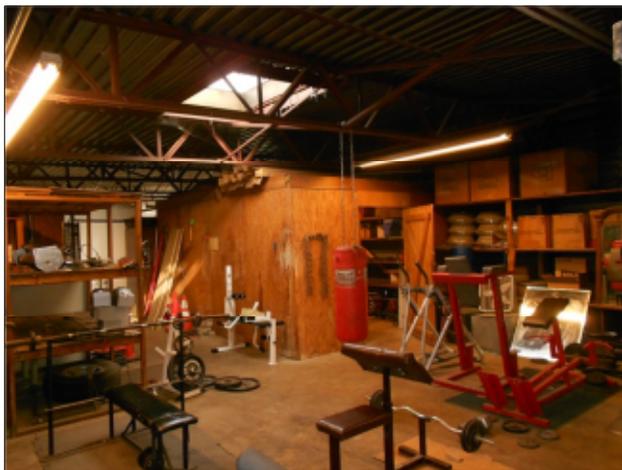
13 – Temporary storage room inside structure

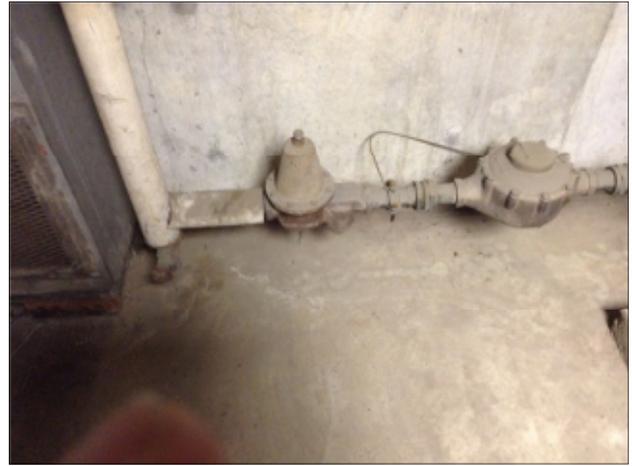
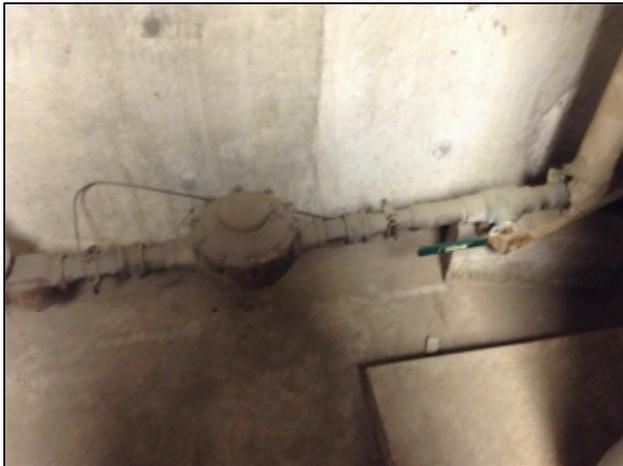
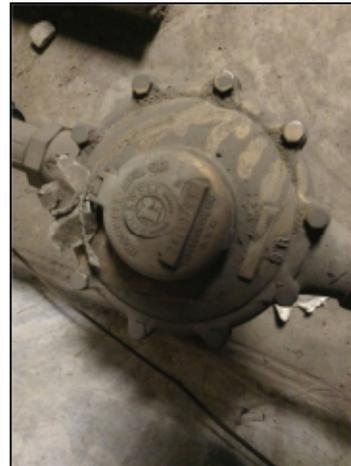
P7 – Water meter and piping

P8 – Water meter and piping

P9 – Water meter and piping

5.1.1 Install back-flow preventer: \$1,200.

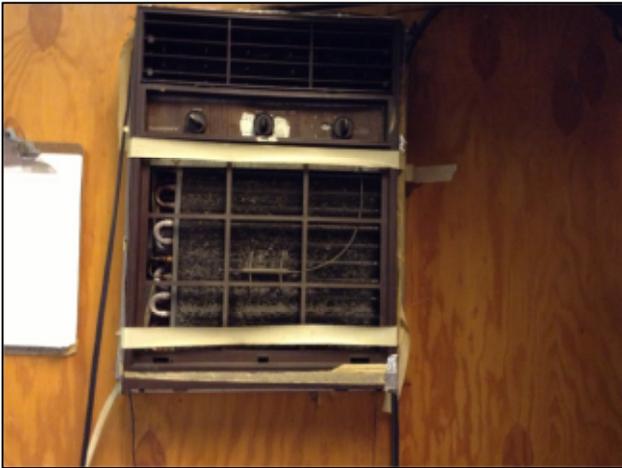
- i. The wall mounted WACUs for the mezzanine base station office is beyond its expected useful life.
Condition: Poor.
- ii. The condition of the WACUs for the mezzanine level main office and storage rooms is Fair.
- iii. The wall mounted WACU for the shop level lunch room is beyond its expected useful life.
Condition: Derelict.
- iv. The condition of the WACUs for the break and vending areas is Fair.

C 1 - Base station office WACU

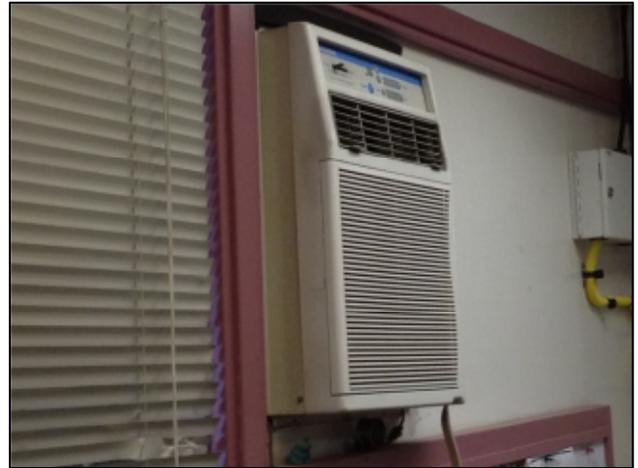
C 2 - Main mezzanine office WACU

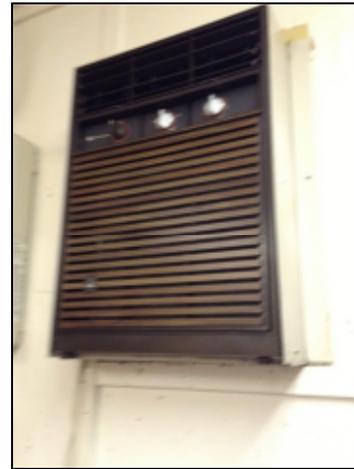
C 4 - Mezzanine storage room WACU

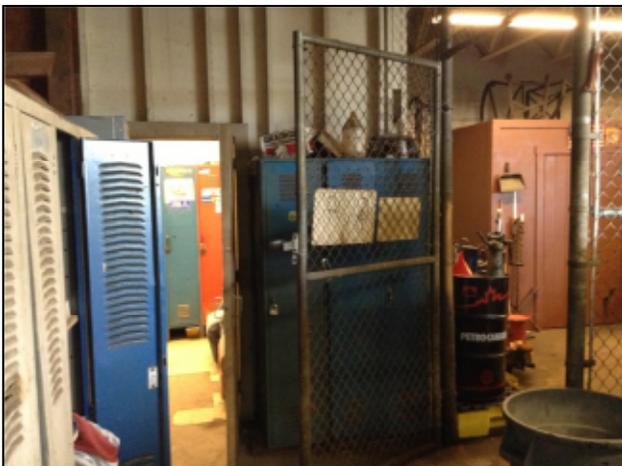
SR – 9 NFPA Classification: Wall clearance vending area

Recommendation: Perform NFPA classification assessment study.

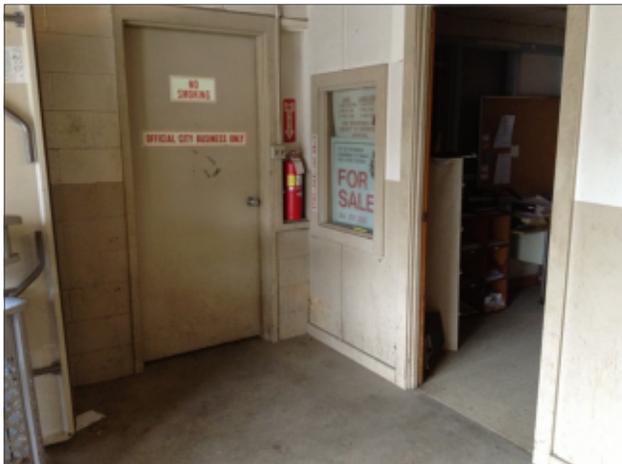
FP3 – General storage room, mezzanine

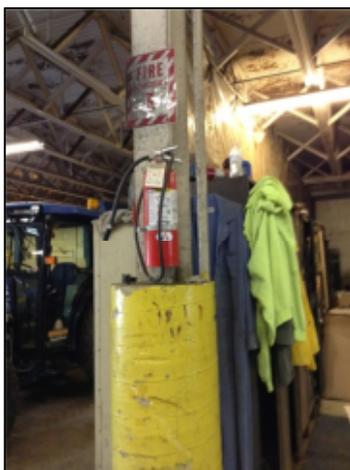
FP5 – Main Shop

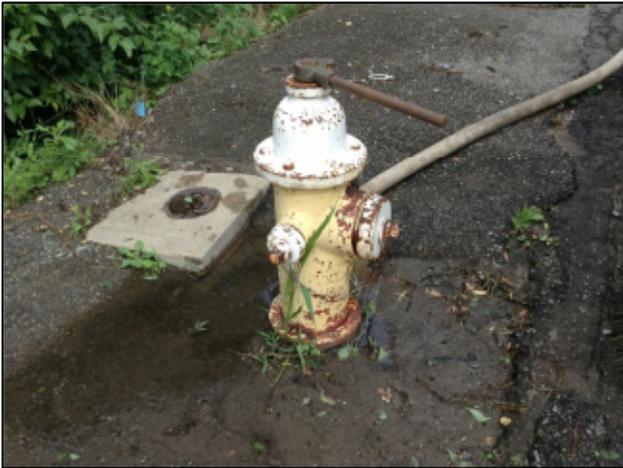
- ii) Condition Assessment: Poor
- 7) Emergency Eye Wash
 - i) Construction: One (1) wash station mounted at exterior of mezzanine level main office.
 - ii) Condition Assessment: Fair

FP7 – Hydrant

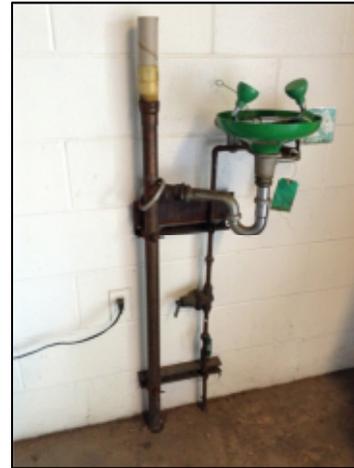
LS1 – Eye Wash

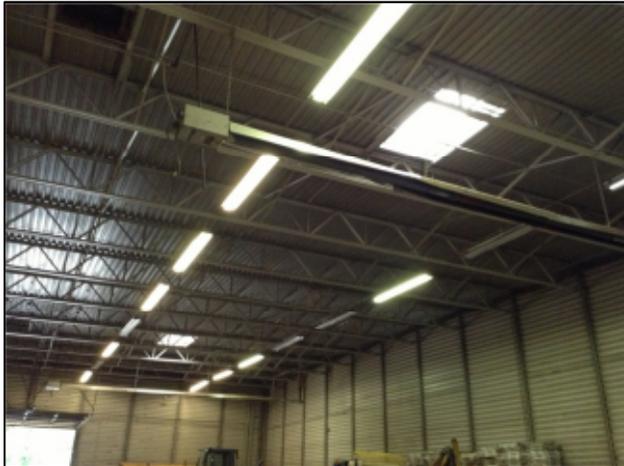
- d. Condition Assessment
 - i. Condition: Fair. Nine (9) fixture lamps unlit in main repair shop floor.
- 2. Exterior Lighting
 - a. Construction
 - i. Four (4) perimeter roof line mounted high pressure sodium HPS fixtures, reported to be 150w lamps.

E 9 – Main Shop

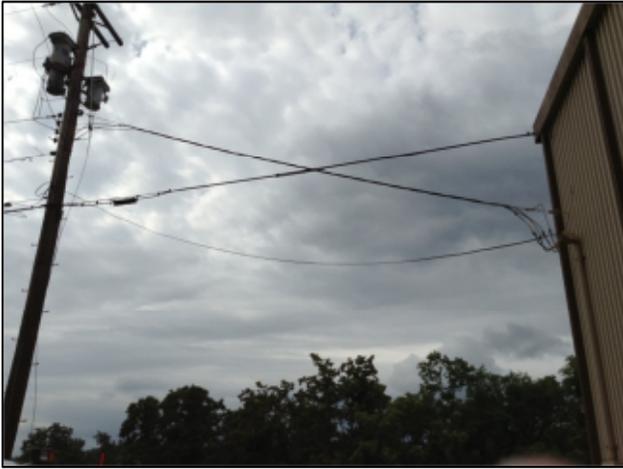
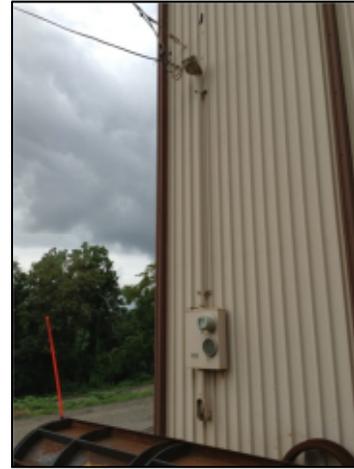
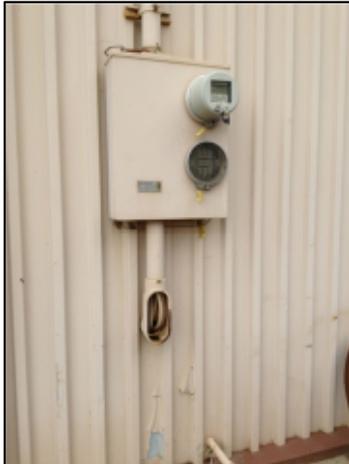
- 4. Utilities Service
 - a. Construction
 - i. One (1) 200 amp, 3-phase, 120-208 volt service. 240VAC present for gasoline filling system.
 - ii. Power service entry conduit missing weather cover. This is a significant safety issue.

E13 – Power Service

- a. Immediate Cost - Install weather cover plate at power service entry conduit.
 - b. Shot-Term Cost - Replace exterior photo cells: \$1,500

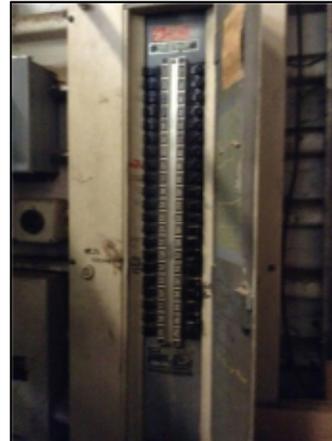
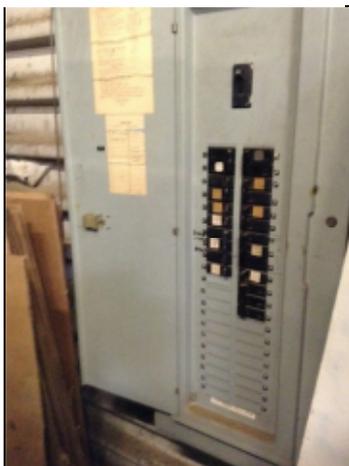
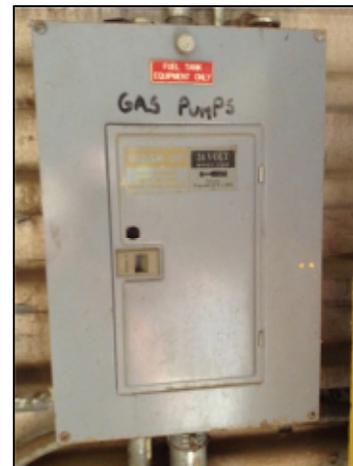
- 3. Power Distribution Panels
 - a. Construction: Original to building. They are beyond their expected useful life. Condition: Poor.
 - b. Condition: Poor.

E16 – Power distribution/breaker panel
