CITY OF
PITTSBURGH
PROPERTY CONDITION REPORT

B110 – Firehouse 14
259 McKee Place
Pittsburgh, Pennsylvania 15213

June 2014

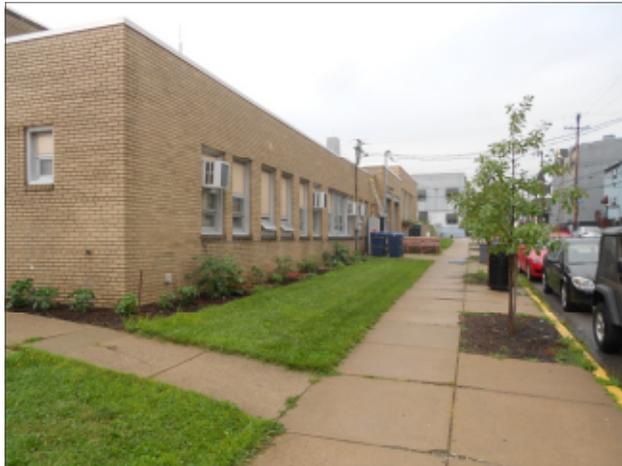
ST3 – Looking NE along Louisa St.

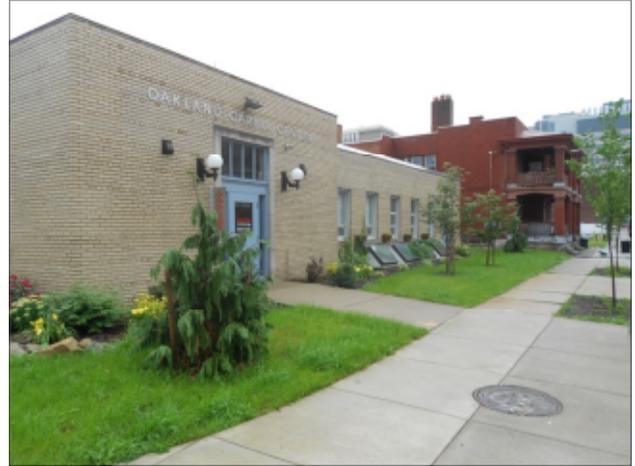
ST4 – Former Police Station, now Oakland Career Center, looking NW along Semple St.

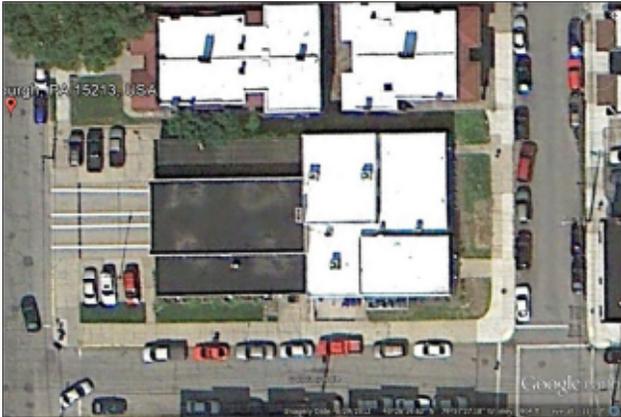
SH7 – View from above – Firehouse 14 at left, Career Center (white roof) at right

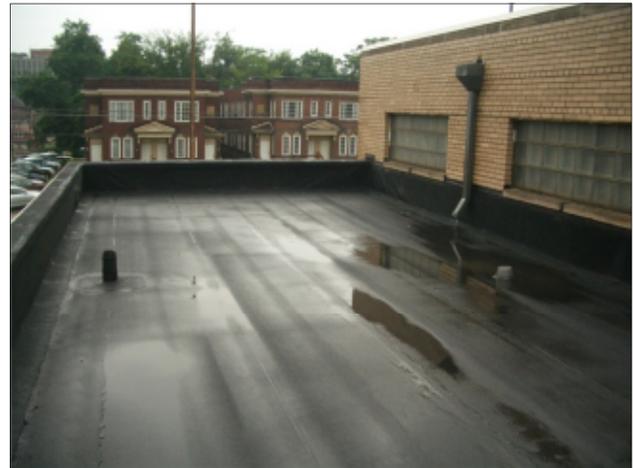
SH8 – SE lower roof looking SW

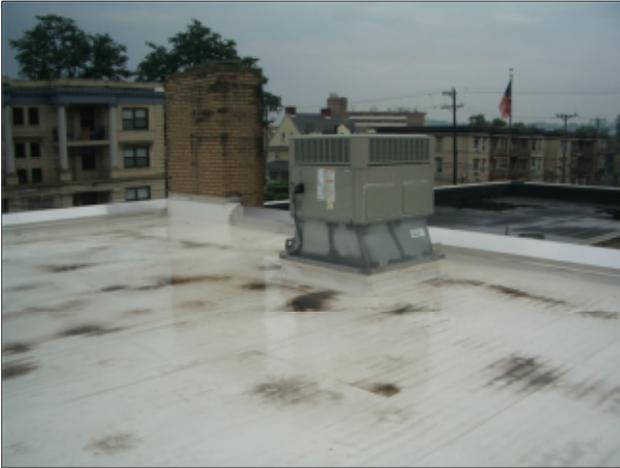
SH13 – Upper roof looking S

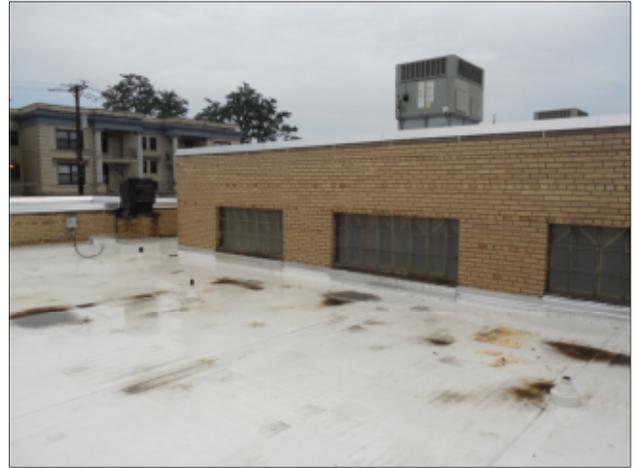
SH14 – Lower roof looking S

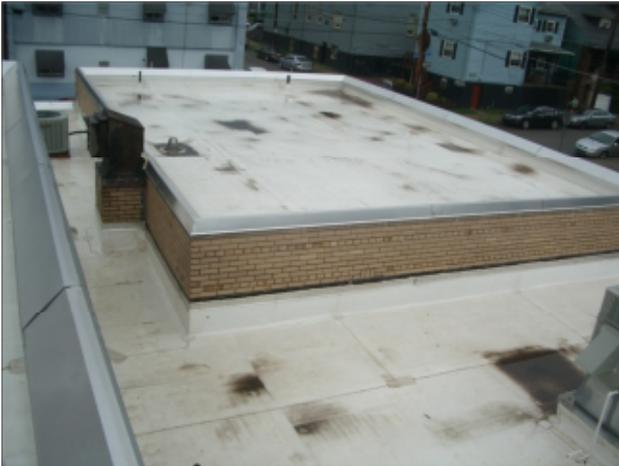
SH15 – View from upper roof looking NE

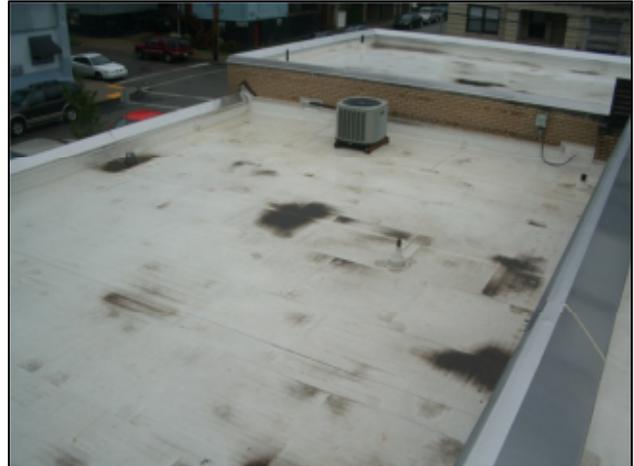
SH16 – View from upper roof looking NE

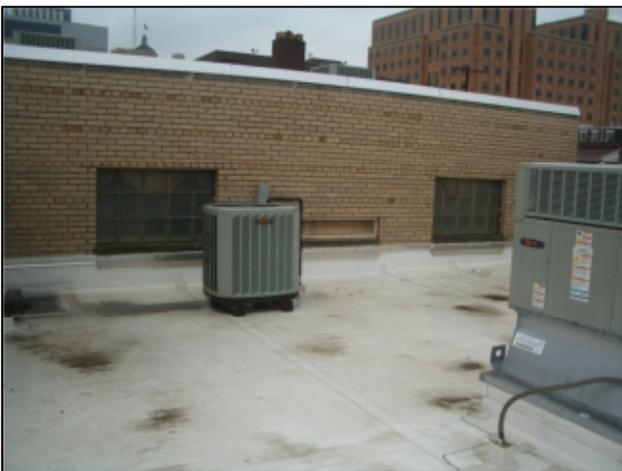
SH17 – Lower roof looking SW

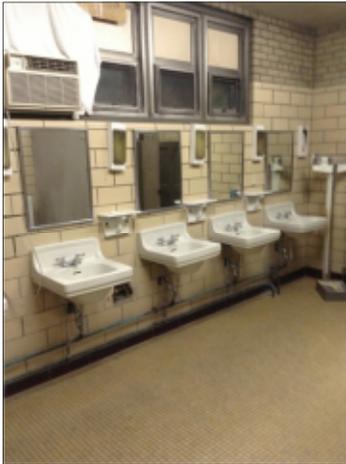
P1 – Lavatory sinks - Typical

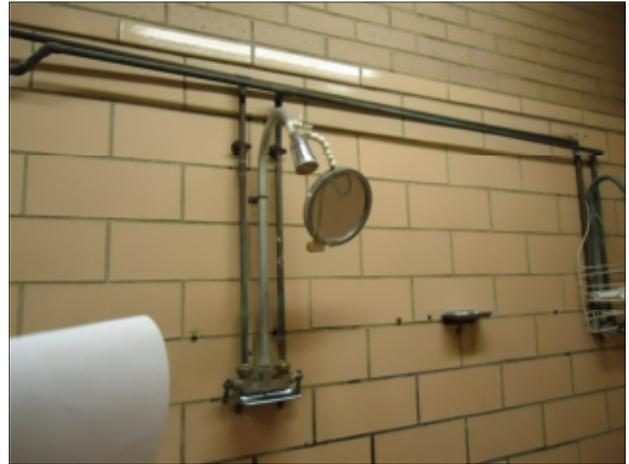
P2 – Locker area showers - Typical

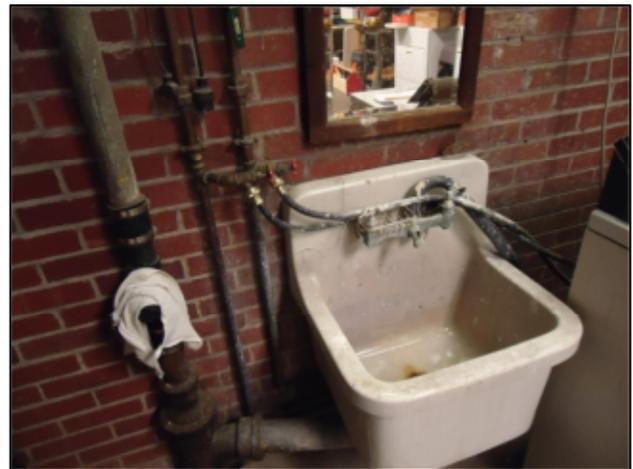
P4 – Service sink

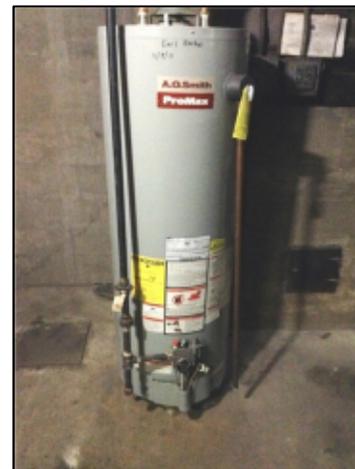
P6 – Domestic water heater

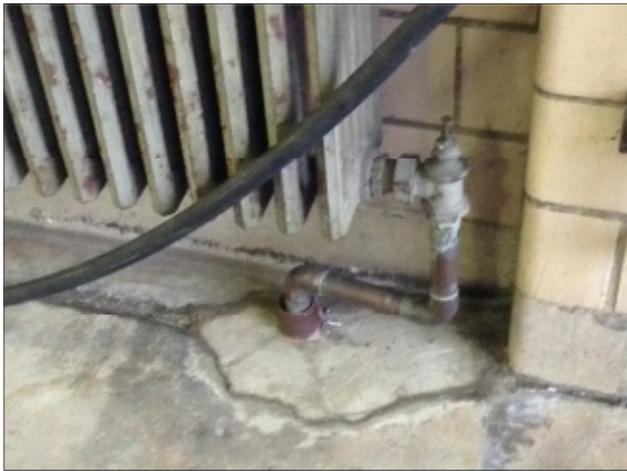
H 1 – HW Radiator – Apparatus Room - Typical

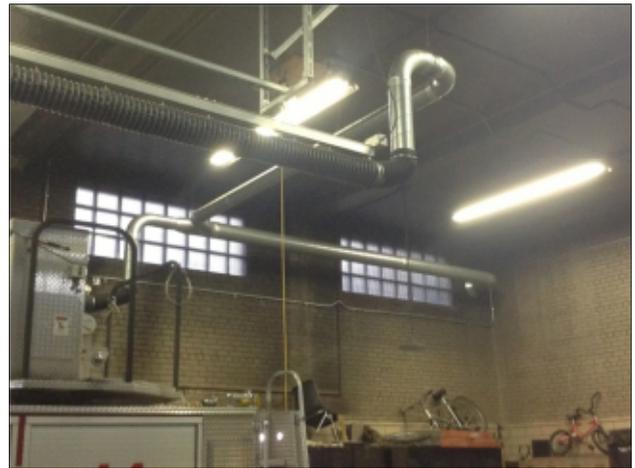
H 2 – Direct Connect Vehicle Exhaust System (DCVEX)

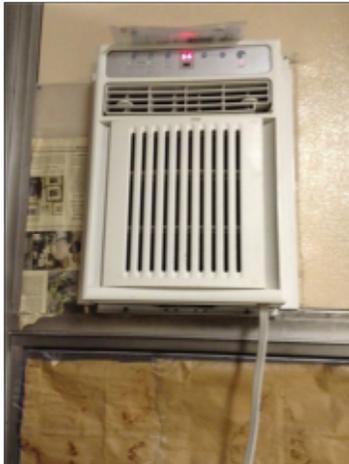
H 3 – Dormitory WACU - Typical

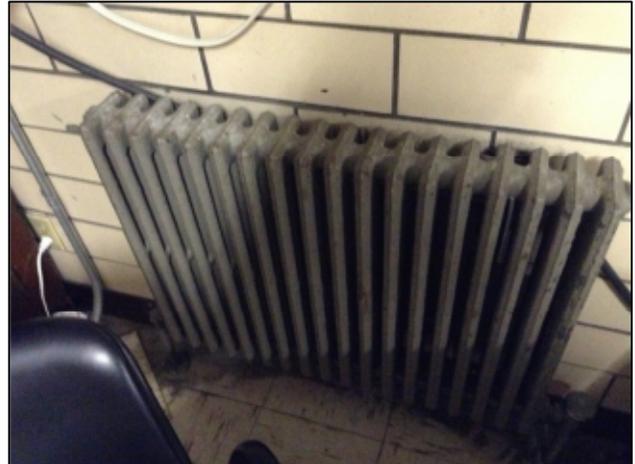
H 4 – HW Radiator Dormitory - Typical

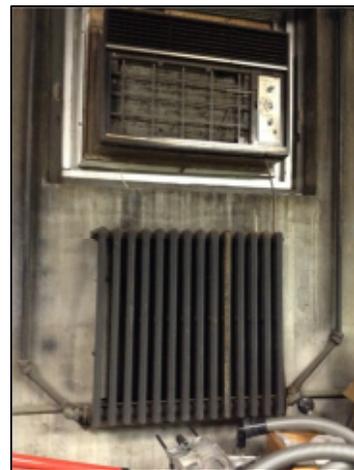
H 6 – Lower level WACU and HW Radiator

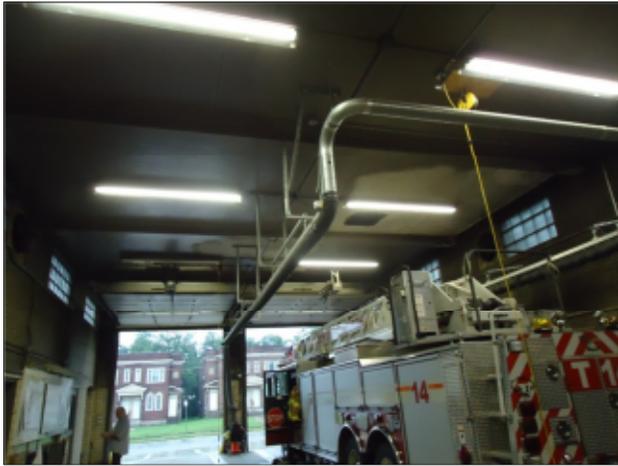
E 1 – Lighting – Apparatus Room

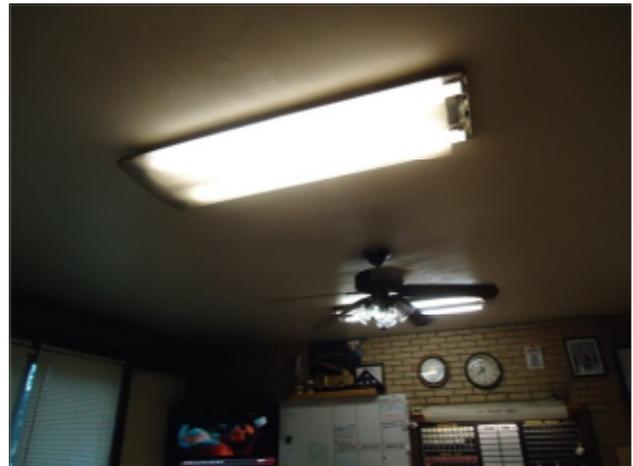
E 2 – Lighting - Lounge

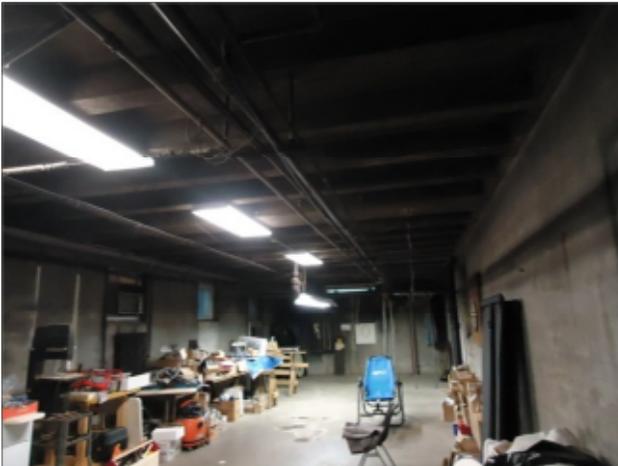
E 3 – Lighting Lower level work room

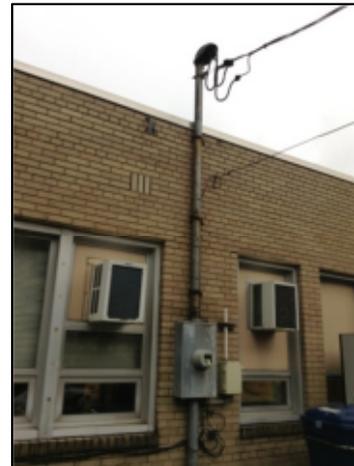
E 4 – Power service entrance

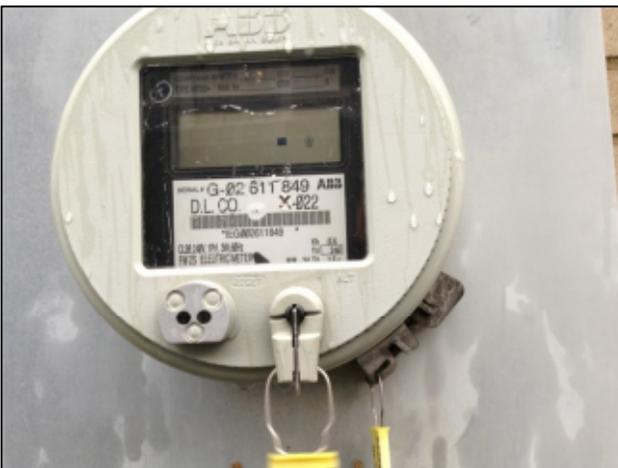
E 5 – Meter

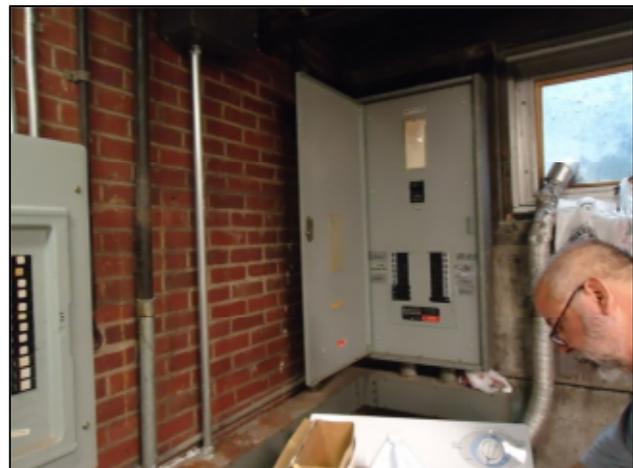
E 6 – Main power panel

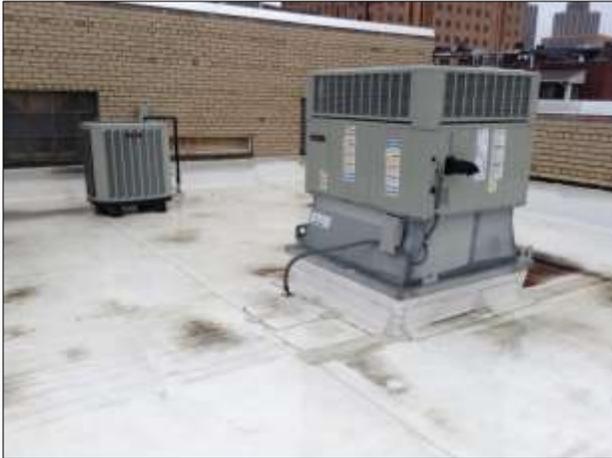
HVAC 1 – Packaged Roof-Top-Unit (RTU) -1

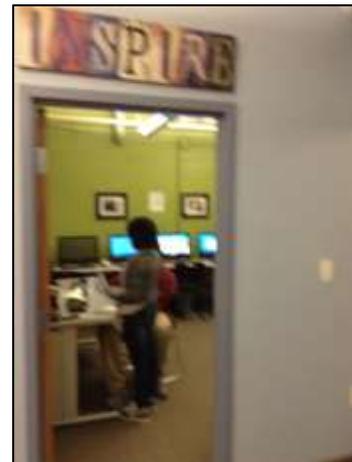
HVAC 17 – Computer lab (limited supply air) B07

5. Estimates: Suggested remedies and Opinion of probable cost
 - 5.1. Immediate Costs
 - 5.1.1. See GFI in Life Safety section.
 - 5.1.2. Add occupancy sensors for basement classroom and support spaces: \$1,300
 - 5.2. Short-Term Costs
 - 5.2.1. Add portable room filtration unit computer lab B07:

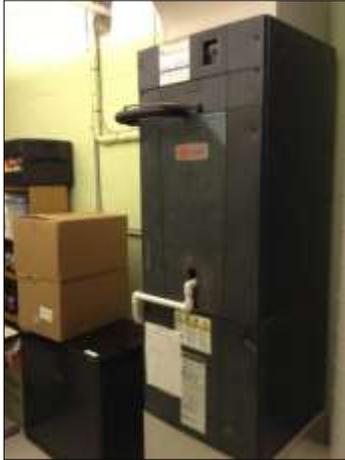
HVAC 18 – Air Handling Unit (AHU)

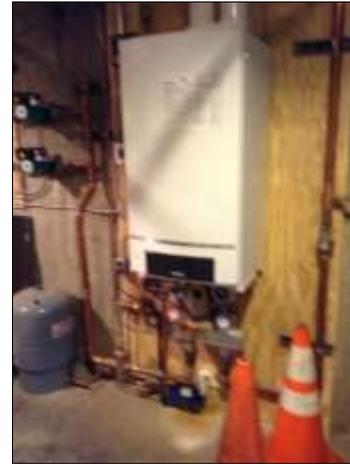
HVAC 19 – Hot water heating boiler - 1

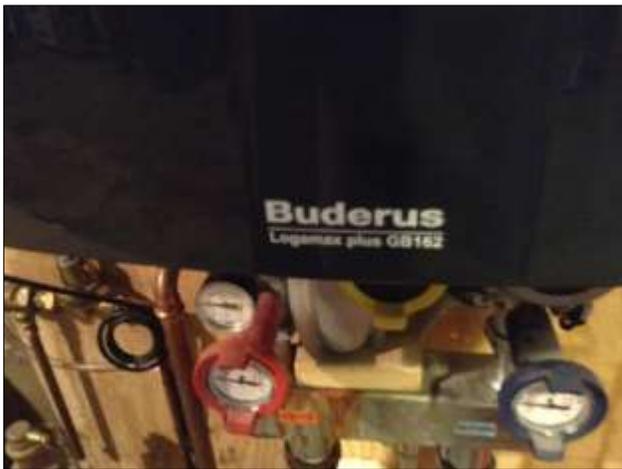
HVAC 20 – Hot water heating boiler - 2

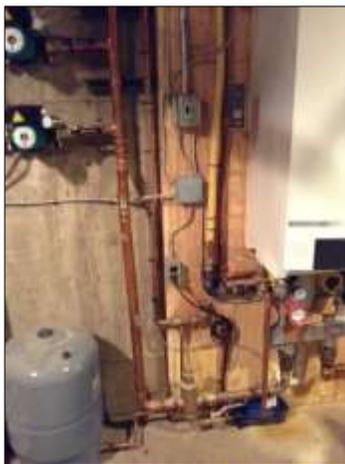
HVAC 22 – Hot water heating pumping and piping manifold

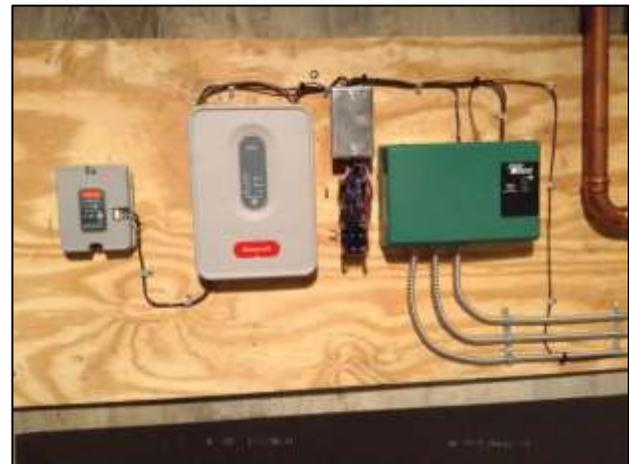
HVAC 23 – Digital control systems

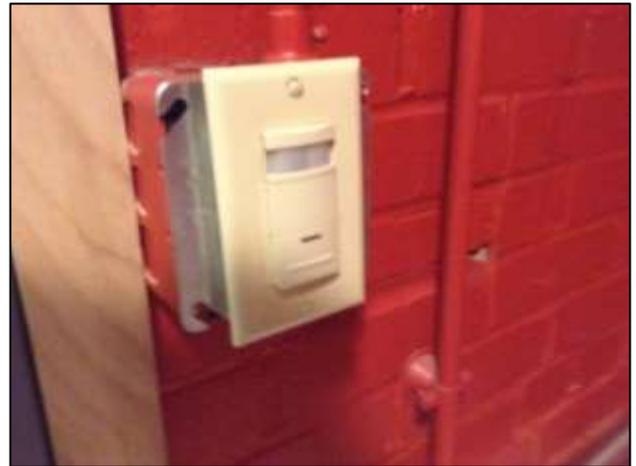
E10 – Occupancy detector (typical)

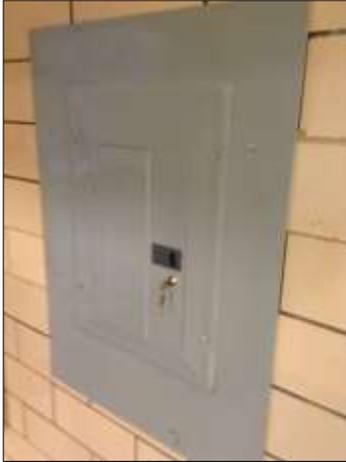
E13 – 1st Floor breaker panel - 1

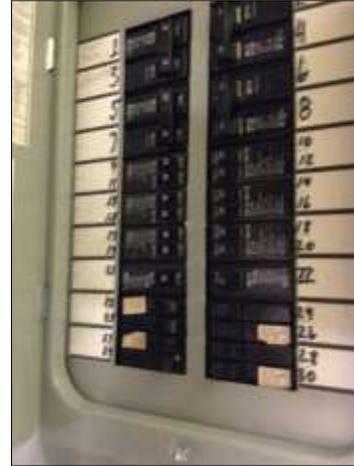
E14 – 1st Floor breaker panel - 2

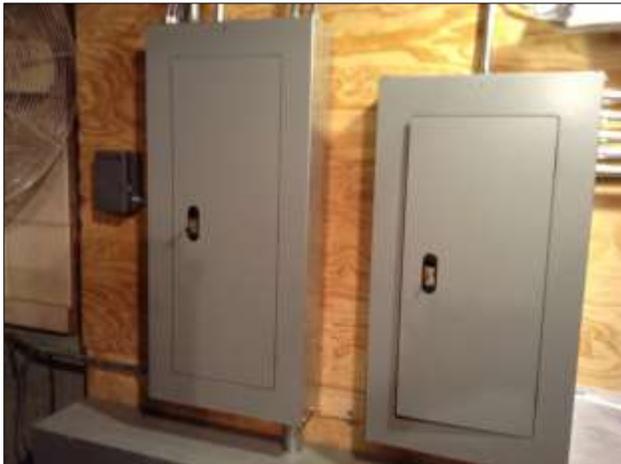
E15 – Basement power and breaker panels

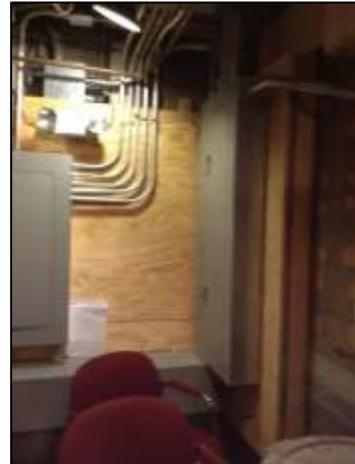
E16 – Electrical conduit

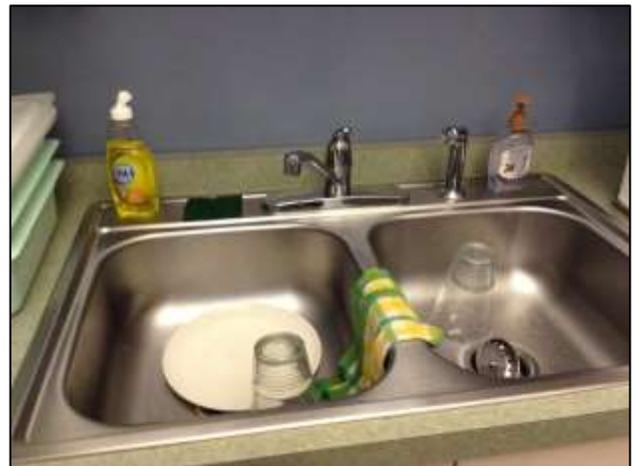
P4 – Kitchen sink (typical of 2)

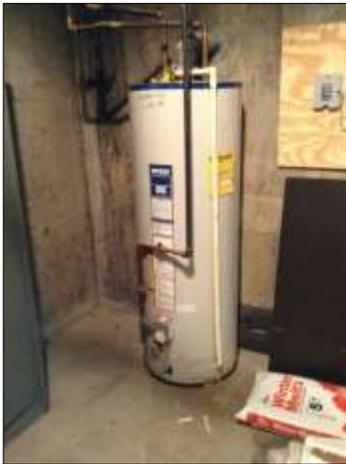
P5 – Domestic Water heater

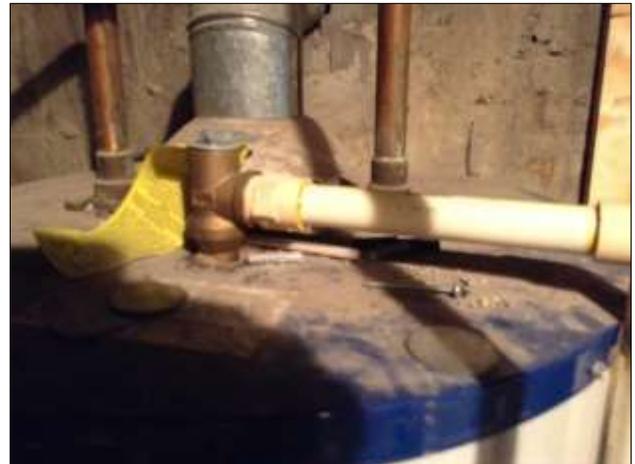
P6 – Domestic Water heater PRV and piping

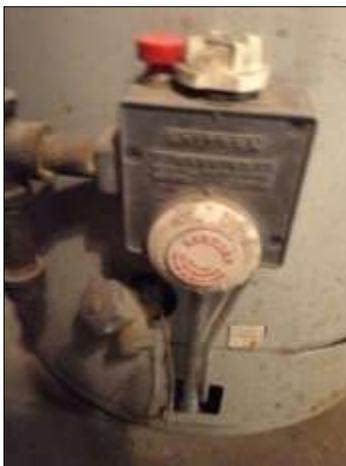
P7 – Domestic Water heater control

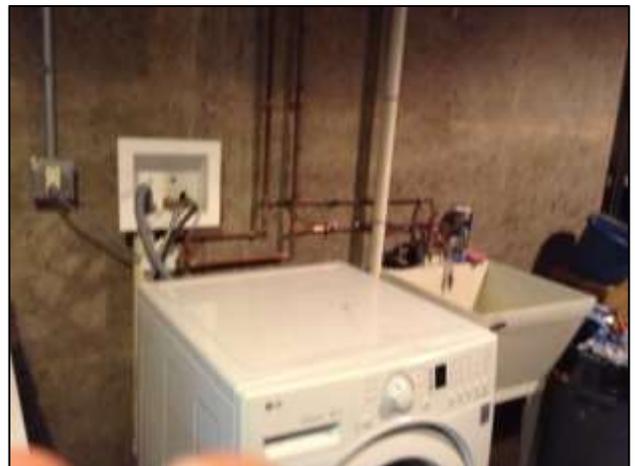
P8 – Basement Laundry

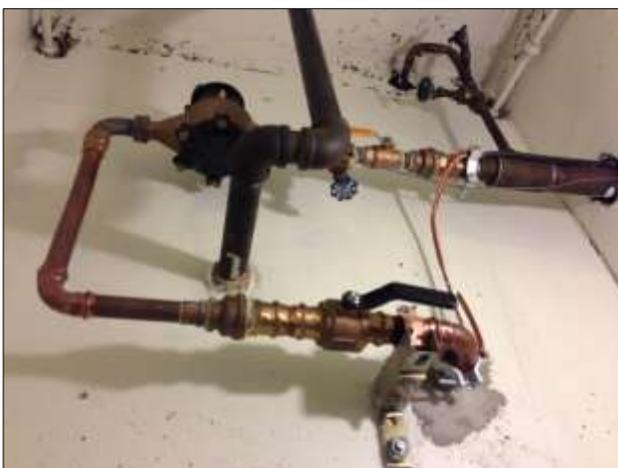
P9 – Water service: meter and shut-off

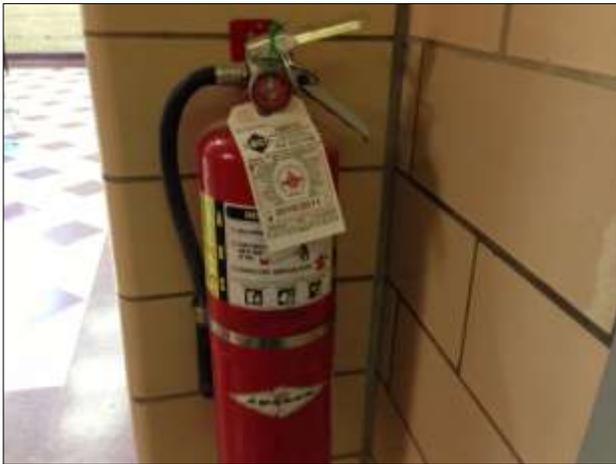
1. Fire Extinguishers
 - 1.1. Construction: One (1) fire extinguisher present, one (1) missing.
 - 1.2. Condition Assessment: **Derelict**
 - 1.2.1.1. Physical Deficiencies: One (1) missing unit
 - 1.2.1.2. Maintenance observations: One (1) expired testing date
2. Alarm Systems
 - 2.1. Construction Smoke Alarm: Two (2) observed smoke alarms present, one per floor.
 - 2.2. Condition Assessment Smoke Alarm: **Fair**
 - 2.3. No observable fire pull-stations present. **Potential Code Violation.**

FP 1 – Extinguisher (testing out-of date)

8. Estimates: Suggested remedies and Opinions of probable cost
 - 8.1. De Minimus Conditions
 - 8.1.1. Test fire extinguisher at Community room entrance.

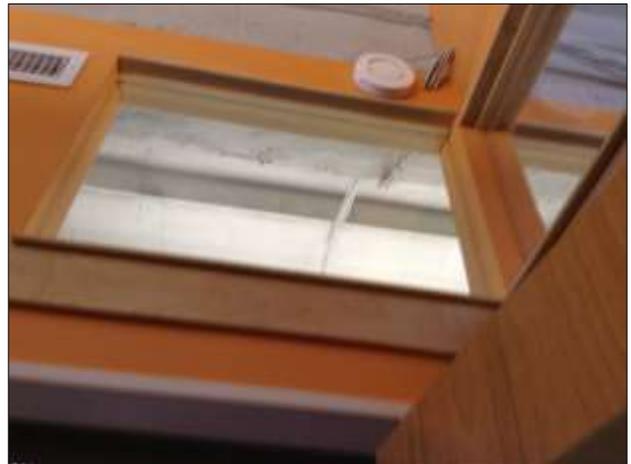
FP 2 – Basement classroom training area smoke detector B05

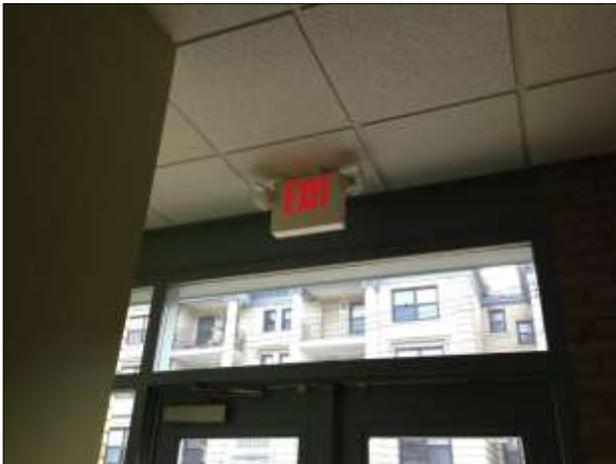
LS 1– First Floor emergency existing sign/light (typical)

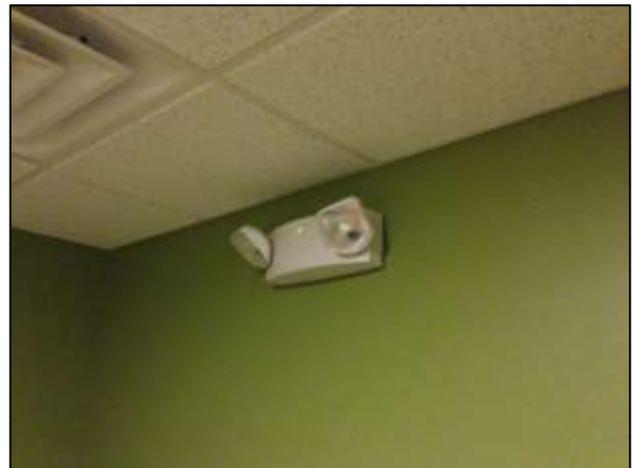
LS 2– Emergency light (typical)

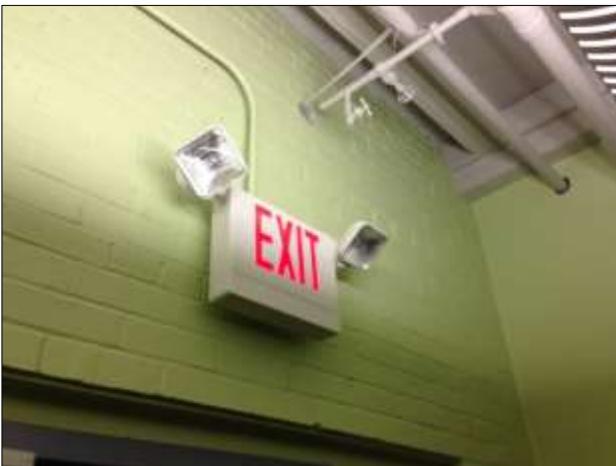
LS 3 – Basement emergency existing sign/light (typical)
